Investigation of Fatality,
Pipe Rack Finger Failure and Fall
South Marsh Island Block 93
OCS-G 21618
October 13, 2001

Gulf of Mexico
Off the Louisiana Coast

U.S. Department of the Interior
Minerals Management Service
Gulf of Mexico OCS Regional Office

New Orleans
October 2002

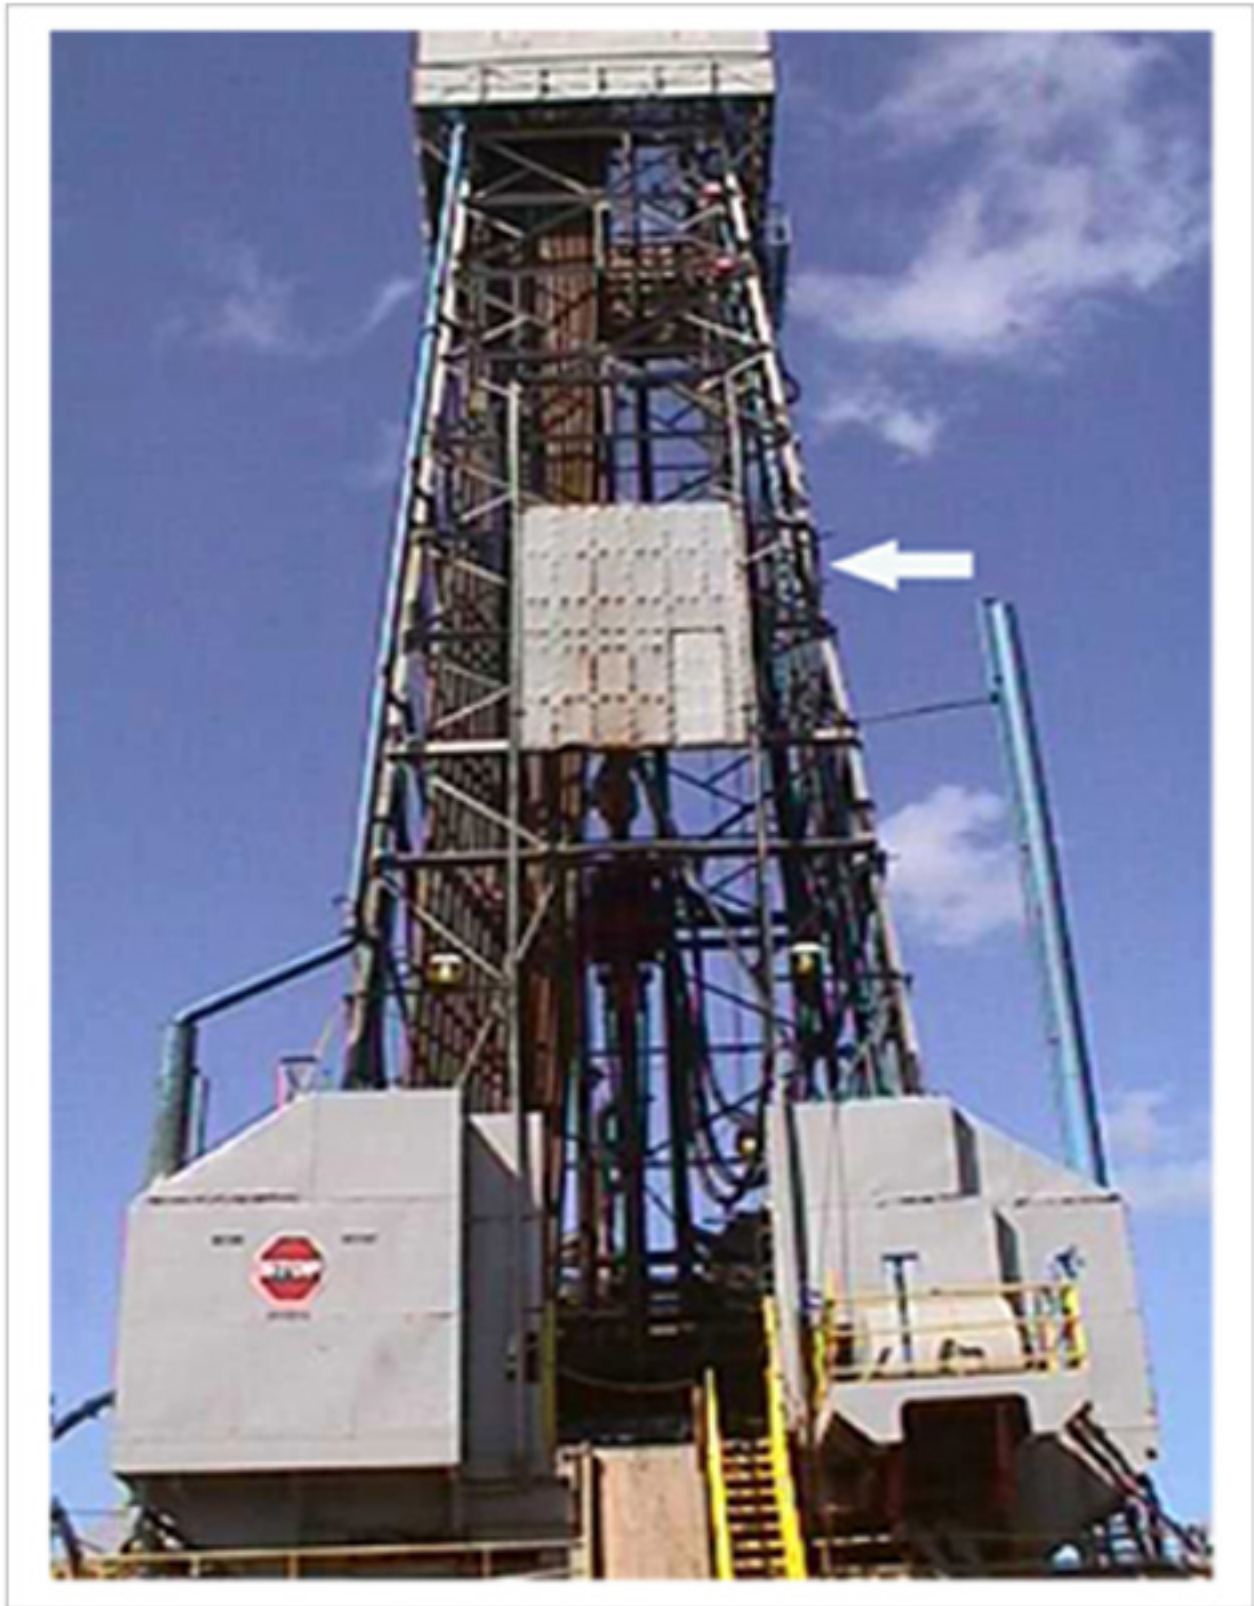
F-1 was standing between the stand of pipe and the mousehole when the nine-stand pipe rack finger holding the two stands of previously racked 3½-inch drill pipe fell approximately 85 feet to the rig floor (*see Attachment 2*). The pipe rack finger fell and apparently struck F-1 on the crown of his hard hat; hit F-2 on the right forearm, then fell onto the drill floor (*see Attachment 3*). F-1 fell onto the rotary table.

Pride Arizona: Location of Pipe Rack Fingers

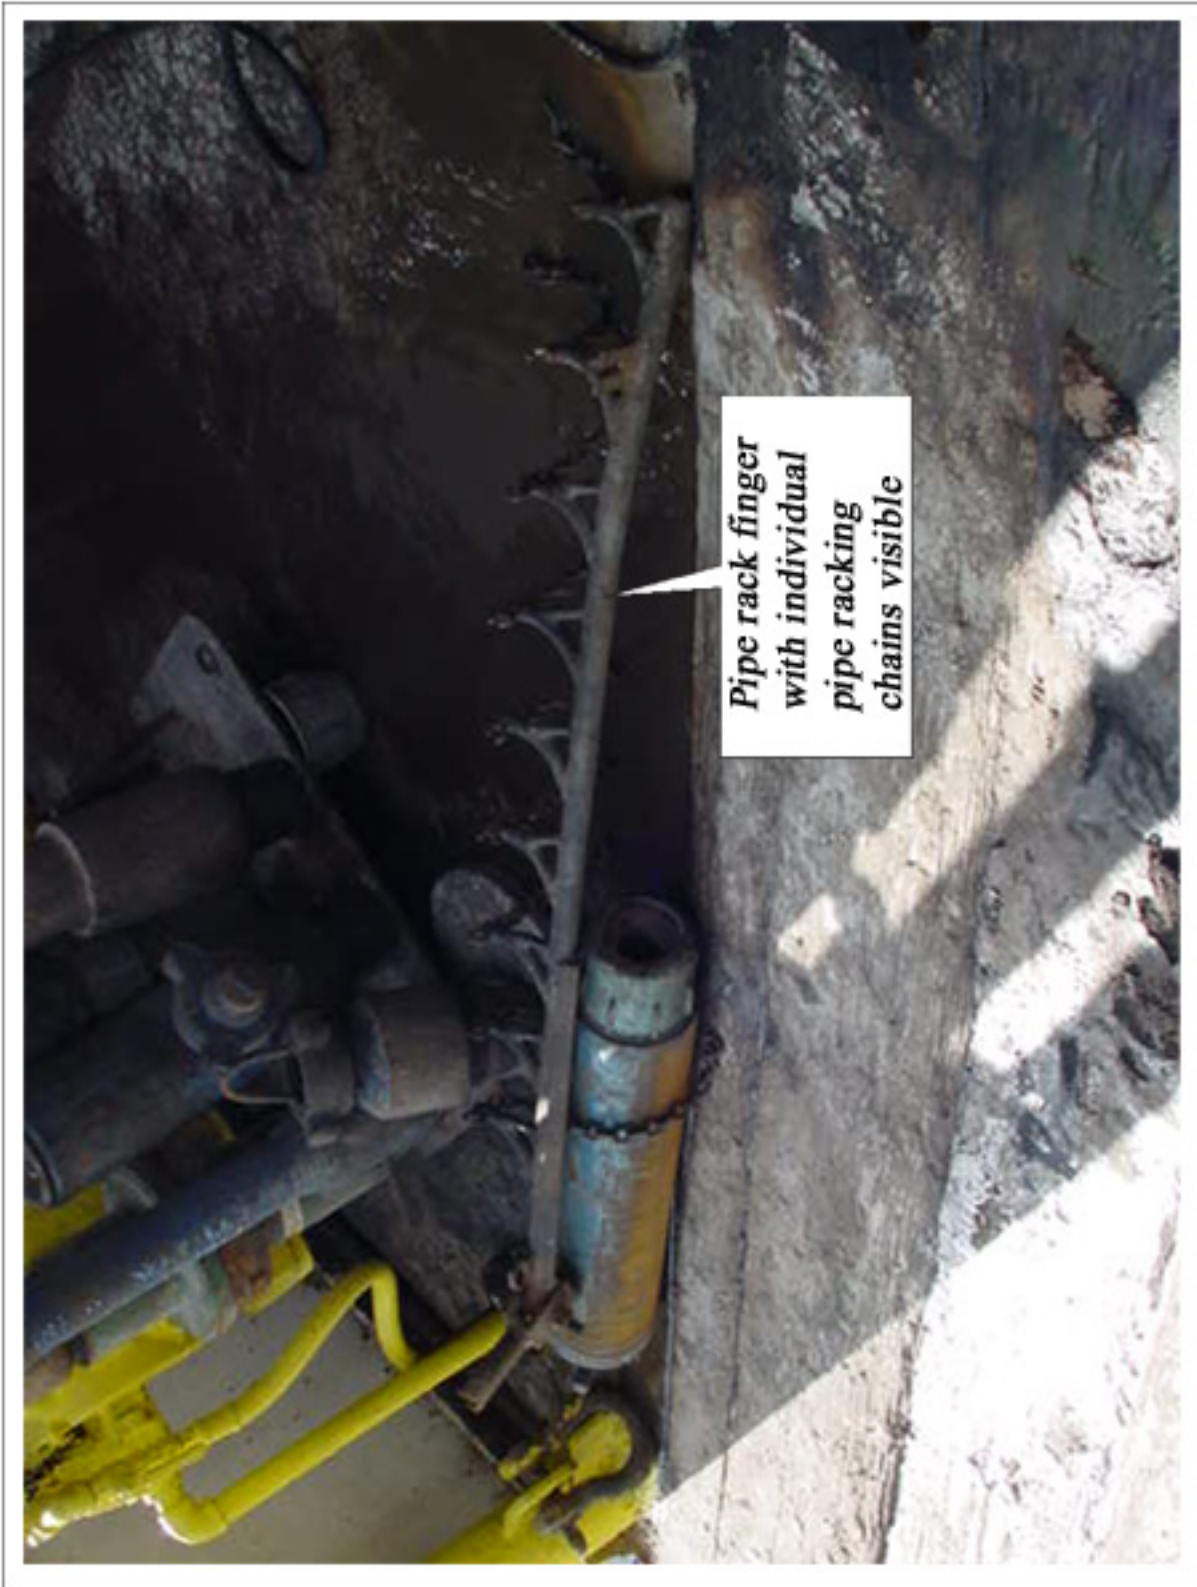
Fallen Pipe Rack Finger on Derrick Floor

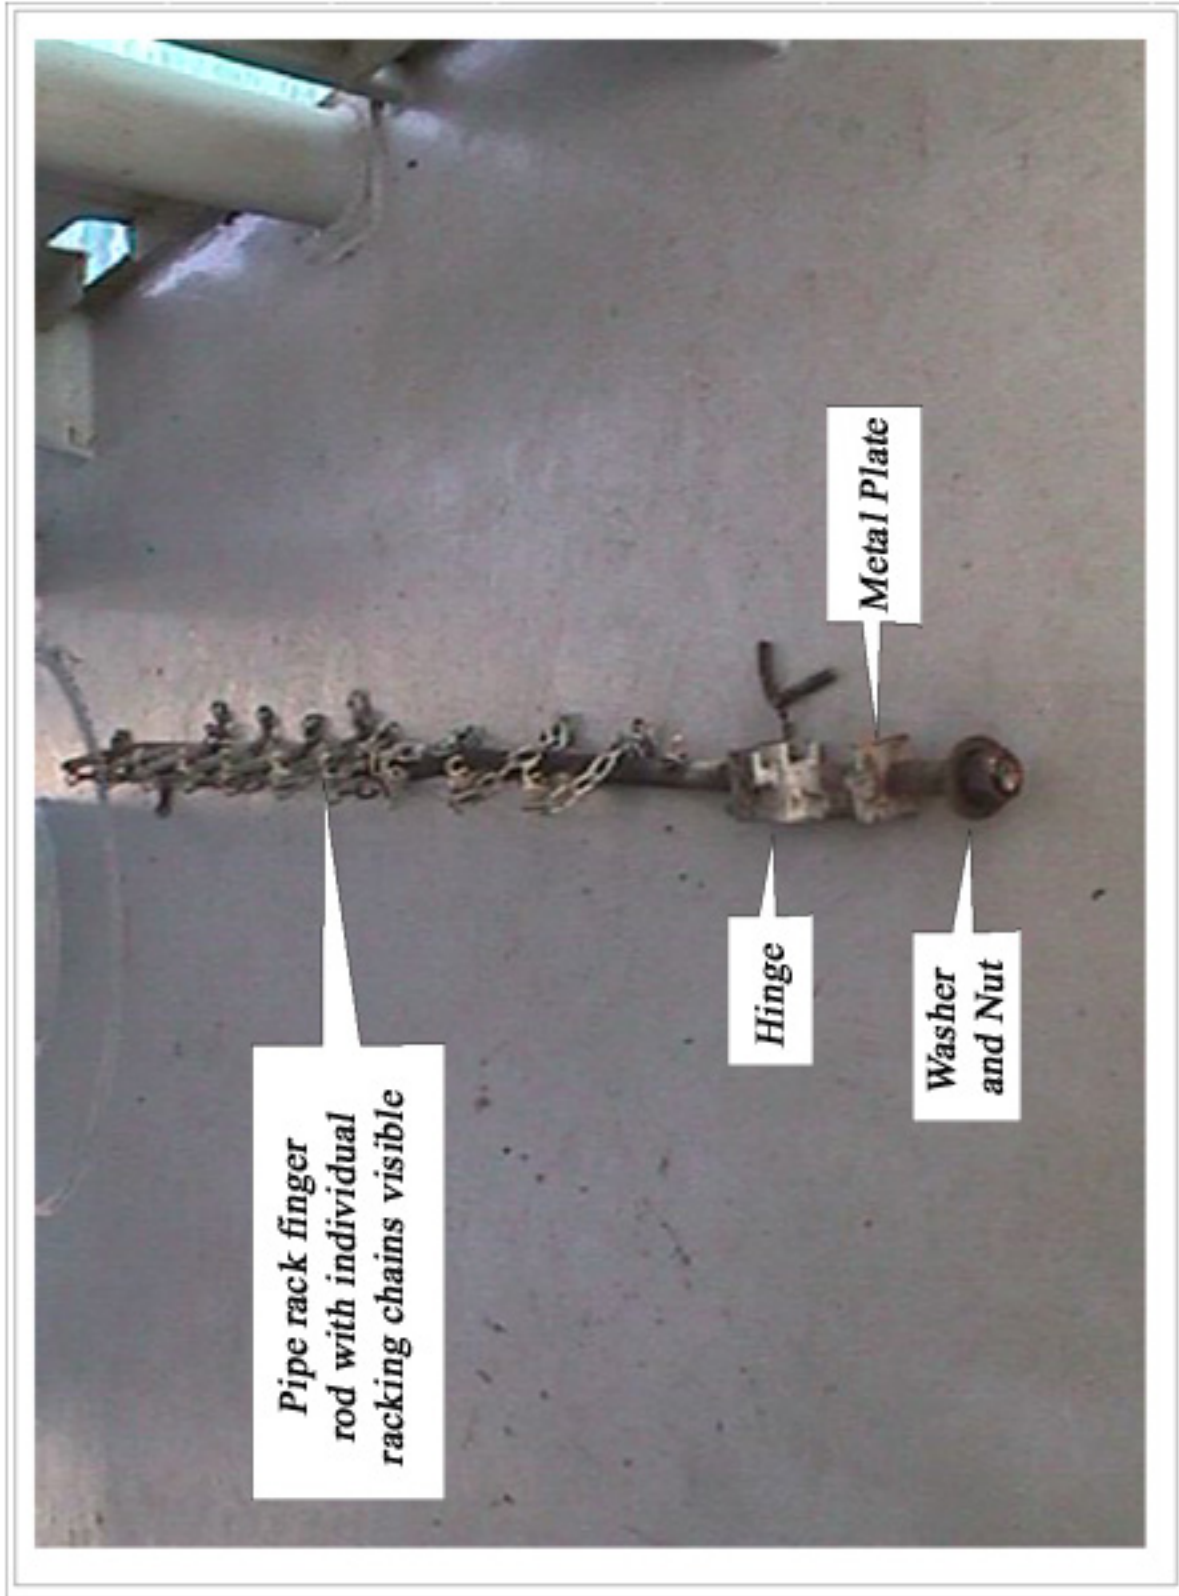
A Nine-stand Pipe Rack Finger Removed from the *Pride Arizona* after the Accident (not the one involved in the accident)

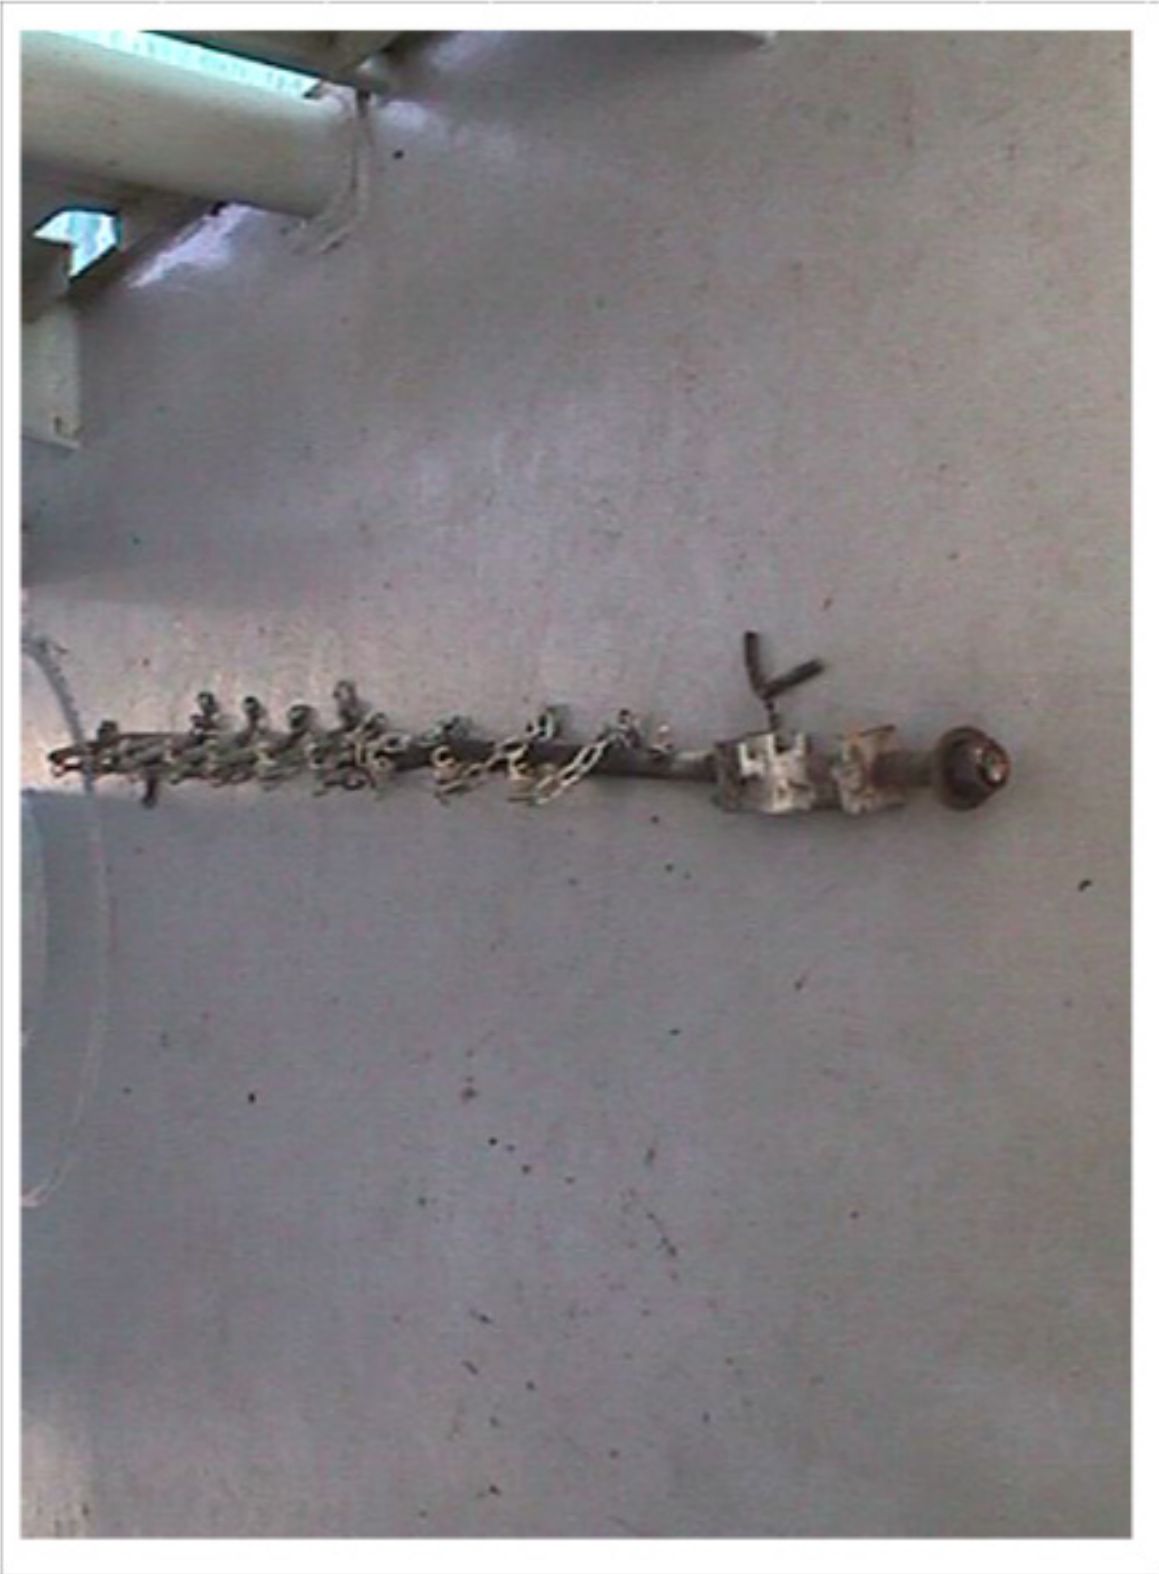
Description of Pipe Rack Fingers A typical nine-stand pipe rack finger on the *Marine 15/Pride Arizona* consists of an 8-foot long by 1¼-inch diameter solid bar that is attached and hinged to a 12-inch long by 1¼-inch diameter machined bolt. A piece of flat iron approximately 3-inch by 3-inch is welded at approximately the midway point onto the machined bolt. The machined bolt is equipped with the flat plate and a companion piece of flat plate, washer, and nut anchor the pipe rack finger to an 8-inch thick “I” beam, which is bolted to the derrick (*see Attachment 4 and 5*). The overall weight of the pipe rack finger is approximately 60-70 pounds. The hinge allows the pipe finger to be raised and secured out of the way when

Fallen Pipe Rack Finger

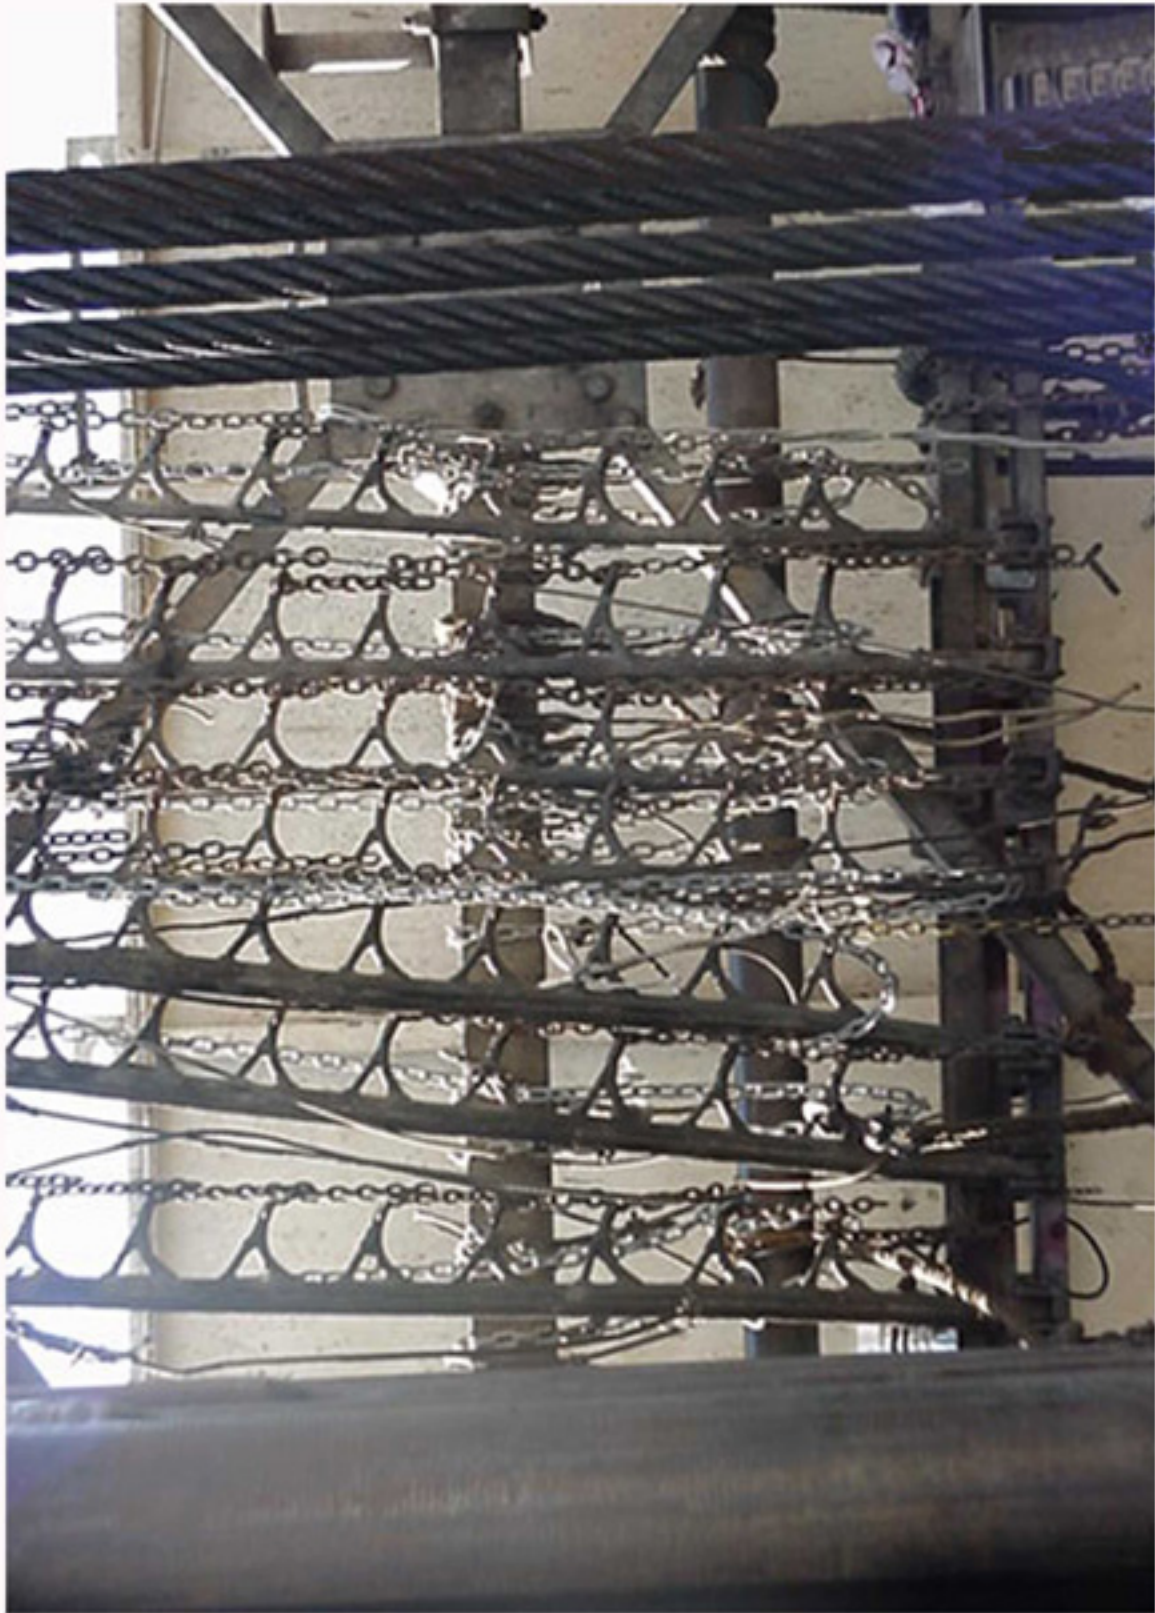
not in use (*see Attachment 6*). When in use, the pipe rack finger is lowered at the hinge. As each stand of pipe is racked against the pipe finger, it is chained to the finger. Each pipe rack finger is also supposed to be equipped with a safety chain attaching the pipe rack finger to the derrick. This safety chain is installed to prevent the pipe rack finger from falling from the derrick should the pipe rack finger break or become detached from the derrick (*see Attachment 7*).

Pipe Rack Fingers and Chains, Secured Position on the Pride Arizona

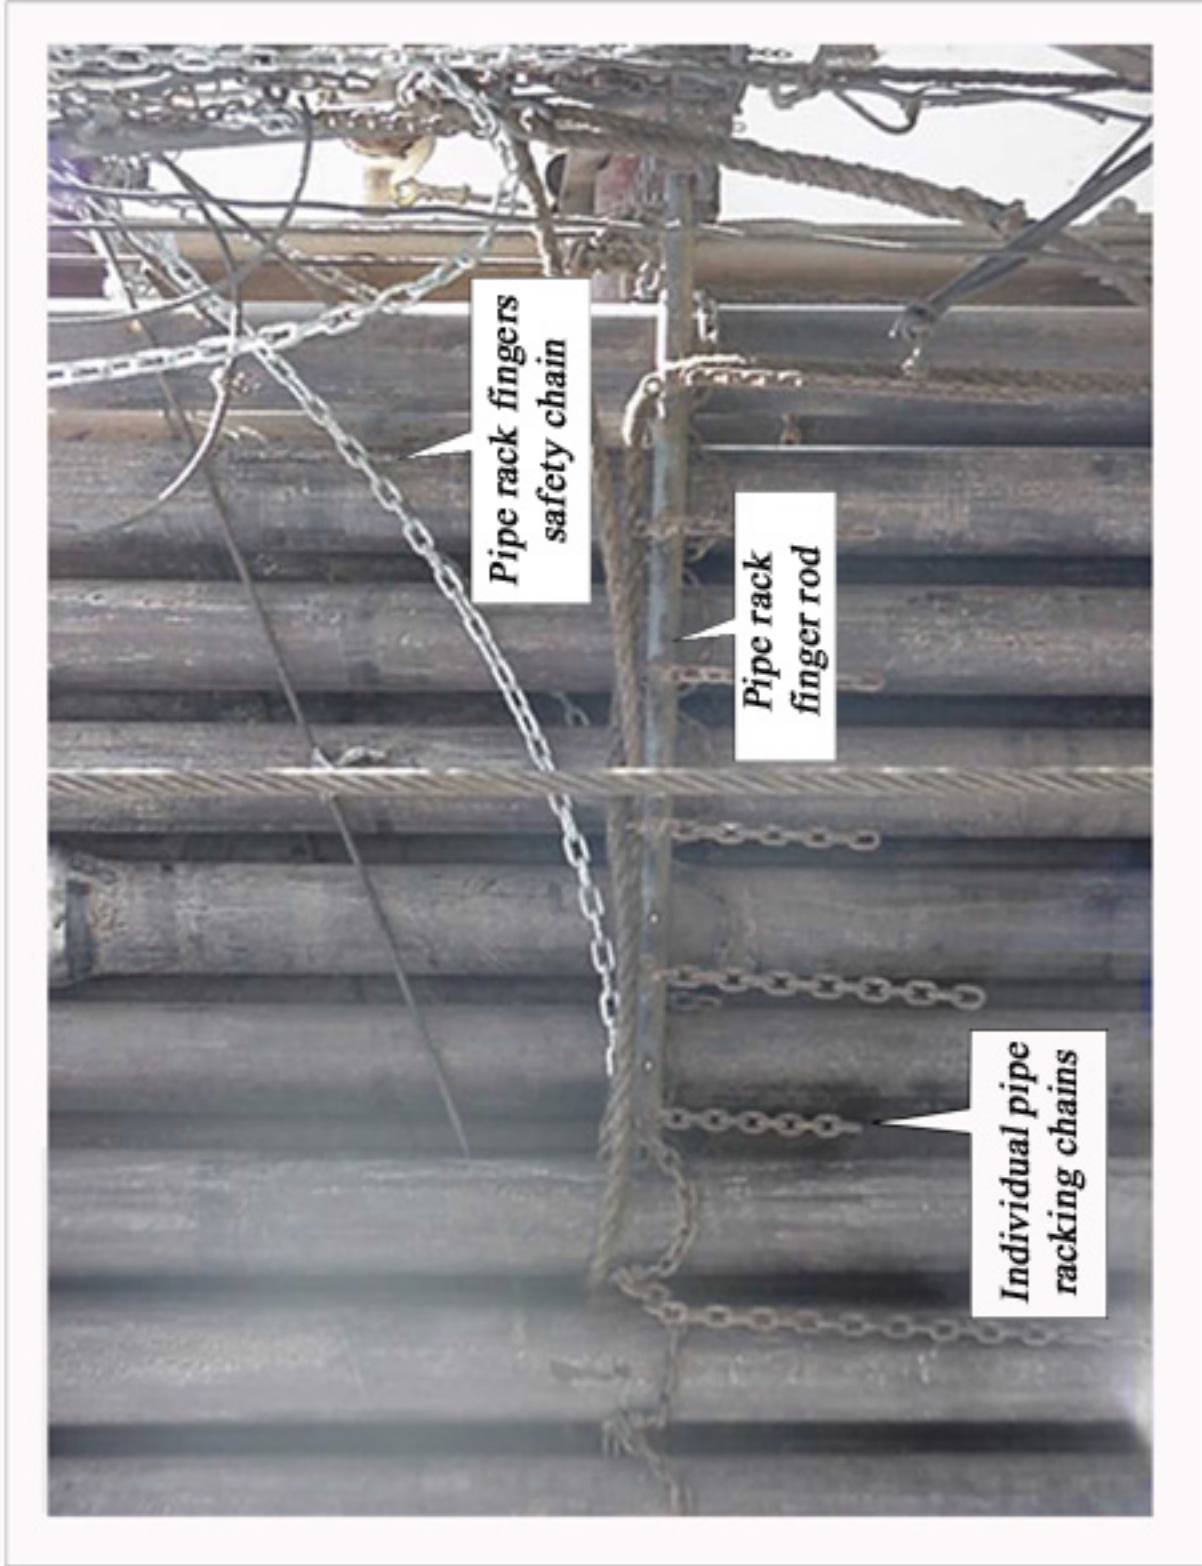
During the investigation, MMS investigators also discovered that there was no safety chain attaching the pipe rack finger to the derrick. Thus, when the metal rod failed, the pipe rack finger fell to the floor.

Example of a Pipe Rack Finger Holding Pipe on the *Pride Arizona* at the Time of the Accident

- a. Written policies and procedures for inspection, maintenance/repair, and replacement of pipe rack fingers;
 - b. Use of safety chains or other devices/methods to secure all pipe rack fingers and prevent them from falling from the derrick;

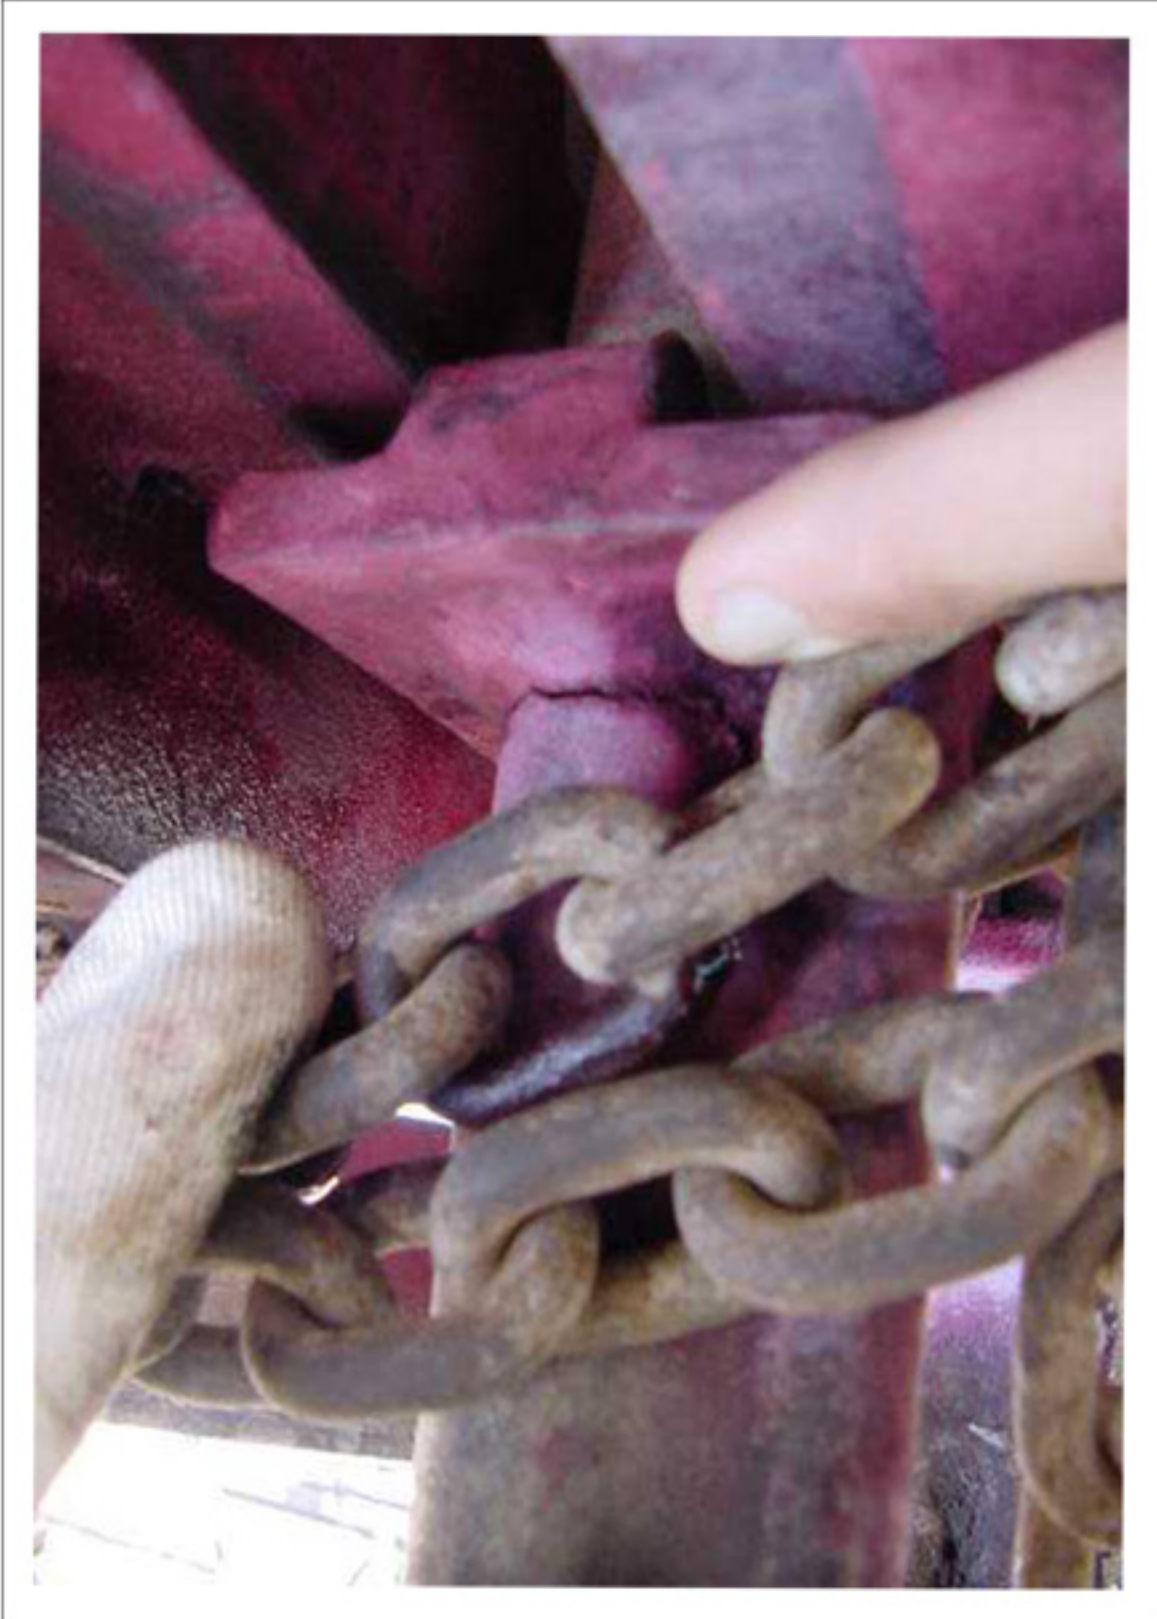
- All the bolts attaching the derrick legs to the shoes show severe corrosion; base shoe bolts are also badly corroded; some have been changed out with studs and nuts; all bolts in the derrick are corroded; a large number of the bolts are too short; the locks on lock nuts are not making sufficient contact to properly lock.
- Braces in the space above the V-door need replacing.
- At least two other fingers appear to be cracked in the same area as the one that fell (*see Attachment 8*).
- Most of the fingers have been repaired or worked on.

- Derrick – Finger pin welds (Fwd) – all welds cracked at pin;
- Derrick – Finger pin welds (Aft) – all welds are cracked and some have been repaired using all-thread rod that was welded to existing stock.

Example of a Cracked Weld on a Pipe Rack Finger Installed on the *Pride Arizona* at the Time of the Accident. (Note: This picture was obtained by MMS during the investigation. It was not taken from the inspection report prepared by Universal Marine Inspections)

- A complete new set of bolts be installed within 90 days,
- Braces in spacing above the V-door be replaced, and
- A complete new set of fingers be installed.

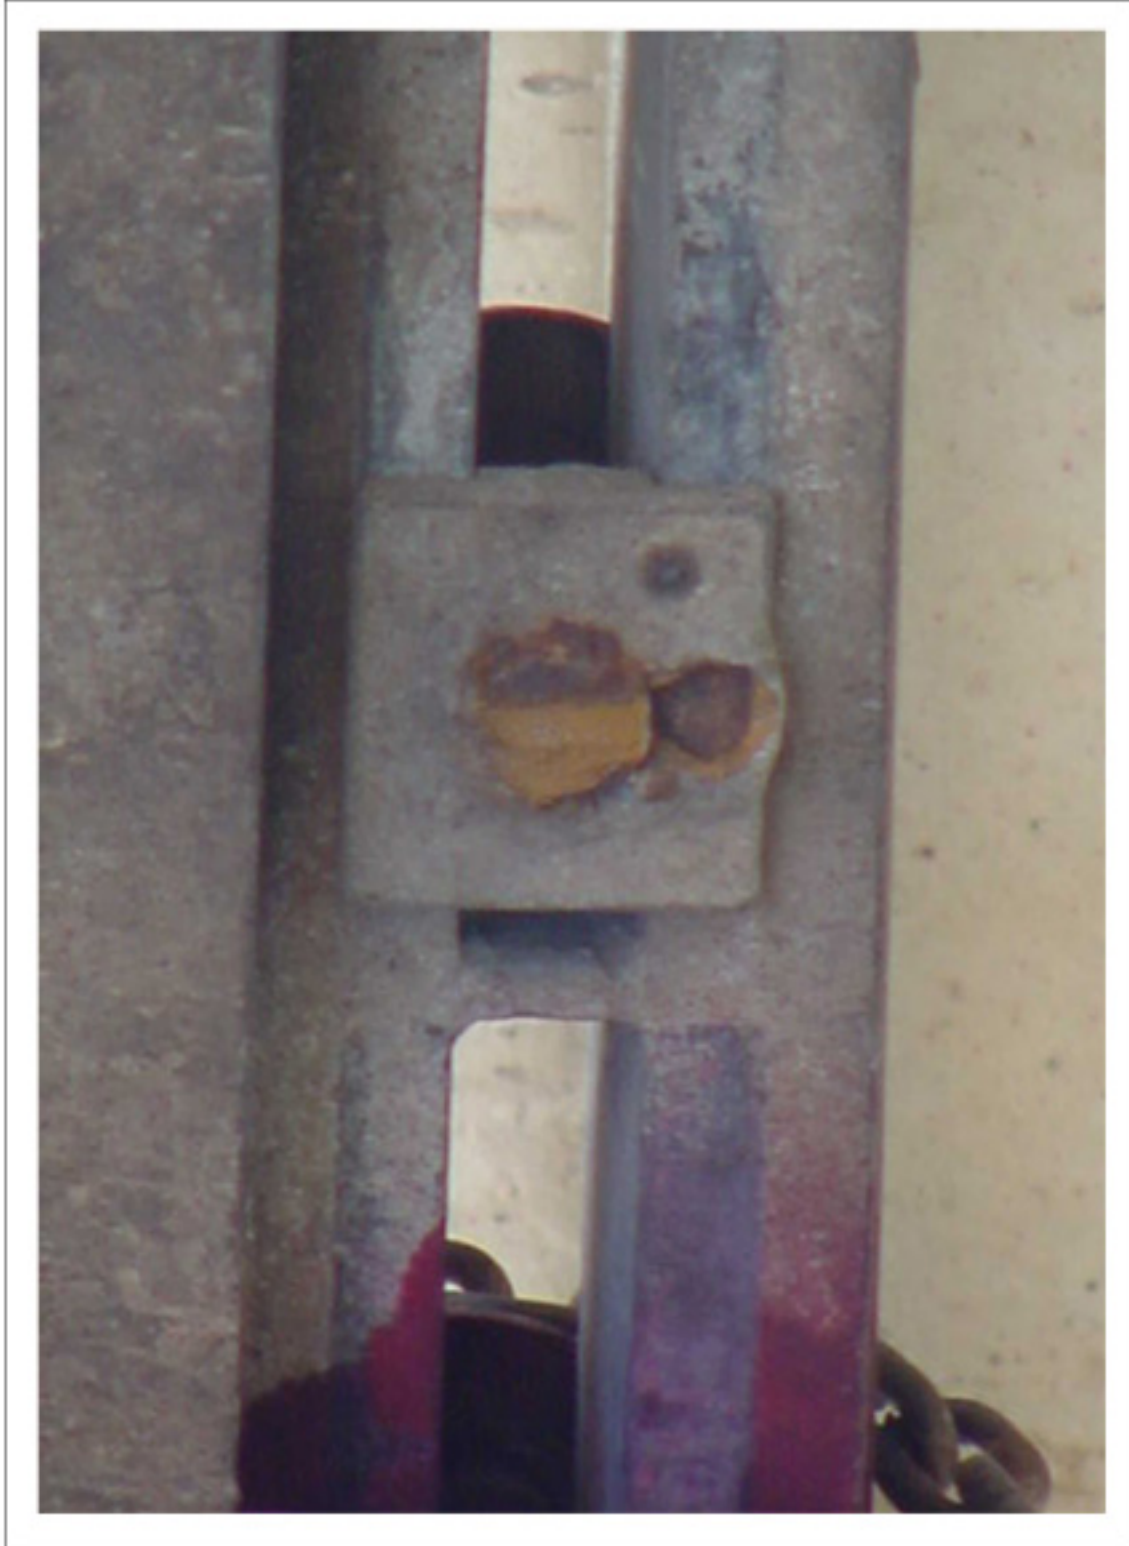
From the investigators' examination of the pipe racking area in the derrick and examination of the pipe rack finger that failed, the investigators observed that the metal rod attaching the finger to the derrick broke next to the 3x3 metal plate. This left the plate and the rod attached to the "I" beam in the derrick (*see Attachment 9*). The break showed irregularity along the face and indications of corrosion (*see Attachment 10*). A piece of ½ inch by 3 feet angle iron was welded along the metal rod of the finger to keep the rod from bending. A second short metal rod had been welded beneath the main rod between the metal plate and the hinge. This rod also broke away from the metal plate as shown in Attachments 9, 10, and 11. MMS requested copies from the Operator of any metallurgical analyses that were done on the broken pipe rack fingers or other pipe rack fingers that were removed after the accident. The only information given to MMS was the results of post-accident magnetic particle inspection of the pipe fingers. These inspection results did not provide any information as to the cause of the metal rod failure.

Base-End of Broken Pipe Rack Finger still Attached to Derrick after the Accident

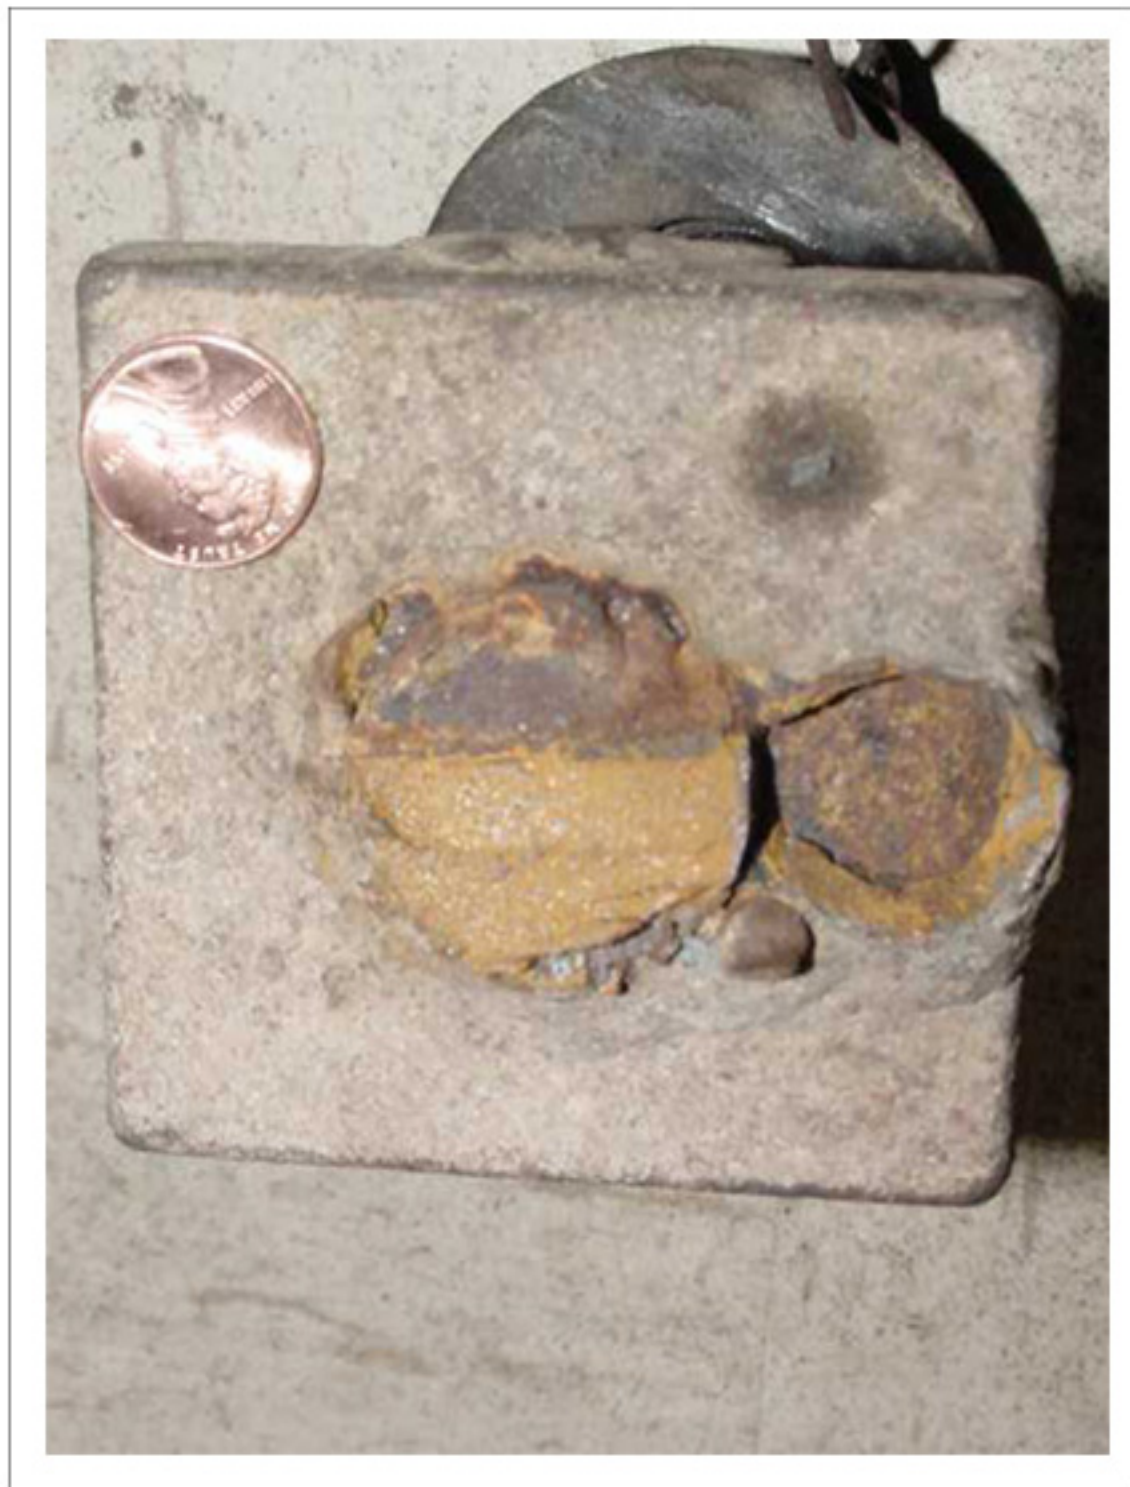
Base-End of the Broken Pipe Rack Finger Removed from the Derrick after the Accident.

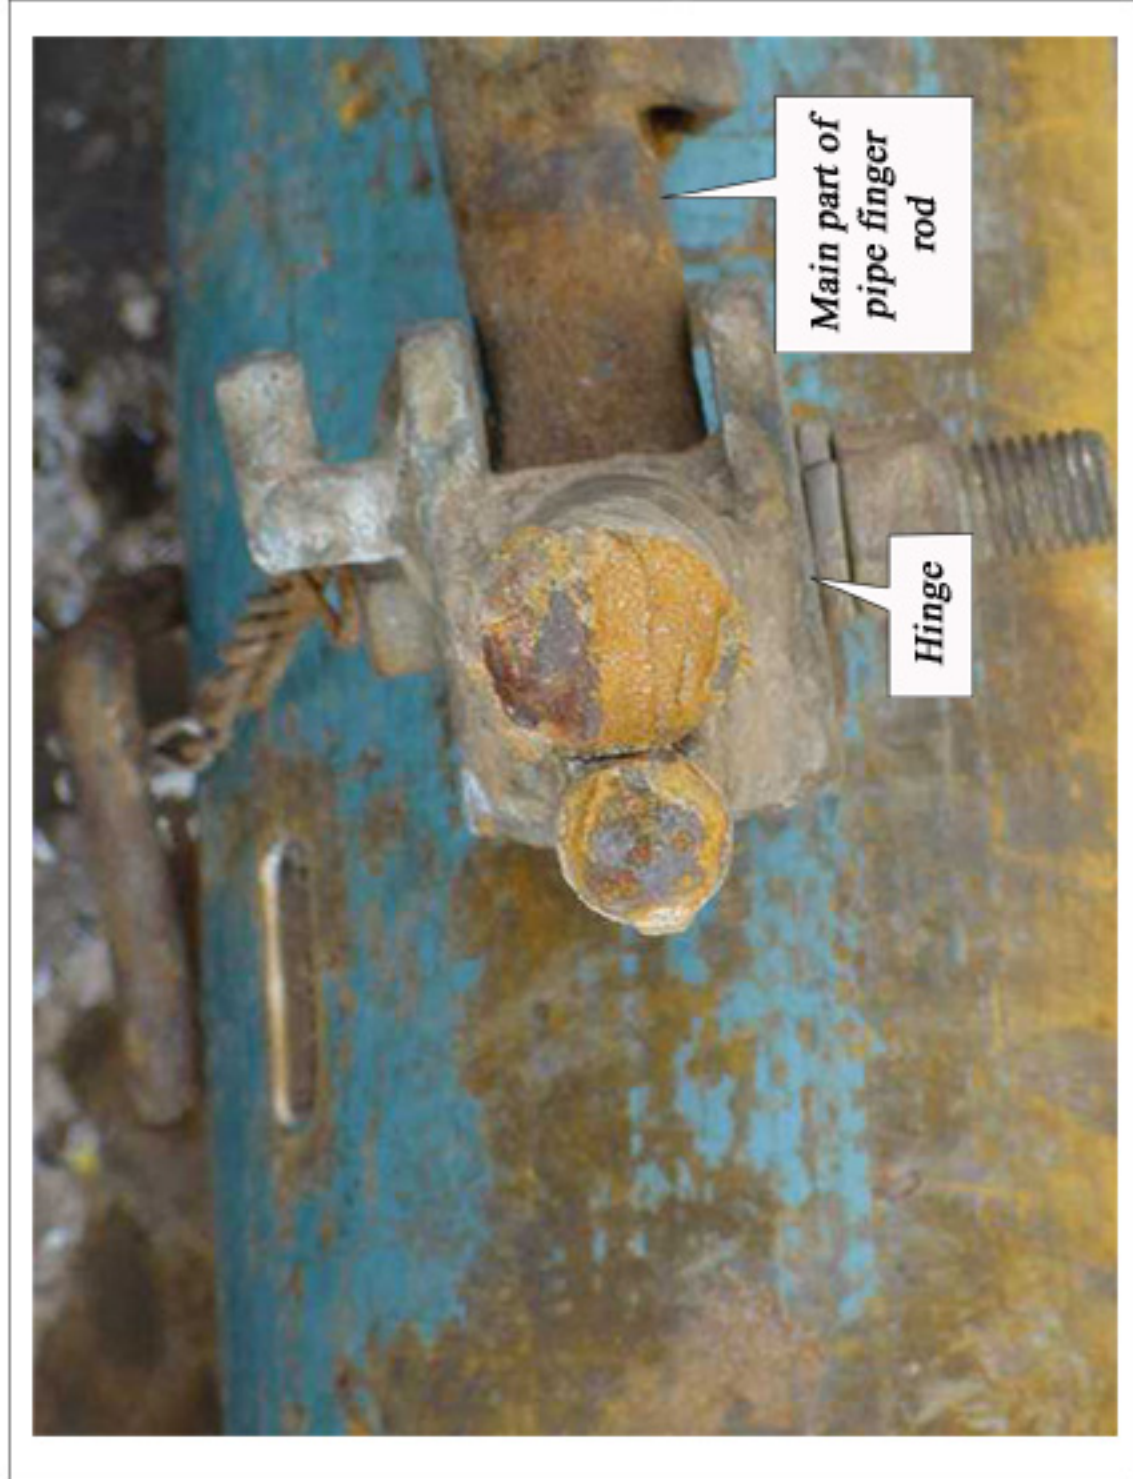
Causes The accident was a result of the failure of the metal pipe rack finger rod and the absence of a safety chain to prevent the pipe rack finger from falling to the rig floor. The associated failure of the Contractor to detect the missing safety chain and the unsafe condition of the pipe rack finger prior to the accident was also a cause of the accident.

Broken End of Pipe Rack Finger-Part that Fell from the Derrick.
