**Investigation of Blowout, Injuries, & Fatality,
Brazos Block 417
OCS-G 22190, Well 1
July 13, 2001**

Gulf of Mexico
Off the Texas Coast

U.S. Department of the Interior
Minerals Management Service
Gulf of Mexico OCS Regional Office

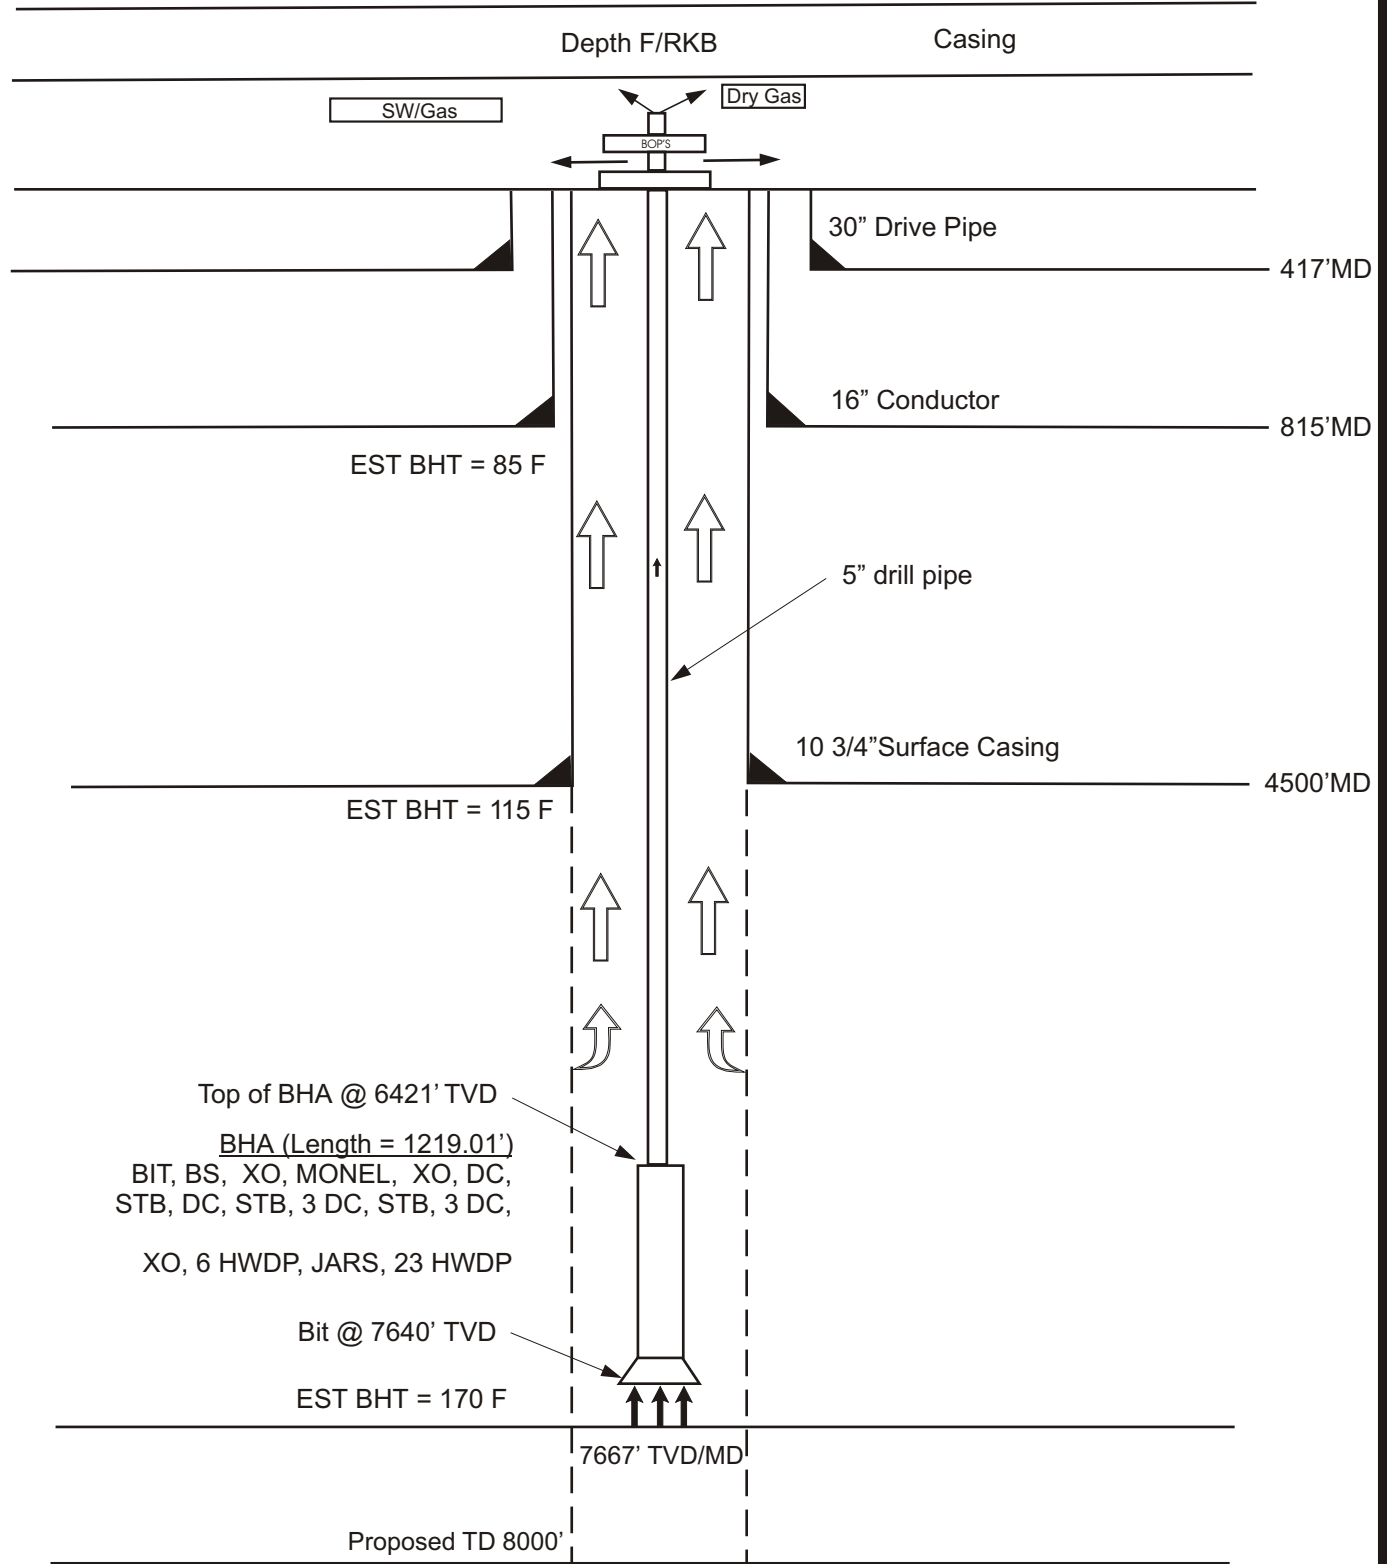
WellBore Schematic, Well No.1

with no cement returns. A 1¼-inch wash string was run into the annulus to 320 feet or 120 feet below the mudline, and a 50-sack cement top job was performed. The new wellhead and BOP's were nipped up to the A section. The BOP's were tested to 3,500 and 5,000 psi, and the casing was tested to 2,600 psi as per the MMS-approved APD. A new drilling bottomhole assembly (BHA) with a 9⅞-inch bit (excluding a float valve) was made up for drilling the production hole. During interviews with the day pusher *Marine IV*, the day driller *Marine IV*, and the night pusher *Marine IV*, they said that night drilling supervisor for ADTI told them to leave the float valve out of the new bottomhole assembly for drilling the production hole. (A float valve had been run in the bottomhole assembly while the surface hole was being drilled.) During interviews with Helis and ADTI, it was stated there was no policy requiring the use of a float valve during drilling through a gas zone below surface casing. After the 10¾-inch surface casing shoe was drilled out of, the leak-off test (LOT) failed, and the shoe was squeezed with 250 sacks of cement and retested. The 10¾-inch surface casing shoe was then successfully tested to an equivalent mud weight (EMW) of 13.8 pounds per gallon (ppg) LOT. Helis's contract drilling engineer from PPI said during his interview that a loss returns zone at around 4,200 feet might have affected the cement job on the 10¾-inch casing. *For wellbore schematic, see Attachment 2.*

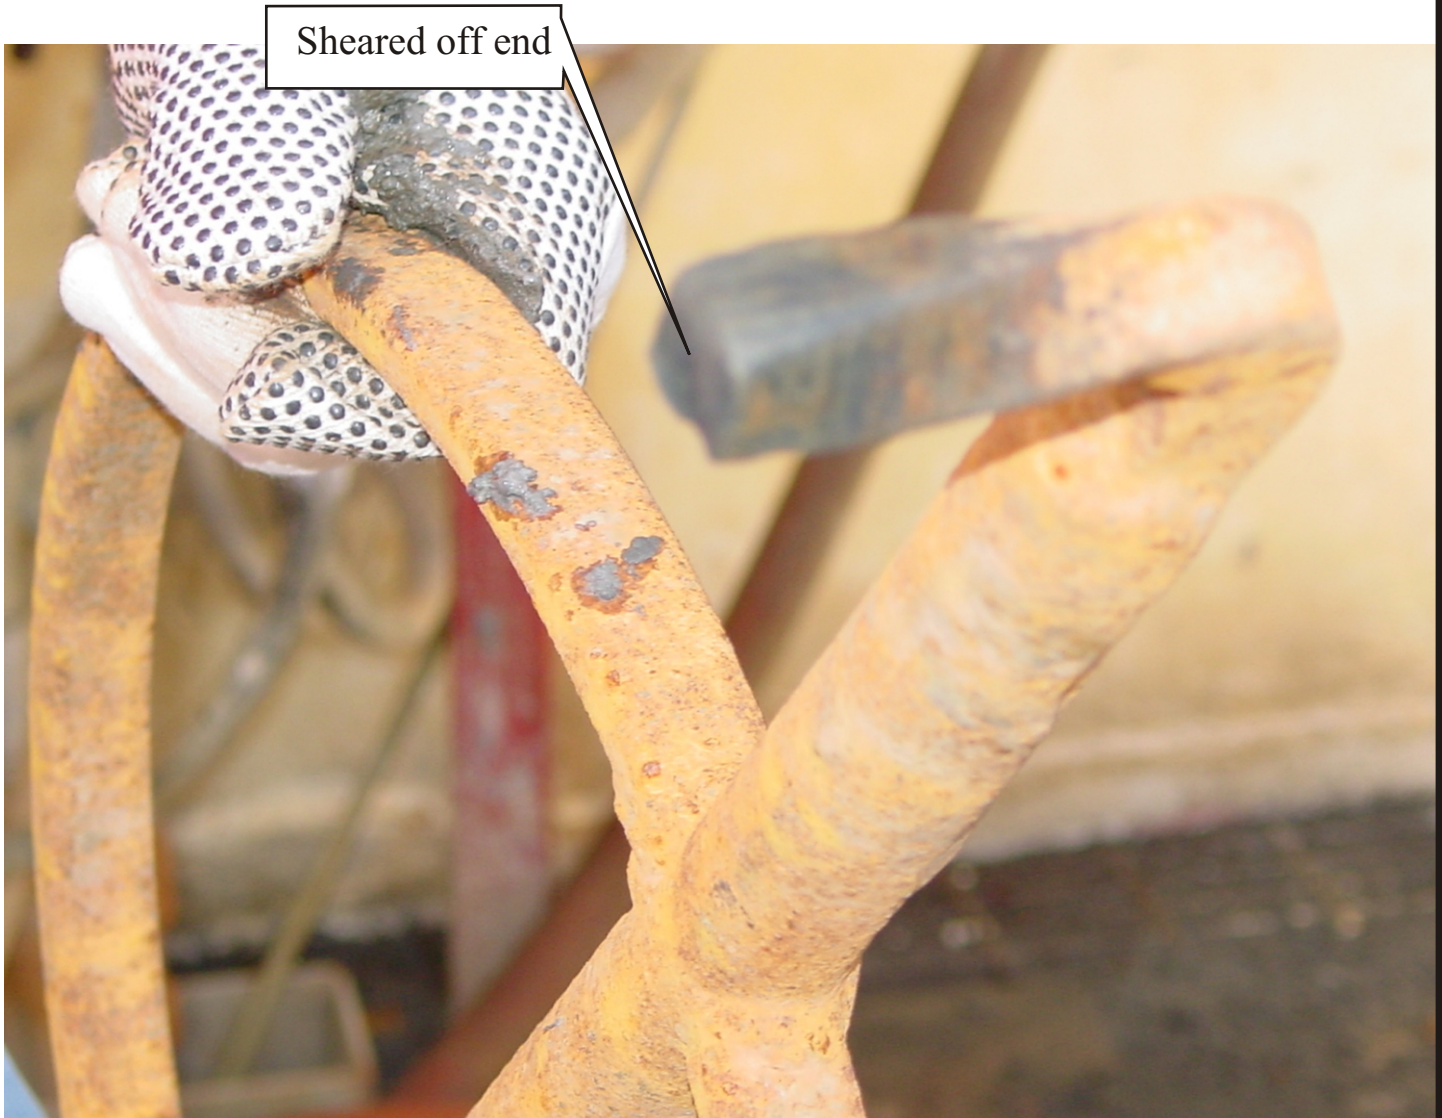
Photo of Valve Handle

July 13, 2001 - The rig floor safety valve was stabbed. The valve would not close with two men applying torque to the handle. The mud flowline temperature was approximately 150° Fahrenheit and the two men were burned on their arms and back. A third man assisted in the attempt, and sufficient torque was applied to the closing handle to shear it off at in the key opening of the valves. *For photos of valve handle and*

sheared off portion, see Attachments 4 and 5, respectively. When the valve was recovered later, the shear direction of the key indicated that the valve was being turned in the correct direction. Because of the hot temperature of the mud, the men had to put on slicker suits and be sprayed with water to continue working on the rig floor. While being sprayed with water, the floor hands removed the rig floor safety valve and attempted to stab the kelly, but the mud flow was too strong and too hot for them to be able to stab the pipe. The mudflow increased until it was shooting over the top of the derrick. Gas began to flow with the mud from the drill pipe, and it became unsafe to continue work on the rig floor. The rig abandonment alarm was sounded at 0425 hours.

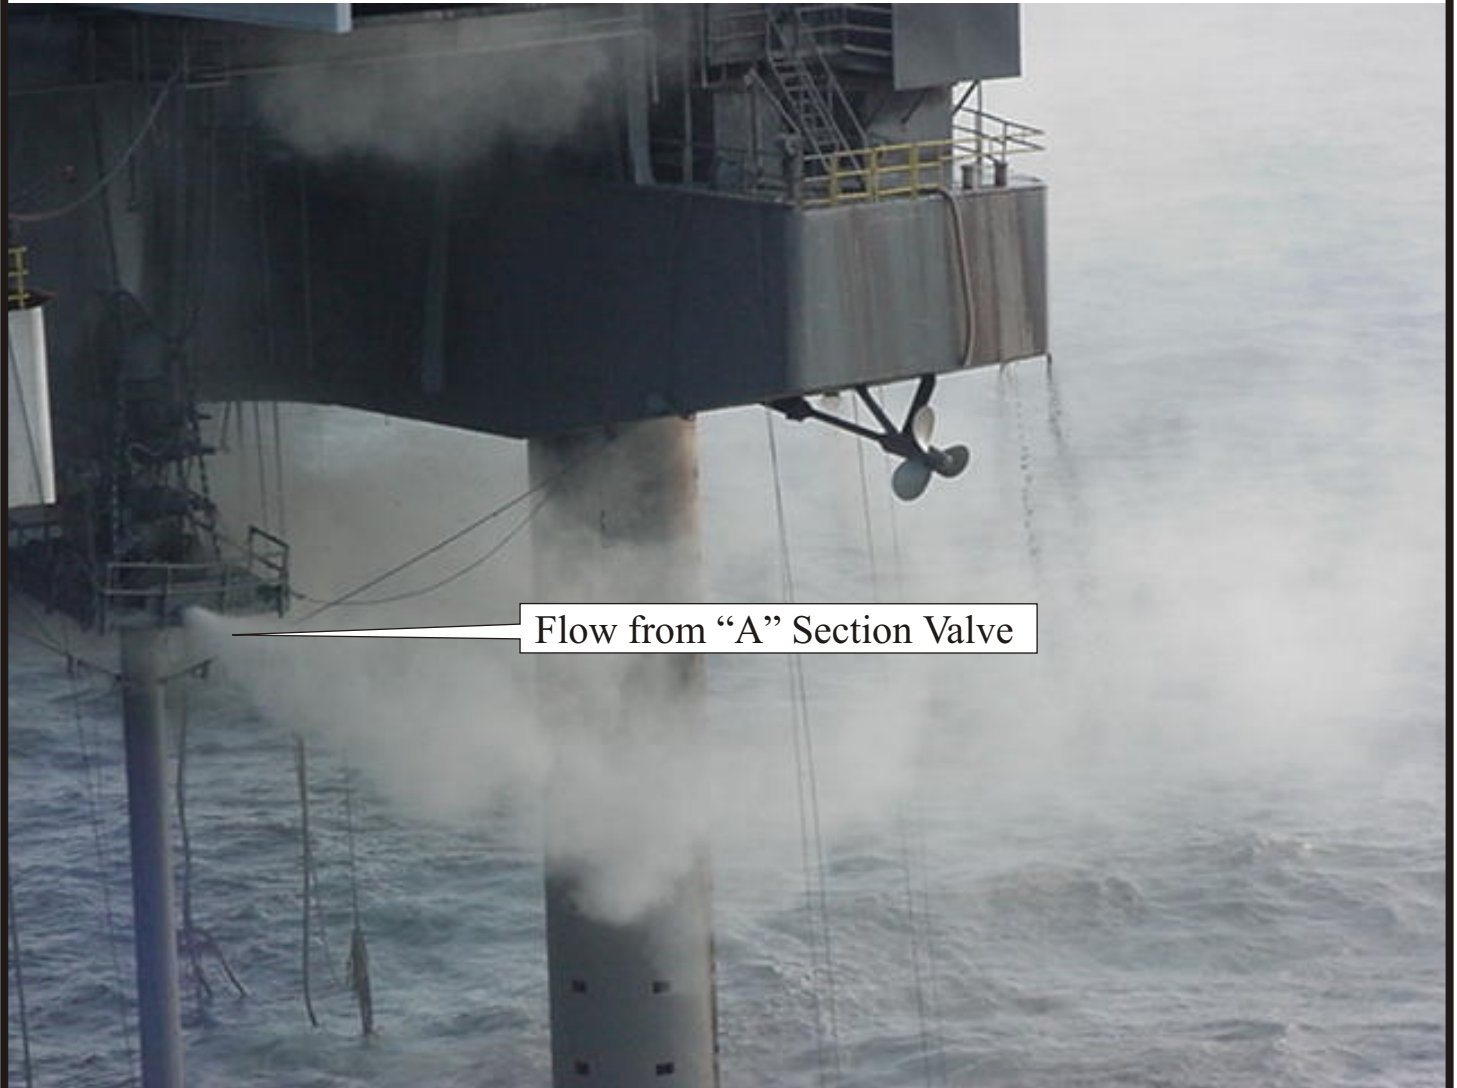
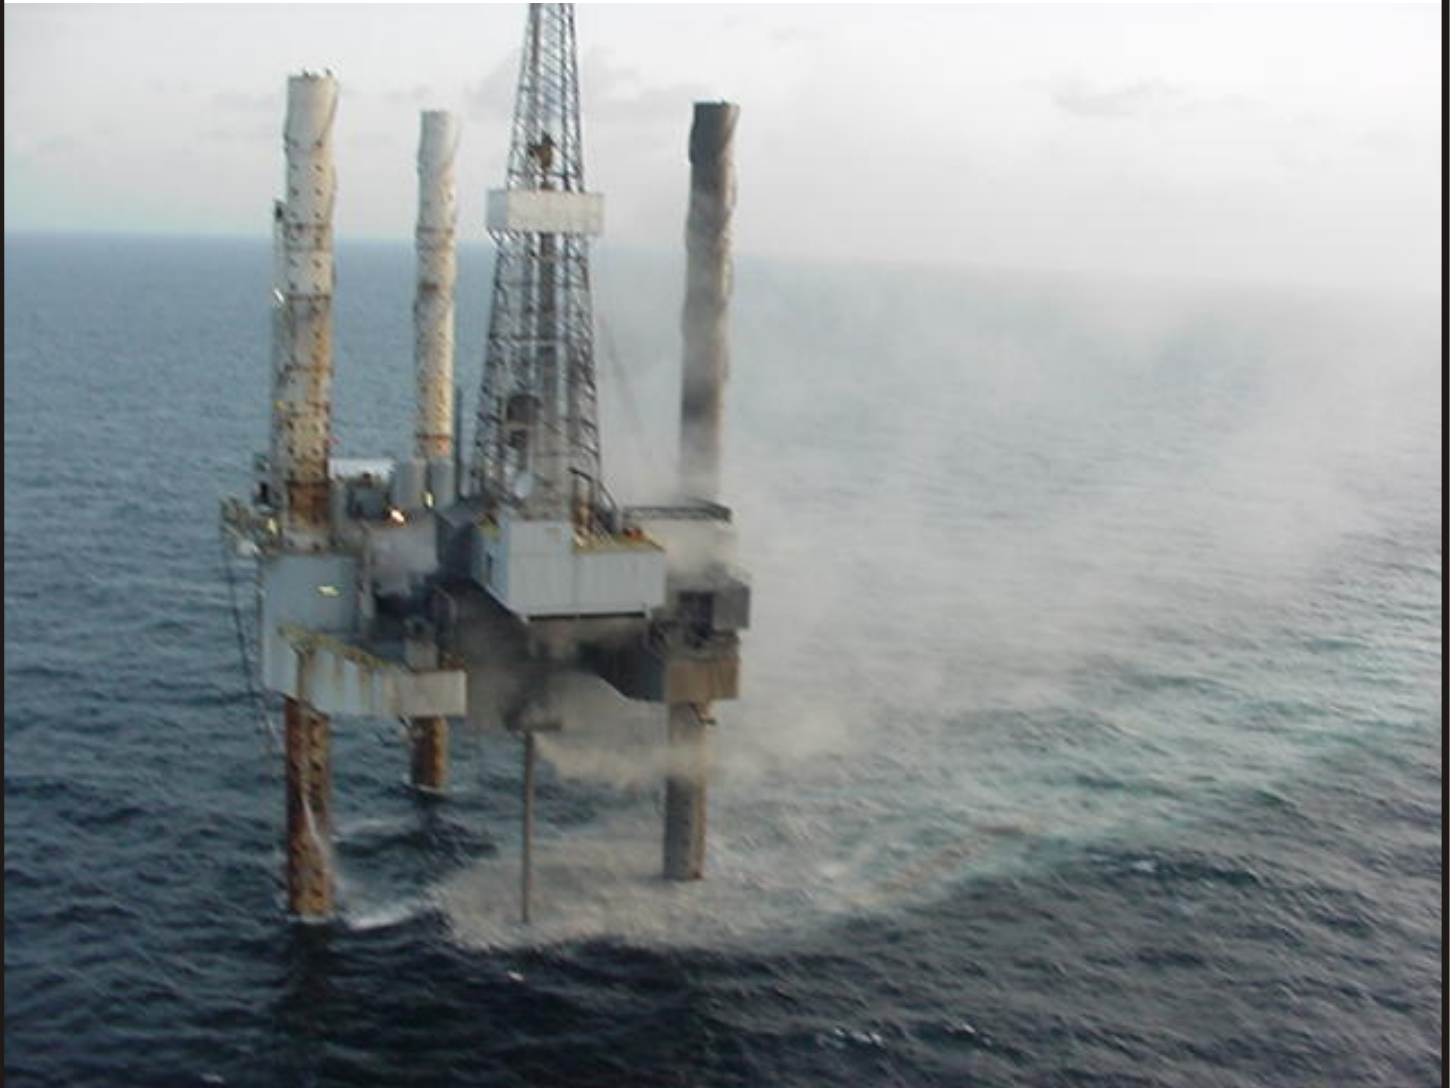
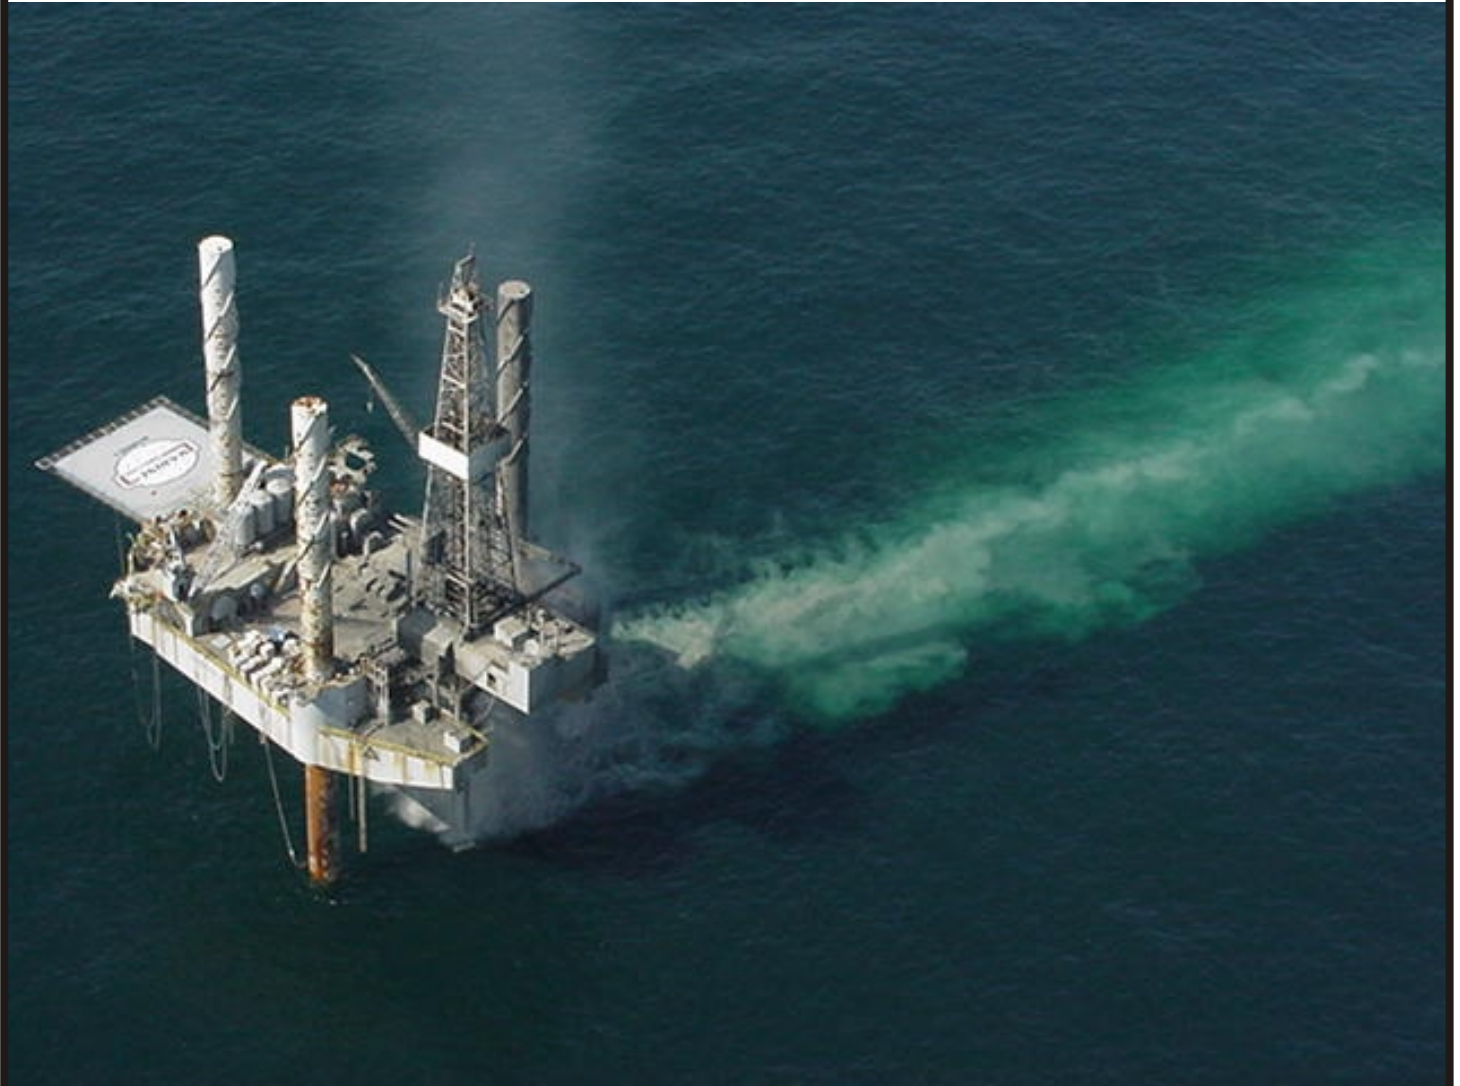
July 13, 2001 - The rig floor was very slippery because of the water-base mud that was blowing out of the hole, and two Marine Drilling floor hands said that they slipped down while running to evacuate the rig. Both capsules were loaded and departed the rig at the same time, 0430 hours. Personnel mustered at the escape capsules, but because of excessive noise, a roll call was impossible to complete. After they left the rig, two-way, hand-held radio communication was maintained, and it was discovered that the ADTI night supervisor was missing from capsule No. 2. The capsule No. 2 assignment list was left in the galley, but capsule No. 1 did have its assignment list. The ADTI night supervisor was last seen at the stairs and instructing others to board capsule No. 2. Roll call was not conducted at capsule No. 2 before launch. The ADTI night supervisor did not board capsule No. 2. The Marine Drilling senior toolpusher said during his interview that he thought he saw someone in the water after capsule No. 2 was launched. The crew was picked up by the Coast Guard at approximately 0630 hours and transferred to the workboat *Miss Melaine* and brought into the Tesoro base at Surf Side, Texas. *For photos of the rig approximately four hours after the well began to flow, see Attachments 6, 7, and 8.*

Photo of Rig after Well Began to Flow

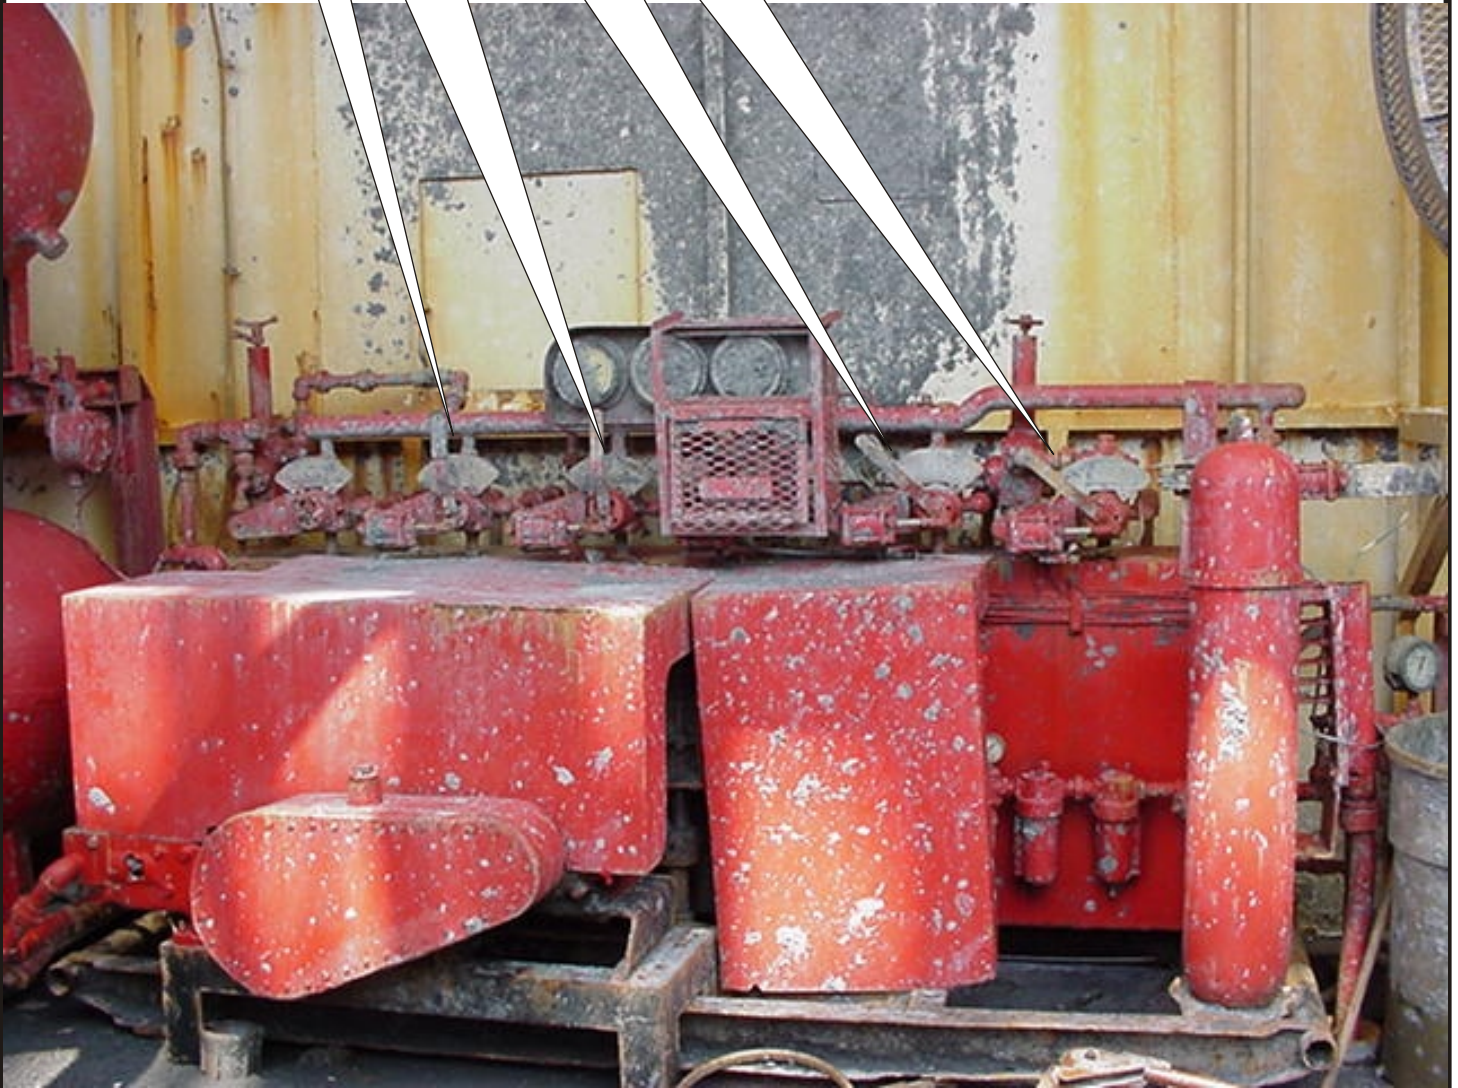
August 5, 2001 - When MMS inspectors boarded the rig, they discovered the blowout preventers (BOP's) opened and the casing valve on the "A" section opened, and observed the failed rig floor safety valve. It was also discovered that sand had cut out the drill

The blowout preventers (BOP's) did not include blind shear rams.

Photo of Opened BOP's.

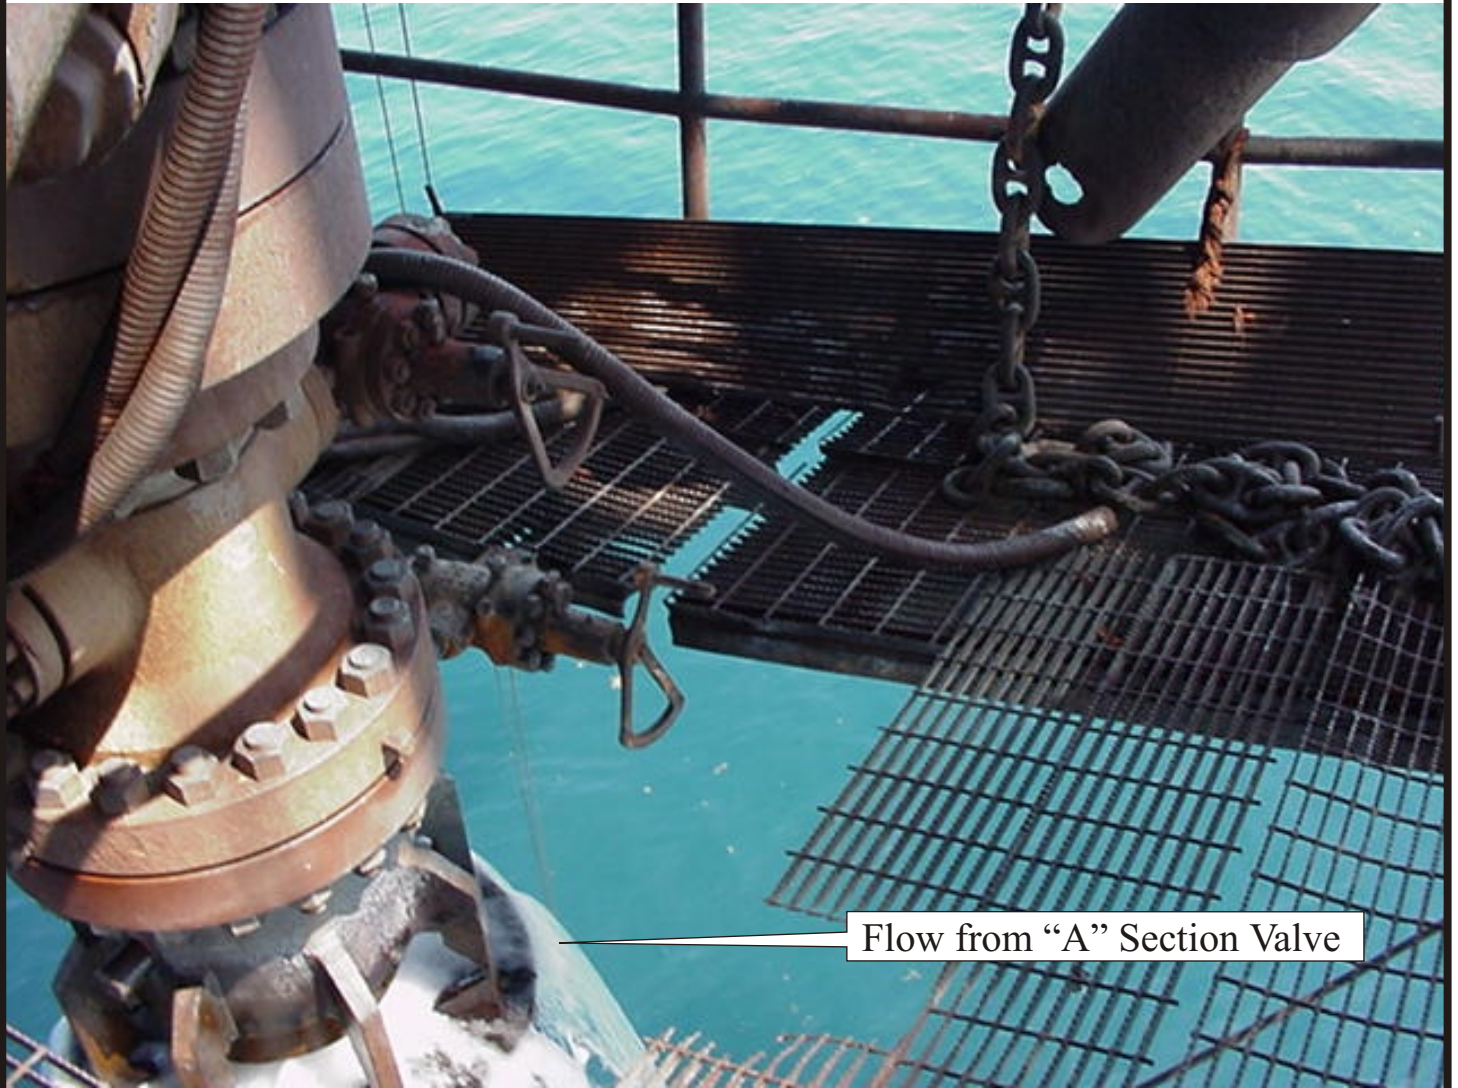
Observations On July 13, 2001, when MMS made a fly-by observation of the blowout, gas flow was seen from the A section valve.

Had the A section valve been closed, flow from the surface by conductor casing annulus could have been prevented or at least been substantially reduced.

Photo of Flow from "A" Section Valve

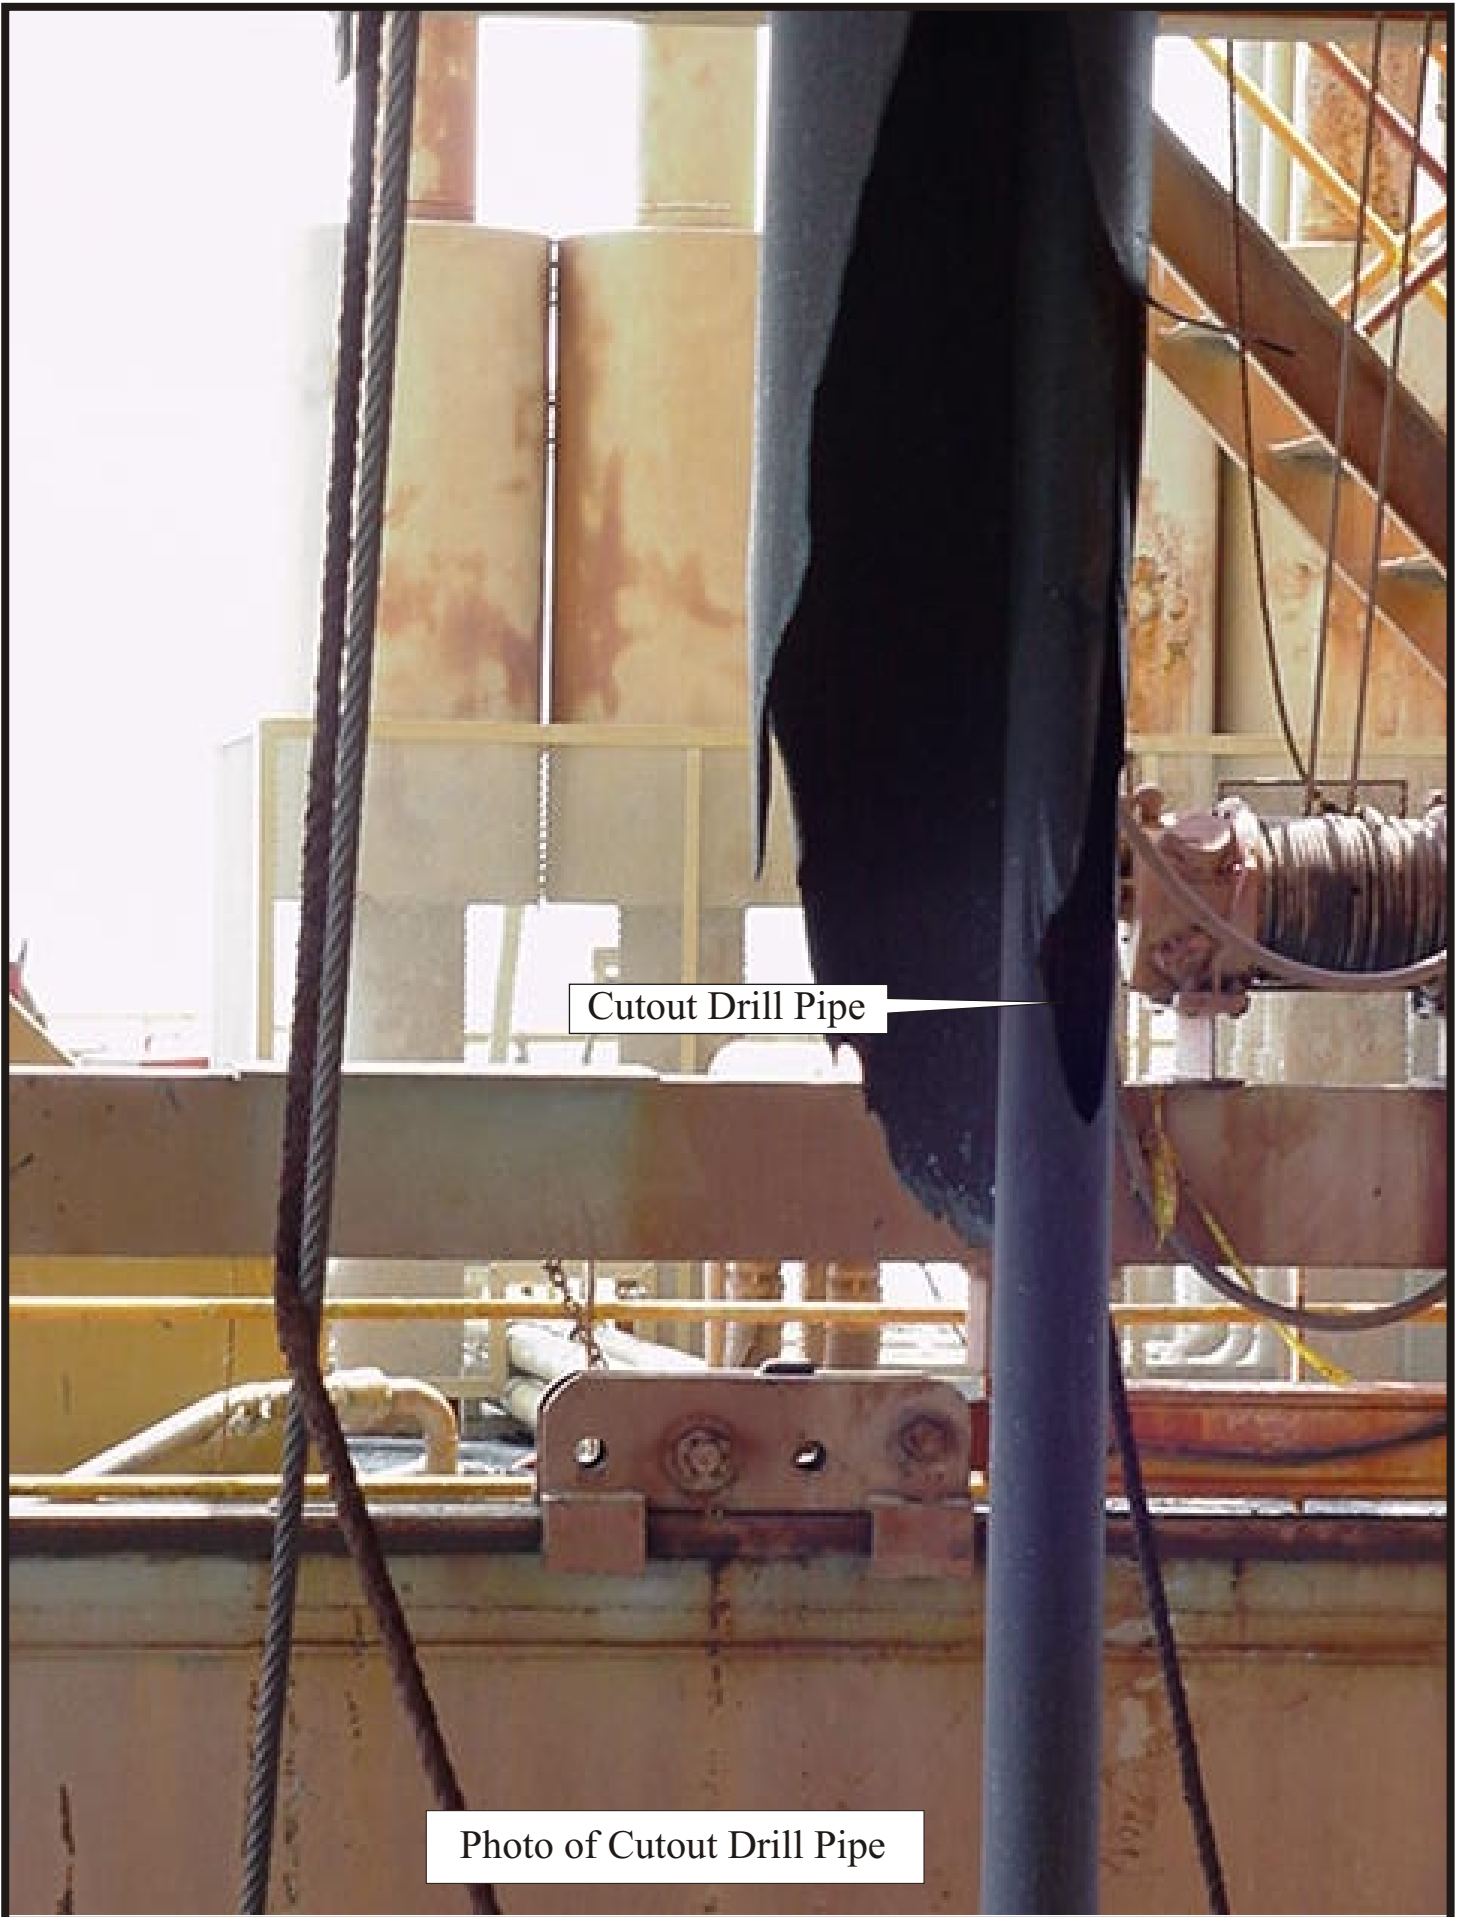
Photo of Cutout Drill Pipe

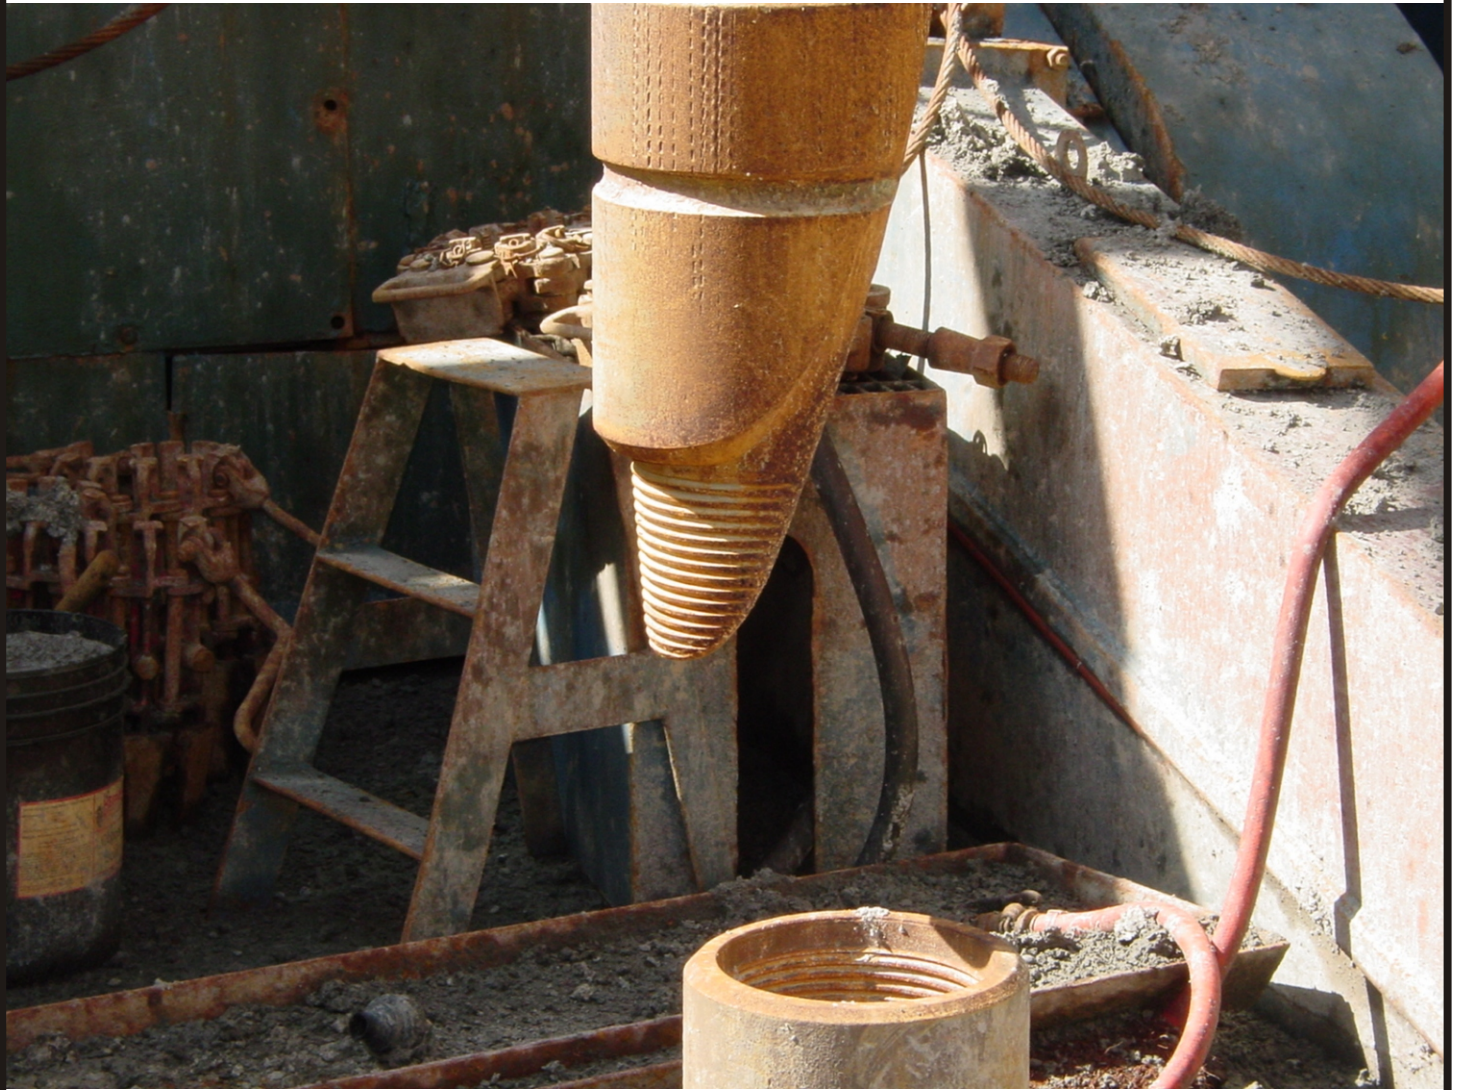
Photo of Worn Drill Pipe Due to Flow up Drill Pipe

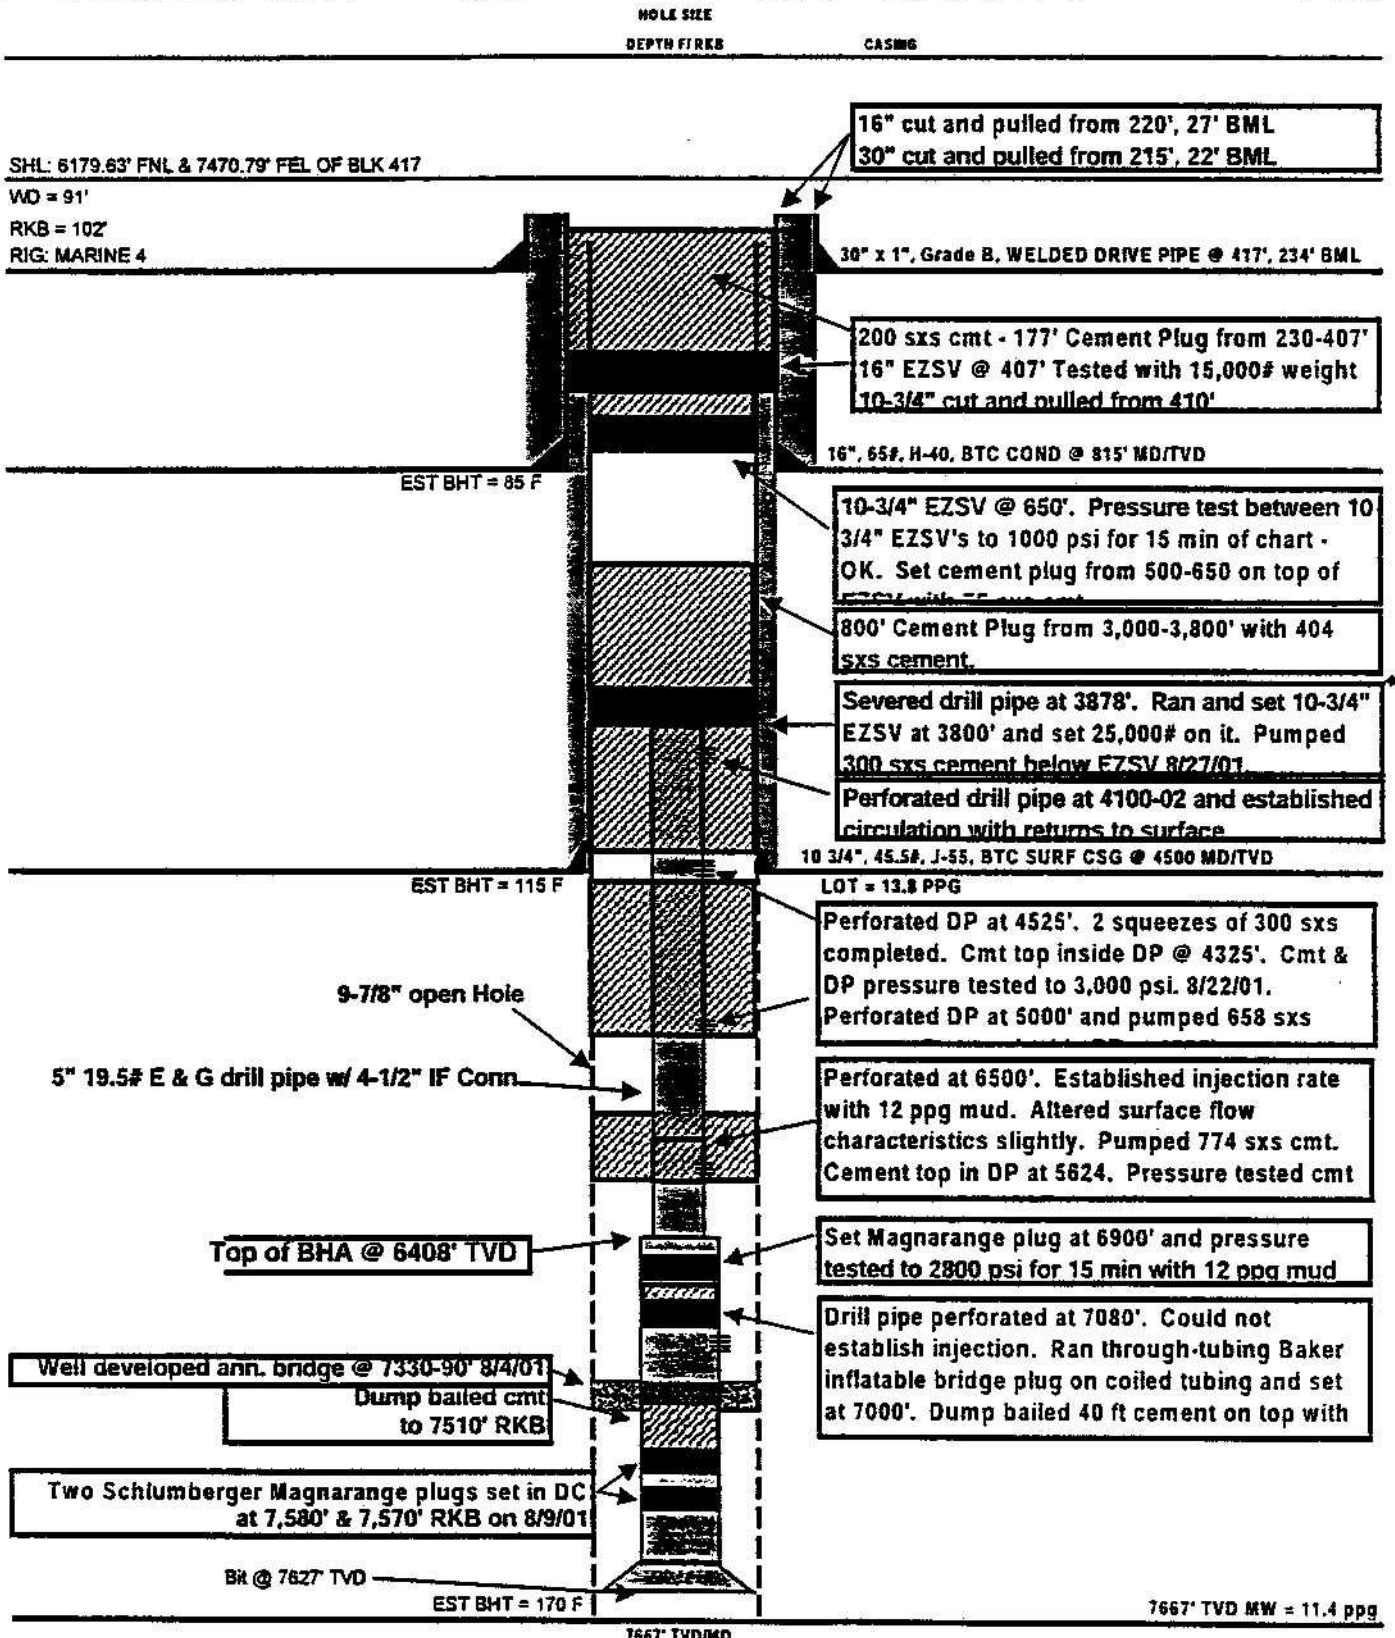
Drawing of Final Abandonment for Well #1

September 1, 2001 - Well 2 was not required to kill the flow from Well 1, because Well 1 ceased to flow because of water influx through the sand cuts in the casings. Final abandonment of Well 1 was completed with five cement plugs, several annular squeeze cementings, and all casings cut and recovered to 22 feet below the mudline. Well 2

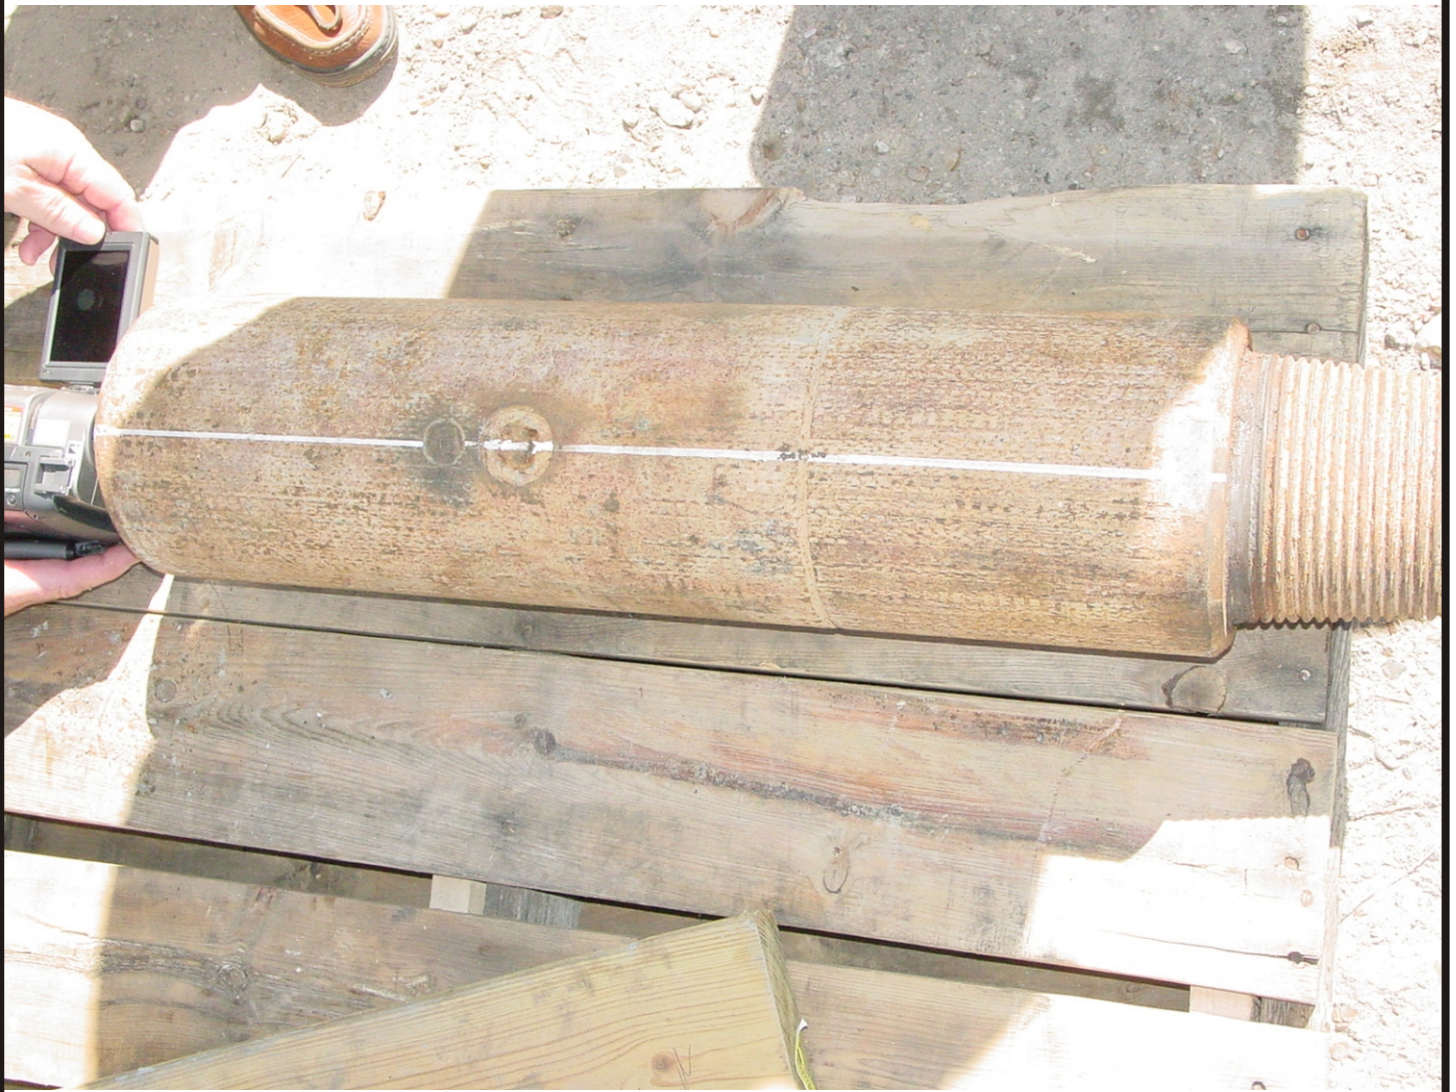
October 25, 2001 – Panel members and the District Supervisor of the MMS Lake Jackson Office went to C&H Machine Shop in Channelview, Texas, to witness the examination of the rig floor safety valve that failed to close during the well control event that occurred on *Marine IV* on July 13, 2001. Other interested parties attending the examination included personnel from Global Marine, ADTI, Pride Offshore, Global Manufacturing of Arcadian Inc., and a private consultant. During the examination, cement and wet mud were found behind the ball of the valve. It was also noted that the rig floor safety valve had a service break in the body that requires proper torque, or the valve will not operate properly.

Photo of Rig Floor Safety Valve at C & H Machine Shop
