**Investigation of Blowout, Injuries, & Fatality,
Brazos Block 417
OCS-G 22190, Well 1
July 13, 2001**

Gulf of Mexico
Off the Texas Coast

U.S. Department of the Interior
Minerals Management Service
Gulf of Mexico OCS Regional Office

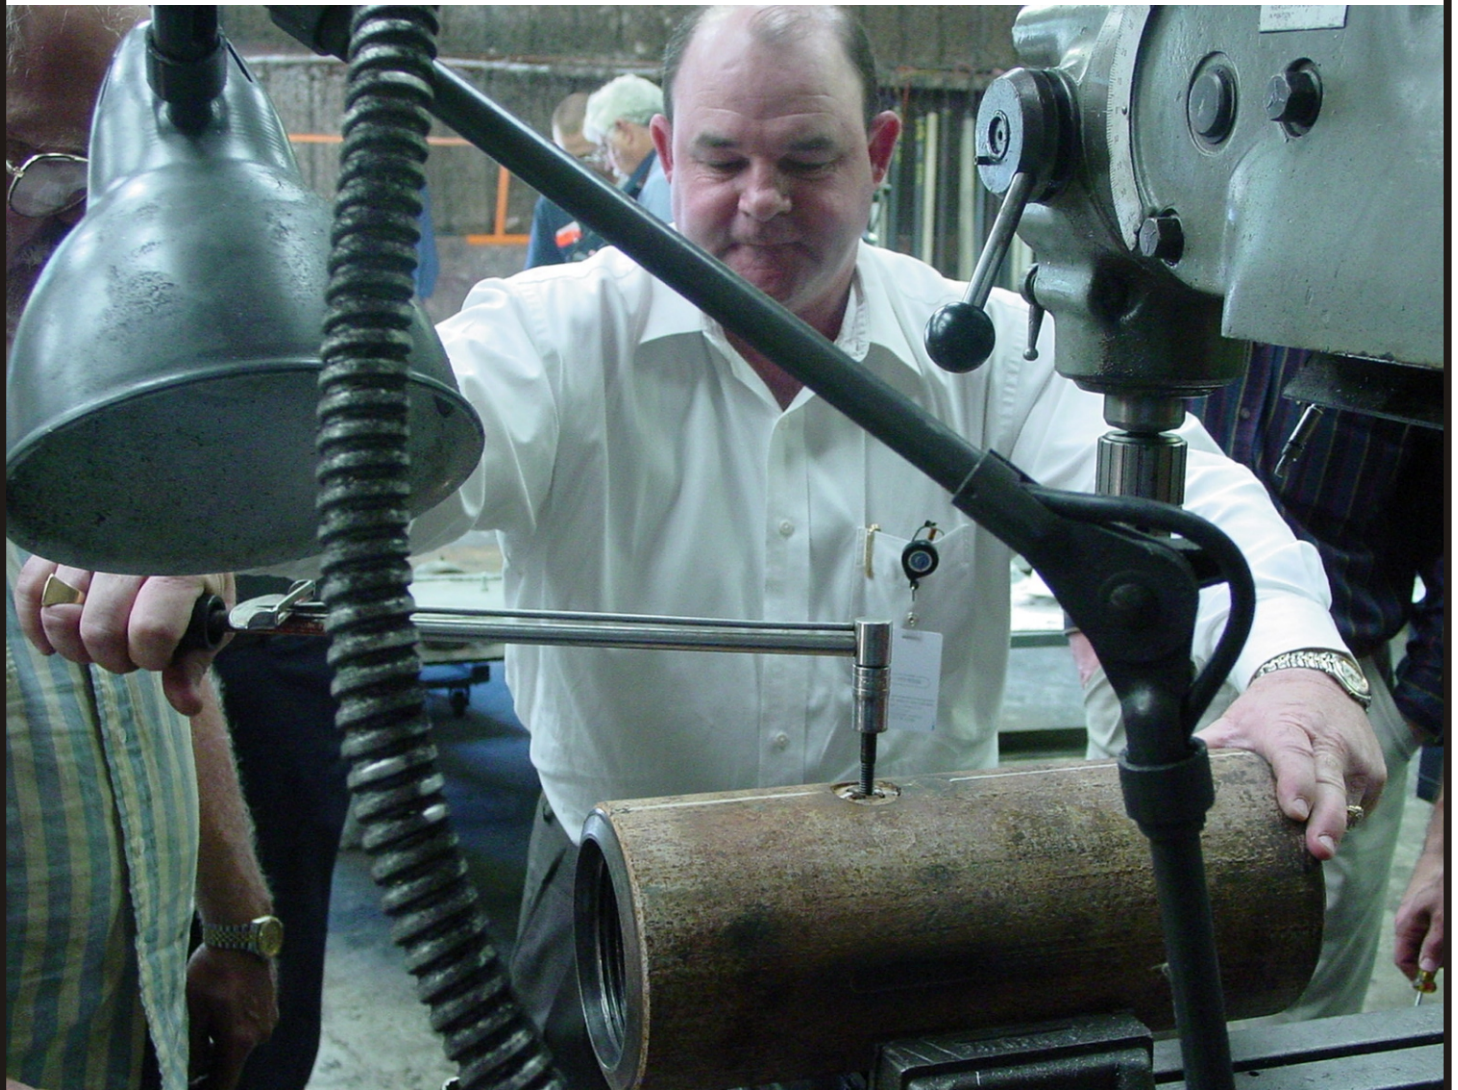
Tests performed on the rig floor safety valve have revealed that the valve was frozen open with cement, mud, and sand. (The primary purpose of the rig floor safety valve is to provide a means to shut in the well if it is flowing up the drill pipe.) The rig floor safety valve was last tested beginning at 1230 hrs on July 8, 2001, when the last BOP test was performed. However, the valve is also used during cementing and, in this case, had been used to squeeze cement in the 10³/₄-inch casing shoe at 0900 hrs July 9, 2001, when the LOT was insufficient. *For photos of lab tests on the rig floor safety valve, see Attachments 16, 17, and 18 respectively.*

Photo of Gentleman Trying to Turn the Key Opening on the Rig Floor Safety Valve

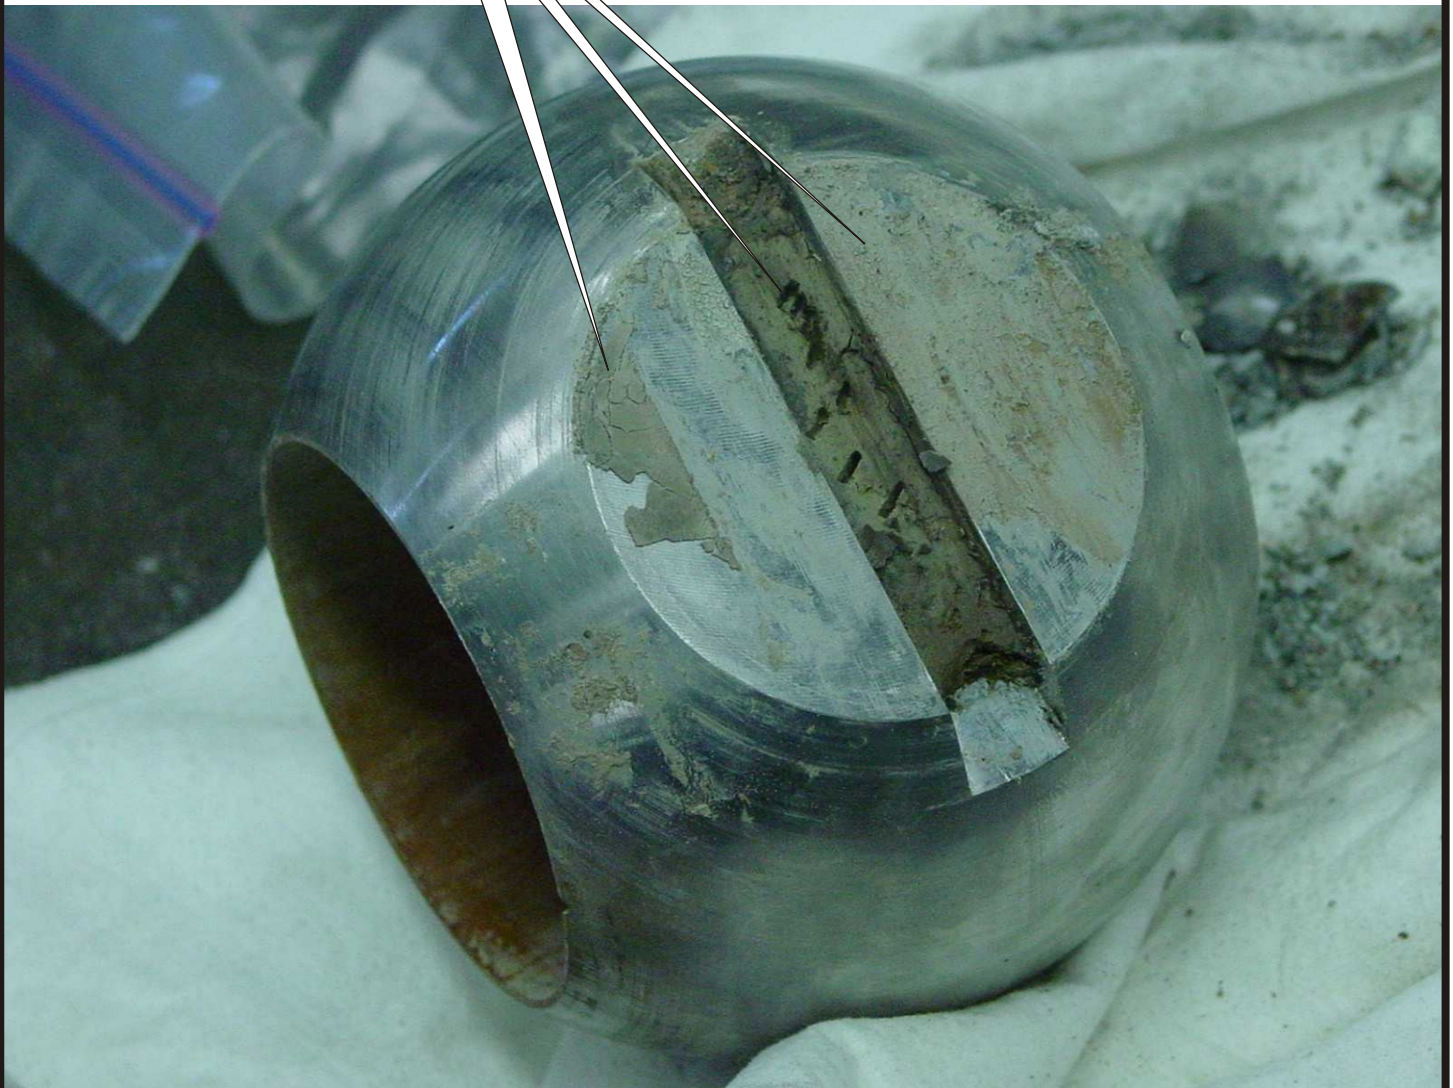
**Part I
Blowout
Cause** The rig floor safety valve was frozen open and the inability to close this valve resulted in the loss of well control.

Dried mud and cement

Photo of Ball from Rig Floor Safety Valve with
Mud and Cement on It

1. Maintain a primary rig floor safety valve to be used for well control purposes only. In addition, a second valve should be available for use during cementing, wire line, and other routine operations.

2. Function- and pressure-test both rig floor safety valves as part of the normal BOP tests. Note: Both valves should be actuated daily.
3. Check also that the rig floor safety valves with service breaks in the body are made up to the designed torque specification to ensure proper valve operation.

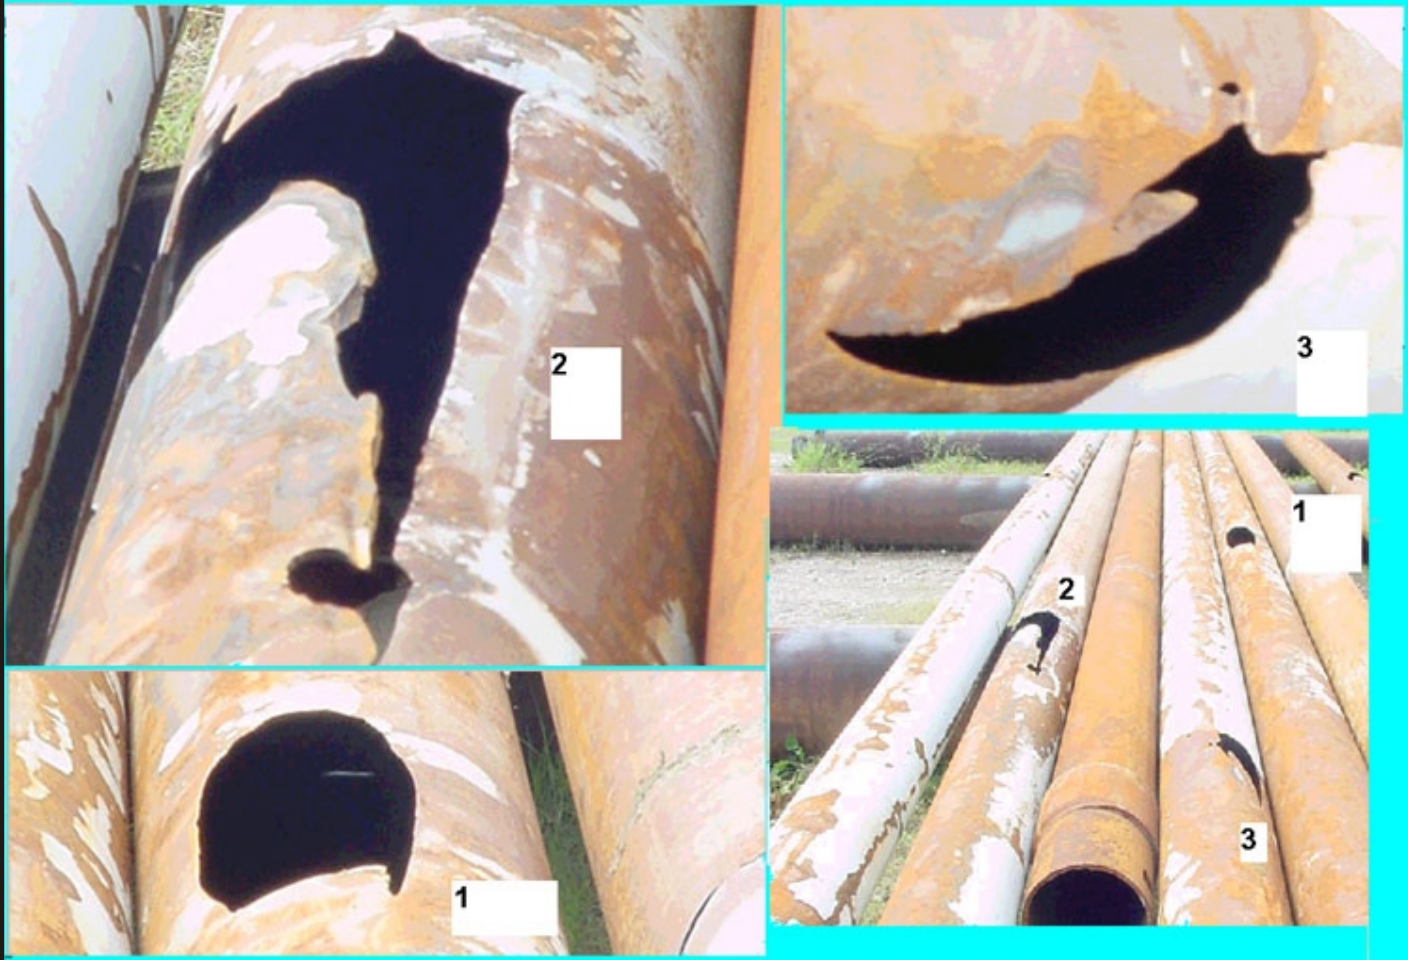
Damages The *Marine IV* BOP stack, bell nipple, casing, and 7,667 feet of drill pipe were damaged by the high-pressure gas and sand that flowed out of the well. There were also damages to the grating on the Texas deck caused by the water and sand flow from the casing and

to the A valve on the wellhead. The water spray employed to keep the gas from igniting damaged several of the recording instruments. The water also damaged flooring in the quarters. *For a collage of photos showing damage to the recovered casing, see Attachment 19.*

Collage of Photos of Damage to Recovered Casing

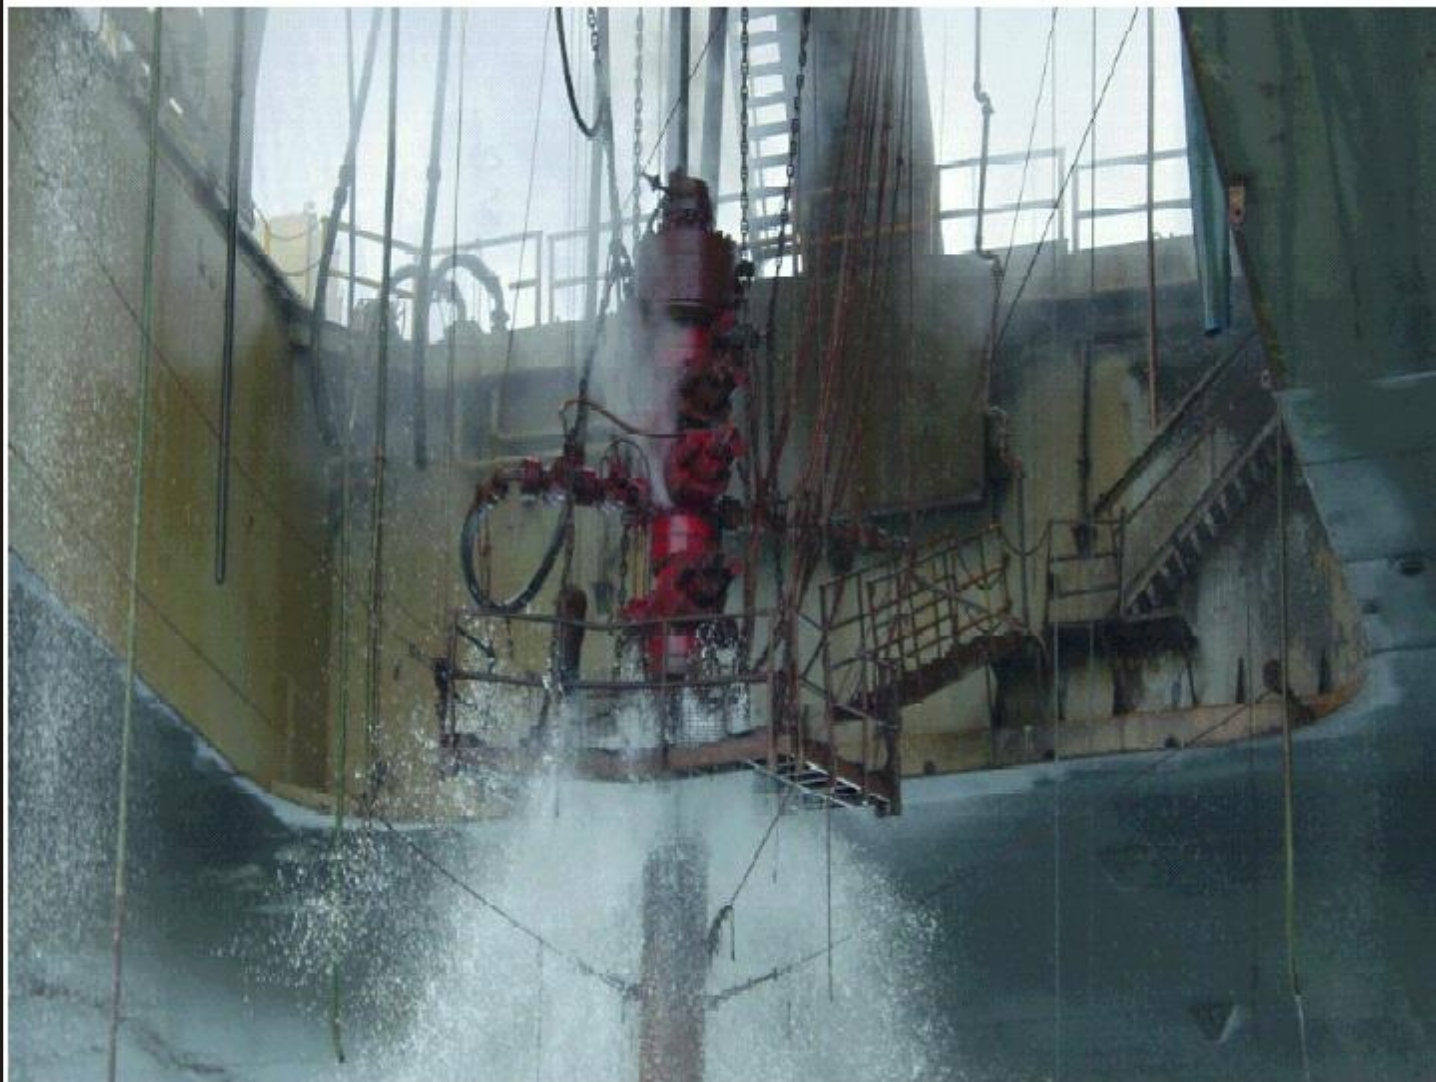
July 17, 2001 –Photos of Well 1 were also taken from the deck of a work boat. *For photo of rig from boat, see Attachment 20.*

Photo of Well Flowing from Beneath BOP Stack
