Oil Spill During Hurricane Lili, Ship Shoal Block 119: Responses, Fate, and Effects

**U.S. Department of the Interior
Minerals Management Service
Gulf of Mexico OCS Region**

**New Orleans
July 2003**

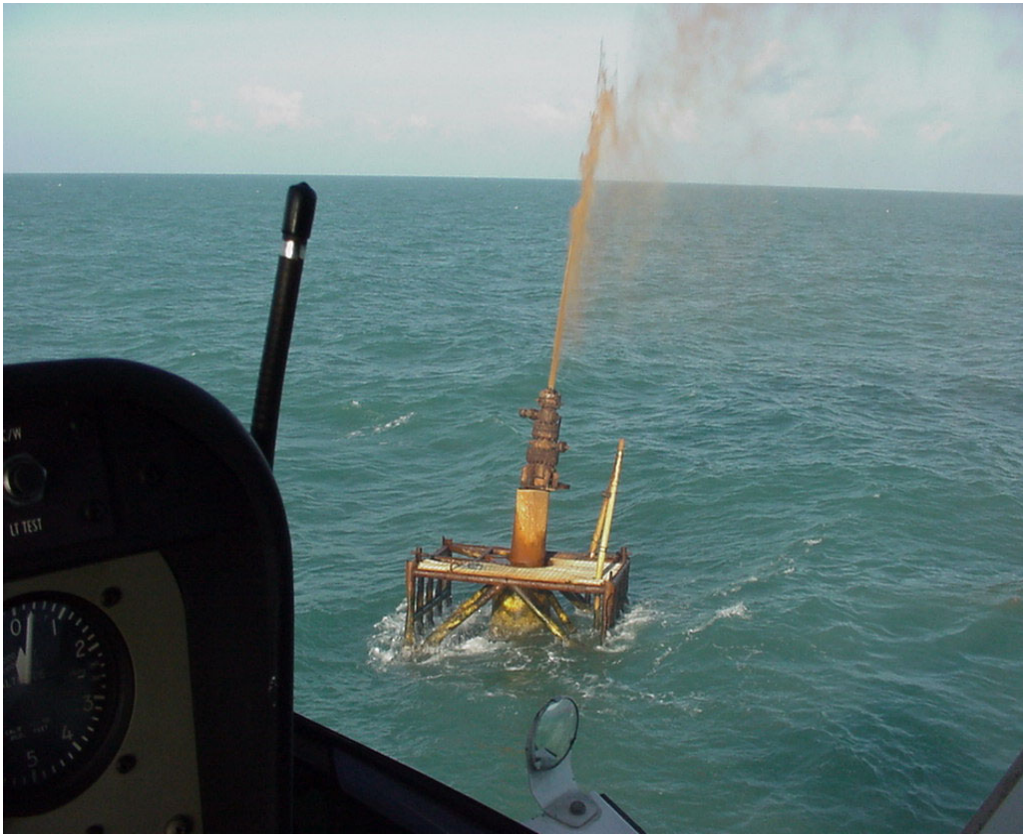
Figure 4. Photograph of Well No. 14.

Murphy Exploration and Production Company (Murphy) was the lease owner at Ship Shoal Block 119 (Figure 2) located 18 mi from shore. During Hurricane Lili, the wellhead at Caisson No. 14 was damaged (Attachment 1) (U.S. Dept. of Commerce, NOAA, 2002a). The well was not in production. It had been shut in and was awaiting MMS approval for plugging and abandonment operations. The engineering diagram for the well is provided in Figure 3. An investigation of the engineering aspects of the release by MMS is ongoing. A mixture of oil, gas, and water spewed into the air. Murphy estimated that 350 bbl of oil spilled (Figures 4 and 5) and later reported that 145 bbl of oil was recovered through skimming. About 205 bbl was not recovered and is assumed to have dissipated. On October 6, 2002, at 1730 CDT, the well was shut in (Table 1).

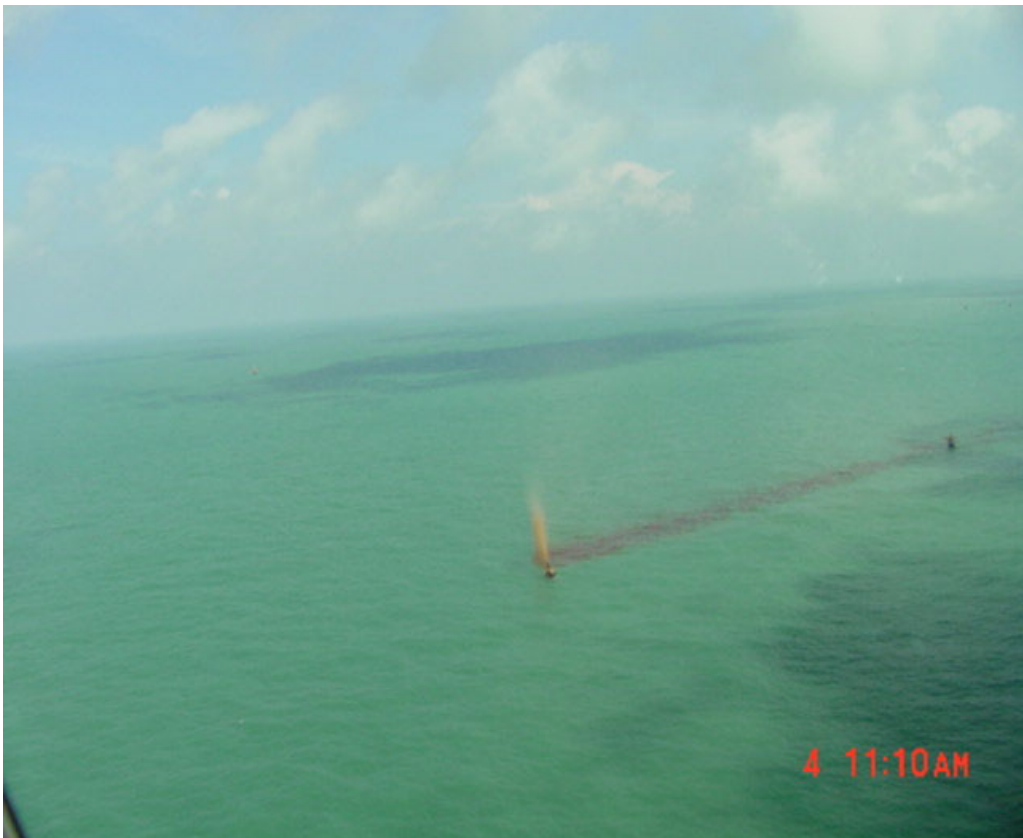
Figure 5. Photograph of Oil Slick.

Overflights were conducted throughout the response. The first report of the spill to the National Response Center was made at 0838 CST on October 4 by Tidewater Marine. Murphy employees describe the spill observed on that day as being dark with no sheen and having windrows at the end farthest from the source. A later flyover noted an orange slick.

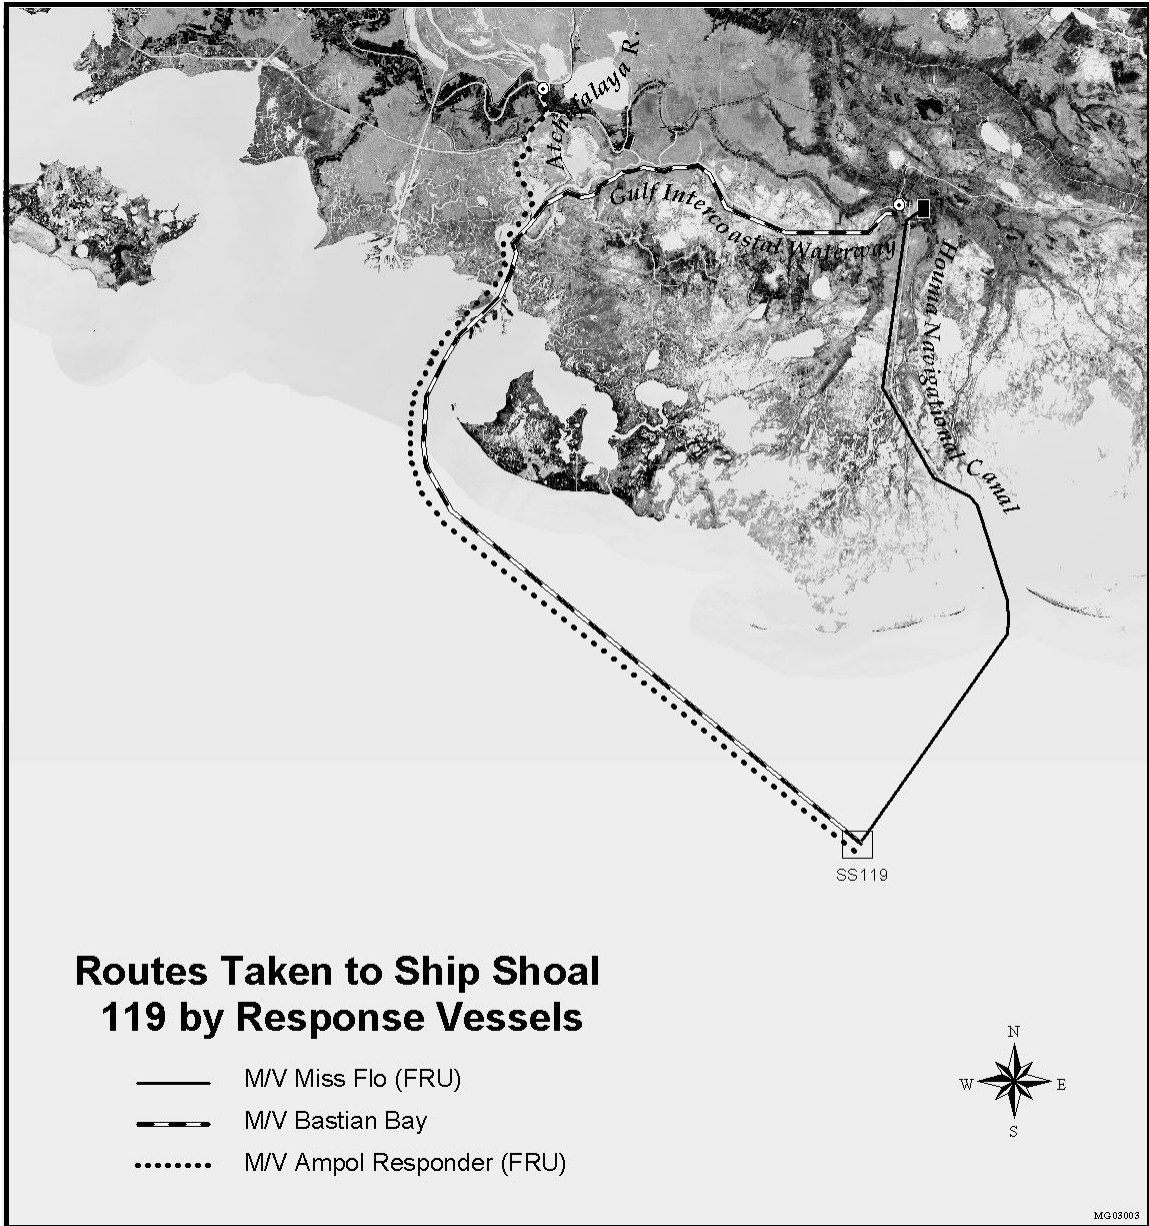
Figure 6. Routes Taken to Ship Shoal Block 119 by Response Vessels.

Murphy mobilized three skimming vessels in response to the spill (Murphy, 2002). These skimmers have the combined capability to recover over 11,000 bbl/day. One vessel departed westward from Houma via the Gulf Intracoastal Waterway to the Atchafalaya River and took 5½ hours to reach the site. A second vessel departed Houma via the Houma Navigational Canal and took 11 hours to reach the spill site. The third vessel departed from the Atchafalaya River in the Morgan City area and took 11.5 hours to reach the spill site (Figure 6).

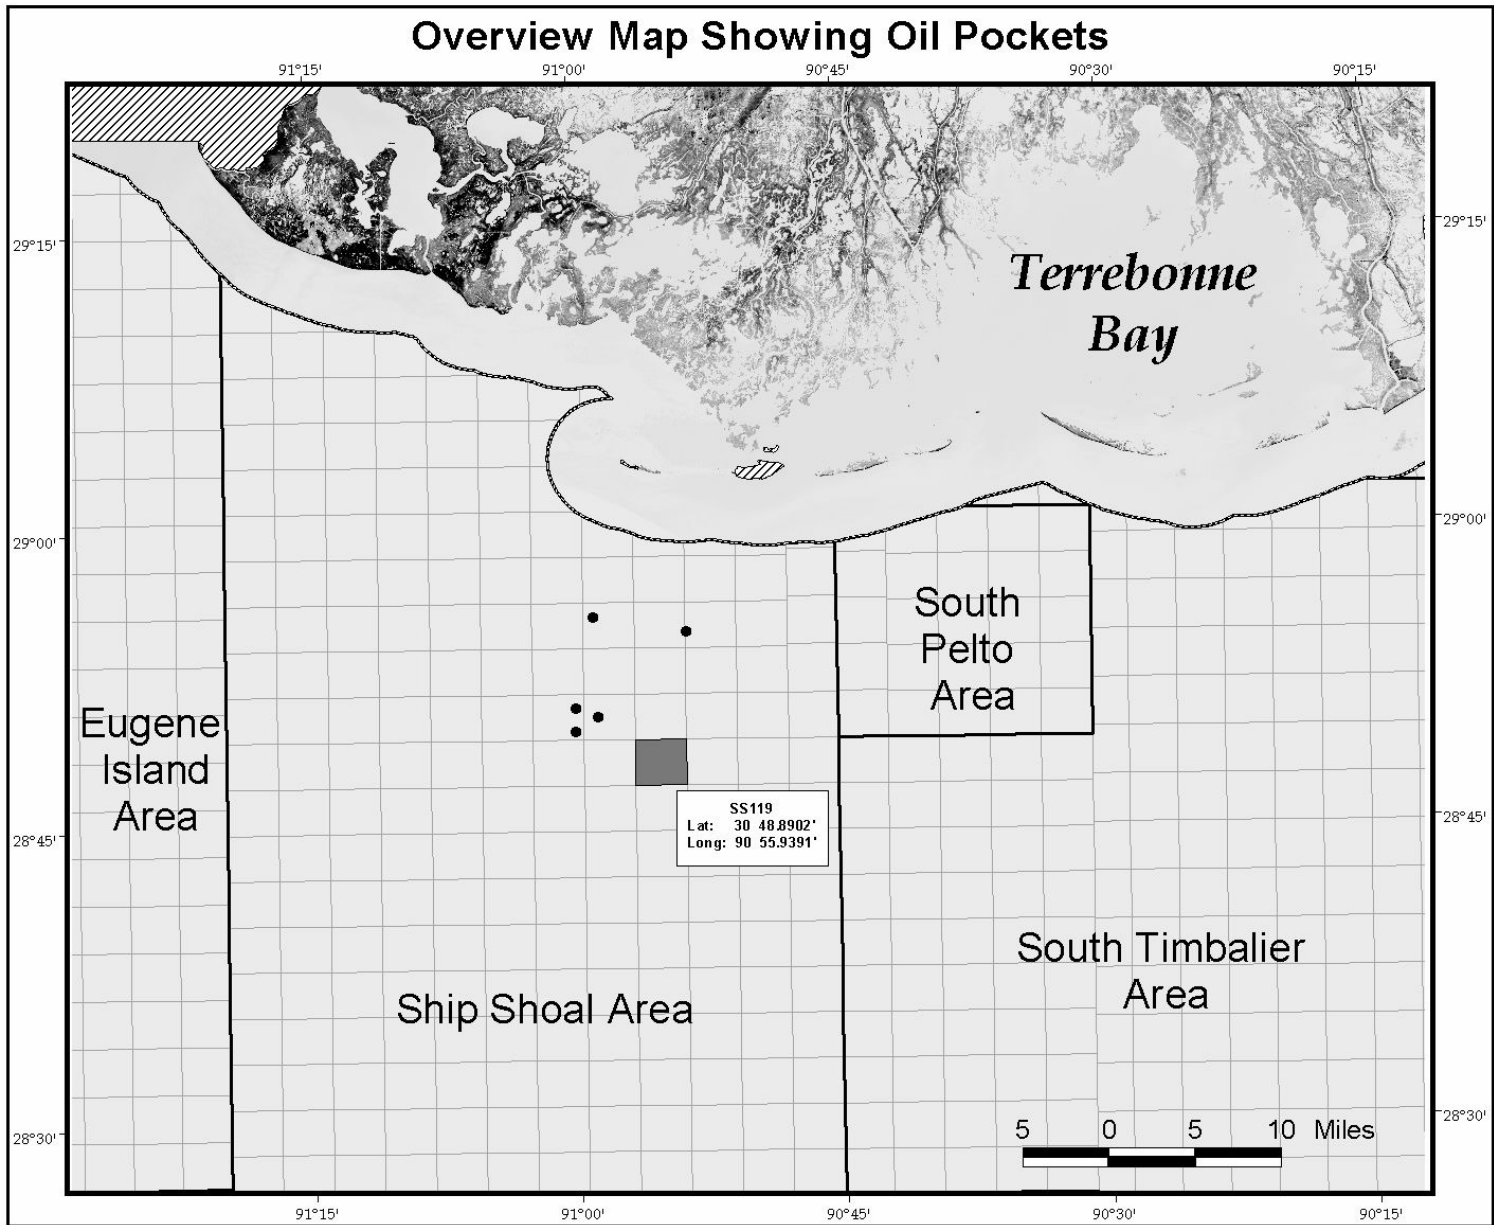
Figure 7. Overview Map Showing Oil Pockets.

Pockets of oil to the northwest and north of Ship Shoal Block 119 were noted. The vessels were directed to these locations by helicopter, and these oil pockets were recovered (Figure 7). On Sunday, October 6, 2002, a final helicopter flyover of a 6-mi radius from the source identified no further recoverable oil. No shoreline contacts were reported.
