**Investigation of Loss of Well Control  
Eugene Island Block 277, Well A-3 BP  
OCS-G 10744  
9 February 2004**

Gulf of Mexico  
Off the Louisiana Coast

U.S. Department of the Interior  
Minerals Management Service  
Gulf of Mexico OCS Regional Office

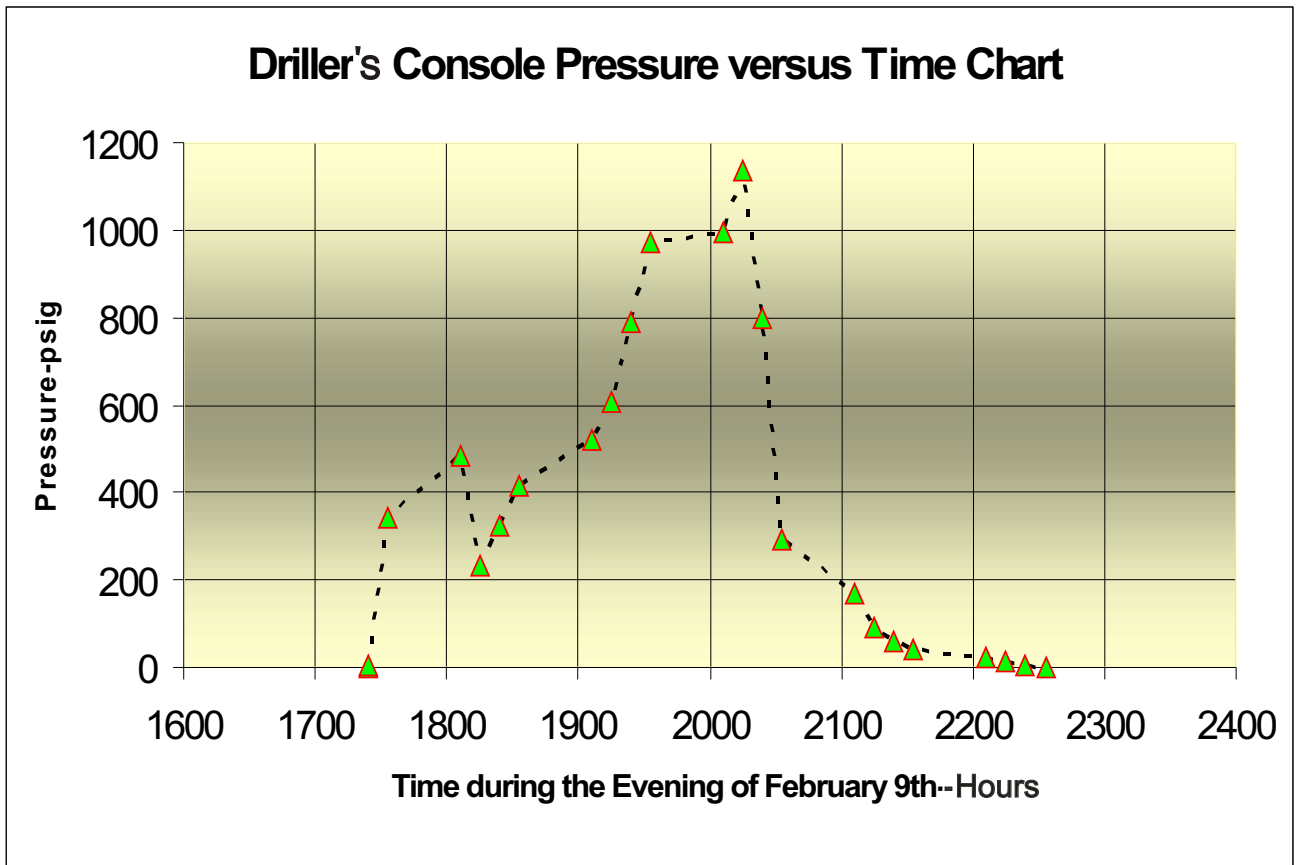
The driller's console gauges recorded similar readings during the rise in pressure on the casing Annulus, and likewise tracked each other during the subsequent fall in that pressure from approximately 1,265 psi to 0 psi. According to testimony, this fall in Annulus pressure to 0 psi was thought to be evidence that the shoe of the surface casing had broken down and the gas was bleeding into the normally charged sands near the shoe.

***Gauge Failure and Failure to Detect Annulus Pressure*** – Two gauges monitoring the buildup in the pressure on the Annulus of the casing strings erroneously indicated the pressure peaked at 1,265 psi and declined to 0 psi. A third gauge on the choke manifold checked immediately before the loss of control indicated the actual pressure on the Annulus in fact continued to rise above 3,000 psi. The two primary gauges failed simultaneously and returned a false reading of pressure decline.

Chart: Driller's console pressure versus time chart.

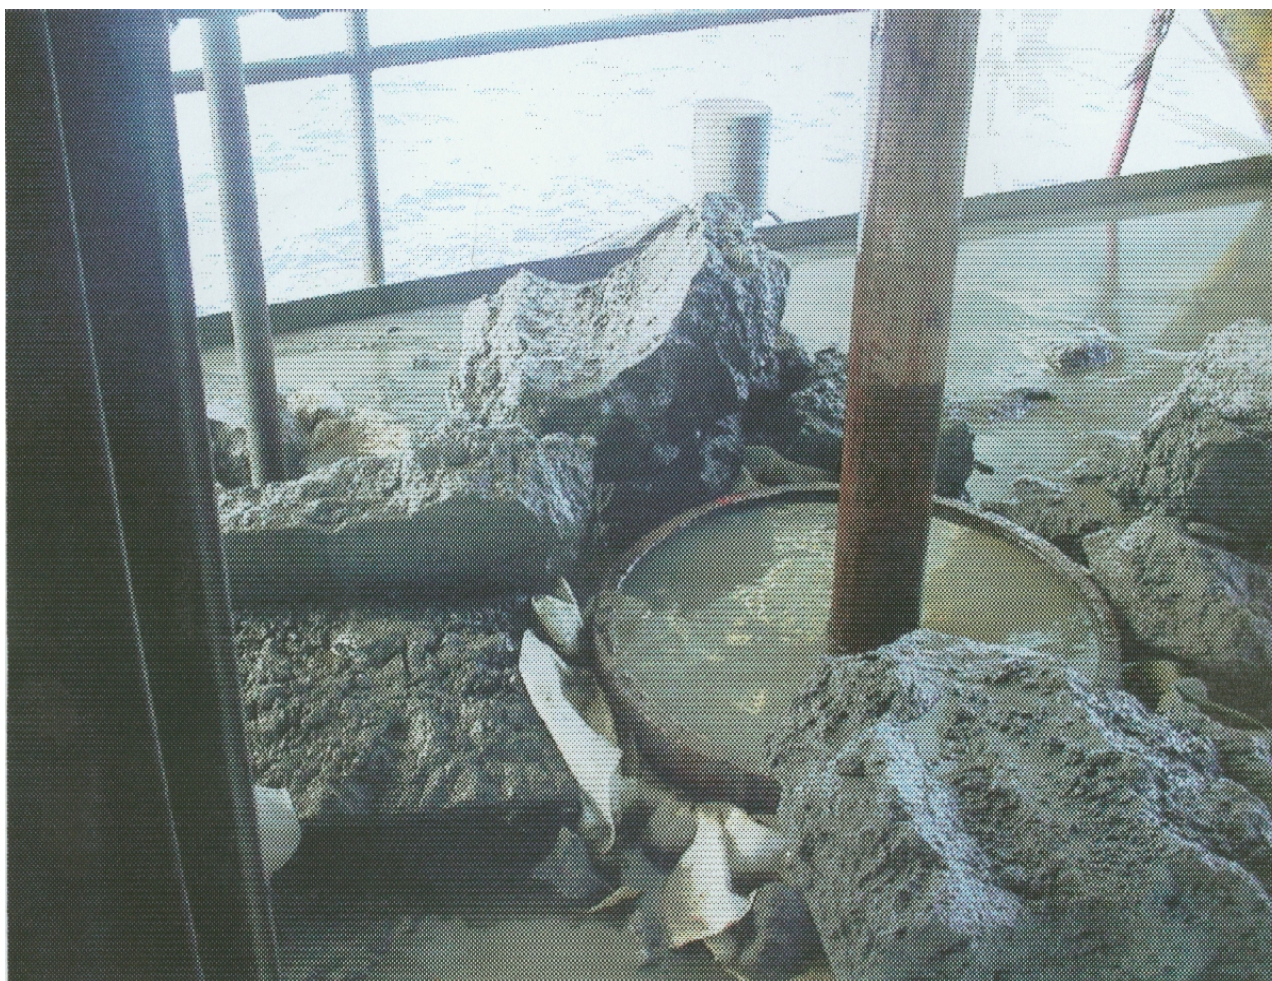
*0825 hrs* – The helicopter landed on the Rig, and supervisory personnel went to the stern of the Rig and observed that the Well appeared to be static. The wellhead was observed to be surrounded by a buildup of mud, sand, and cement with an oily residue, the pile being approximately 3 ft by 10 ft by 10 ft sloping to 4 inches at the kick rail (*See Attachments 4 and 5*). Oil was observed on deck and a slick continued to trail from platform. The group returned to EI-258 “A.”

Buildup of debris on platform after incident.

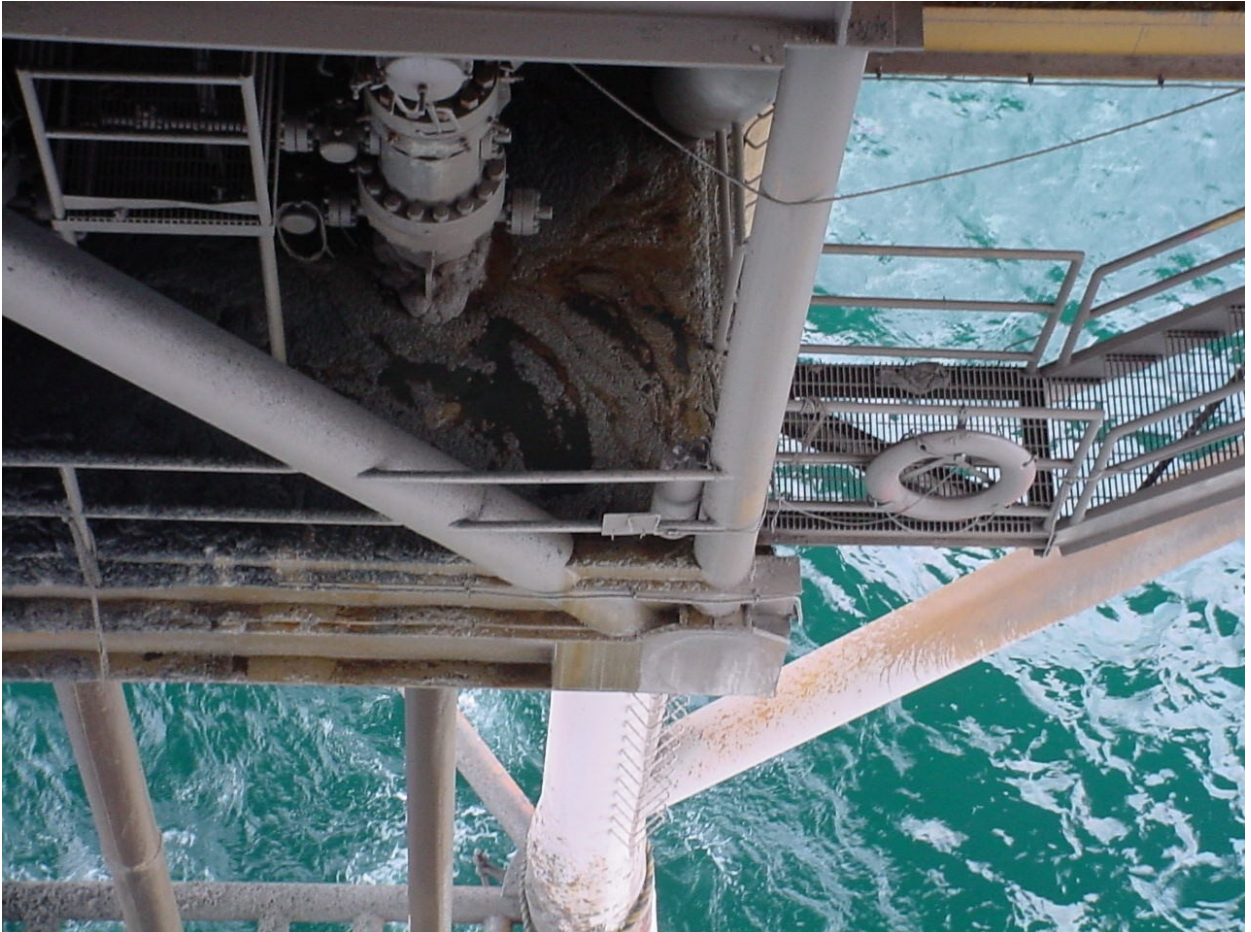
Buildup of debris on platform after incident.

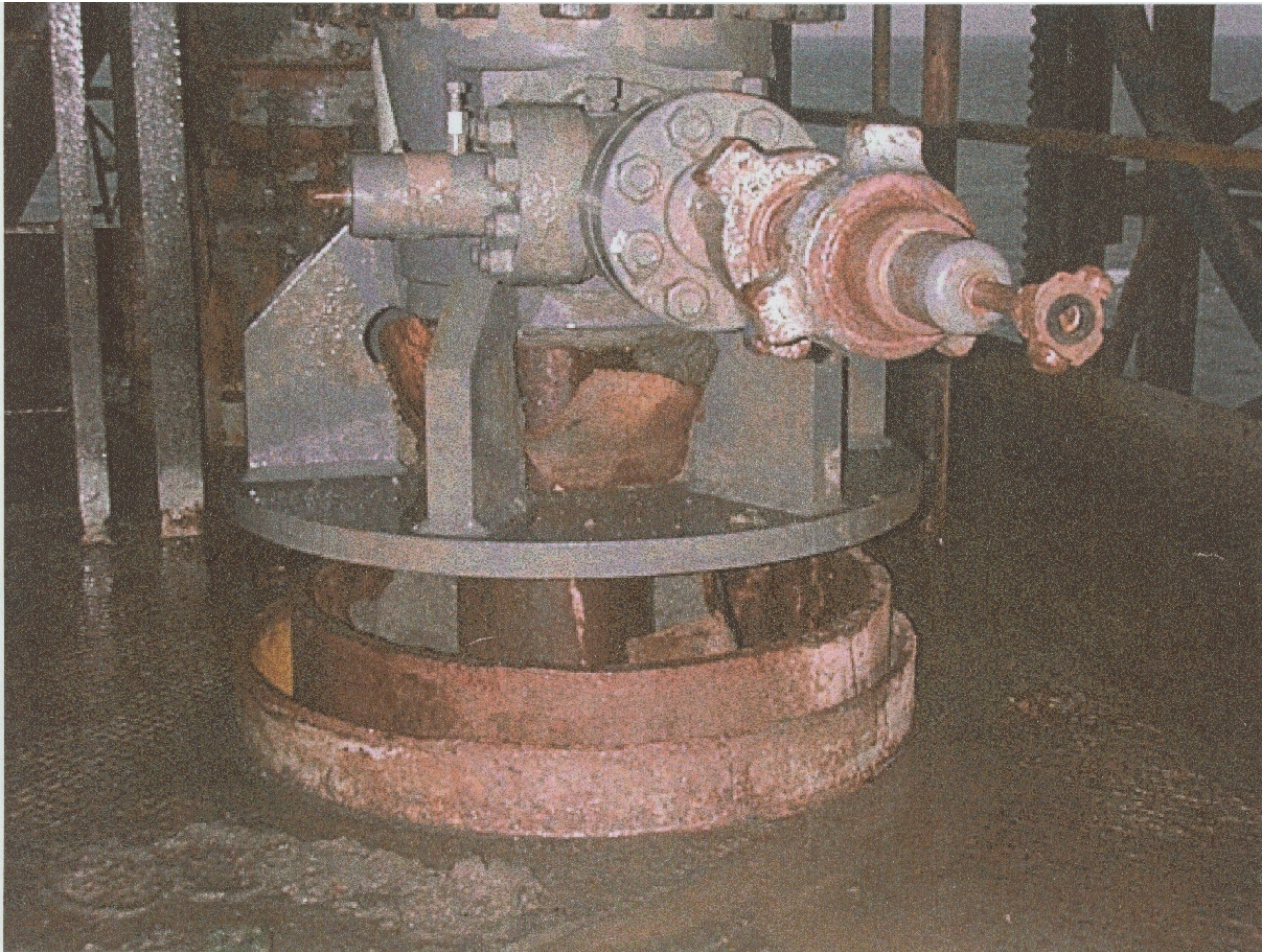
As part of the preparation to pump kill mud, followed by cement, a crew member opened the choke slightly to test for residual pressure. Testimony from crew members states that upon the opening of the choke, high-pressure gas flow caused the crewman to shut the choke valve back in immediately. Simultaneously, a supervisor for EPL testified that he noticed the independent choke gauge was reading approximately 3,000 psi Annulus pressure. This observation was immediately followed by the bursting of the surface casing below the wellhead.

Wellhead: After the incident, showing parted casing.

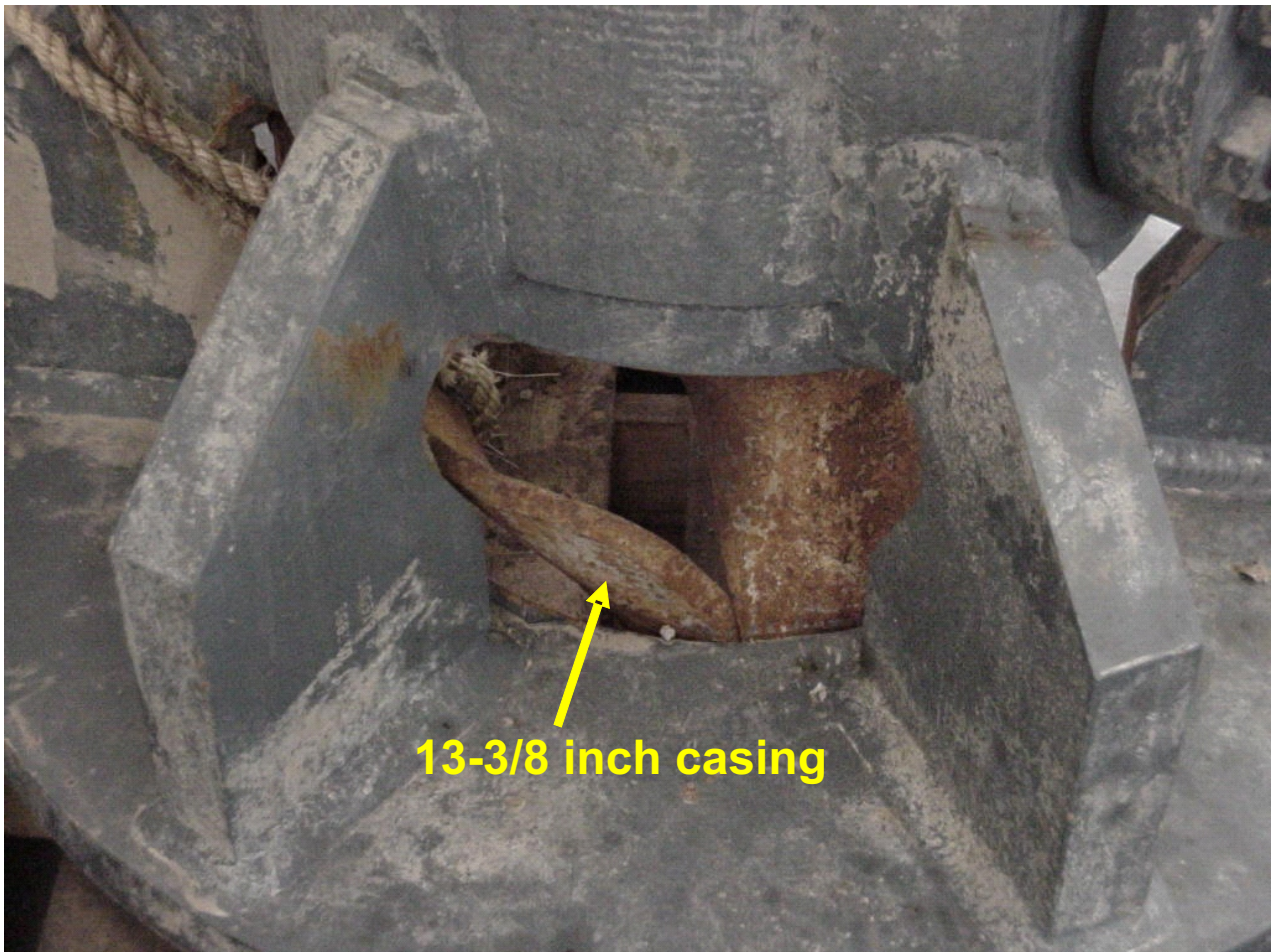
Damaged 13 3/8 inch slip-on wellhead (SOW) and casing.

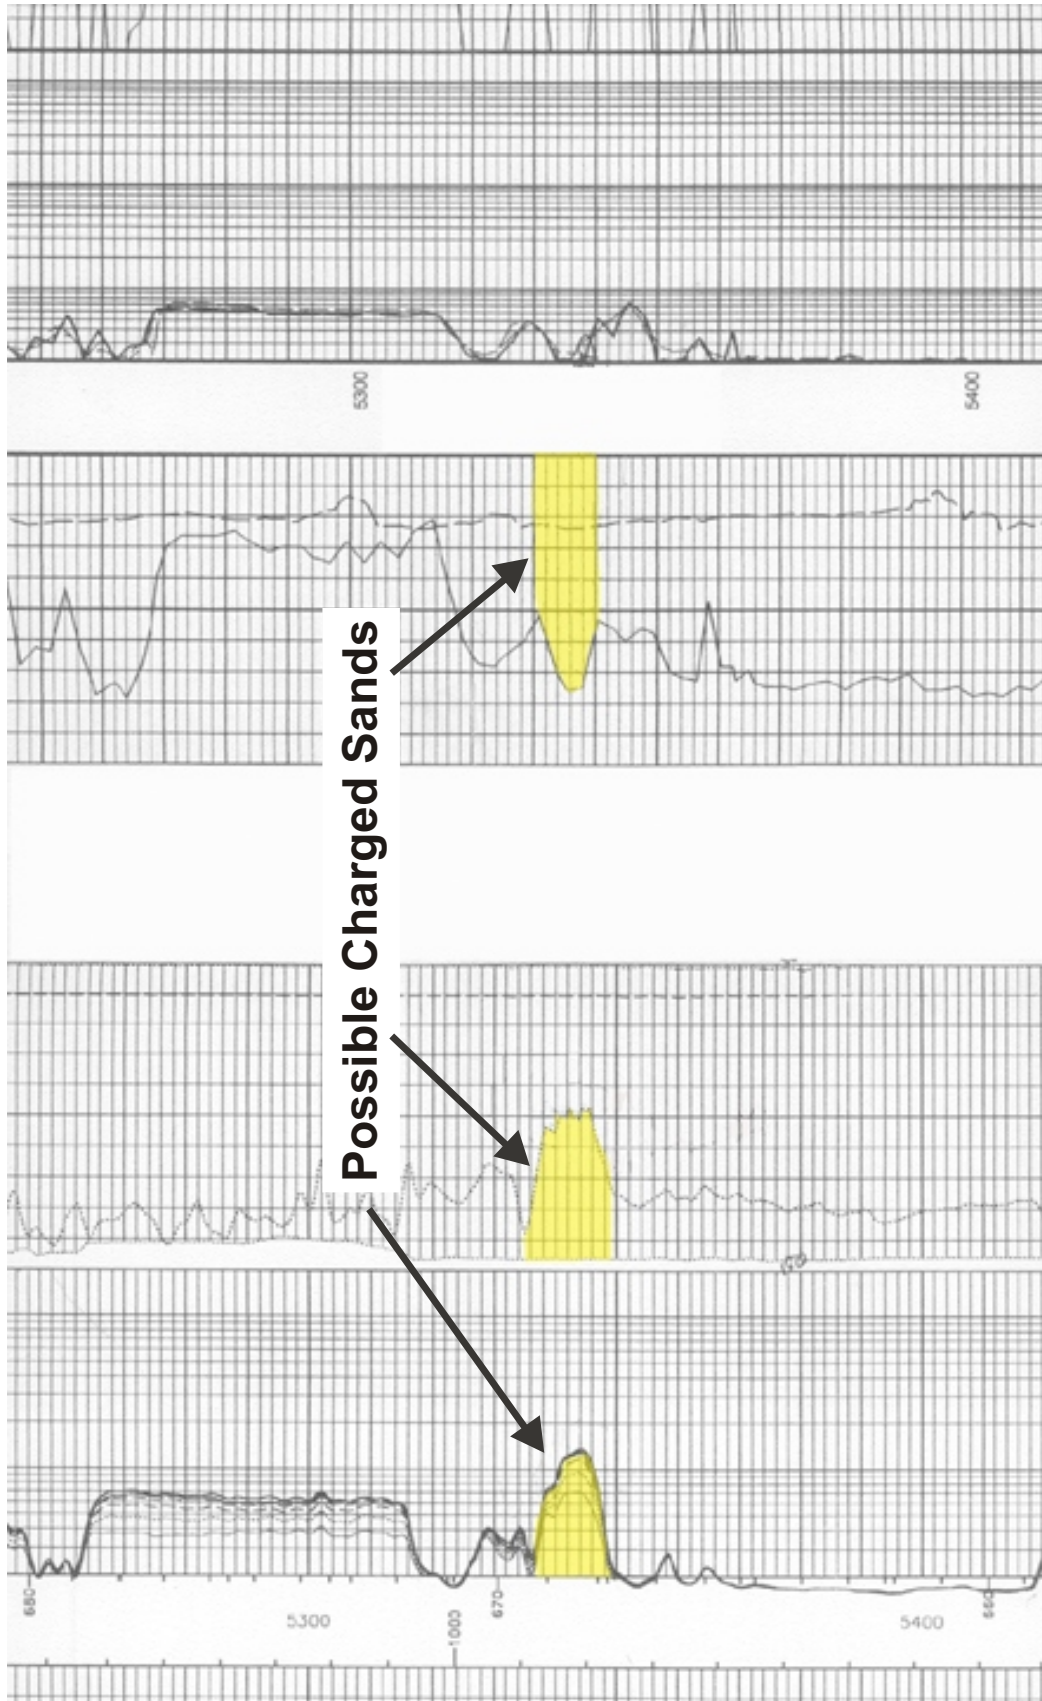
Testimony and written accounts state that after the driller's gauges were registering 0 psi on the Annulus, the choke was opened to check for flow, and high pressure was found. Only then, just prior to the explosion that led to the loss of control, was a third gauge on the choke manifold observed to be registering approximately 3,000 psi. This pressure had two possible sources: (1) pressure that migrated upward from a shallow sand that was not covered by the intermediate

Logs on Well A-3 and A-3 BP showing possible charged sands.

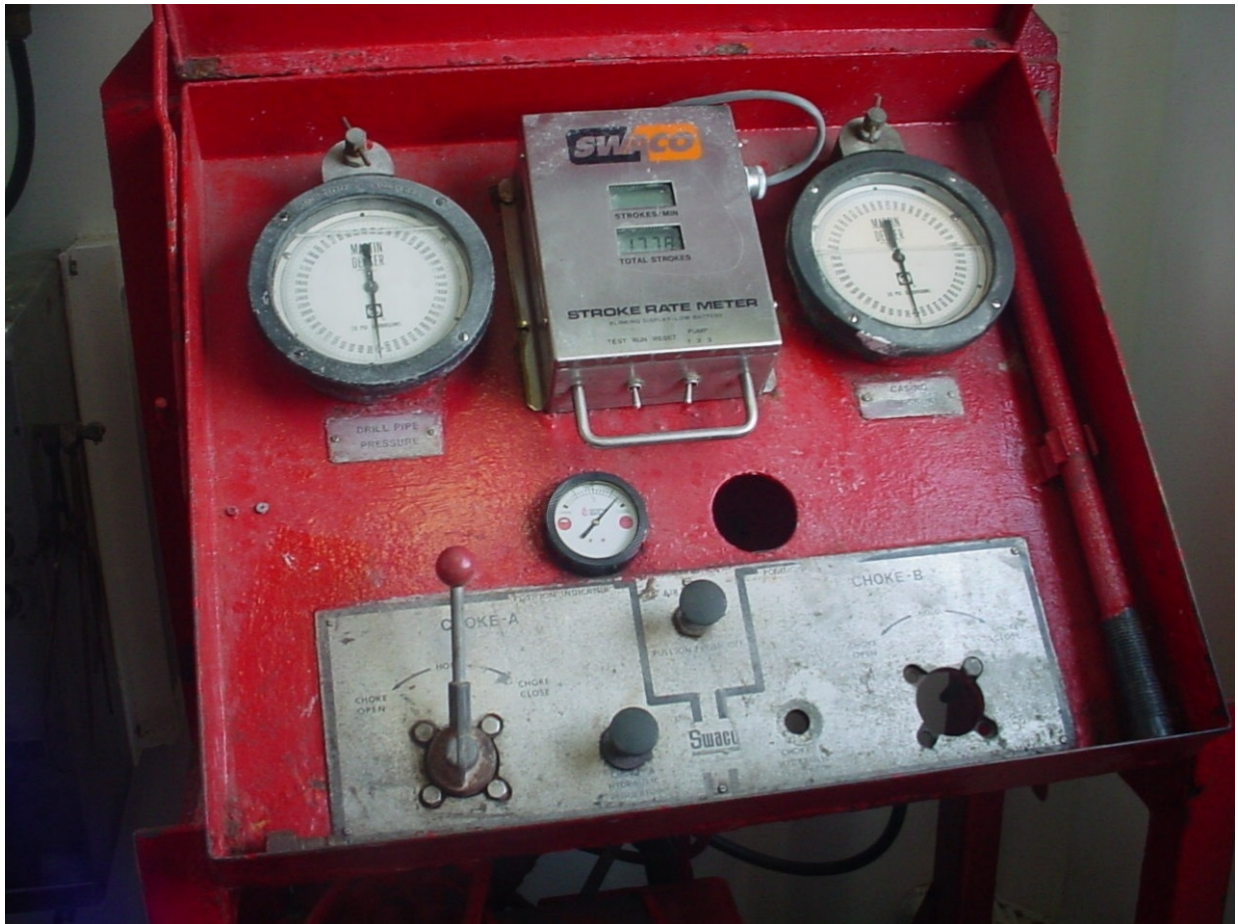
Testimony was given that the failure of the driller's console gauges to indicate the true pressure on the Annulus accurately is a reason the pressure was allowed to build up to the point of casing failure. Statements were made by management of EPL that, had the true pressure buildup been known, alternative courses of action to control the pressure, such as early "bull-heading" kill fluid or "lubricating and bleeding" the Annulus would have been initiated.

Driller's console gauges.

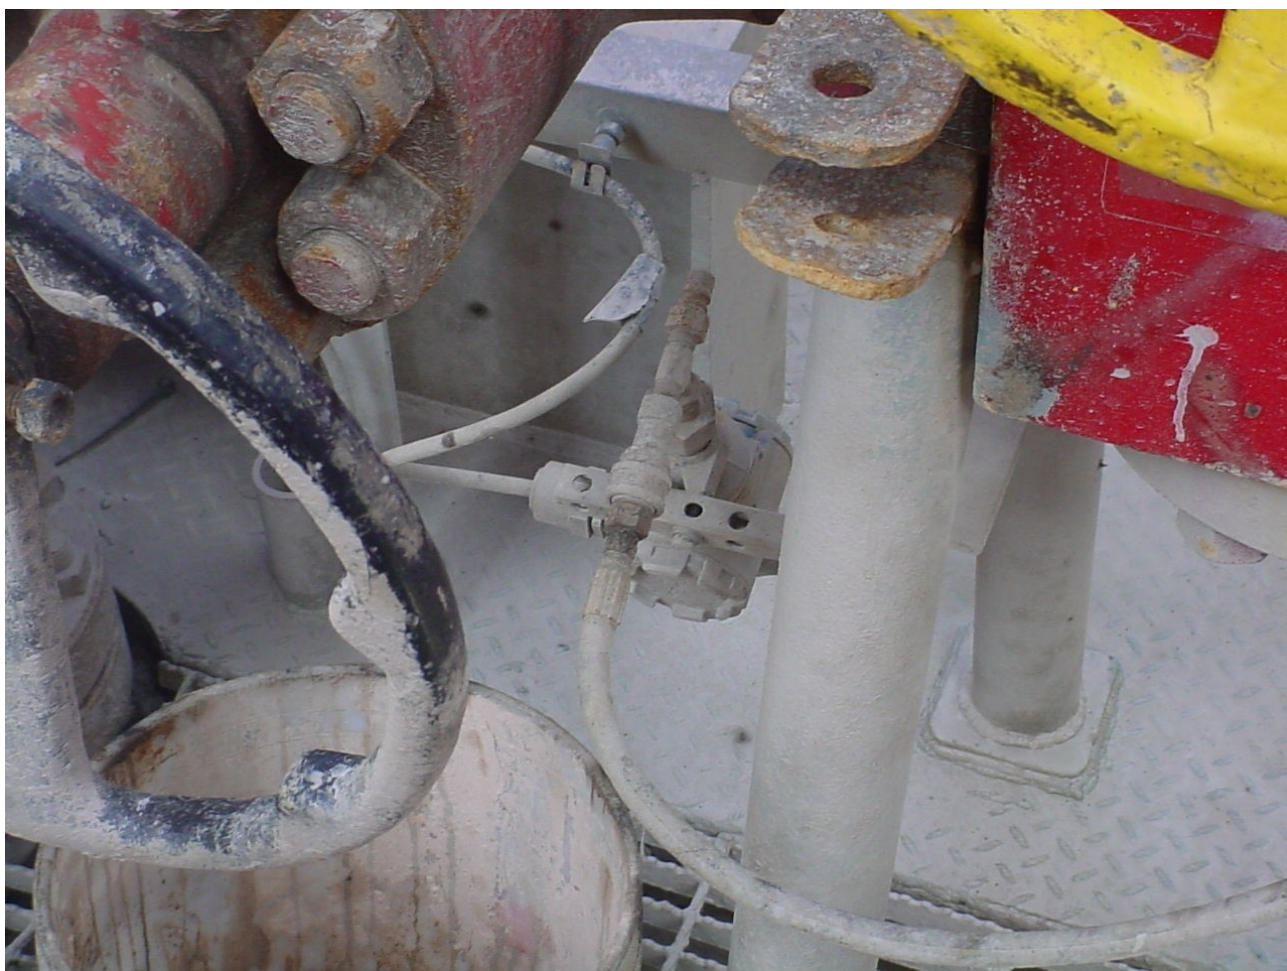
During after-the-fact interviews with Boots and Coots personnel, testimony was given that a small leak was found in the hydraulic system that could have resulted in a loss of 100 psi per hour. It is not known if these comments referred to the later tests by OI and Swaco, or were estimates, or were the result of actually gauged tests conducted by Boots and Coots.

Hydraulic line to driller's console gauges and reservoir, after incident.

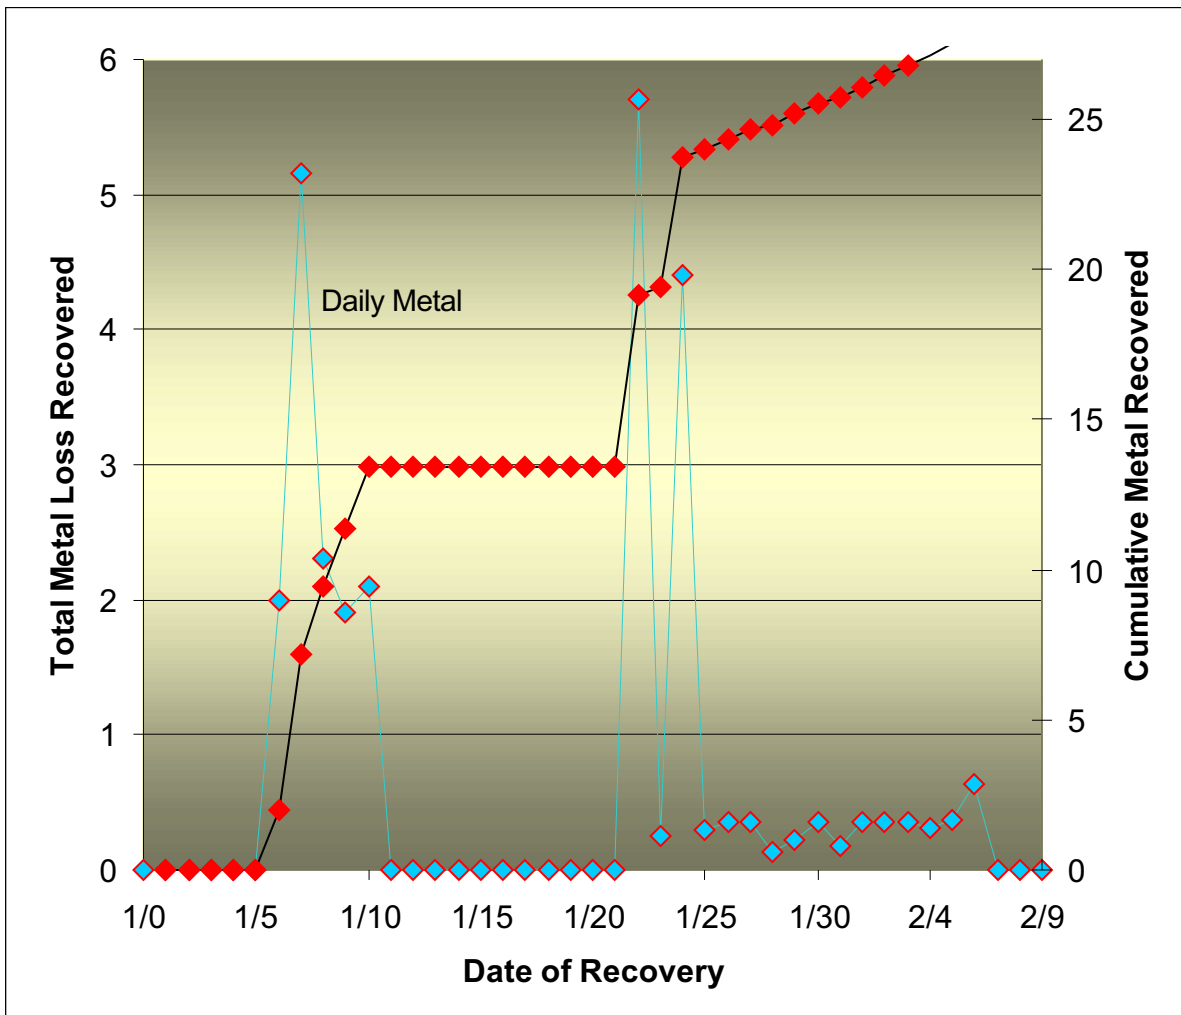
Chart: Ditch magnet metal recovery versus time.

- 1) Careful attention to rig alignment and periodic checks of same;
- 2) Monitoring of ditch magnets and other evidence for wear in casing;
- 3) Redundant capacities, systems and/or sensors for gauges;
- 4) Frequent routine checks of hydraulic systems for gauges;
- 5) Detailed analysis of logs to identify unexpected pressure and productive zones, especially shallow gas; and
- 6) Pressure tests of casing at or near the required dates.

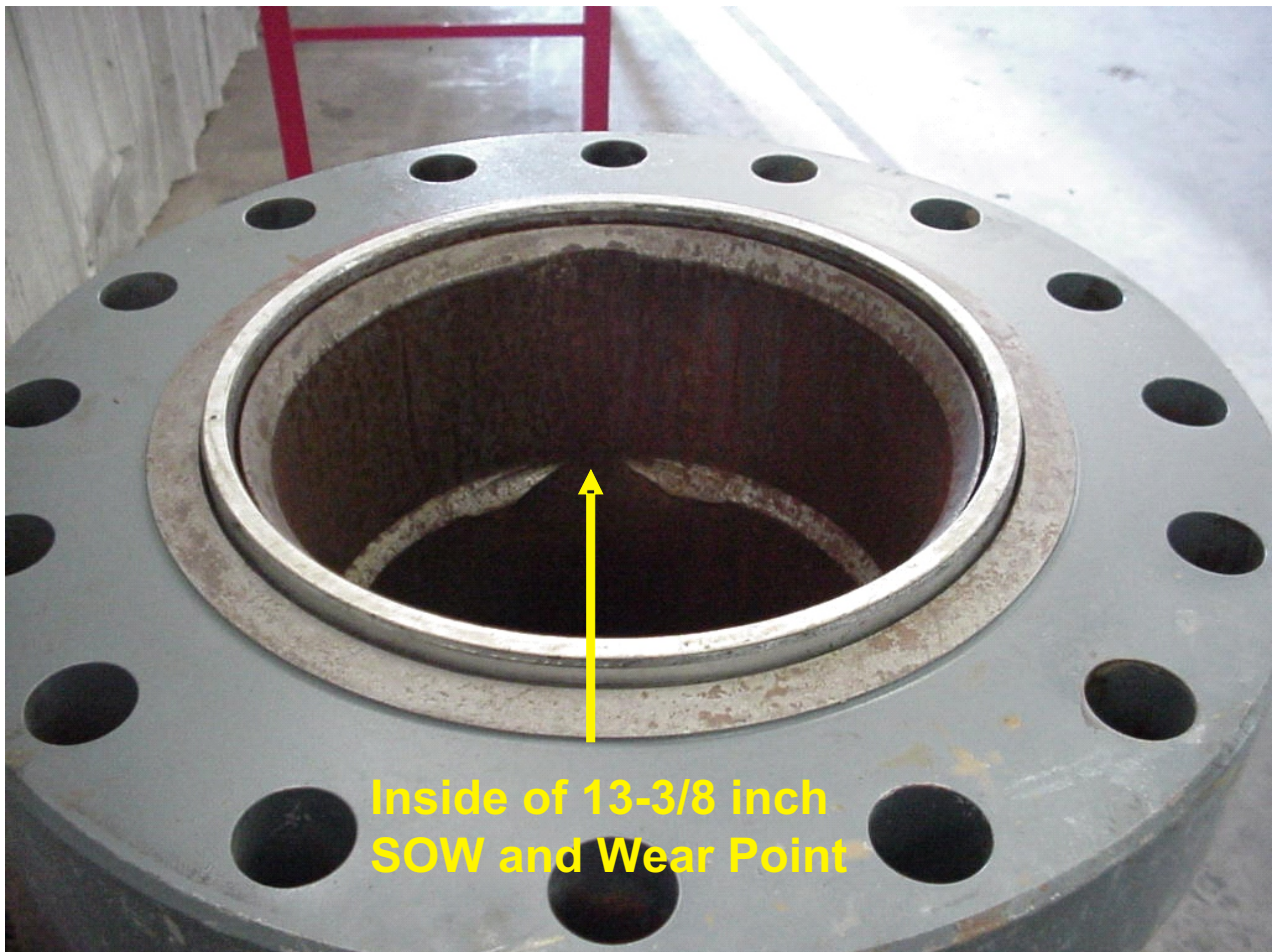
Following the burst surface casing, the top of the casing, slip-on wellhead, and spool were recovered and returned to shore for analysis. Severe wear was found on the interior surface of the burst casing, which was heavily grooved in the area where the casing ultimately split.

Worn and damaged 13 3/8 inch SOW.

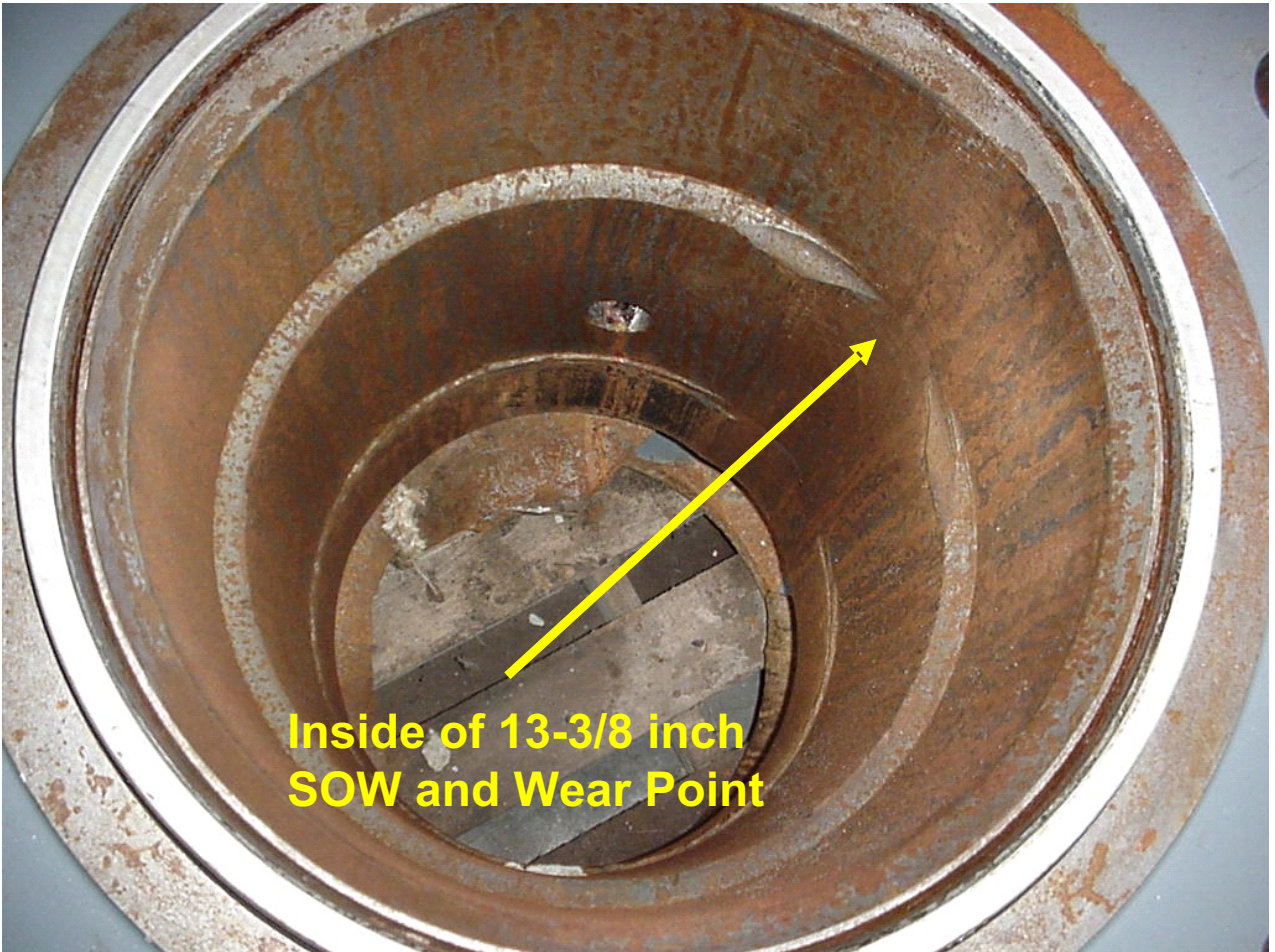
Immediately above the casing, the spool was also found to have been heavily worn in an area in line with the vertical wear seen on the casing stub (*see Attachments 15, 16, 17, 18, and 19*).

Worn and damaged 13 3/8 inch SOW, inside details.

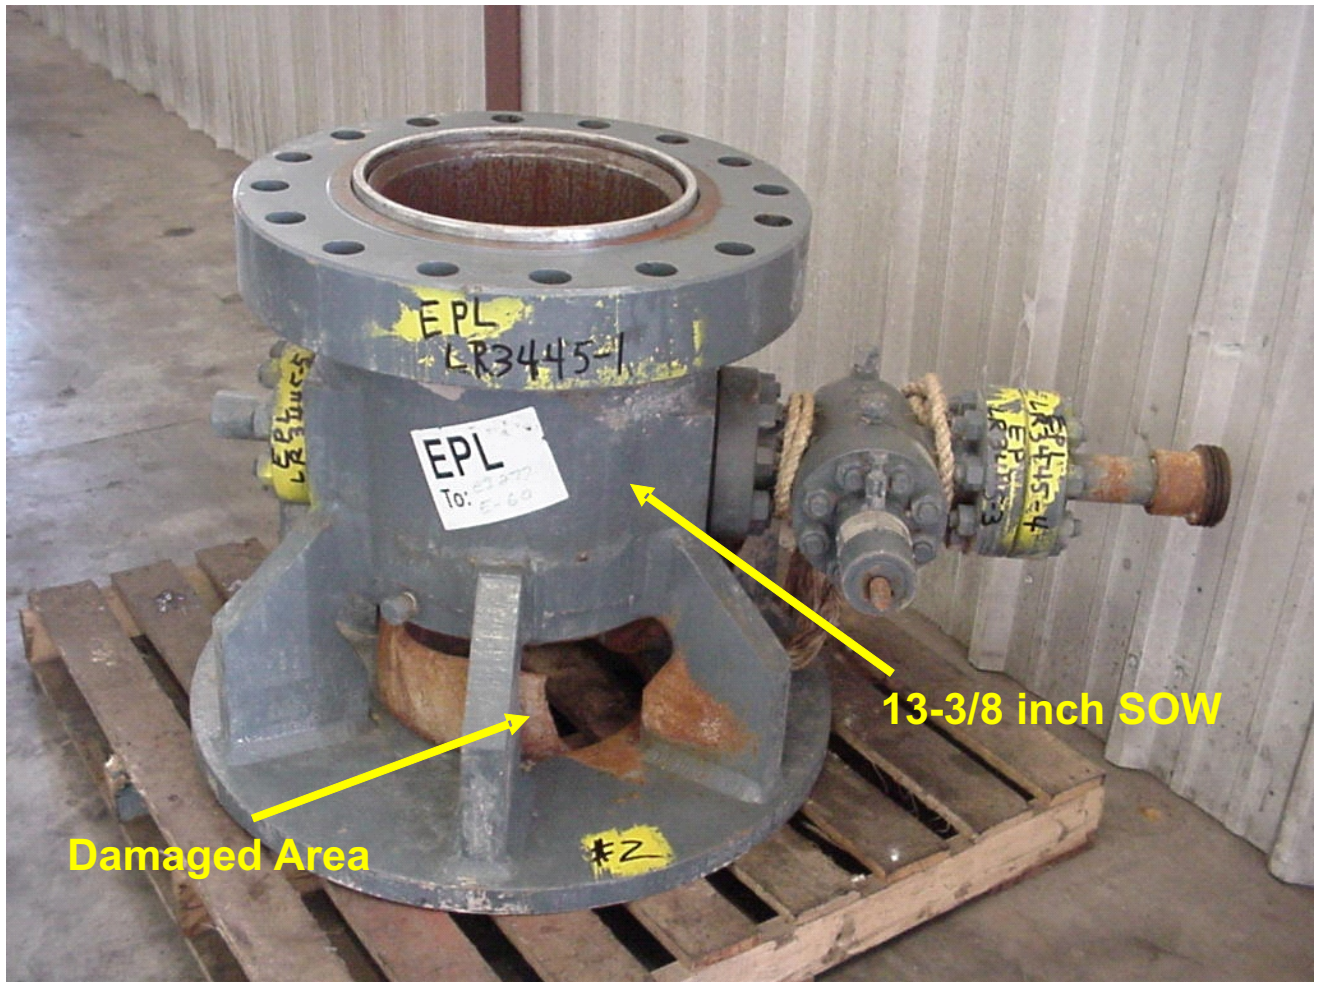
Damaged SOW and top of 13 3/8 inch casing.

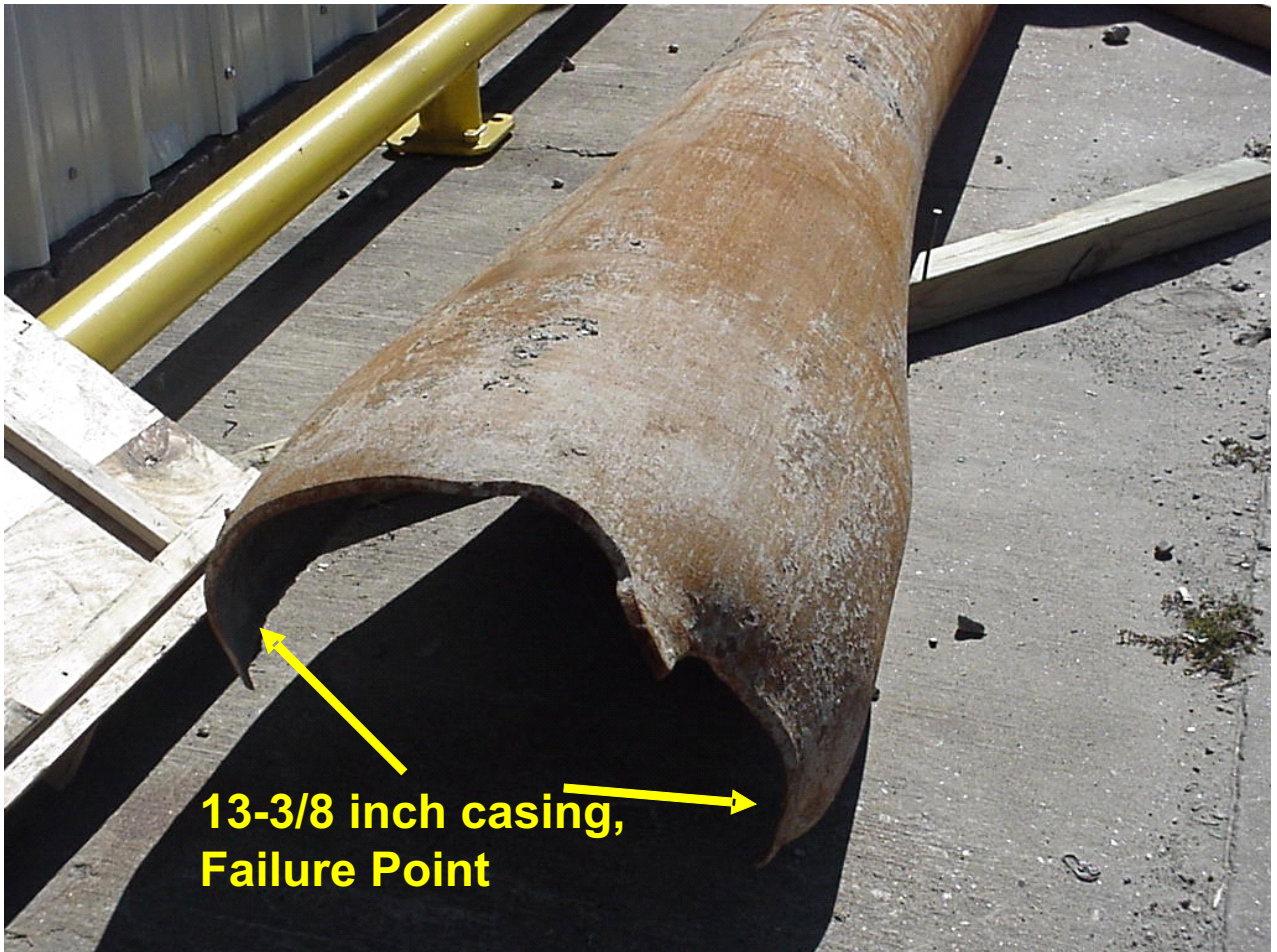
*“The 13 3/8” casing burst failure occurred because of eccentric wear of the casing internal surface. The wall thickness near the burst region was worn down to as low as 0.191” (nominal wall thickness is 0.480”). This reduced wall thickness significantly decreased the internal pressure capacity of the casing.*

Split, ballooned, and parted 13 3/8 inch casing.

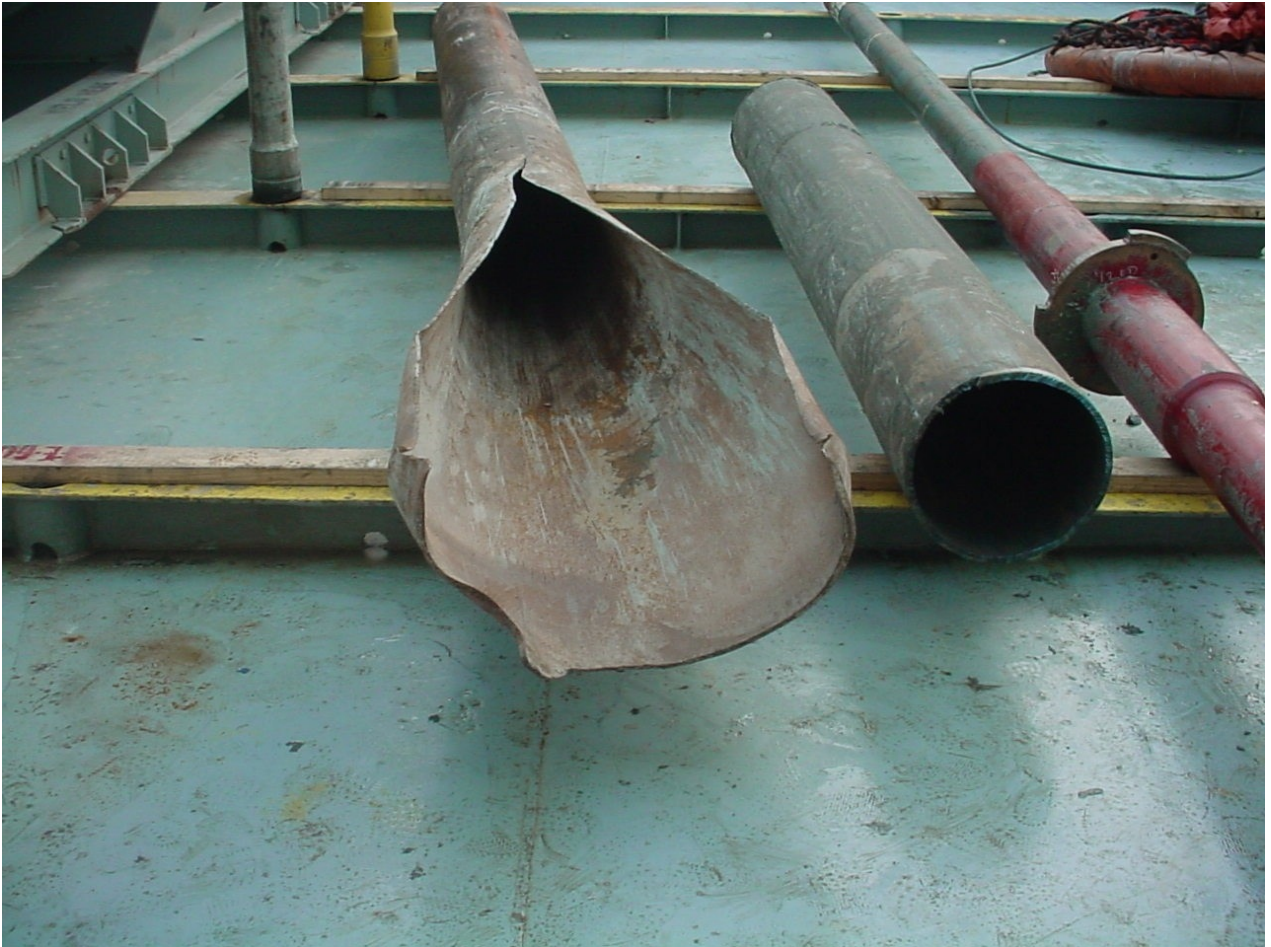
Damaged casing.

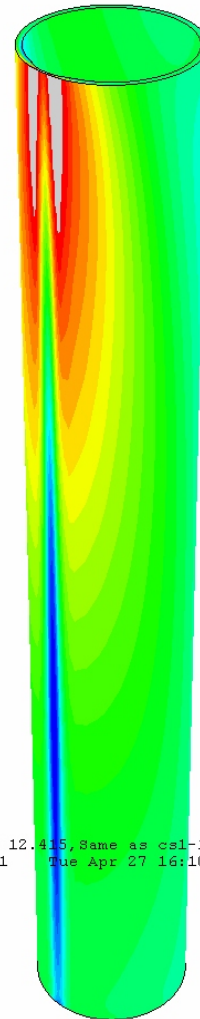
Stress distribution along the outside surface of the worn casing [From T. H. Hill].

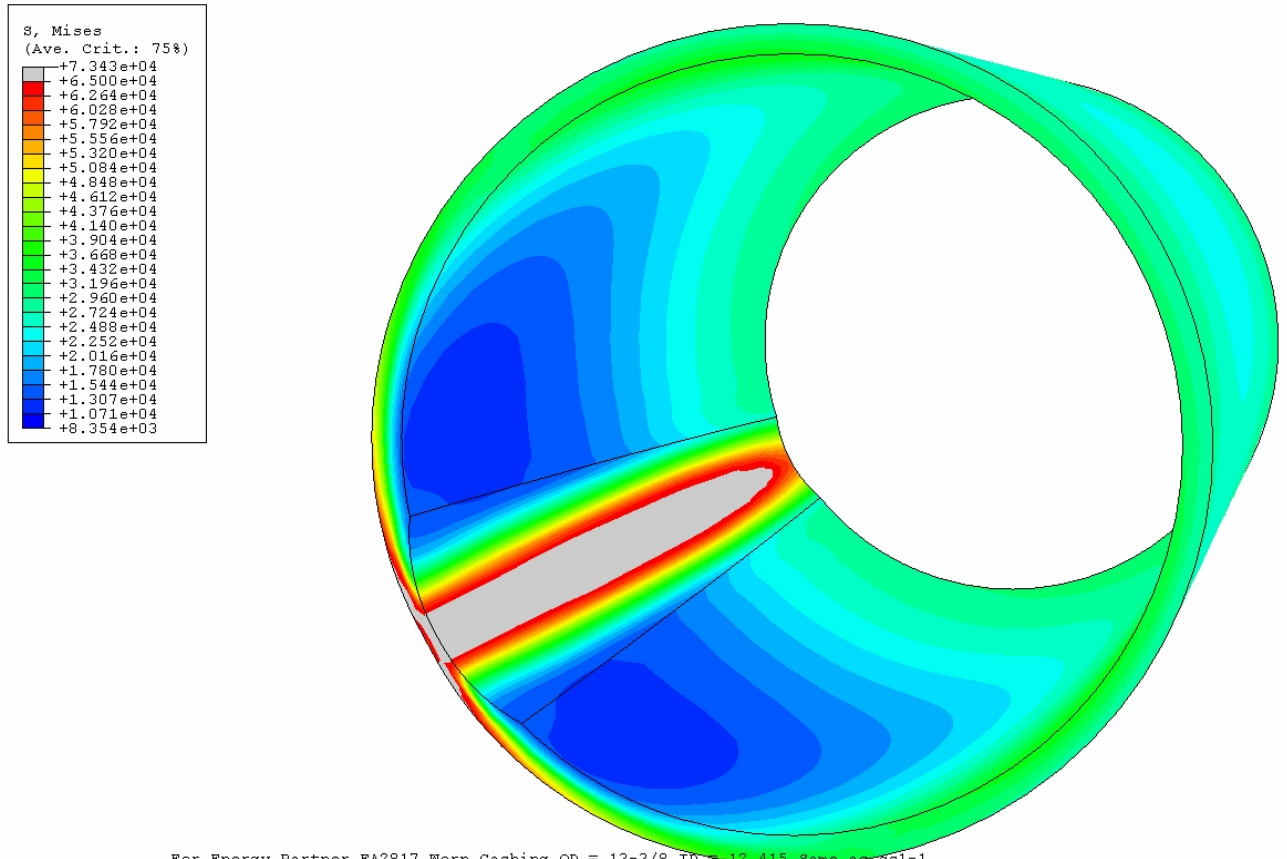
Stress distribution along the inside surface of the worn casing [From T. H. Hill].

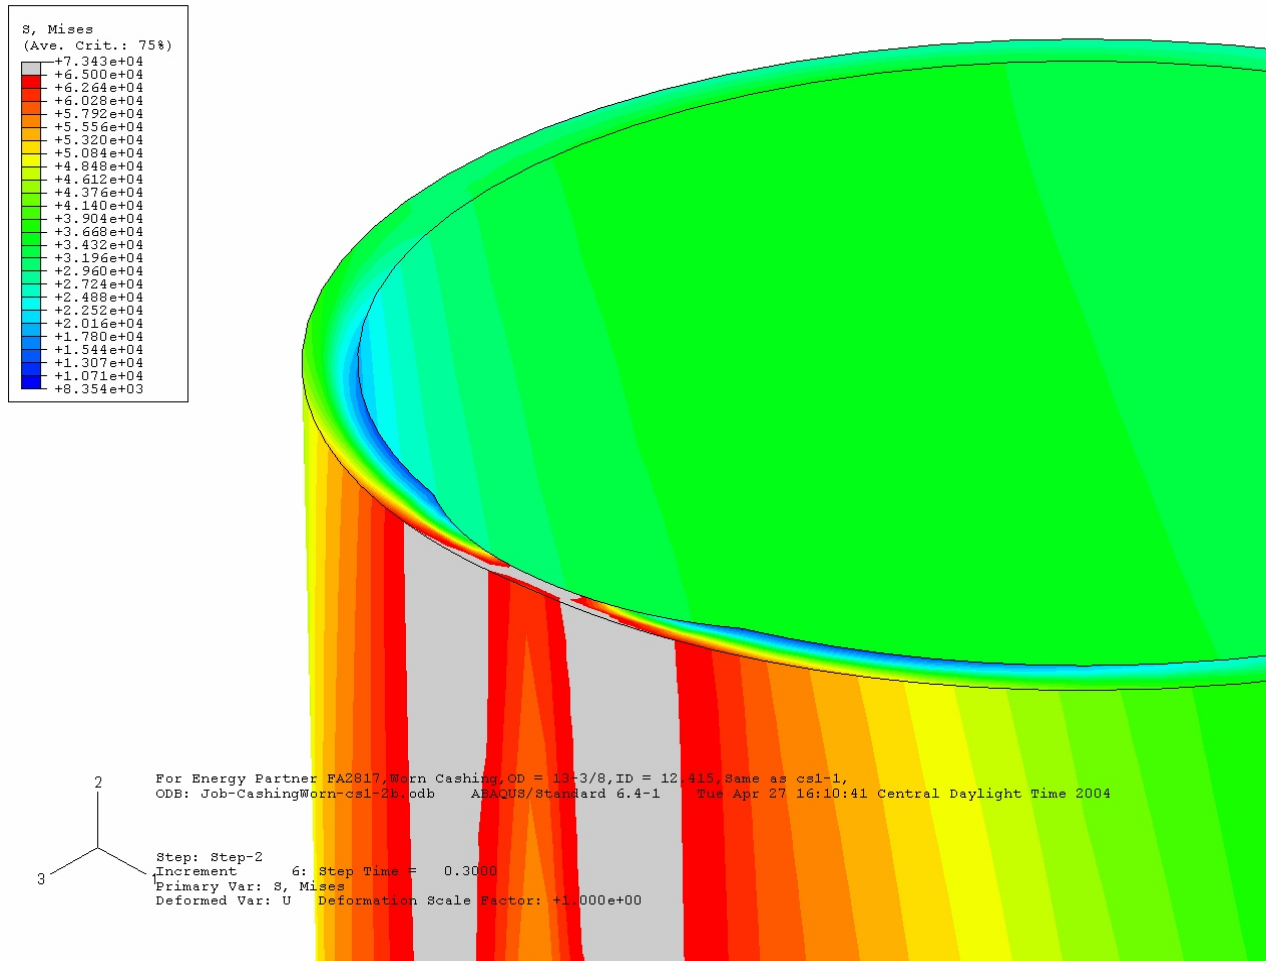
*“Three dimensional non-linear finite element analysis (FEA) of the casing in the worn condition with pressure load applied to the internal surface indicated that a minimum threshold pressure of 2,300 psi was required to cause through-wall yielding of the casing joint. This internal pressure is the load at which the burst failure was most likely to occur.*

***Casing Wear and Failure*** – When exposed to 3,000 psi, the surface casing failed below its rated burst pressure of 3,450 psi because of heavy wear in the casing that was not detected. The wear reduced the burst rating of the casing from 3,450 psi to a laboratory tested 2,300 psi.

Internal pressure of 2,300 psi produced through-wall yielding of the worn casing joint [From T. H. Hill].
