**Investigation of Loss of Well Control  
South Pelto Block 10, Well No. 10  
OCS-G 02925  
14 February 2008**

**Gulf of Mexico  
Off the Louisiana Coast**

**U.S. Department of the Interior  
Minerals Management Service  
Gulf of Mexico OCS Regional Office**

**New Orleans  
November 2008**

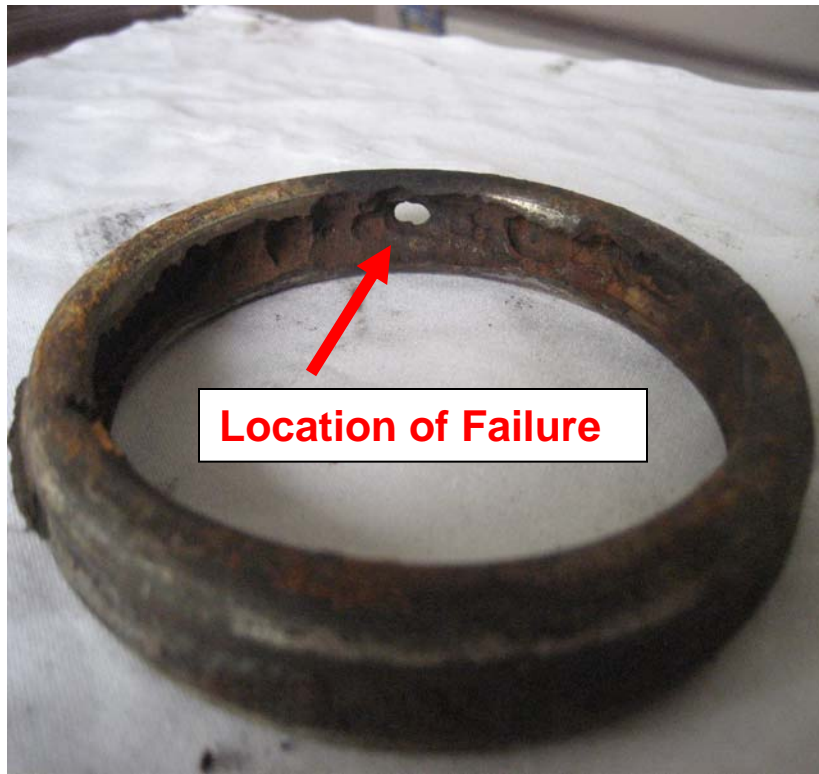
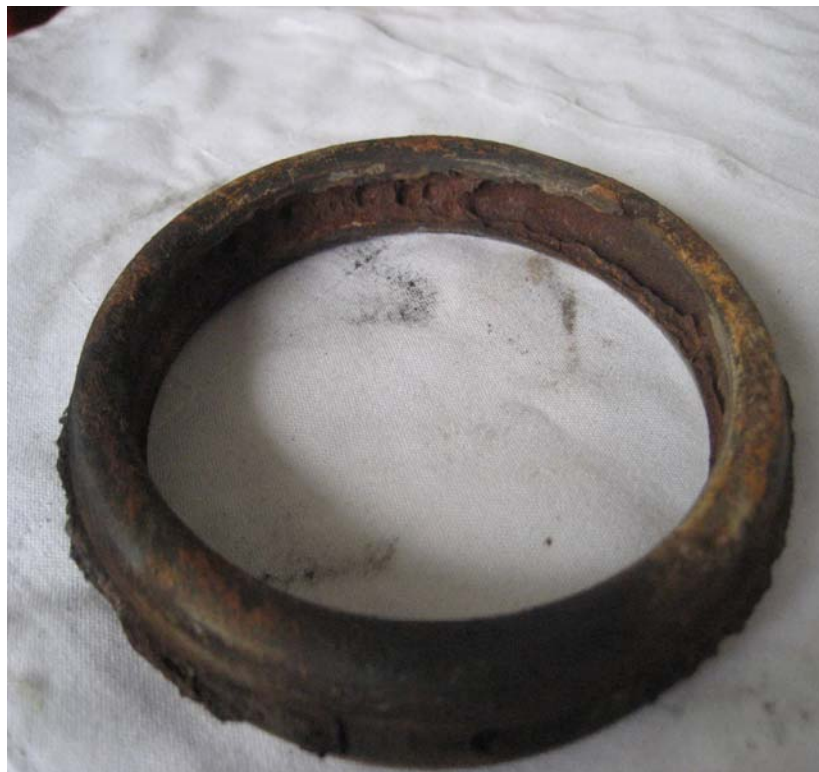
## Attachment 2

1. The exact condition in which the gasket was in prior to the incident is not known; however, it is known that a ring gasket downstream was replaced two days prior due to a possible corrosion failure. Pictures taken during a post-mortem inspection of the tree indicate the gasket involved in the incident was heavily corroded prior to the incident. **Therefore, the amount of corrosion on the ring gasket which lead to the loss of mechanical integrity is concluded to be a cause of the incident.**

Photo of Ring Gasket

1. A brief description of the accident;
2. A summary of the causes; and
3. The following recommendations:
  - a) Lessees and operators should review their policies regarding the performing of acid operations especially if an SCSSV is not functioning properly.
  - b) Lessees and operators should review their platform specific emergency plans to reduce further injuries or accidents when an incident occurs.
  - c) Lessees and operators should be able to trace the history of ring gaskets in the field regardless of previous ownership, and/or determine the condition of said ring gaskets prior to the performance of future operations.

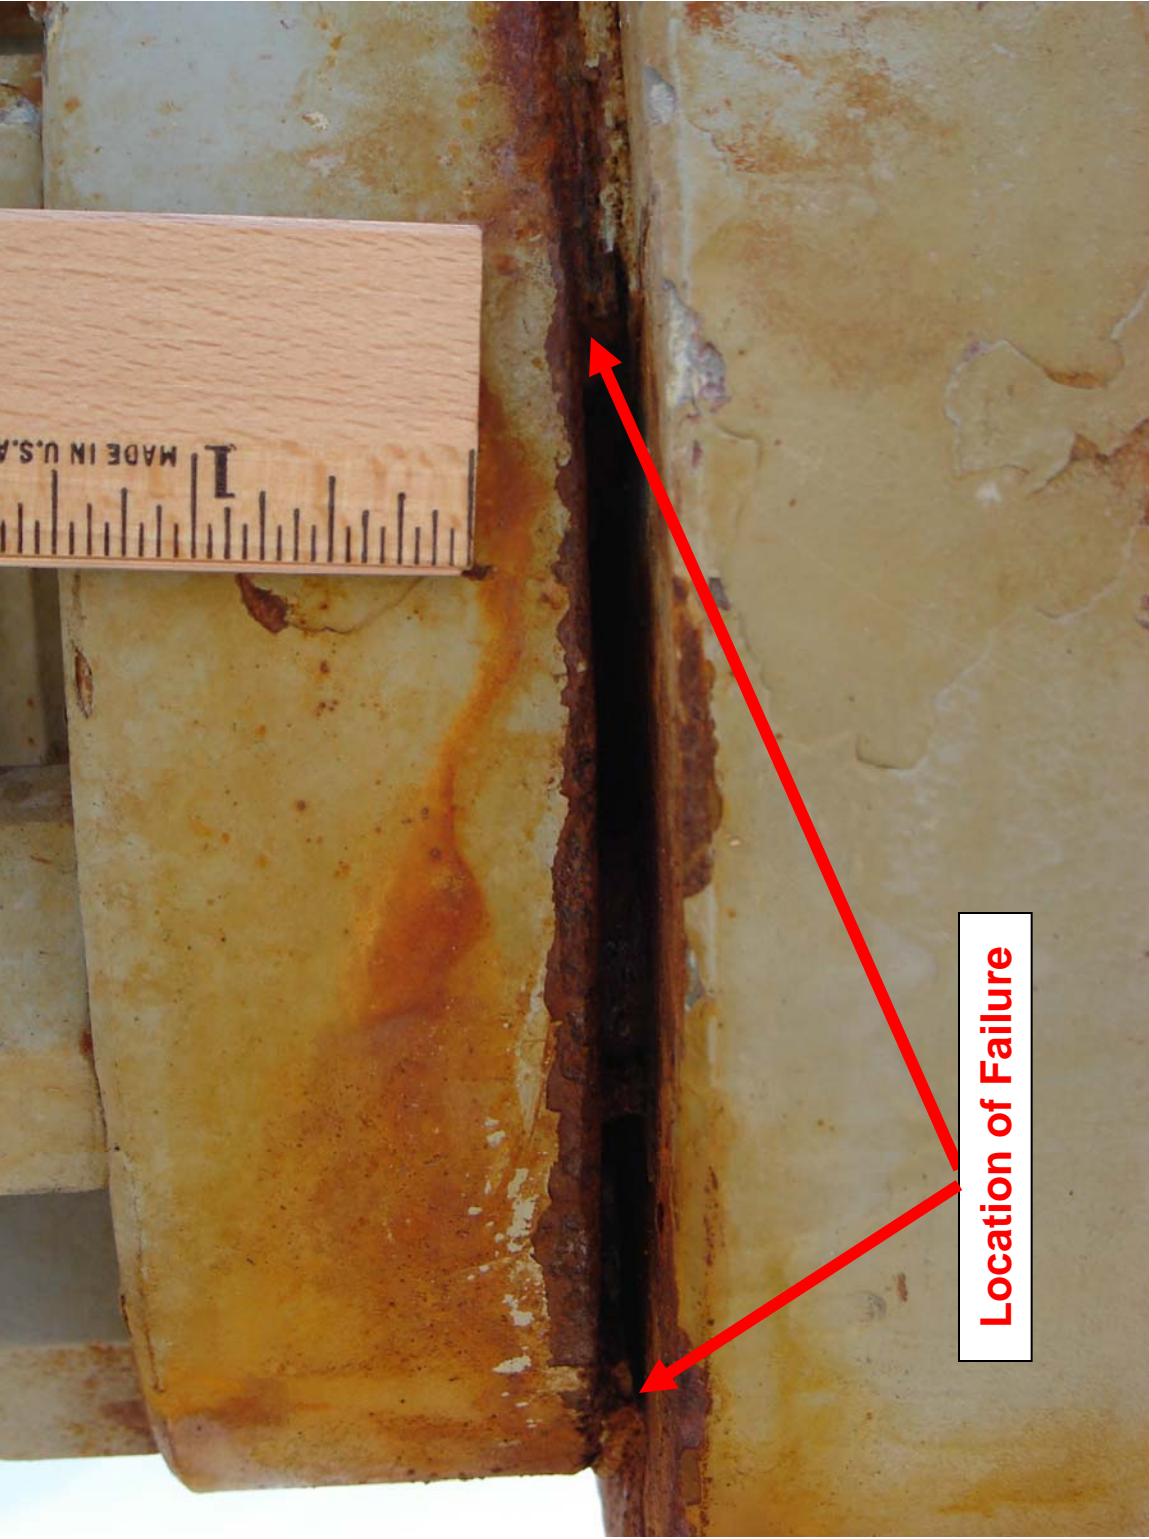
**Attachment 3**

At 1740 hours, the Well began leaking natural gas between the master valve and the adapter.

It is concluded by the panel, that as routine scraping and acid operations were occurring on OCS-G 02925, Well No. 10, to repair a leaking SCSSV, the ring gasket in between the master valve and its adapter failed and caused the release of natural gas into the atmosphere.

Photo of Connection Between Master Valve and Adapter Flange (Location of Ring Gasket Failure)

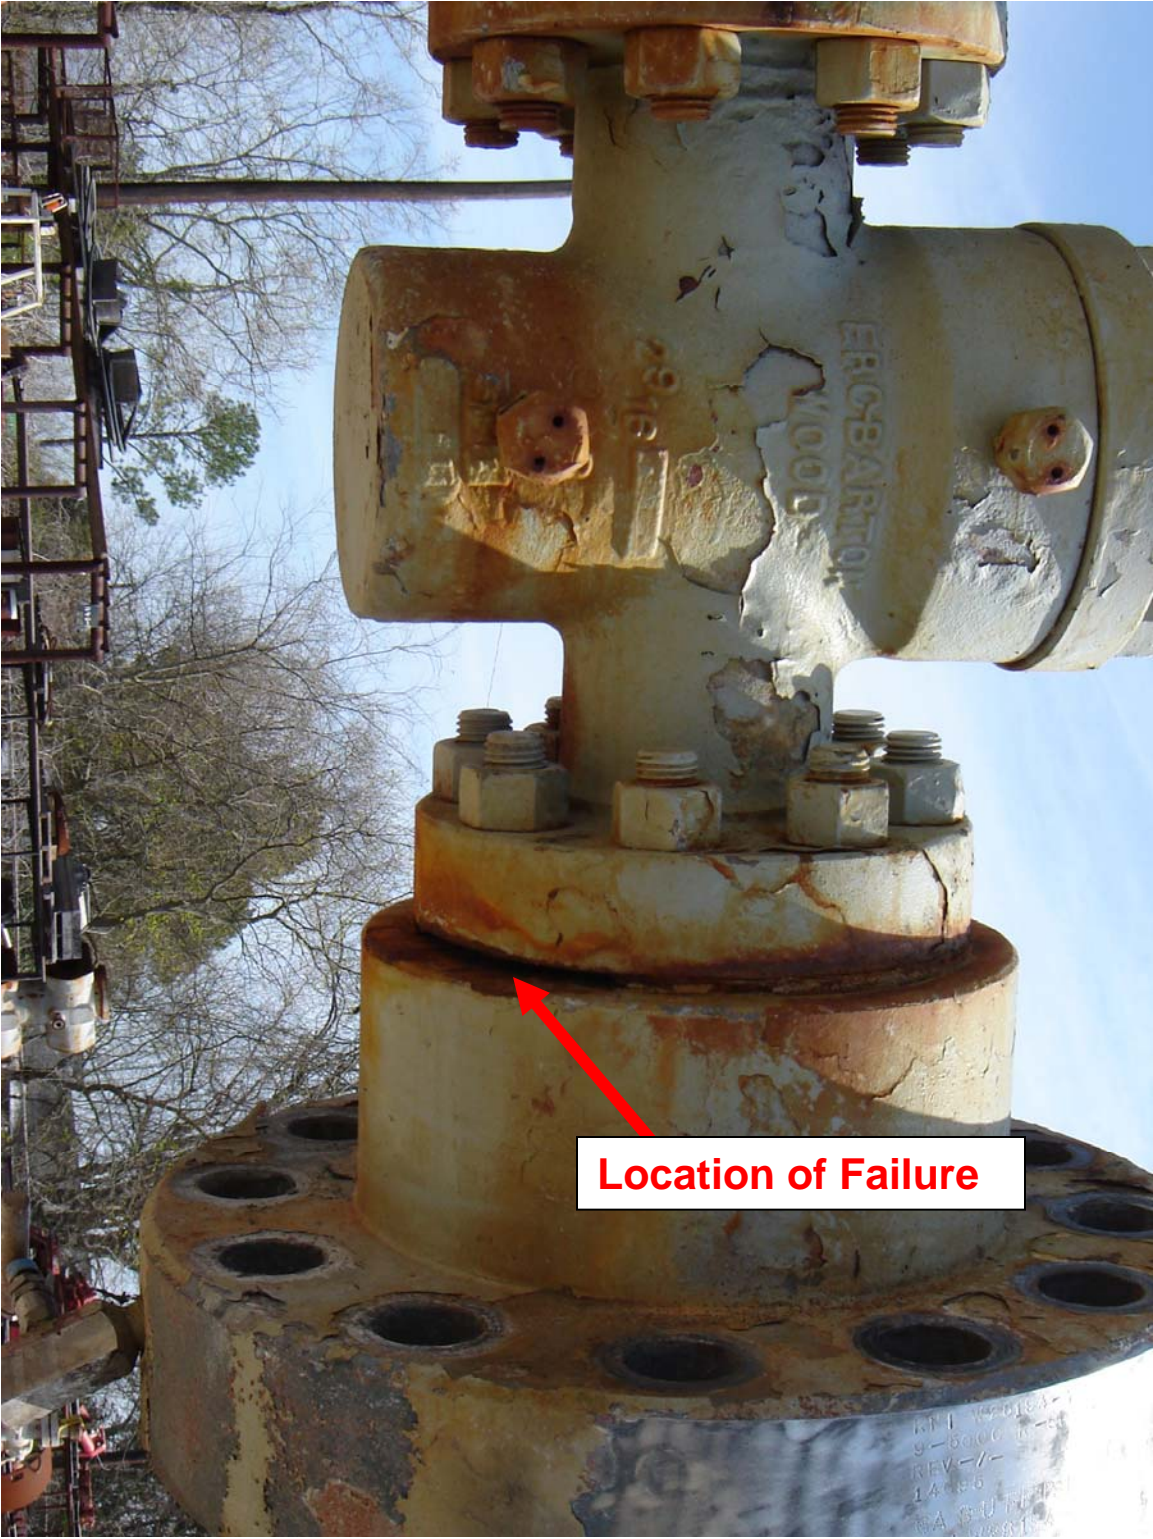
**Attachment 4**

**Photo of Connection Between Master Valve and Adapter Flange**

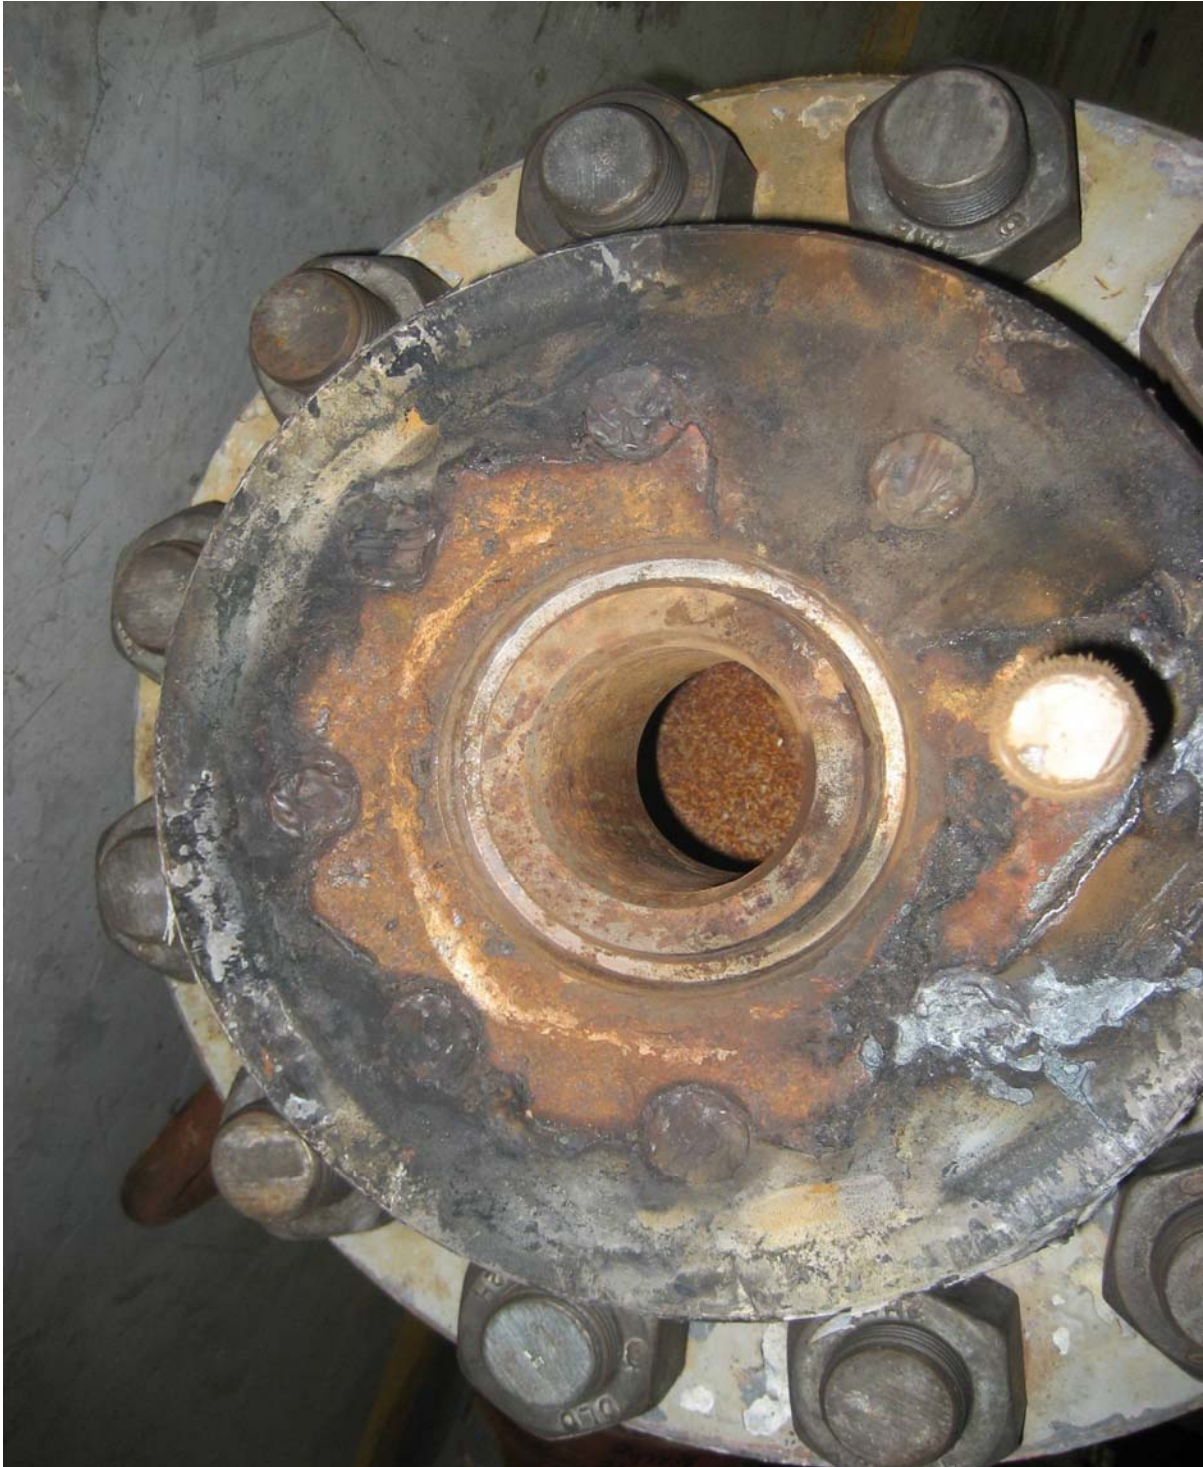
## Attachment 5

**Photo of Adapter Ring Groove and Corrosion**

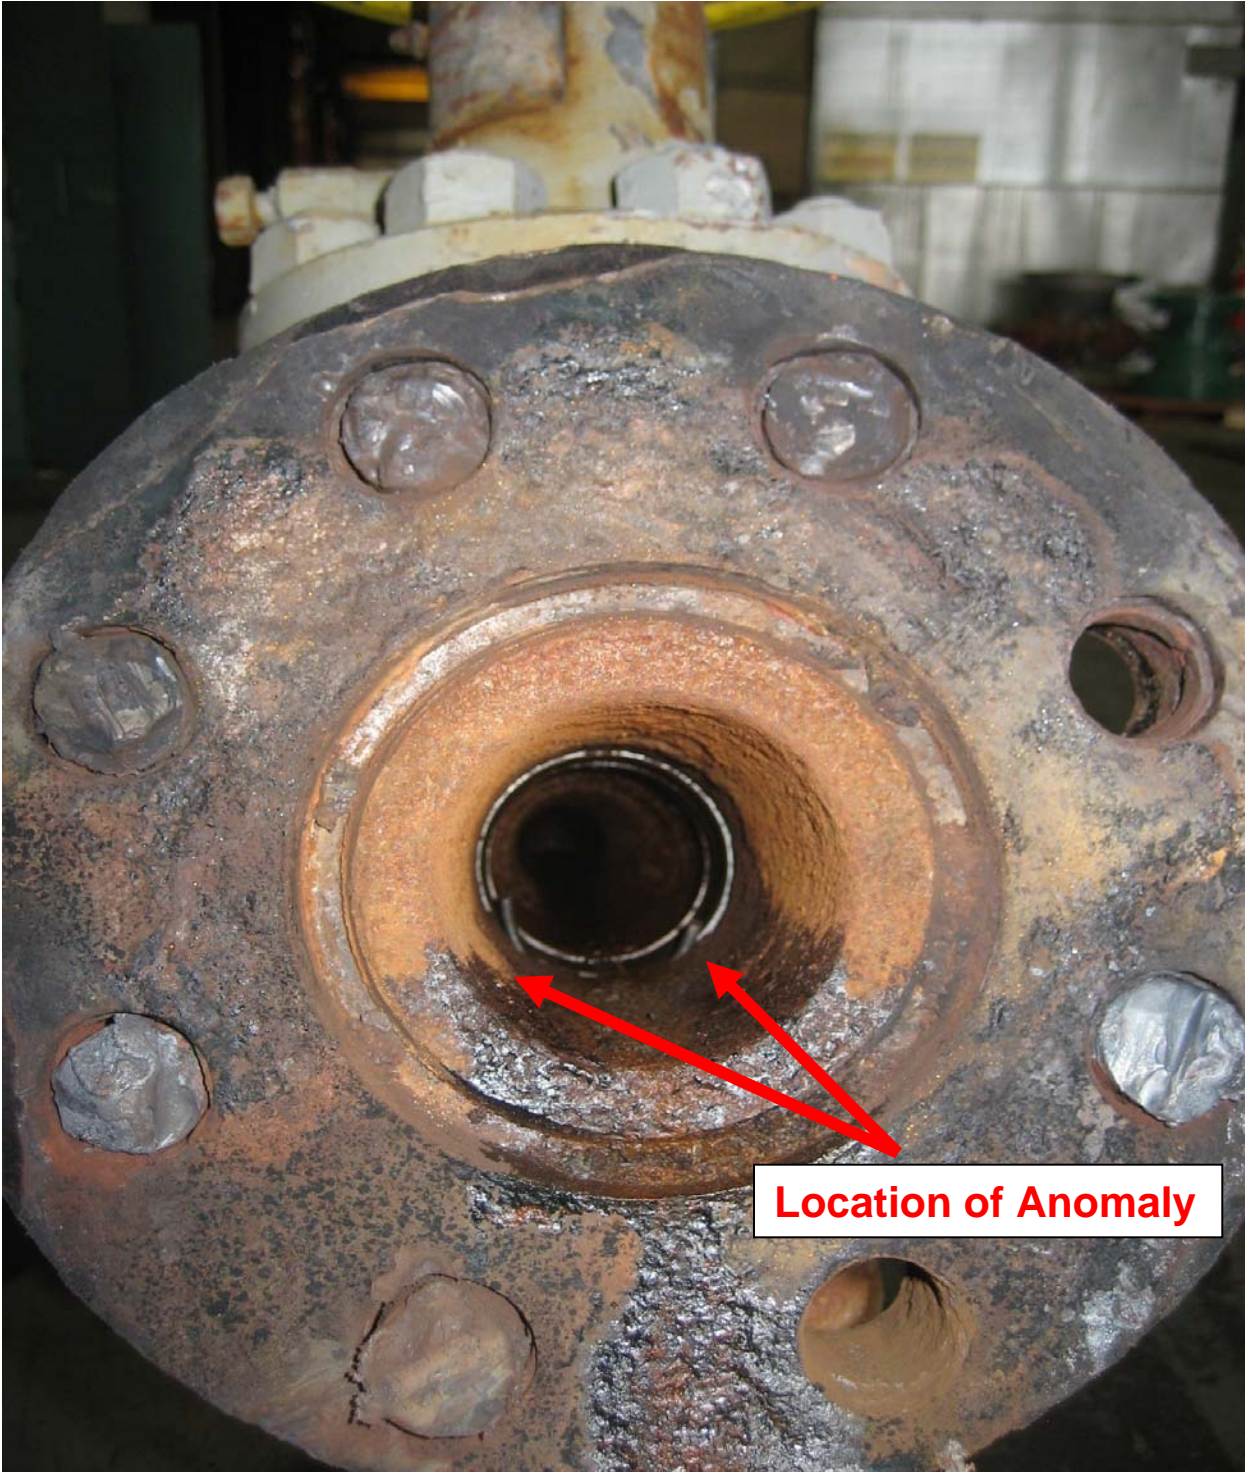
**Attachment 6**

**Photo of Master Valve Ring Groove and Corrosion**

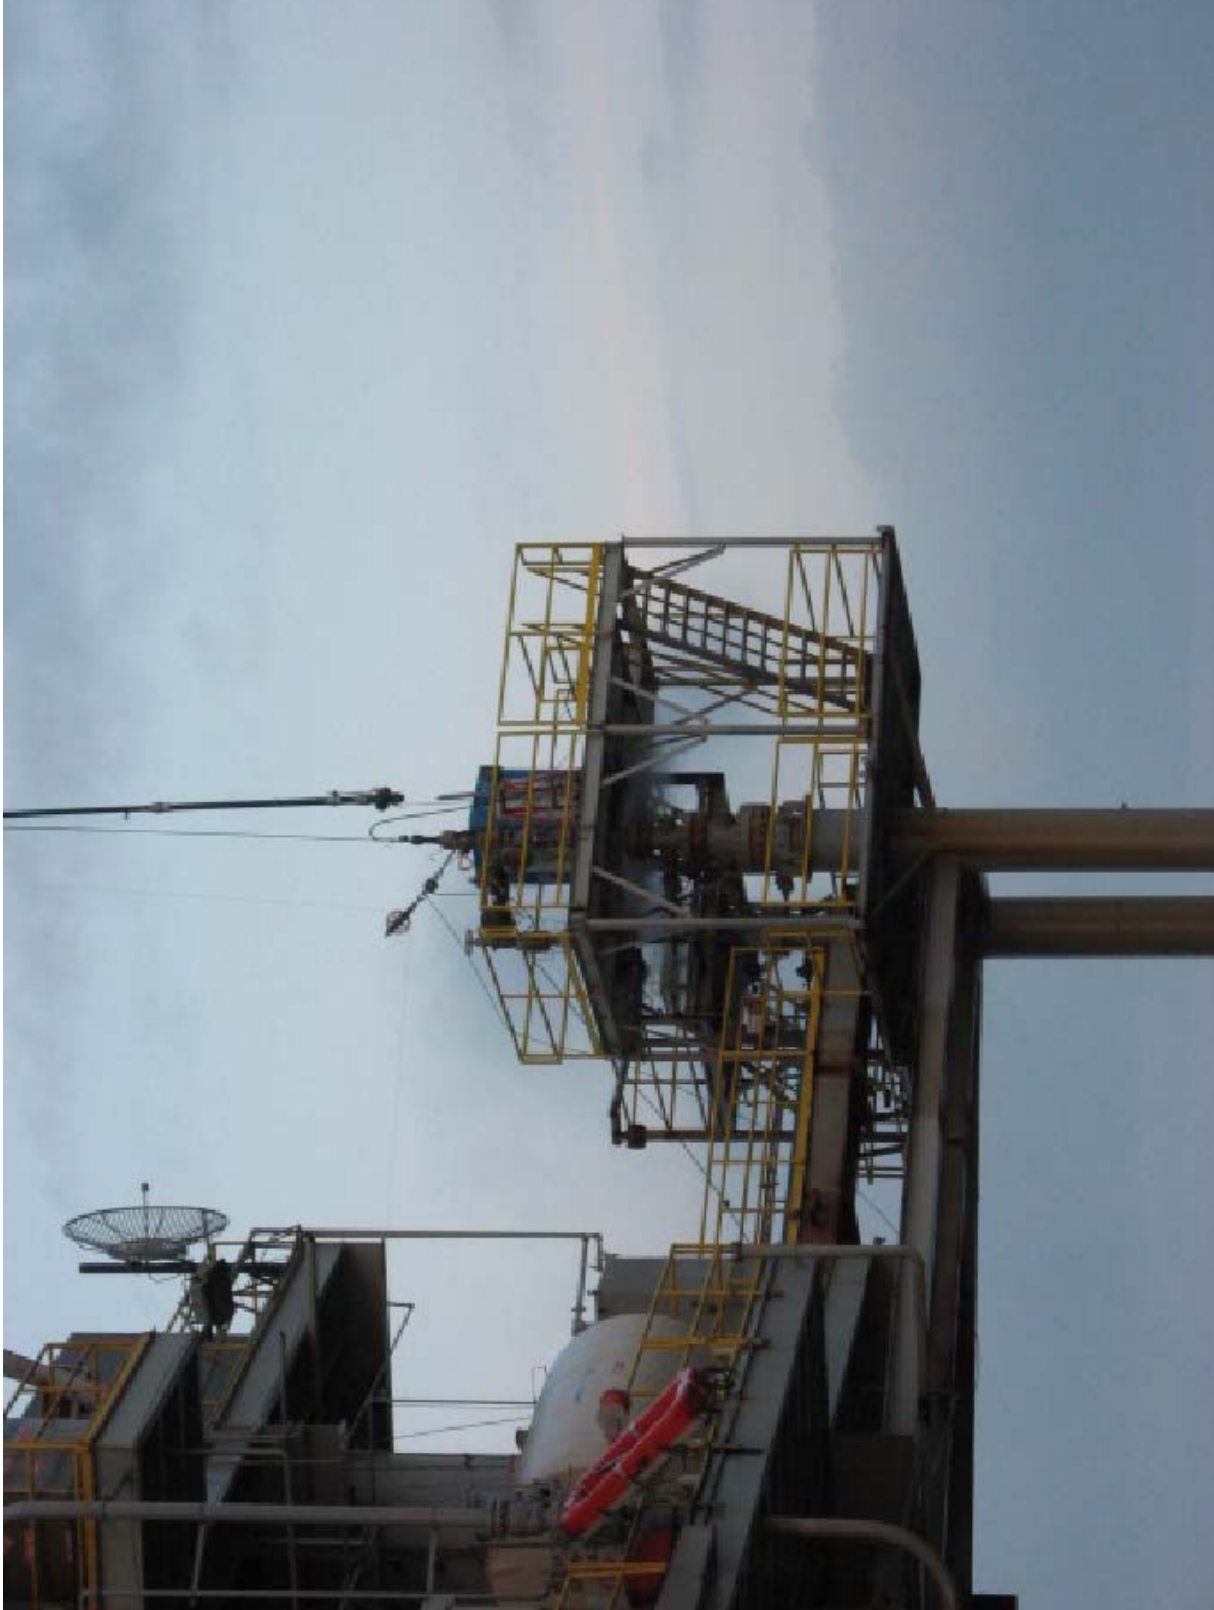
# Attachment 9

Photo of Well No. 10 During Loss of Well Control

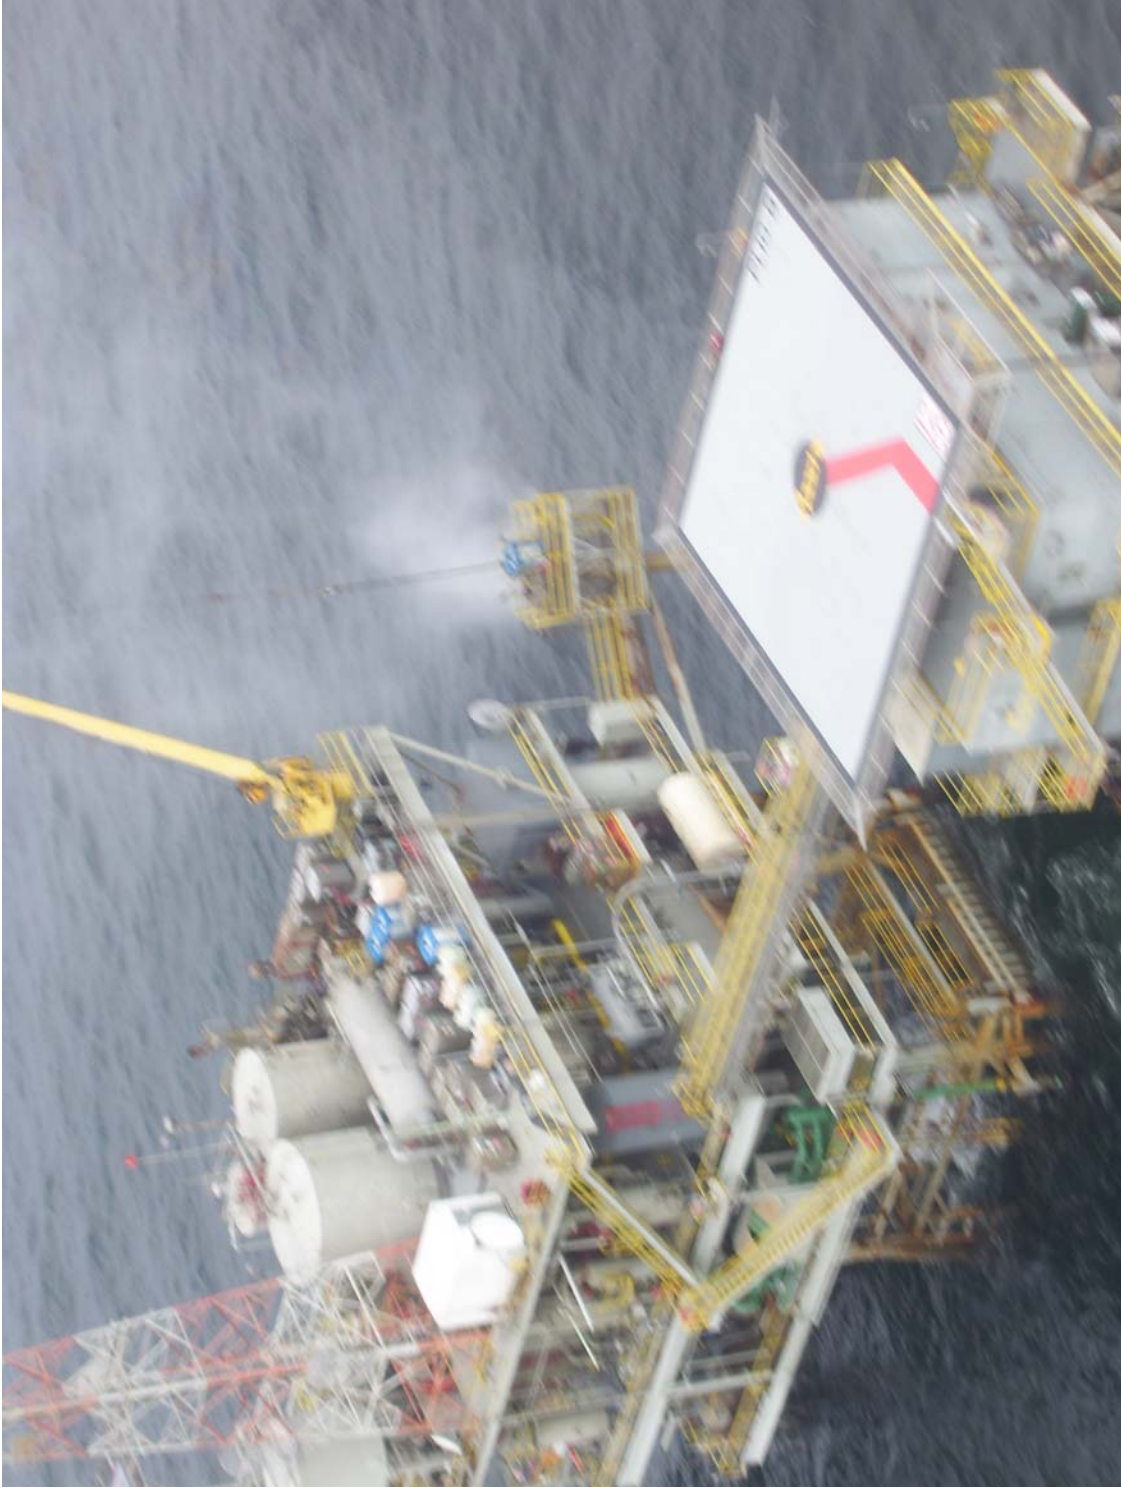
# Attachment 10

Photo of PL 10 During Loss of Well Control

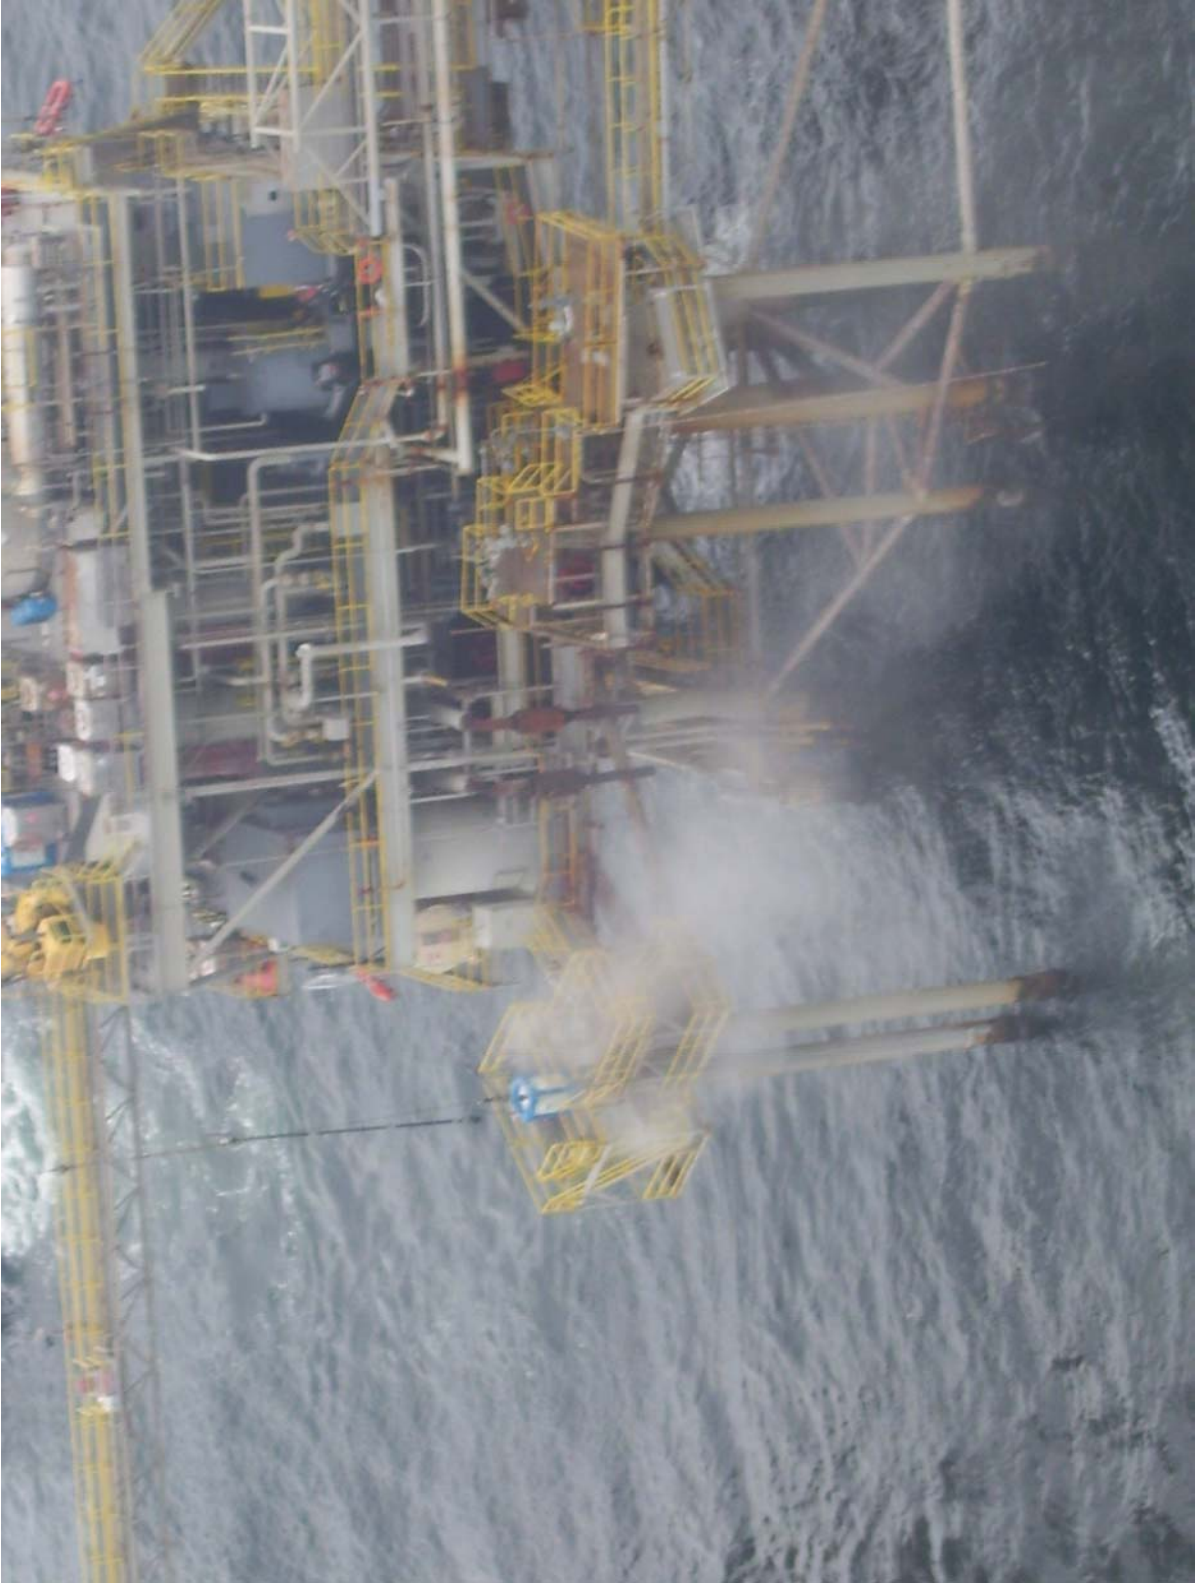
# Attachment 11

Photo of PL 10 During Loss of Well Control
