**Investigation of Fatal Accident
North Padre Island Block 969, Platform JA
OCS-G 5953
19 January 2008**

**Gulf of Mexico
Off the Texas Coast**

**U.S. Department of the Interior
Minerals Management Service
Gulf of Mexico OCS Regional Office**

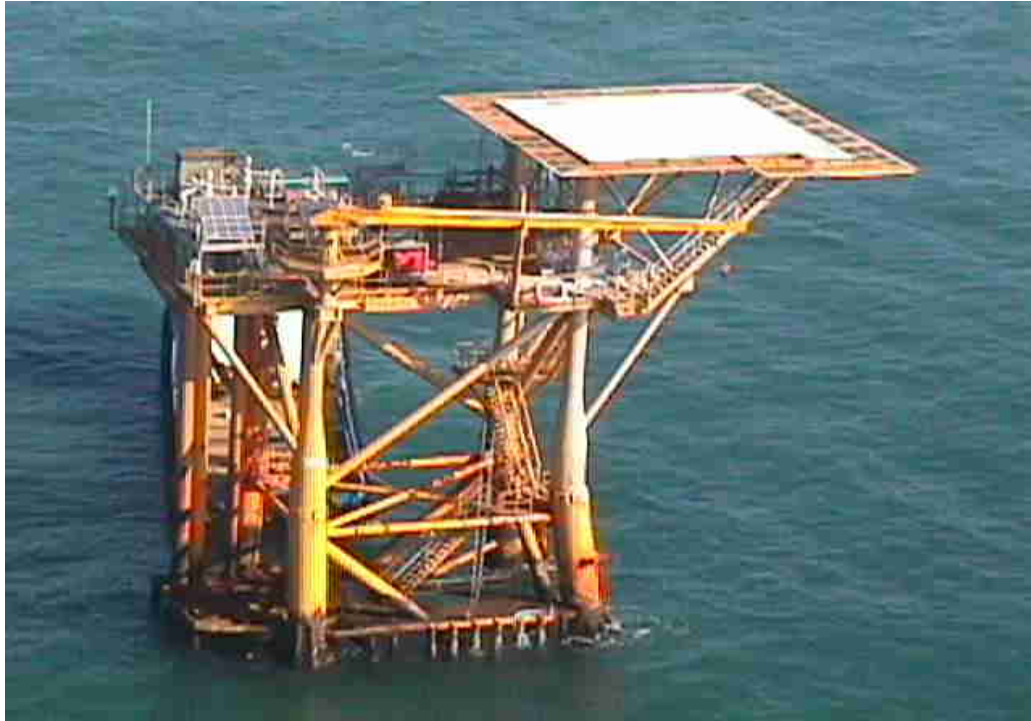
Figure 1: Photo of PN 969, Platform JA.

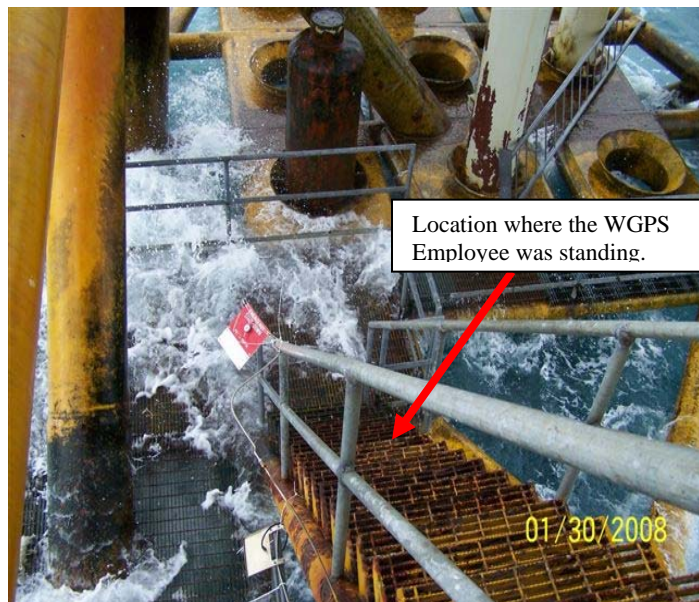
The OSW was tasked to perform regularly scheduled navigation aid inspections or "Quarterly Inspections". The WGPS Employee volunteered to go to PN 969 on the morning of January 19, 2008 with the task of assessing the reason for shut in and to bring the platform back online. It was assumed that the ESD was the likely cause of the shut in. If the ESD was determined to be the cause of shut in, the plan was to affect permanent repair if feasible (temporary if needed) in order to bring the platform back online. The WGPS Employee (presumably) determined that the permanent fix was feasible and descended the stairways to an elevation of approximately +10 to +12 feet above the boat landing.

Figure 3: Photo of the WGPS Employee's location on stairs leading to boat landing.

Based on the information obtained during this investigation, it is the conclusion of this panel that on the morning of January 19, 2008, the WGPS Employee was washed overboard as he attempted to replace the boat landing ESD station in high winds and rough seas. The WGPS Employee was not wearing a life jacket, and it was determined by the Nueces County Medical Examiner's Office that the cause of death was drowning. This panel further concludes that the decision of the WGPS Employee to work on the stairs leading to the boat landing during inclement weather, and the decision to not follow company policy and work at that location without wearing a life jacket, are causes of his drowning.

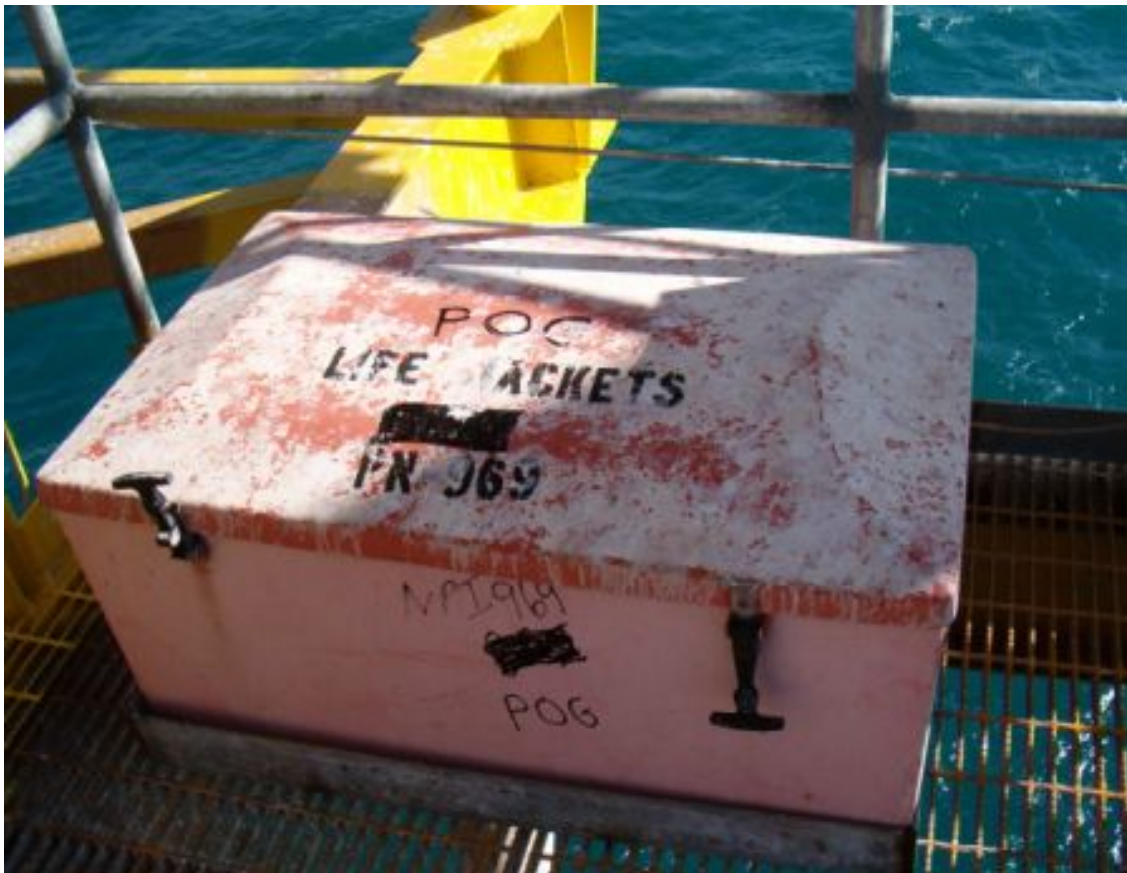
Despite his reputation as an experienced, safe, and conscientious worker, the WGPS Employee was not wearing a life jacket at the time of the incident. There were three to four Type 1 life jackets, in serviceable condition, available at the top of the stairs leading to the incident site (see Figure 4). There was a policy in place, including signage, at the top of stairs explicitly stating “PFD’s Required Beyond This Point” (see Figure 5). The Lead Operator indicated that the WGPS Employee had been made aware of the life jacket policy. There were no other safeguards regarding life vests and descent to the boat landing area known to this investigative panel.

Figure 4: Photo of life jacket box at the top of the stairs.

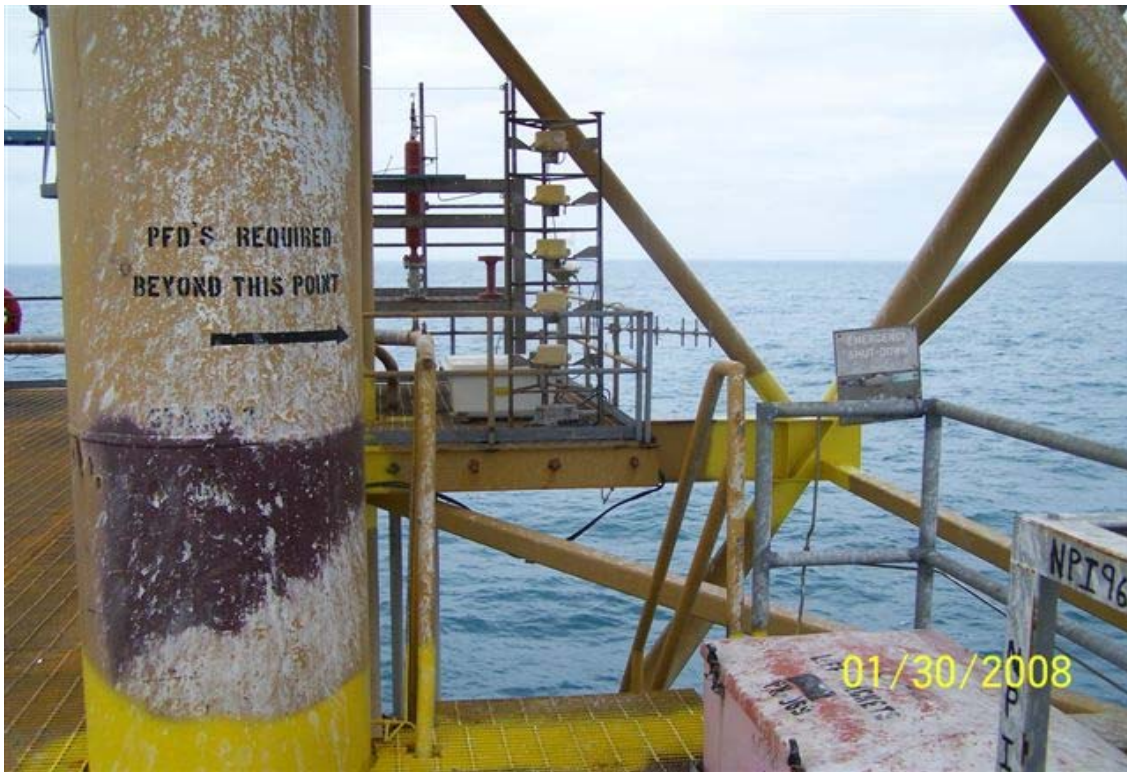
Figure 5: Photo of sign stating “PFD’S REQUIRED BEYOND THIS POINT”.
