**Investigation of Fatal Fall from Rig Pollution Pan  
Galveston Area Block 151, Well No. 6  
OCS-G 15740  
28 January 2008**

**Gulf of Mexico  
Off the Texas Coast**

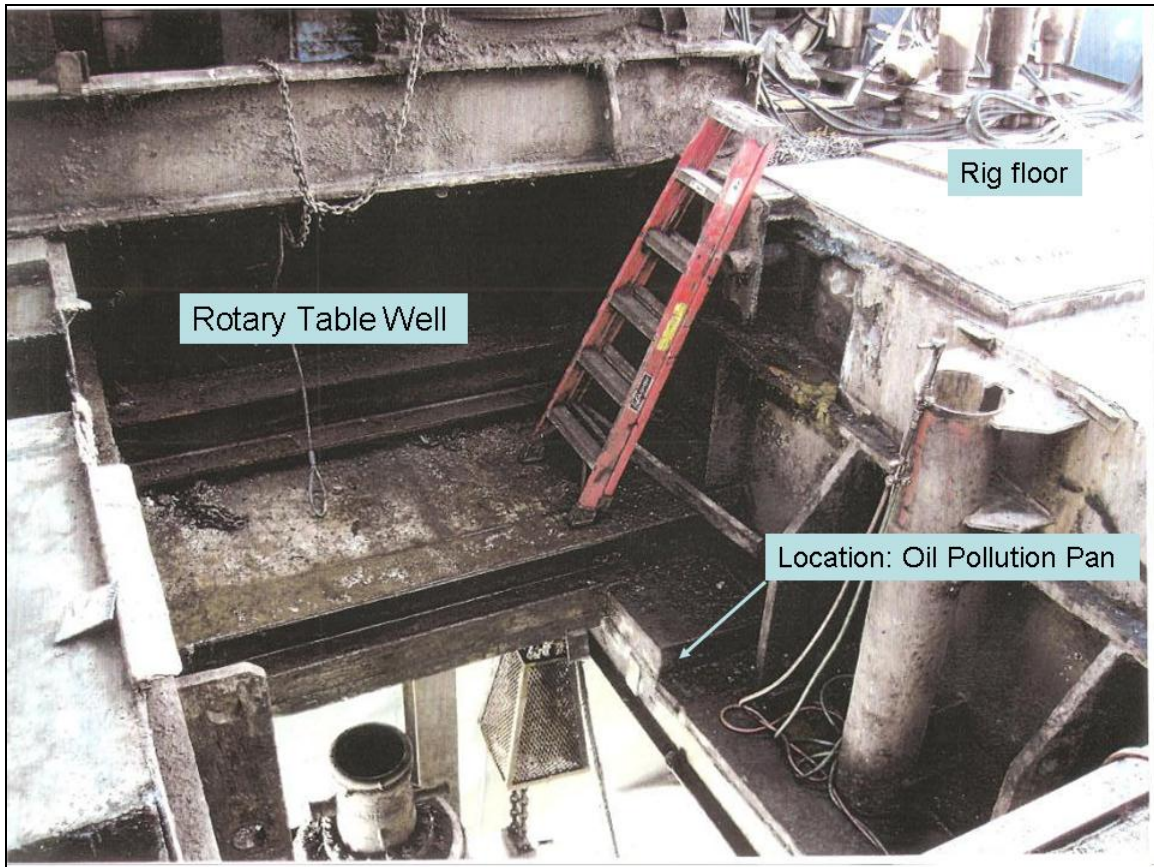
*0500-hrs, 28 Jan:* Removal of the rotary table was completed by the Rig crew. This exposed a 12-ft x 9-ft x 6-ft deep "well" beneath the rotary table (the Rotary Table Well), bottoming on the top of the Oil Pan, (*see figure 2*). The Franks crew then was mobilized to prepare to run the 60-inch drive pipe.

**Figure 2 – Rotary table well and location of oil pollution pan**

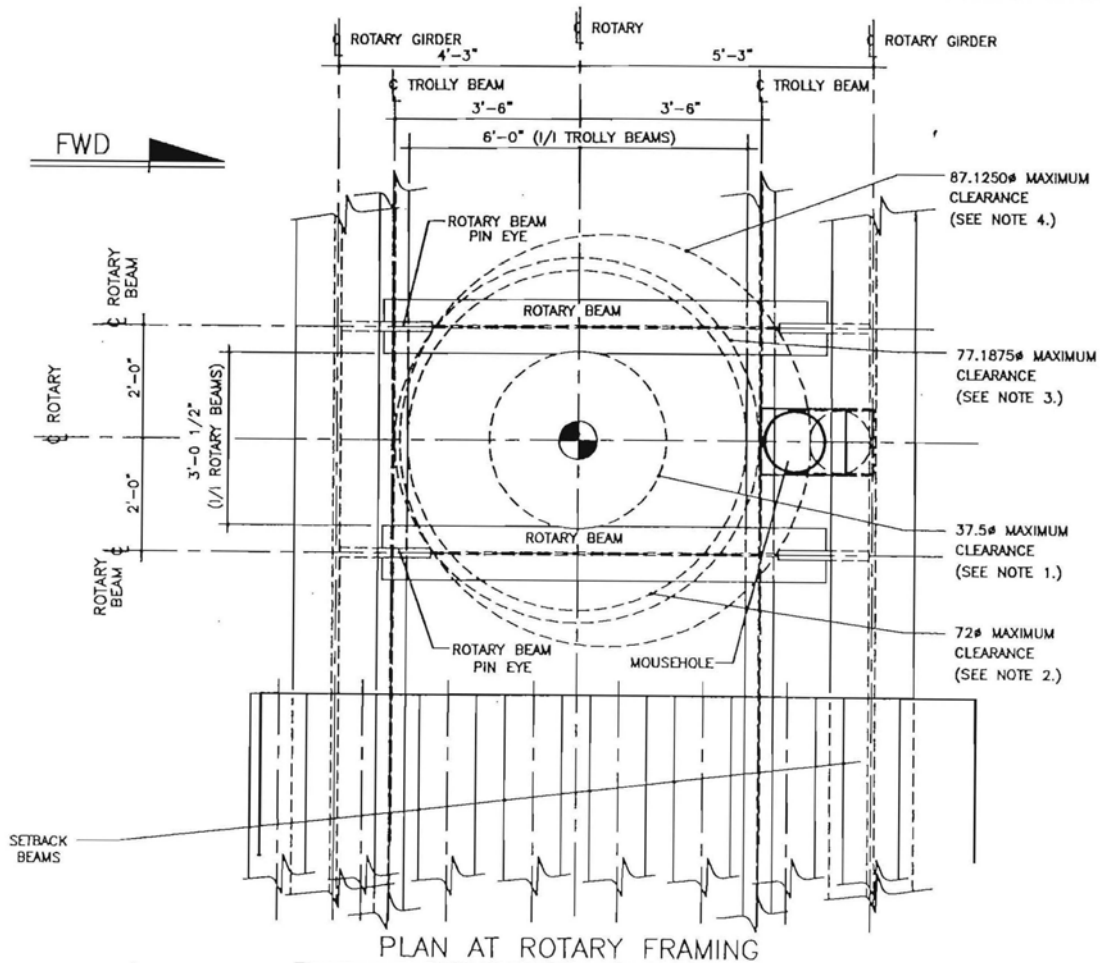
Figure 4: Rotary area clearances

<b>DRIVE PIPE</b>	<b>REMOVE</b>
36" OR LESS	NOTHING REQUIRED
ABOVE 36" UP TO 72"	ROTARY SKID, ROTARY BEAMS & ROTARY DRIP PAN.
ABOVE 72" UP TO 86"	ROTARY SKID, ROTARY BEAMS, ROTARY DRIP PAN, TROLLEY BEAMS & MOUSE HOLE
- RIG MANAGER IS TO BE NOTIFIED FOR OVERDRIVE OPERATION PLANNING.

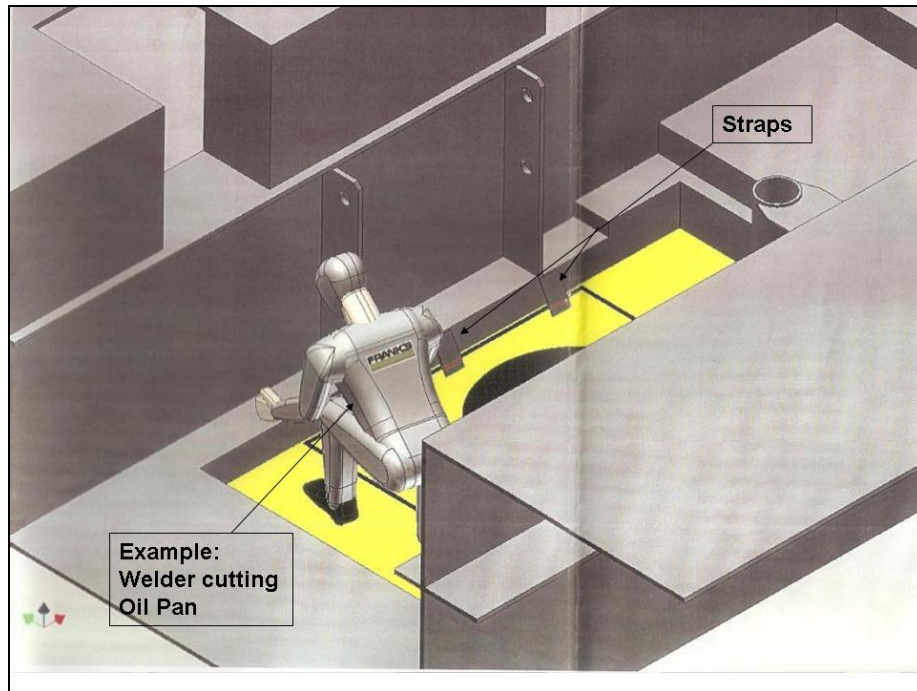
0715-hrs: Two Frank's personnel continued to cut the oil pan under the supervision of the Welding Supervisor (*see figure 5*). The Derrickman approached a Frank's personnel (unidentified) and repeated the Driller's previous admonition to refrain from cutting the Oil Pan. Other Hercules personnel continued maintenance and other operations on the Rig floor to ready the Rig to pickup and run 60-inch drive pipe.

**Figure 5 – Diagram of position of a welder while cutting oil pan** (graphics from Frank's)

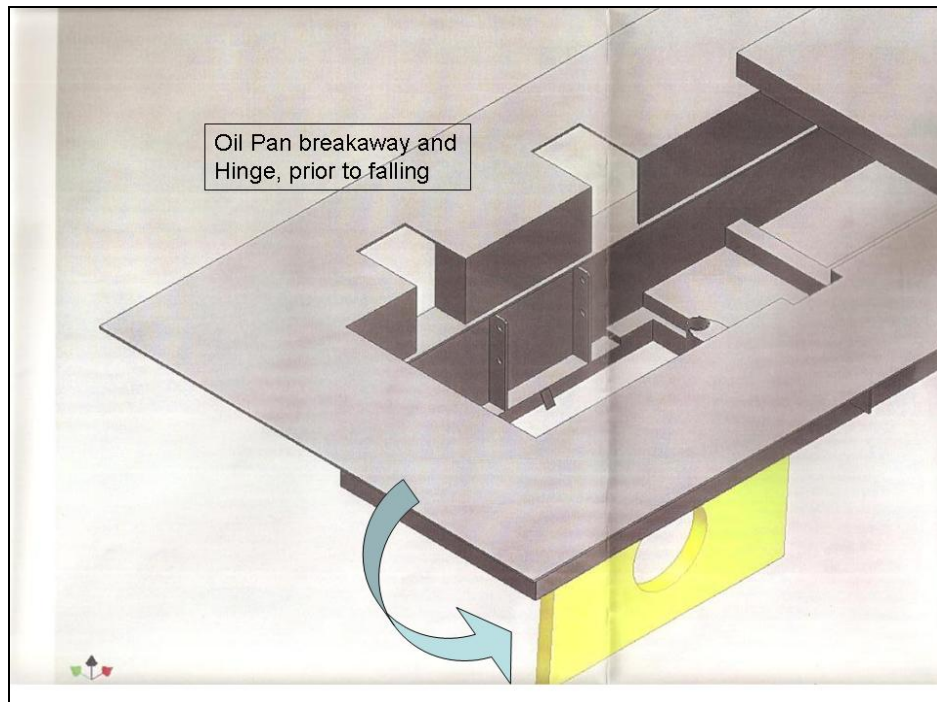
0733-hrs: The Welder #1 continued cutting another of the metal straps that needed to be removed to complete the opening in the Oil Pan. Without warning the entire Oil Pan suddenly dropped downward

hinging on the side being cut by Welder #2 (see figure 6), and then almost immediately fell away from beneath the two welders working on the cut.

**Figure 6 – Diagram showing how the oil pan hinged, and then fell** (graphics from Frank's)

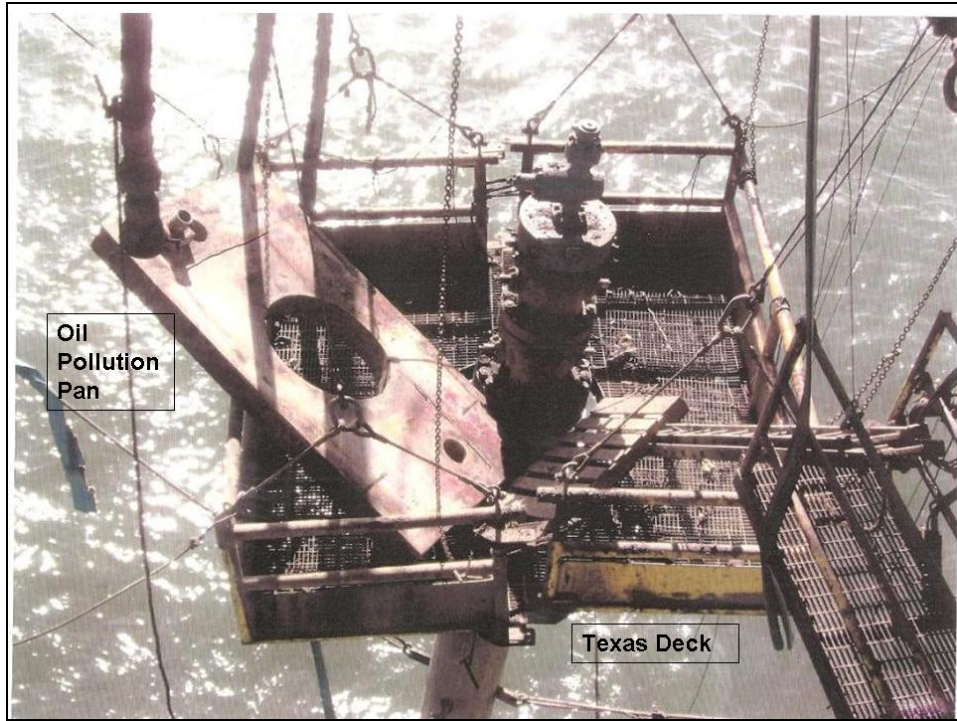
The Welder #1 who had continued to cut the Oil Pan after Welder #2 had stepped out, attempted to grab a hand hold on a sub-structure beam along the side of the Rotary Table Well as the Oil Pan fell. He was able to momentarily hold onto a beam but shortly lost his handhold and fell after the Oil Pan. He struck the Wellhead and/or the Texas Deck some 50-ft below the Rig floor, then continued to fall, finally landing in the Gulf of Mexico (see figures 7 and 8).

**Figure 7 – End location of the oil pan and pallet on the Texas deck**

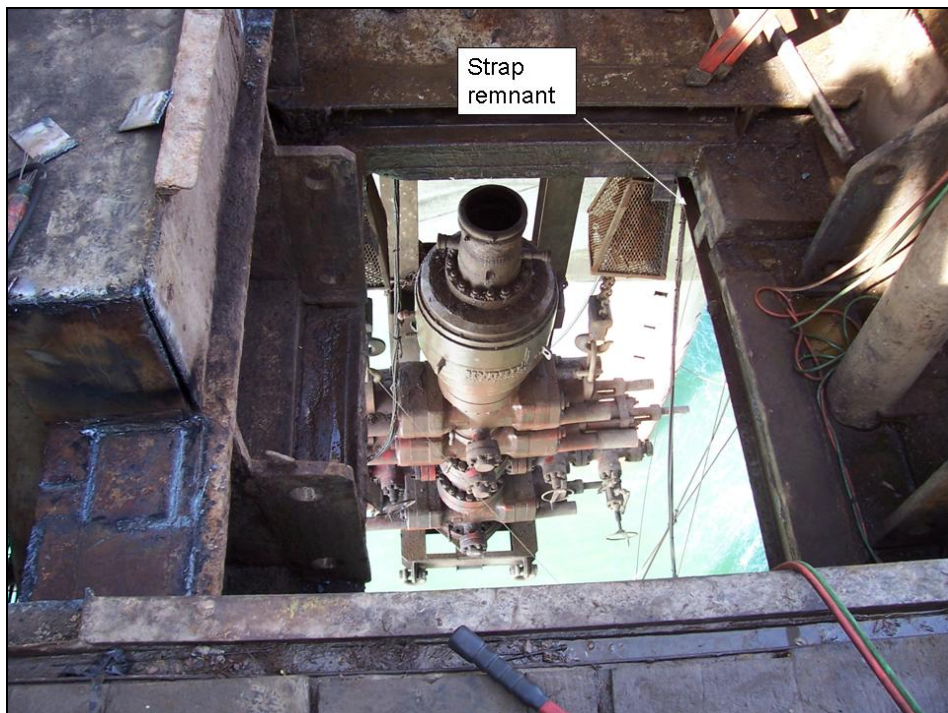
**Figure 8 – View down through the rotary table well after fall of the oil pan**

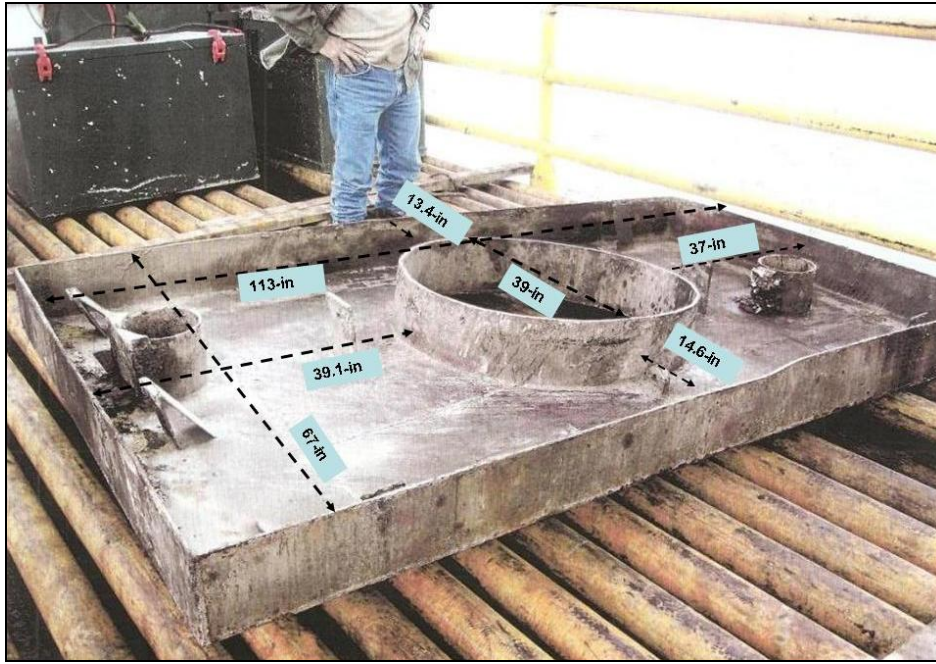
The Oil Pan installed on the Rig could accommodate drive pipe up to 36-inches without modification. Larger pipe would require its removal. The Oil Pan was installed about 6-ft beneath the rotary table. It was tray-shaped, approximately 9’7” x 5’7” and approximately 8-inches deep (*see figure 9*). Because of

**Figure 9 – Dimensions and view of the oil pollution pan**

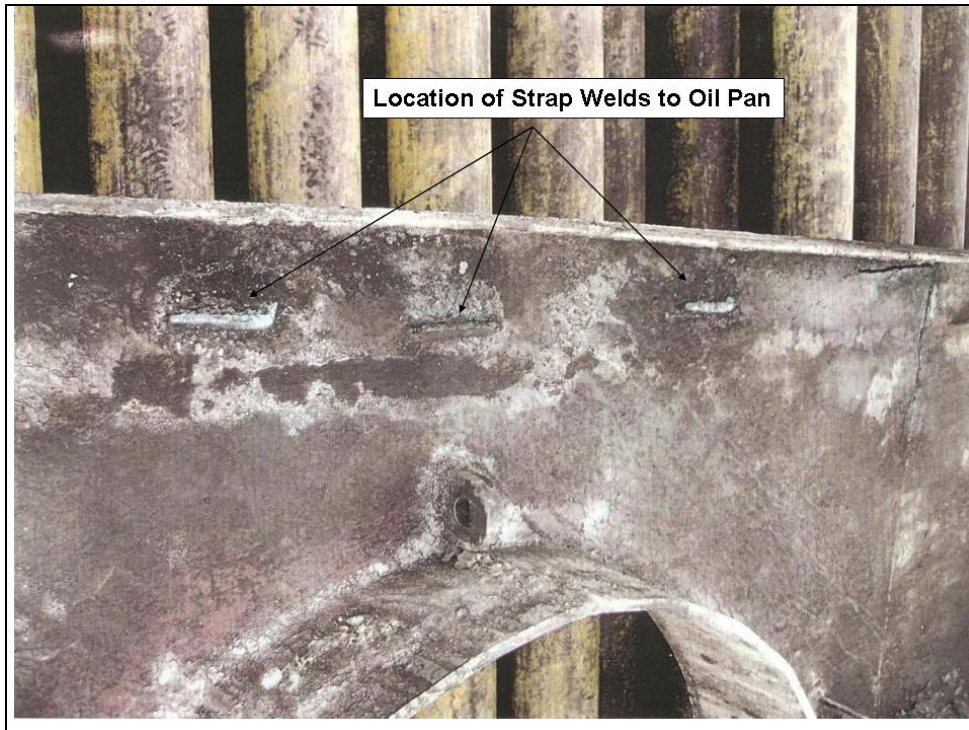
According to testimony, the Oil Pan of the Rig was attached in a different manner from that usually encountered on other rigs. The Oil Pan was not hard-welded around the lips of its sides, nor was it bolted to the rig sub-structure. Instead, it was attached to the Rig sub-structure beams by means of six metal straps (Straps) that were welded to the bottom of the Oil Pan, and then individually welded to substructure beams (*see figure 10 and 11*).

**Figure 10 – View of the location of some strap welds on the oil pan**

- (1) The Straps were the only connection holding the Oil Pan in place. Therefore, cutting the straps allowed the Oil Pan to fall out from beneath the welders.
- (2) Neither the welding supervisor nor the welders knew the straps were the only support for the Oil Pan and no one had reviewed the set up before cutting the pan. They assumed the entire top edge of the Oil Pan was welded to the Rig sub-structure and formed a solid floor.
- (3) Because of the above assumption, the welders working in the Oil Pan were not wearing fall protection.
- (4) Planning for the operation was inadequate, and were not conducted according to Rig or Contractor policy.
  - None of the Contractor crew and only part of Rig personnel attended the JSA/think plan meeting;

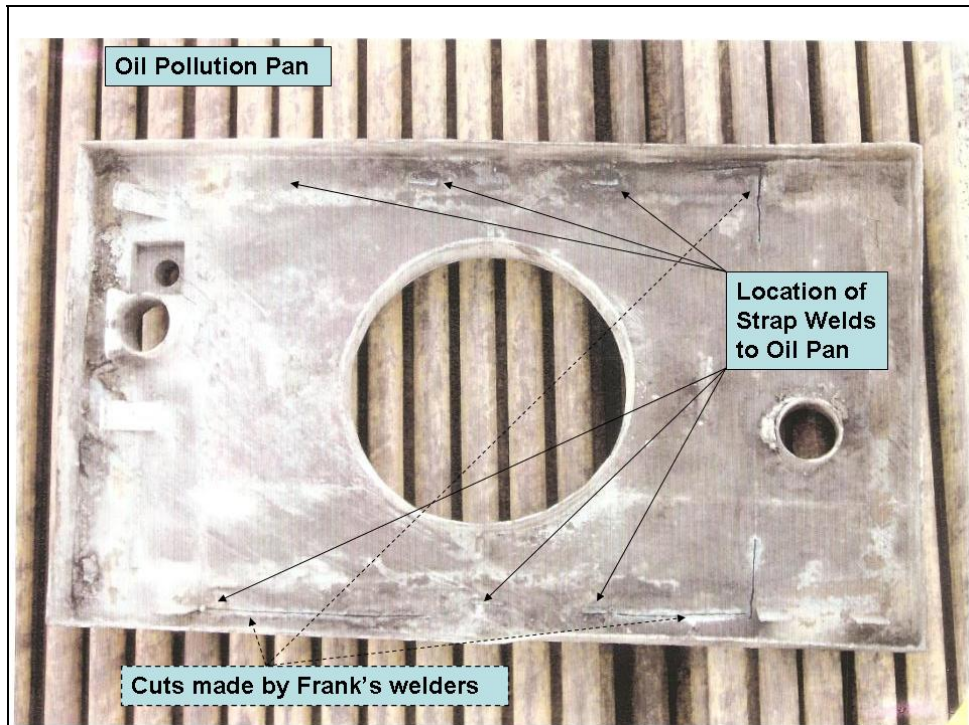
**Figure 11 – Top view of oil pan showing cuts and some strap weld locations**

In order to create an opening large enough to pass the drive pipe, the welders found that it was necessary to cut six steel “straps” attached to the surface of the Oil Pan and also welded to the side of the sub-structure support beams. After a number of the straps were cut the Oil Pan abruptly fell free, dropping approximately 50-ft before landing on the Texas deck. When the Oil Pan dropped away, one of the welders working in the pan also fell striking the wellhead and/or the Texas deck before landing in the Gulf of Mexico. The fall resulted in a fatal injury to the welder.
