**Investigation of Fatality**  
**South Pass Area, South and East Additions, Block 90**  
**Pipeline Right-of-Way OCS-G 26857**  
**18 July 2006**

Gulf of Mexico  
Off the Louisiana Coast

OCS Report  
MMS 2009-028

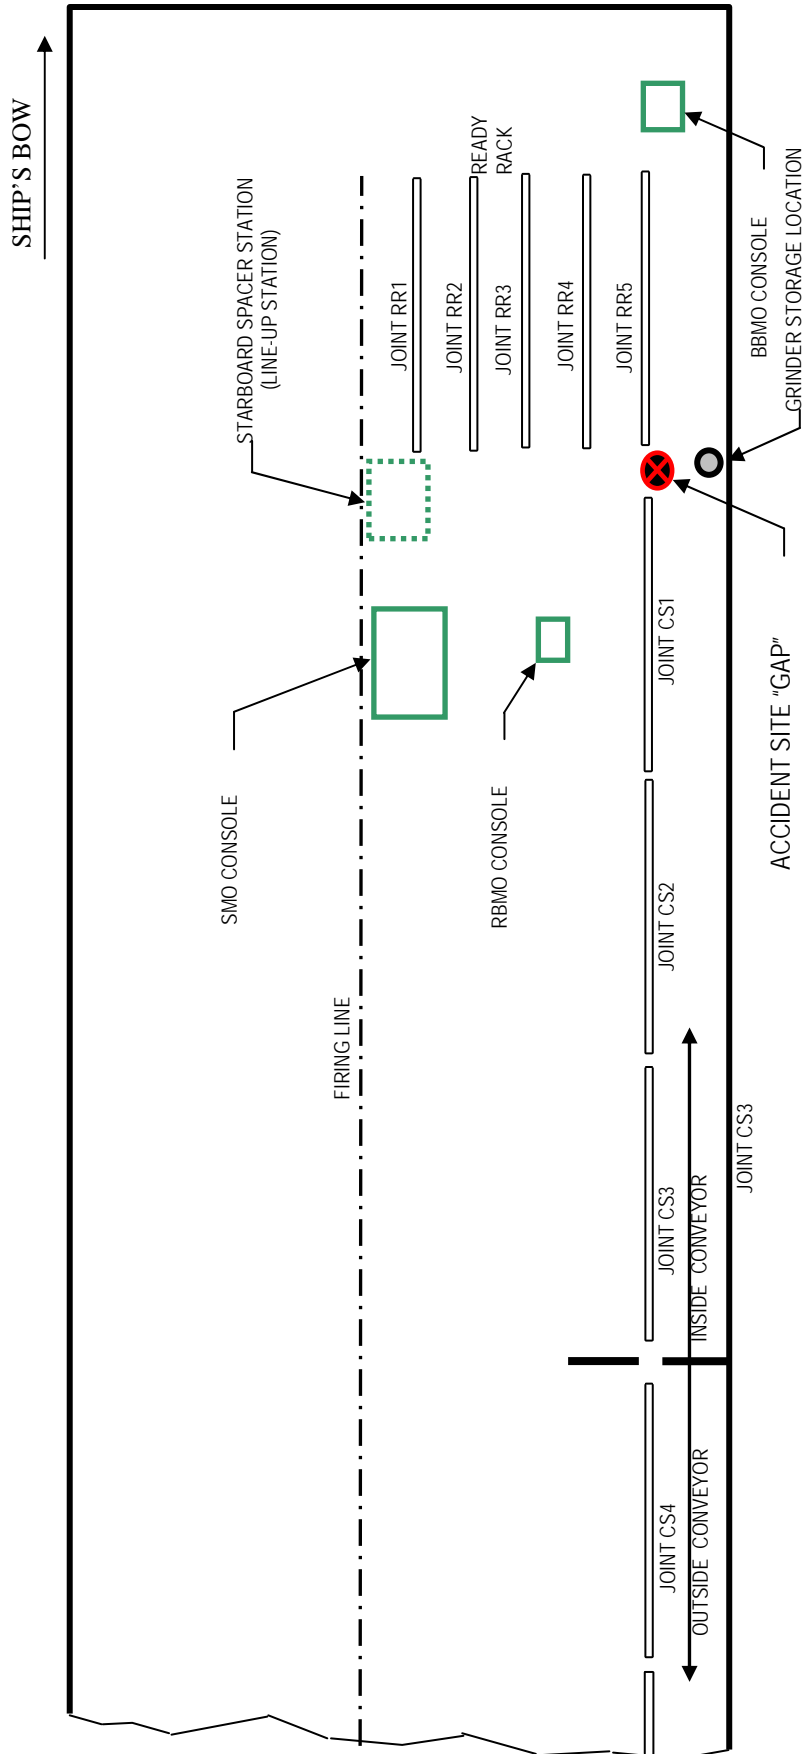
Configuration of the bead stall and ready rack areas at the time of the accident

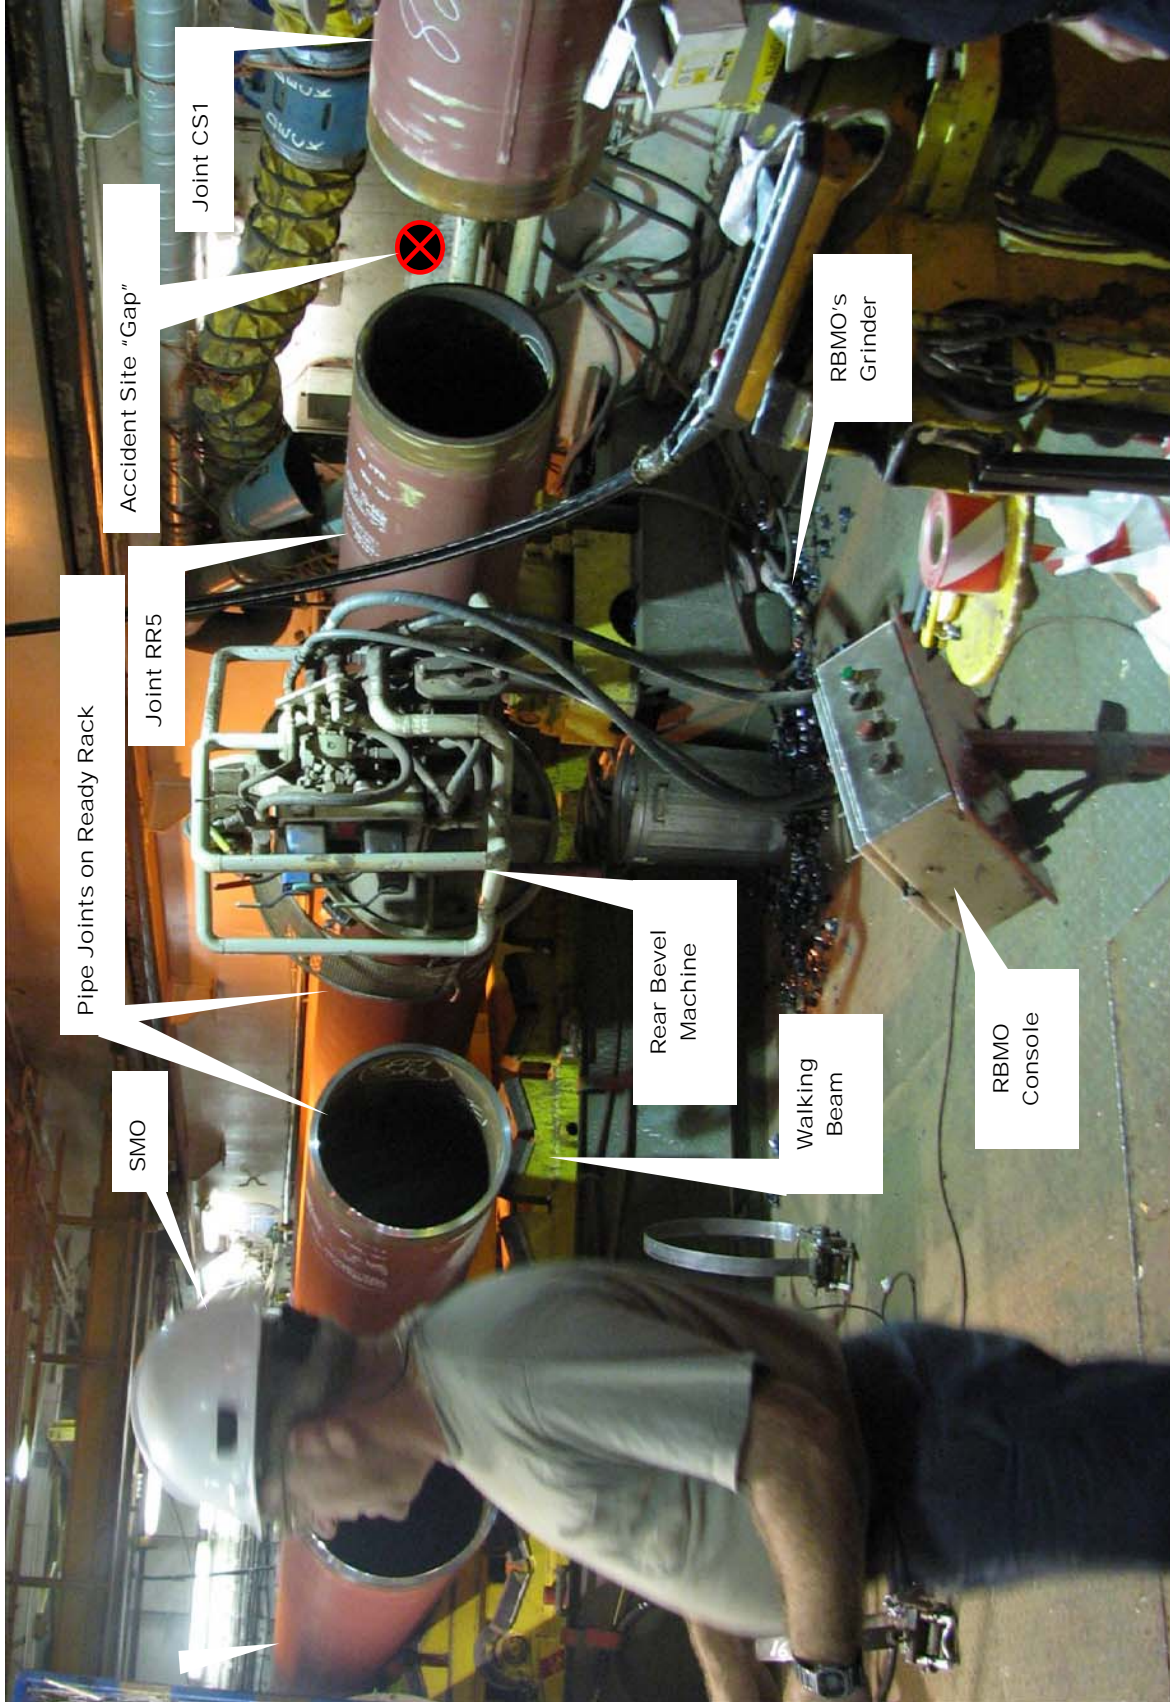
Pipe joint CS1 became energized and advanced towards RR5 while RR5 remained stationary. The investigative panel has not been able to identify a logical explanation of what caused CS1 to begin moving.

The fatality was caused by the inside conveyor system becoming inadvertently energized, causing uncontrolled pipe movement. The responsible conveyor operator (RBMO) did not realize that the

Accident Scene – Looking Toward Bow

- A safety barrier was placed in the area where the RBMO was crushed to prevent personnel from walking or working between the pipe joints at CS1 and RR5.
- A selector switch that controls the inside conveyor system, along with two limit switches, were replaced with new ones. The old switches were shipped out to a lab for further review.
- Allseas evaluated and updated their hazards analyses in the conveyor system and ready rack areas.
- The storage location of the RBMO grinder was moved from the starboard wall to a location on the near side of the conveyor system. This eliminated the need for the RBMO to walk in the gap between RR5 and CS1 to retrieve the grinder

- In addition to the safety barrier placed in the area where RBMO was crushed, more safety barriers should be placed around all exposed pinch point areas along the conveyor system to prevent personnel from also entering those hazardous areas.

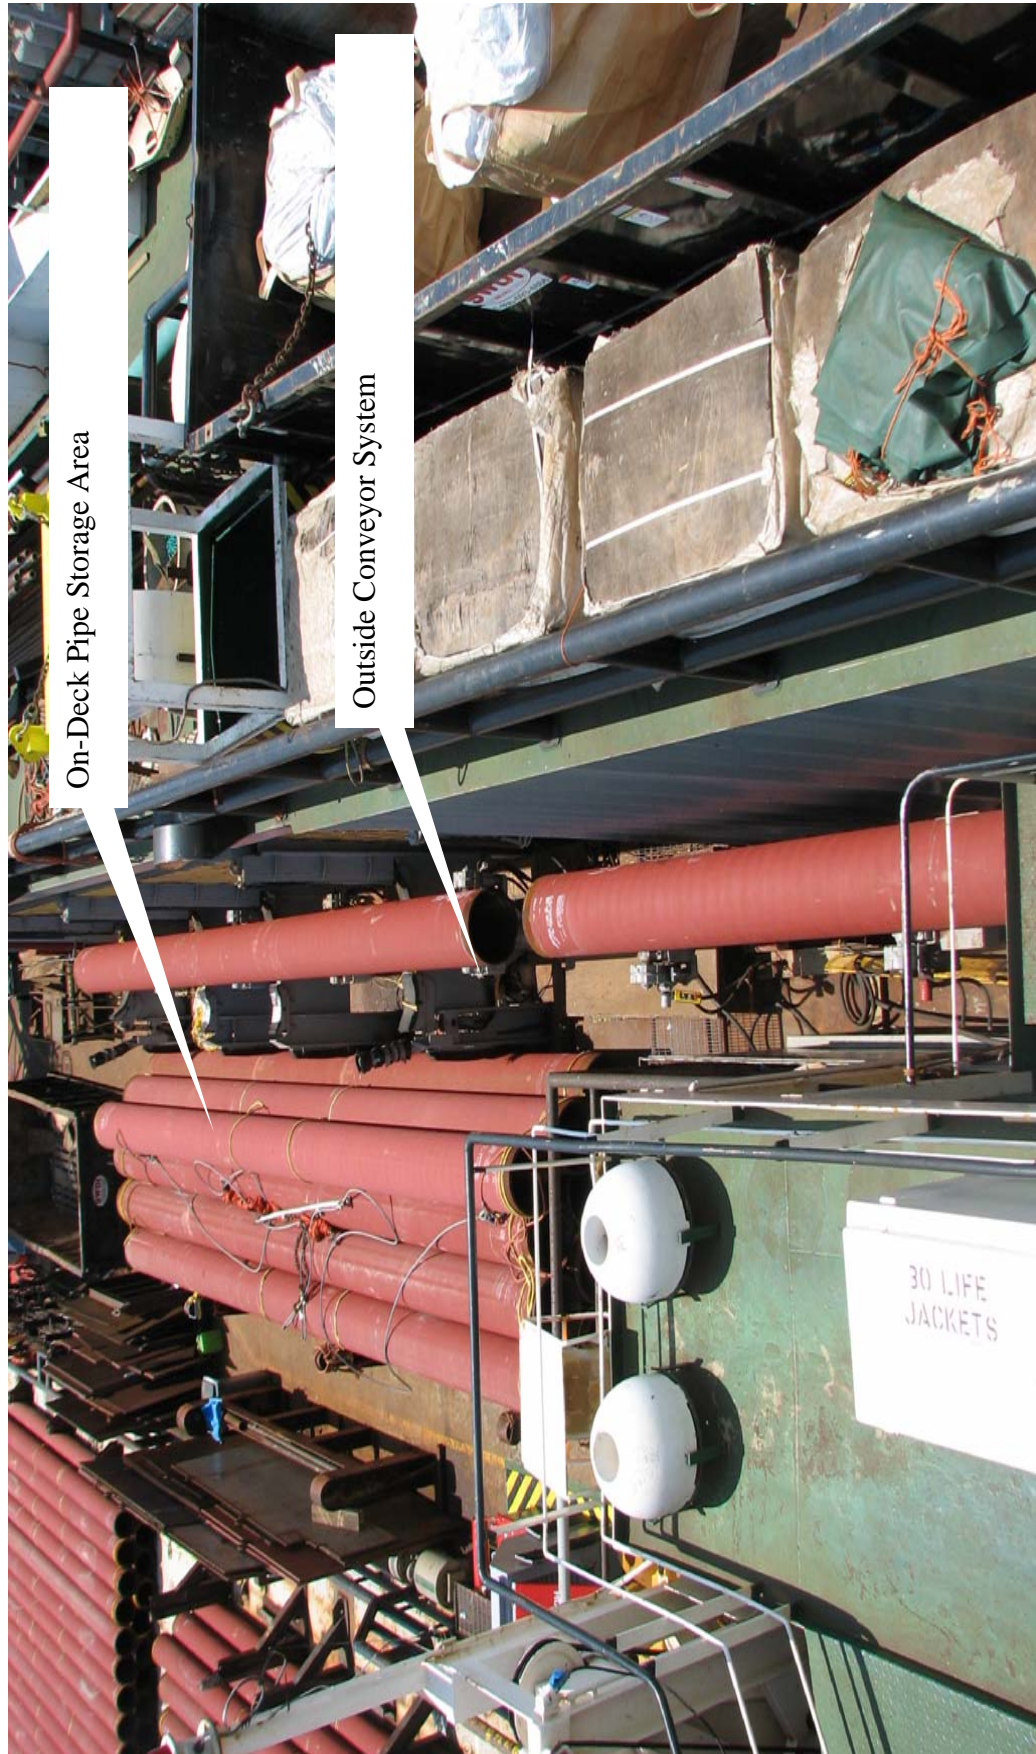
As noted above, the outside conveyor system is used to move pipe joints from the pipe storage area to the inside conveyor system. It is operated by a crew member in the pipe storage area and is independent from the movement of the inside conveyor, which is operated by the RBMO. The crew member in the pipe storage area operates a simple push button to control the outside conveyor system. When he presses the control button, pipe joints on the outside conveyor move forward one joint. The crew member will activate the outside conveyor when he sees that there is an available space on the inside conveyor at position CS3. It is possible for the pipe storage crew member to mistakenly advance a joint of pipe from CS4 when there is already a joint of pipe on the inside conveyor at CS3.

On-deck Pipe Storage Area and Outside Conveyor

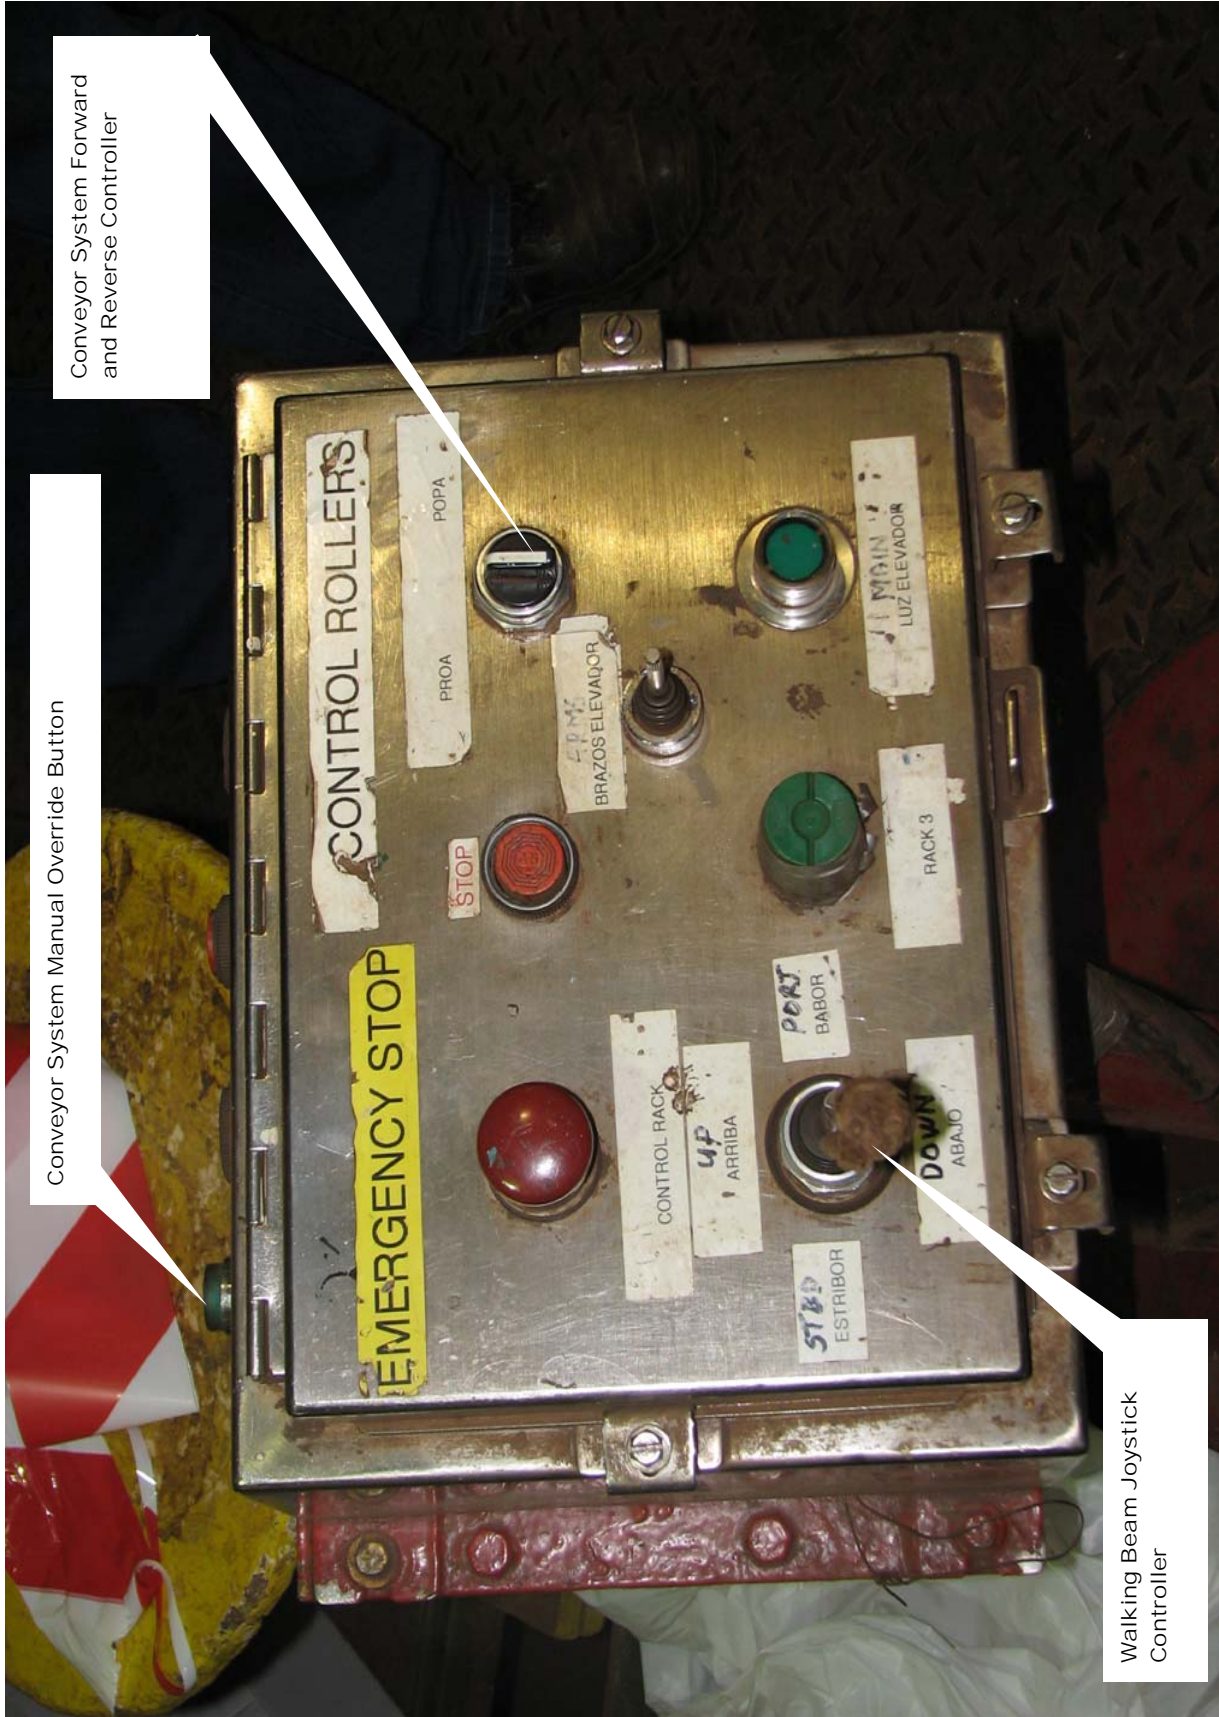
The conveyor control schematics, limit switch', conveyor selector switch, and photographs were examined by a third party engineering firm. The engineering firm report did not mention any deficiencies in the limit switch'. The conveyor control switch that controls the forward motion of the pipe on the inside conveyor system was found to be heavily worn and dirty and to stick in the forward position, which could cause uncontrolled pipe movement under certain conditions. The independent investigation by Allseas also found that there were no defects in the operation of the limit switch', and that the conveyor control switch would occasionally stick in the forward position.

Based on the results of the examination of the controls, it is not likely that the limit switch malfunctioned allowing the pipe joints on the conveyor to move. It is possible that a malfunction of the conveyor control switch contributed to the accident. However, if the limit switch were functioning properly, they would have prevented the pipe joints from moving, once they were engaged, even if the conveyor control switch malfunctioned. Therefore, a malfunctioning conveyor control switch by itself could not have caused the accident. The fact that RR5 had not become energized with CS1 could be attributed to a malfunction in the control system. However, no evidence justifies this conclusion.

7) Possible inadequate inspection/maintenance of the control panel switch was a contributing cause of the accident. None of the crew interviewed mentioned the sluggish action of the conveyor switch. However, Allseas and the third party engineering firm, that analyzed the limit and control panel switches after the accident, did find that the conveyor switch was sluggish and that it was dirty and cracked. This condition could indicate inadequate inspection/maintenance of the switch, although no maintenance guidelines were available for the panel to confirm this. It should also be noted that there is no conclusive evidence that proves the condition of the conveyor switch was a contributing factor to the accident.

Conveyor System Manual Override Button

Conveyor System Forward and Reverse Controller

Walking Beam Joystick Controller

Rear Bevel Machine Operator (RBMO) Console – front view

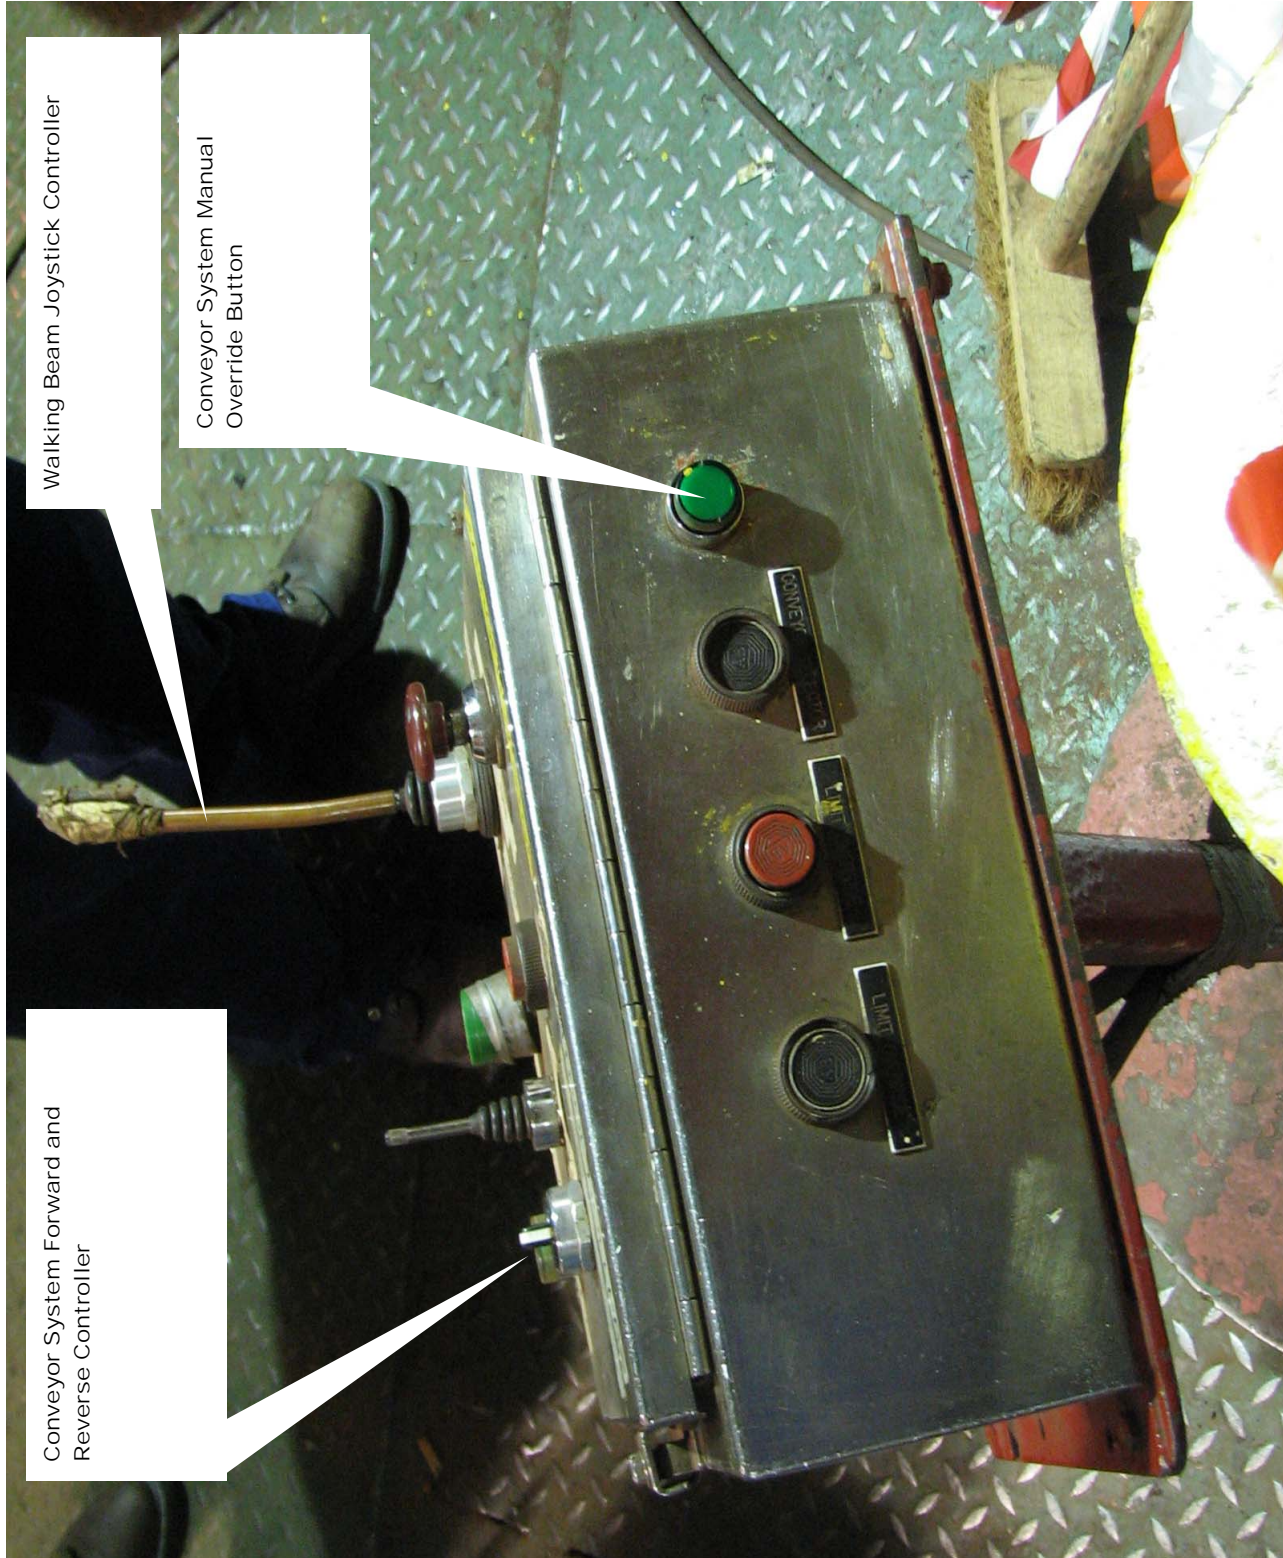
As noted earlier, if the walking beam is used to lift the pipe joint at RR5 while the other joints on the conveyor system are advanced, it is possible to be disengaged from both RR5 limit switches. Limit Switch 1 is disengaged when the pipe joint in position RR5 is lifted approximately 2.5 centimeters off rollers by the walking beam. In this situation, limit switch-2 would not be engaged, which would allow the pipe on the inside conveyor to move forward if the conveyor system were energized by the conveyor switch being stuck in the forward position. The walking beam could have been inadvertently lifted by the RBMO. There was a make shift joystick extension on the walking beam control at knee level. This control stick could have been inadvertently nudged enough to elevate the walking beam.

Rear Bevel Machine Operator (RBMO) Console – top view
