# Existing Conditions Report

269 37<sup>th</sup> Street  
Brooklyn, New York

Red Hook Container Terminal, LLC  
Brooklyn, New York

June 2018

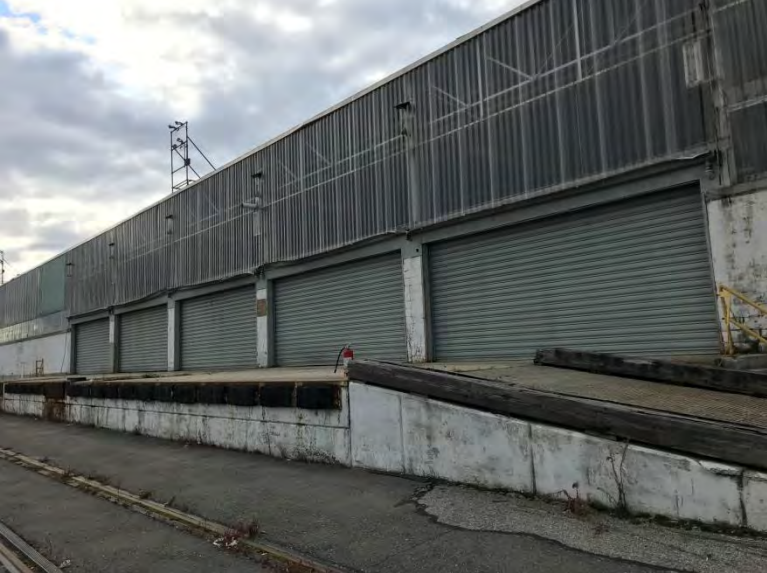
<p>Photo Number: 5</p> <p>Date Taken</p> <p>January 24, 2018</p> <p>Description</p> <p>J1 Shed Exterior - Northwest side</p>

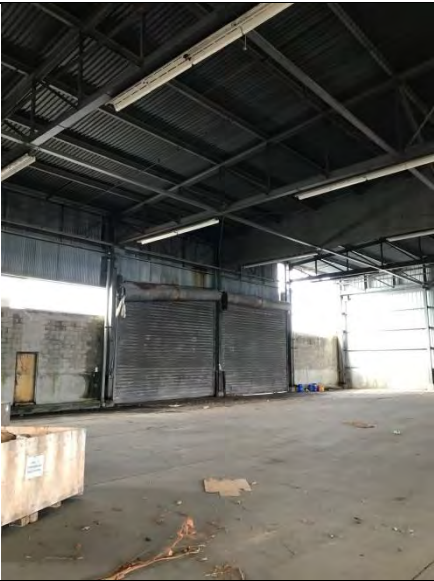
<p>Photo Number: 10</p> <p>Date Taken January 24, 2018</p> <p>Description J1 Shed - Damaged vertical steel door hood</p>

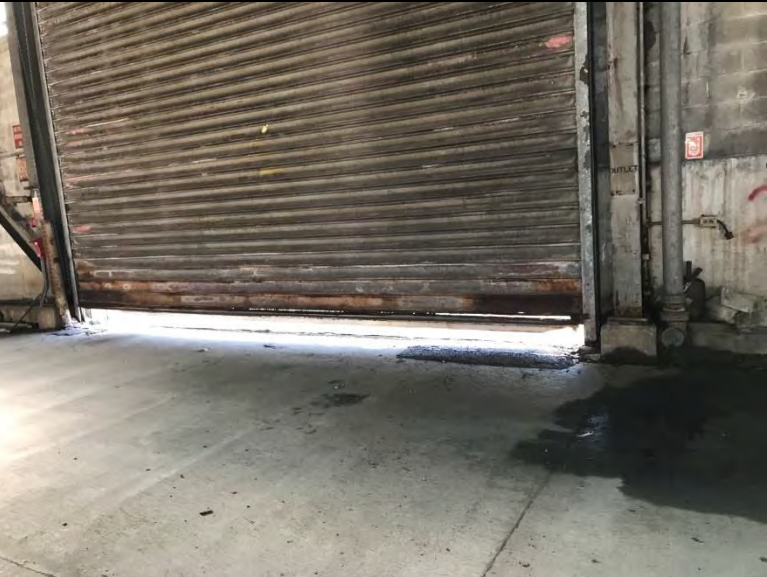
<p>Photo Number: 11</p> <p>Date Taken January 24, 2018</p> <p>Description J1 Shed - Corroded vertical steel door</p>

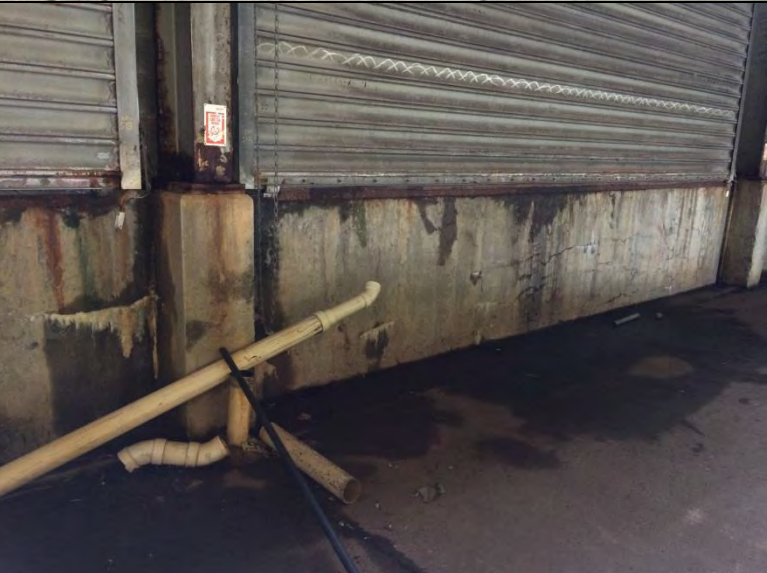
<p>Photo Number: 12</p> <p>Date Taken January 24, 2018</p> <p>Description J1 Shed - Damaged roof drain pipe</p>

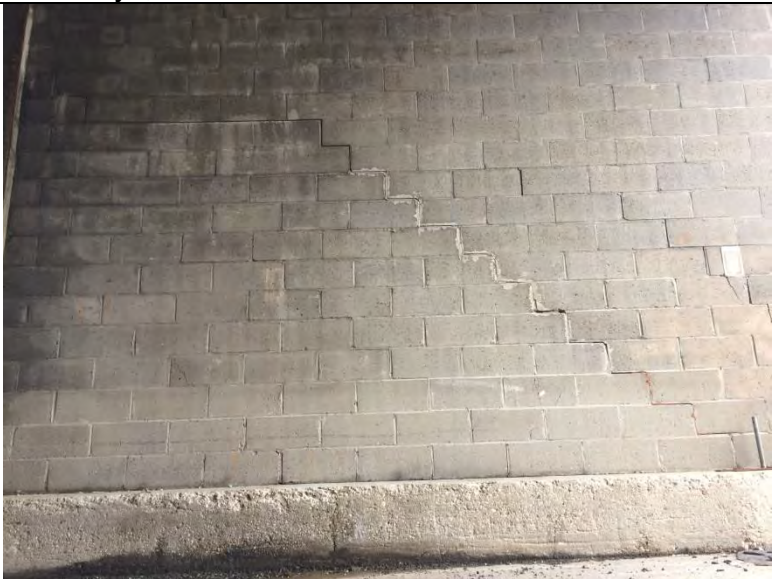
Photo Number: 13

Description  
J1 Shed  
- CMU wall  
crack

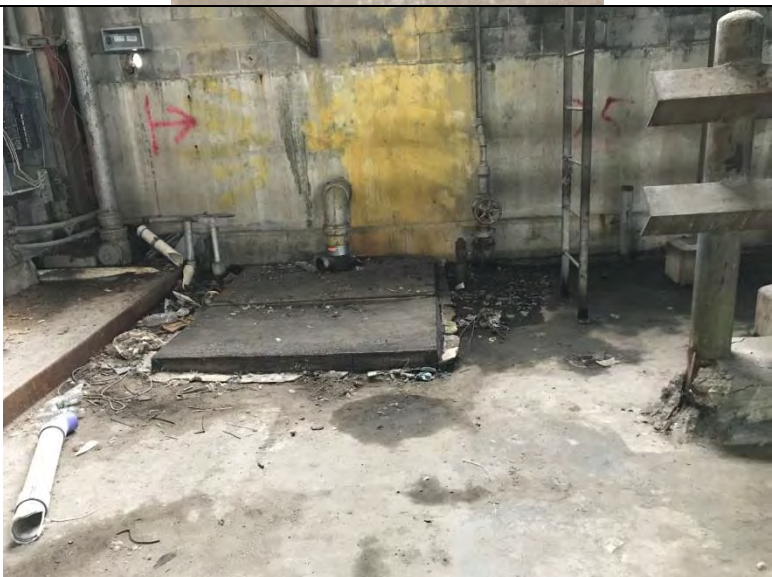
Description  
J1 Shed  
- Crumbling  
floor at sum  
pit

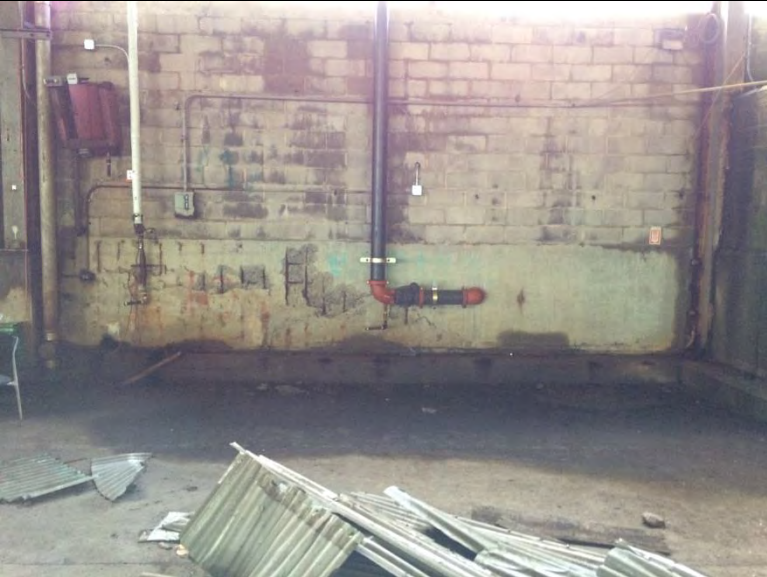
<p>Photo Number: 19</p> <p>Date Taken January 24, 2018</p> <p>Description J1 Shed - Spalling concrete base</p>

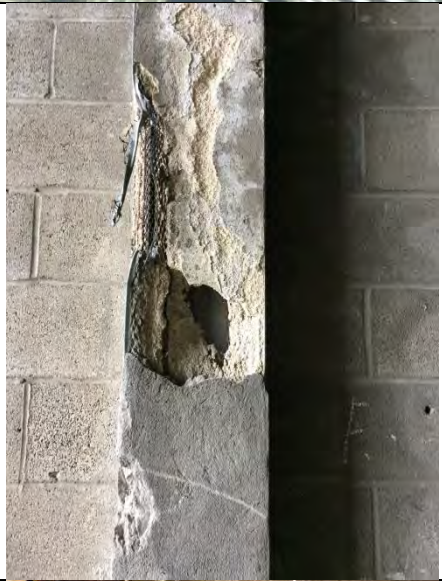
<p>Photo Number: 20</p> <p>Date Taken January 24, 2018</p> <p>Description J1 Shed - Buckling steel column with damaged concrete enclosure</p>

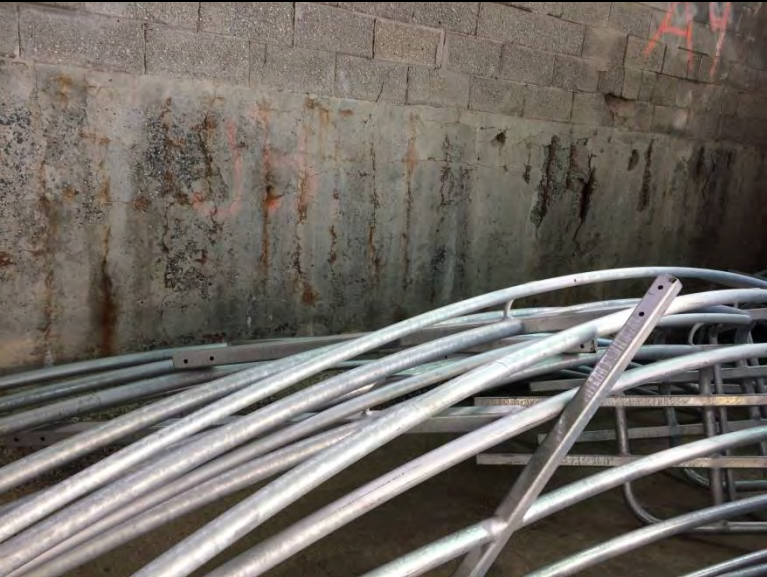
<p>Photo Number: 32</p> <p>Date Taken January 24, 2018</p> <p>Description J2 Shed - Spalling concrete base near east entrance</p>

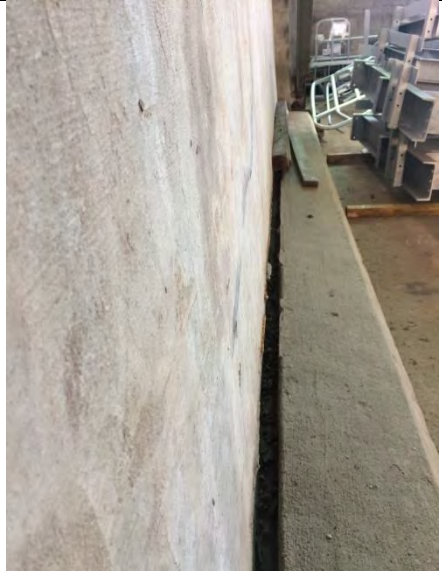
<p>Photo Number: 34</p> <p>Date Taken January 24, 2018</p> <p>Description J2 Shed - Tilted grade beam</p>

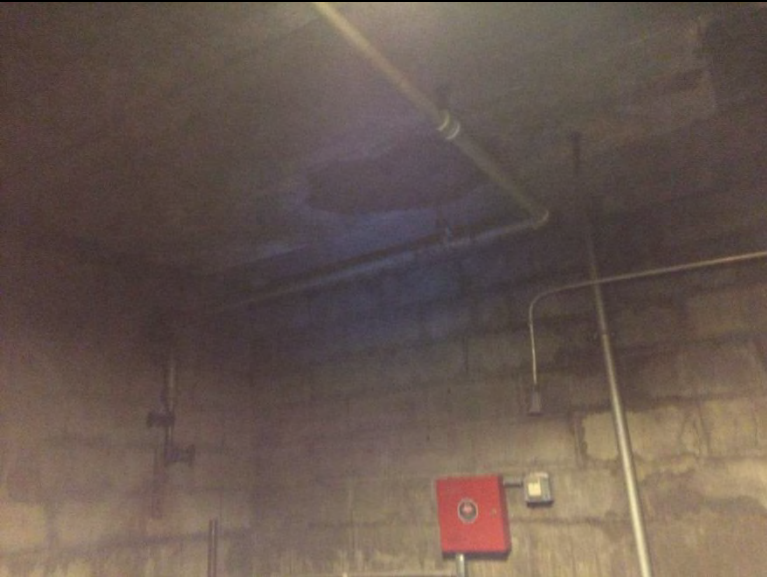
<p>Photo Number: 35</p> <p>Date Taken January 24, 2018</p> <p>Description J2 Shed - Leaking at interior structure</p>

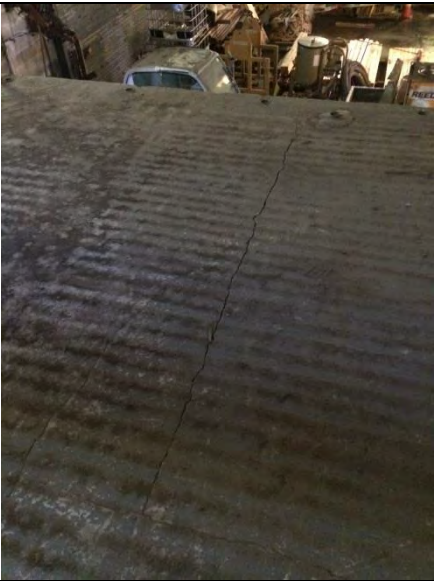
<p>Photo Number: 63</p> <p>Date Taken</p> <p>January 24, 2018</p> <p>Description</p> <p>Graffiti Building - Crack on interior structure roof</p>

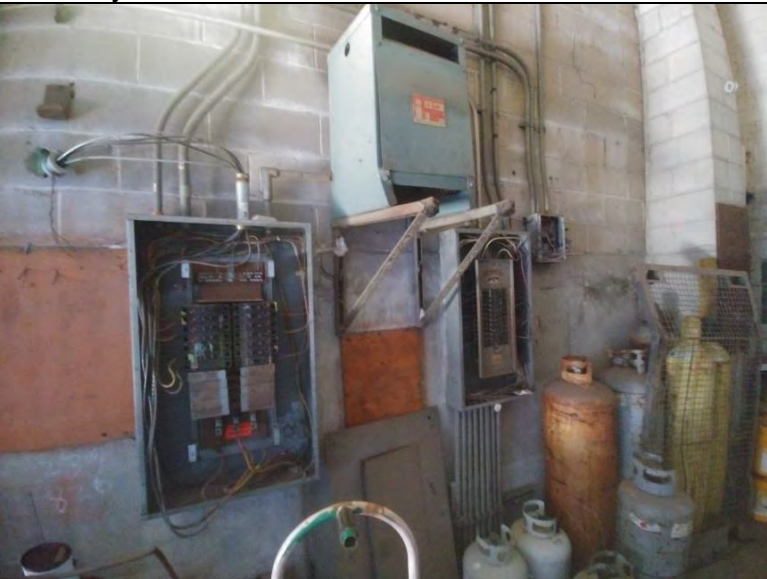
<p>Photo Number: 83</p> <p>Date Taken January 24, 2018</p> <p>Description Graffiti Building South West wall – old electrical circuit breakers and components.</p>

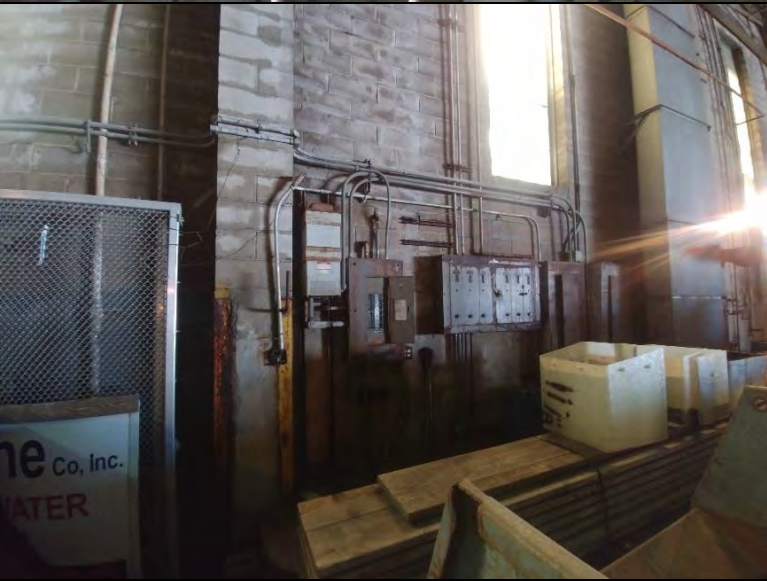
<p>Photo Number: 84</p> <p>Date Taken January 24, 2018</p> <p>Description Graffiti Building South East wall – Electrical components excessive wear. Some enclosure rusted shut.</p>

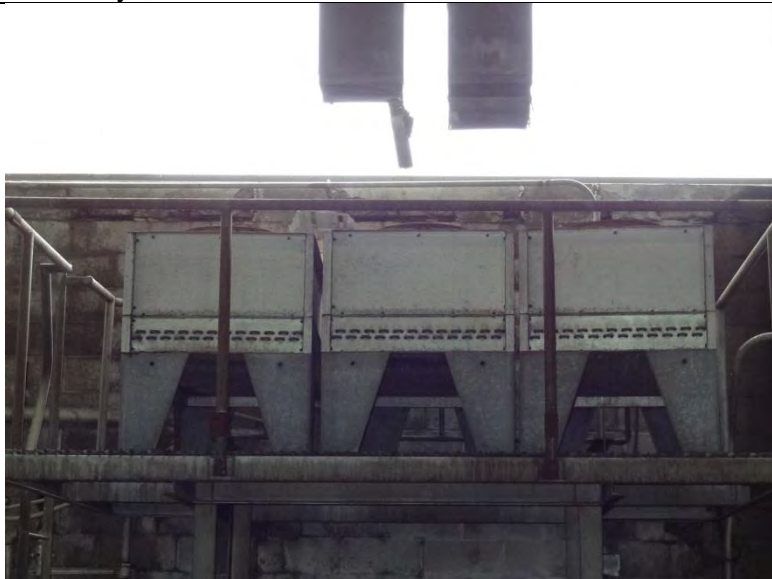
Description  
J1 Shed HVAC  
Ducting  
removed – Non  
existent/Failed

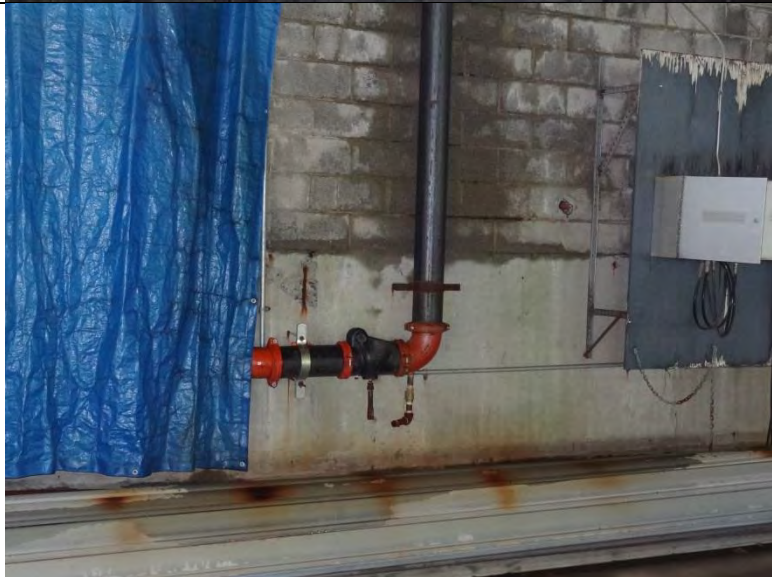
Photo Number: 96

Description  
J1 Shed  
Sprinkler  
System  
plumbing – Fair  
to poor  
condition.

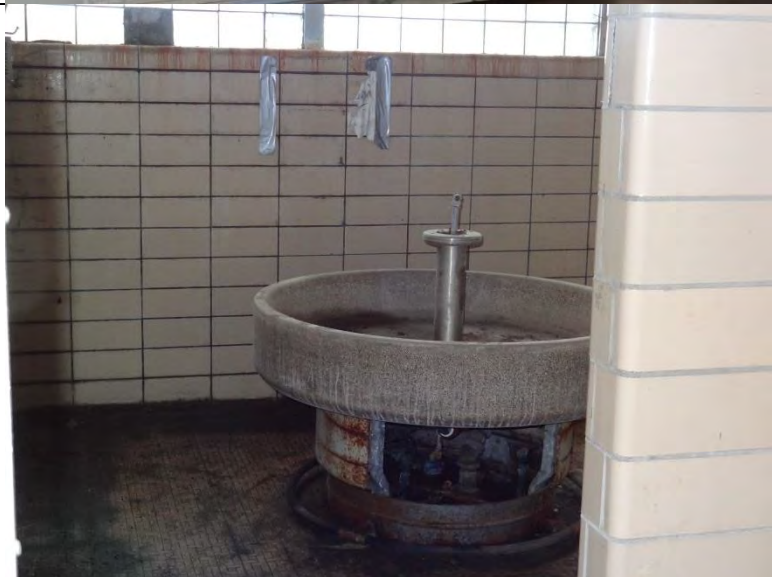
Photo Number: 97

Description  
J1 Shed  
Bathroom  
Plumbing -  
Poor/Failed

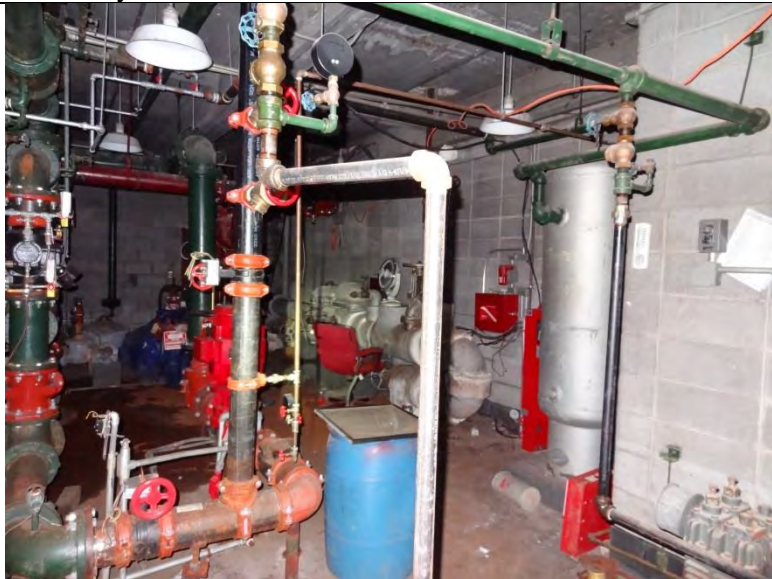
Photo Number: 98

Description  
J1 Shed Pump  
Room – Main  
water service  
and sprinkler  
valve - Piping in  
fair to poor  
condition.

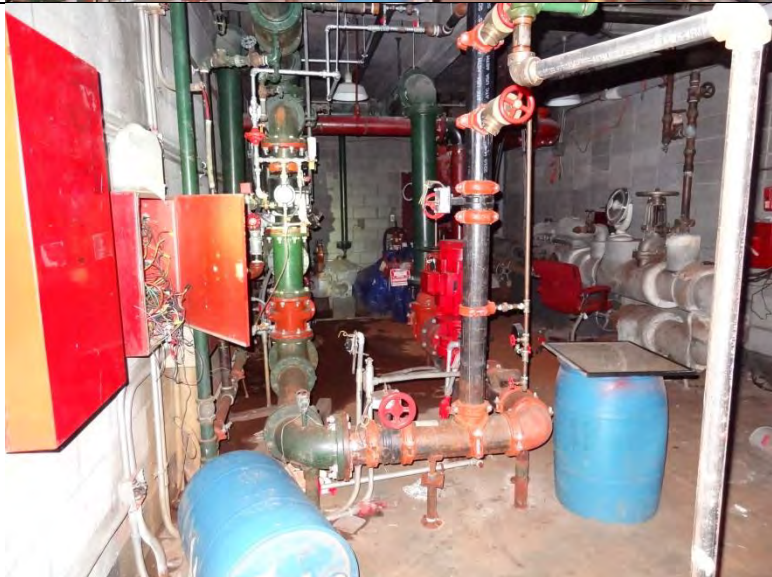
Photo Number: 99

Description  
J1 Shed Pump  
Room – Piping  
in fair to poor  
condition.

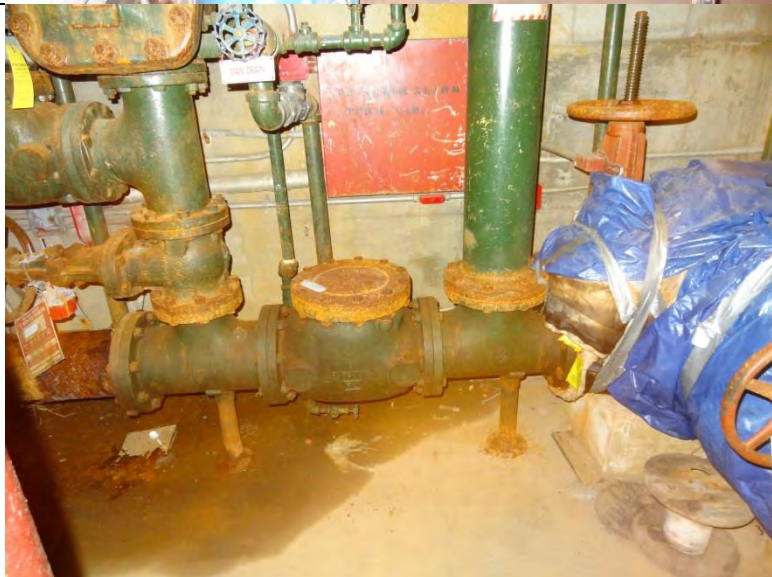
Photo Number: 100

Description  
J1 Shed Main  
Water Piping –  
Failed.

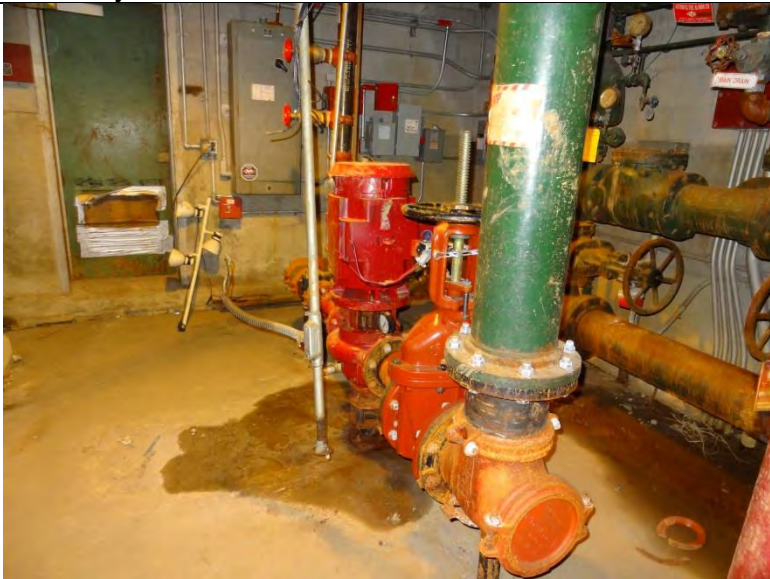
Photo Number: 101

Description  
J1 Shed - Fire  
Sprinkler  
Control Valve  
assembly – Fair  
to poor  
condition.

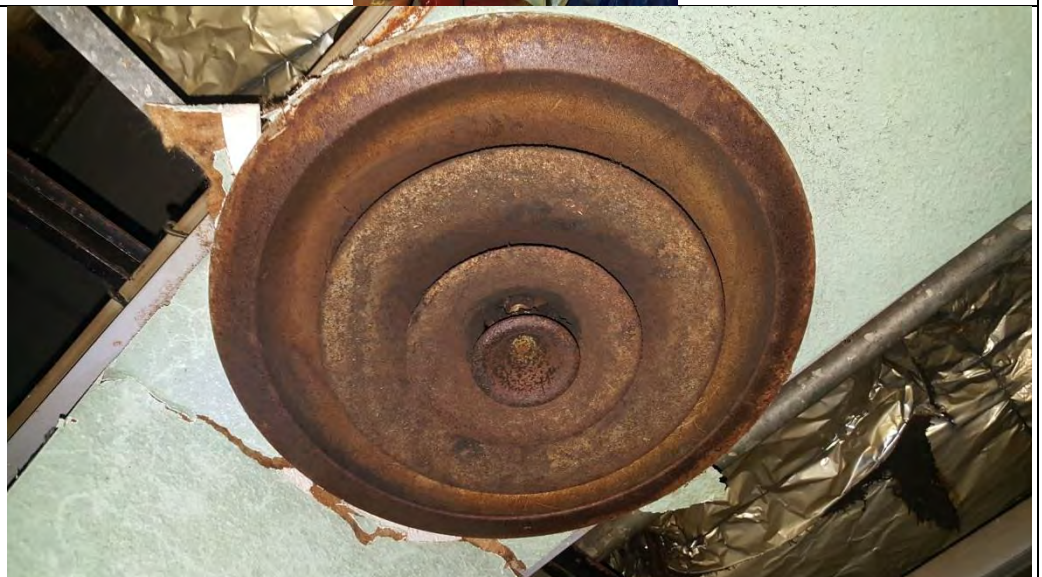
J1 Shed Ceiling  
Air vent - Failed

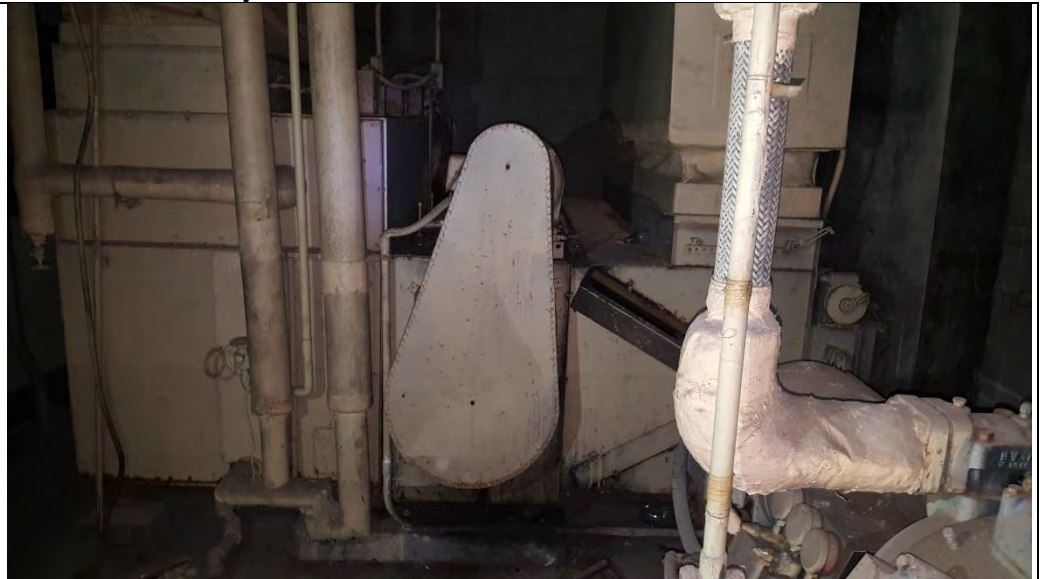
Photo Number: 107  
Date Taken  
January 24, 2018  
Description  
J1 Shed Air Management System – Failed

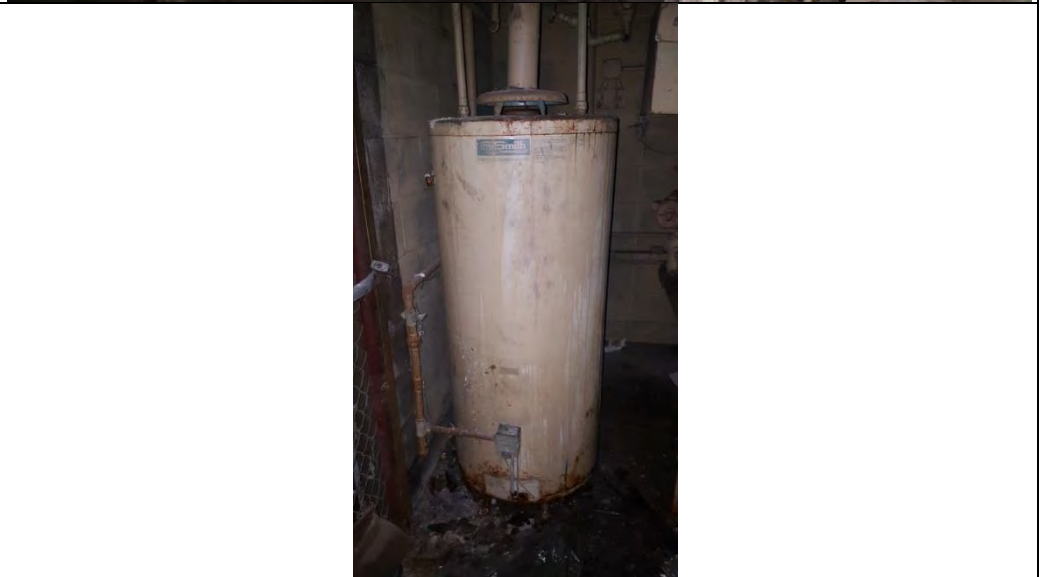
Photo Number: 108  
Date Taken  
January 24, 2018  
Description  
J1 Shed Domestic Hot Water Heater - Failed

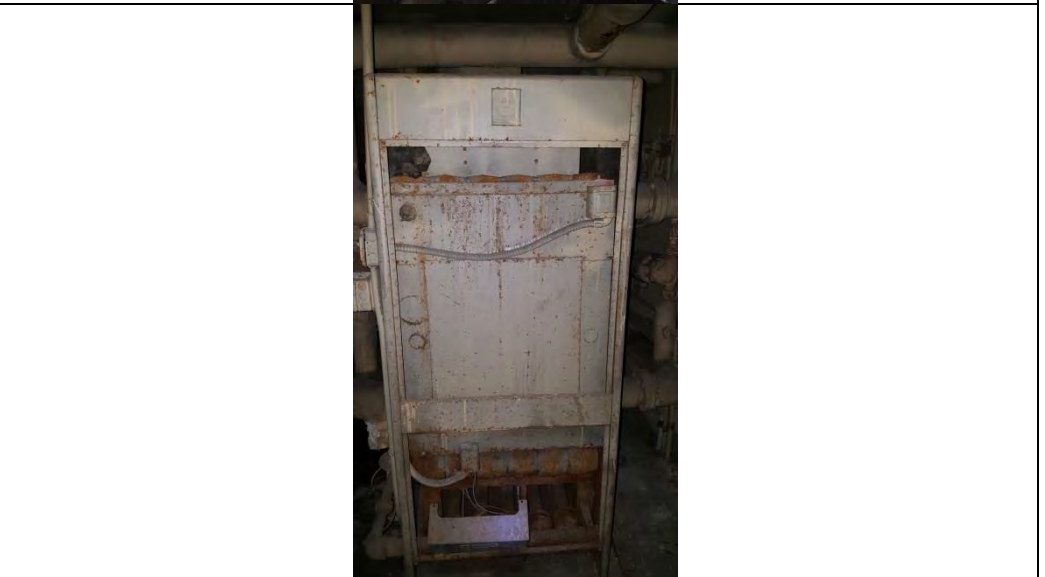
Photo Number: 109  
Date Taken  
January 24, 2018  
Description  
J1 Shed Gas Furnace - Failed

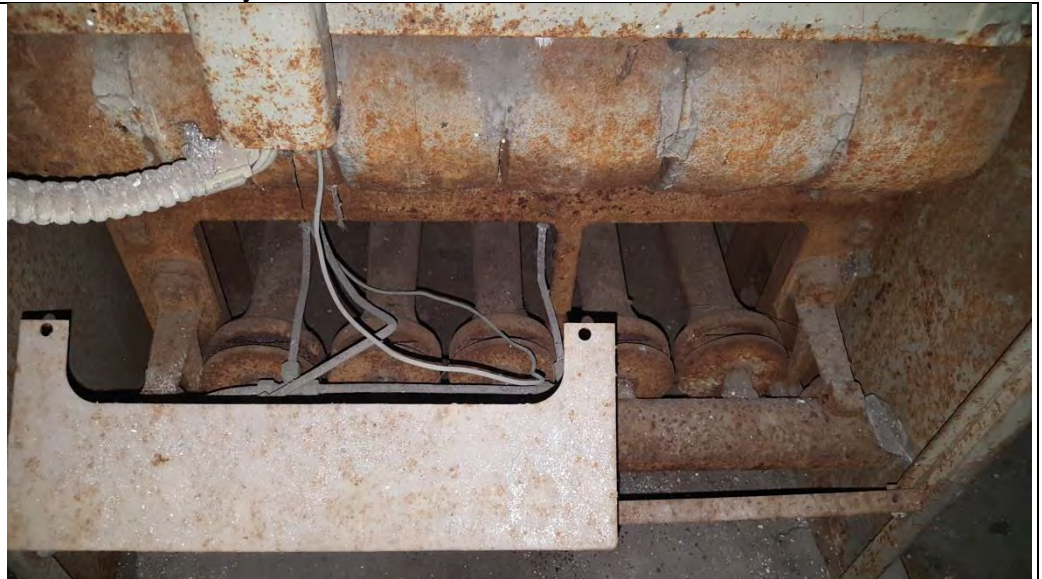
Photo Number: 110  
Date Taken  
January 24, 2018  
Description  
J1 Shed Gas  
Furnace -  
Failed

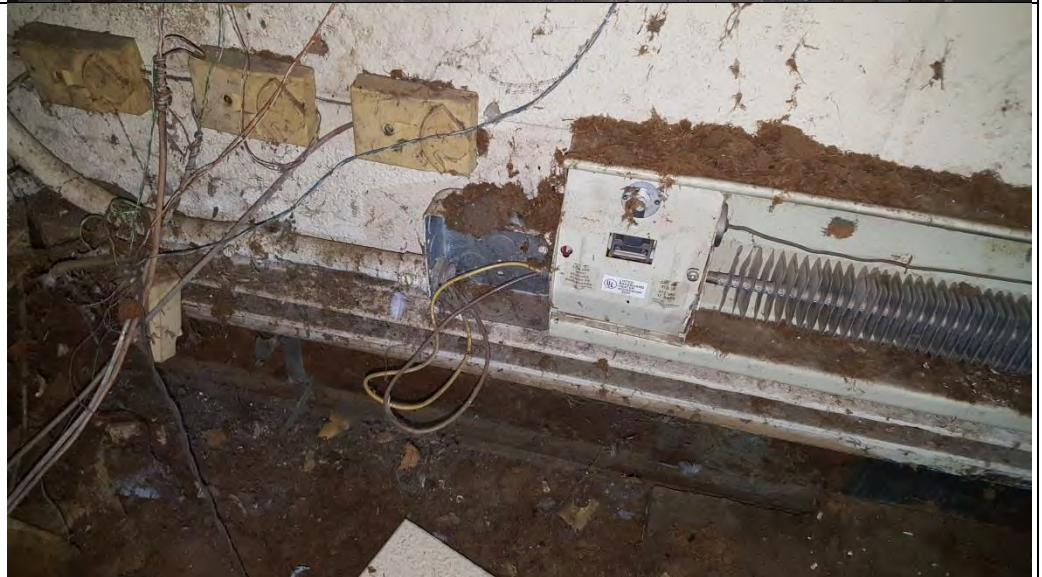
Photo Number: 111  
Date Taken  
January 24, 2018  
Description  
J1 Shed  
Electric Floor  
board Heating  
System - Failed

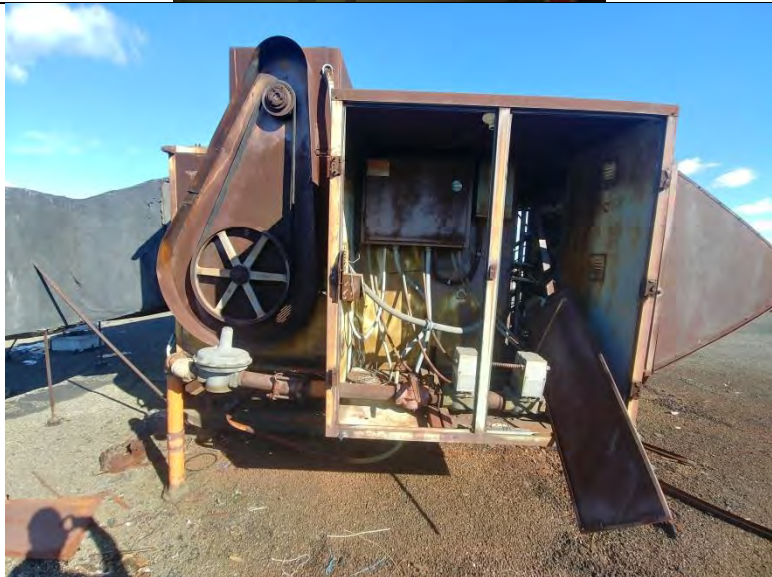
Photo Number: 126  
Date Taken  
January 24, 2018  
Description  
Graffiti Bldg  
Mechanical  
exhaust - Fail

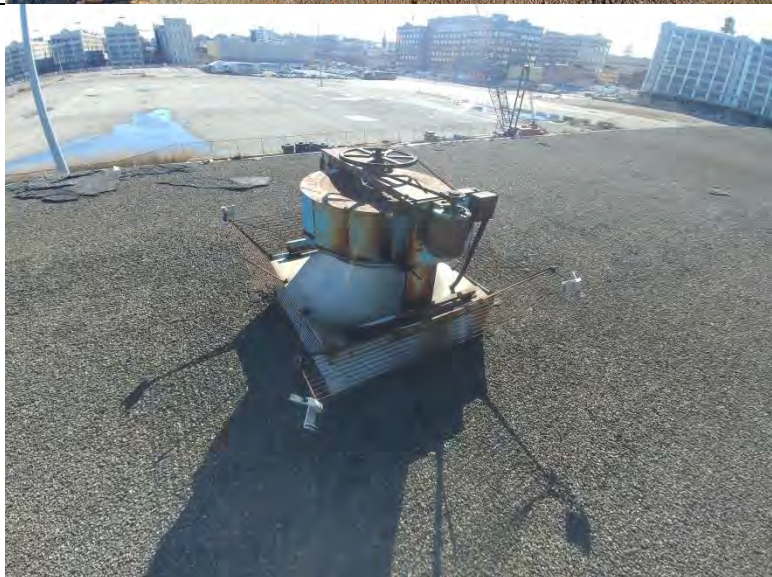
Photo Number: 127  
Date Taken  
January 24, 2018  
Description  
Graffiti Bldg  
Roof Mounted  
Exhaust Fans -  
Fail

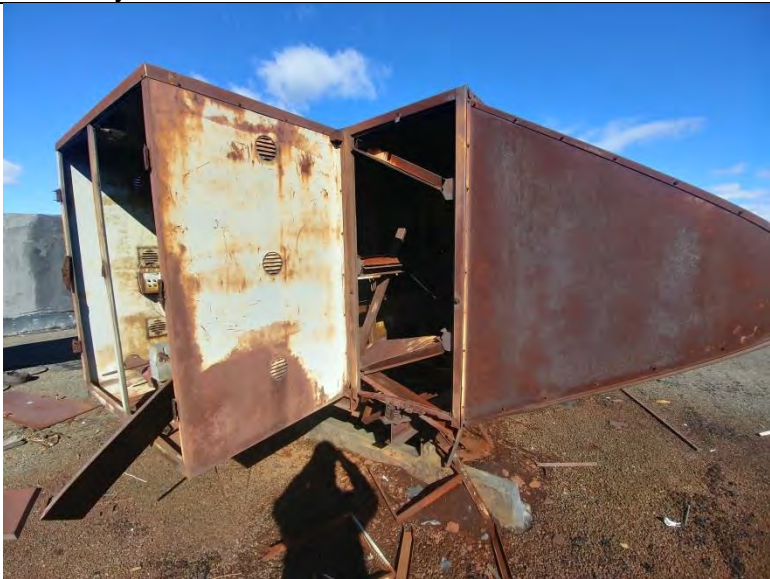
Photo Number: 128

Description  
Graffiti Bldg  
Mechanical  
Exhaust  
Assembly - Fail

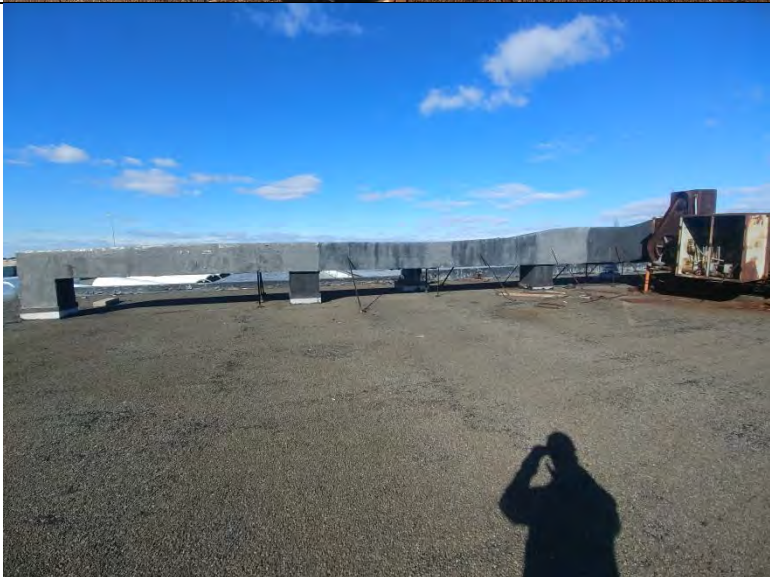
Photo Number: 129

Description  
Graffiti Bldg  
Mechanical  
Exhaust Duct -  
Fail

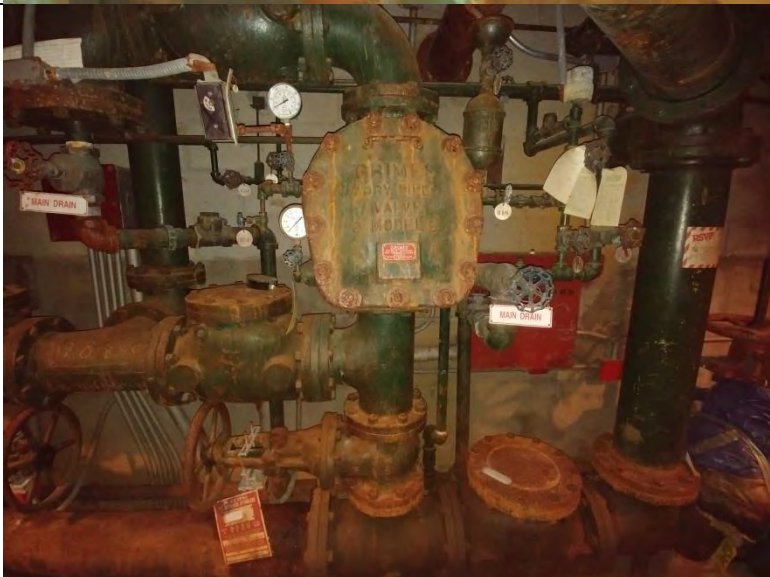
Description  
J2 Shed  
Sprinkler Valve  
– Poor

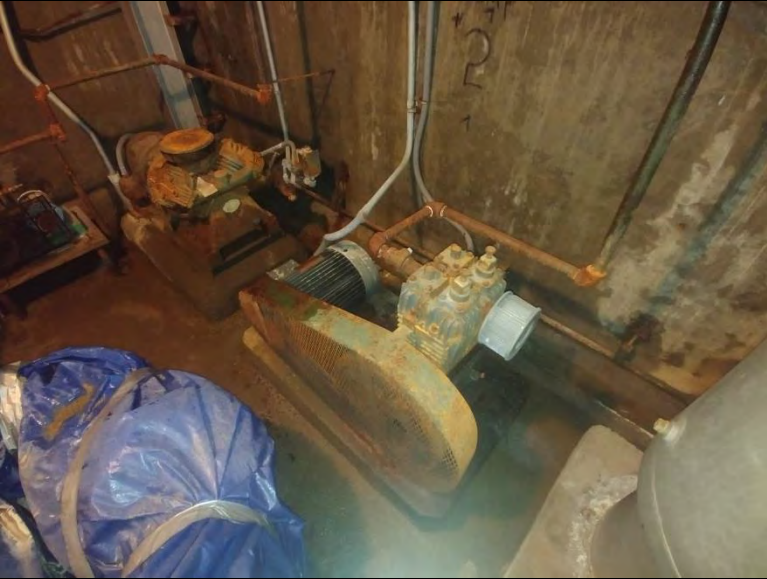
<p>Photo Number: 137</p> <p>Date Taken January 24, 2018</p> <p>Description J2 Shed Mechanical Motor - Fail</p>

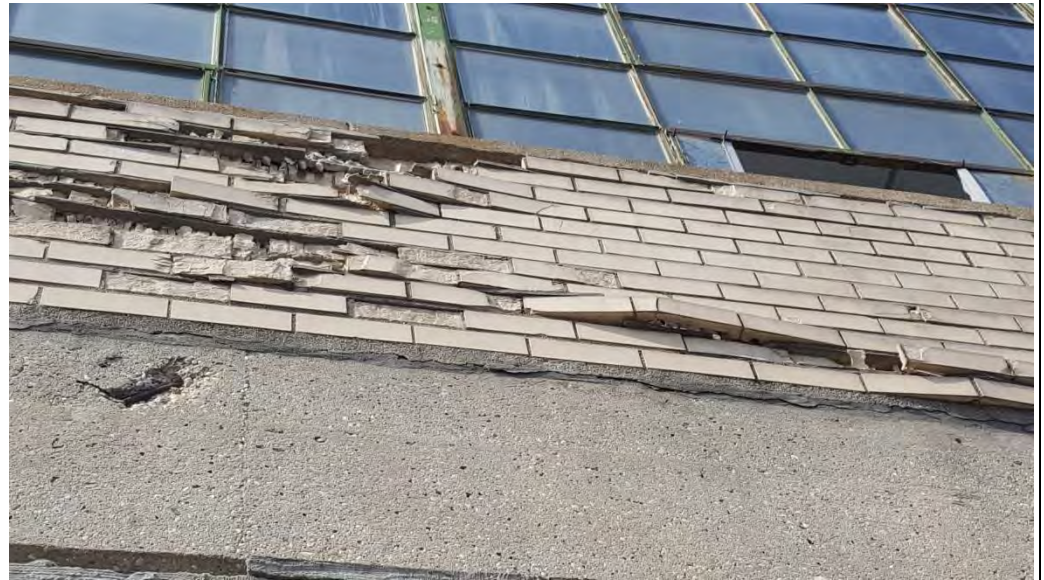
Description  
Tower Building  
– Glazed brick  
damaged on all  
sides of  
building.

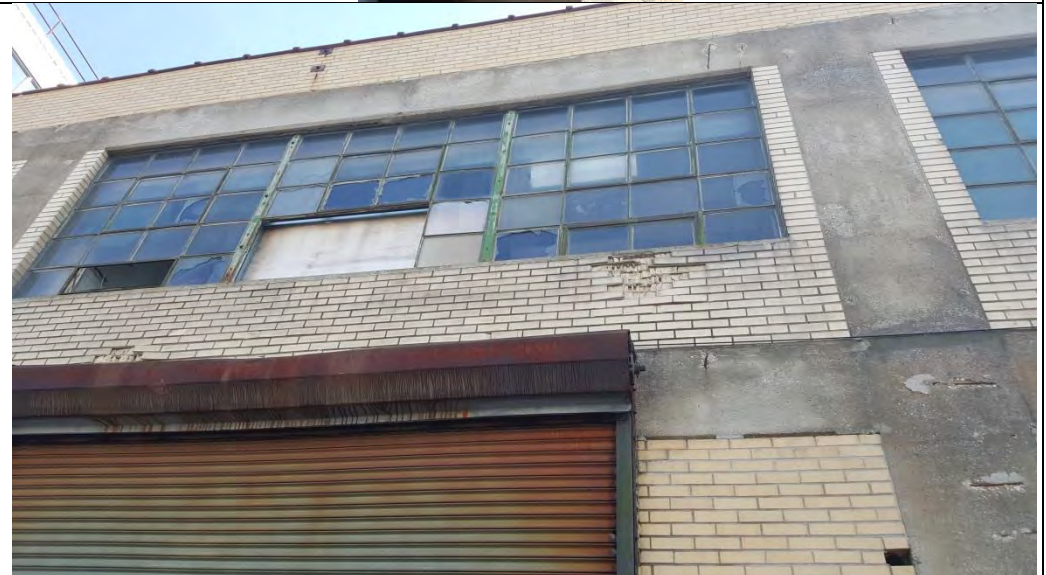
Description  
Tower Building  
– missing/  
broken  
windows and  
corroded roll  
down gate on  
West side of  
building

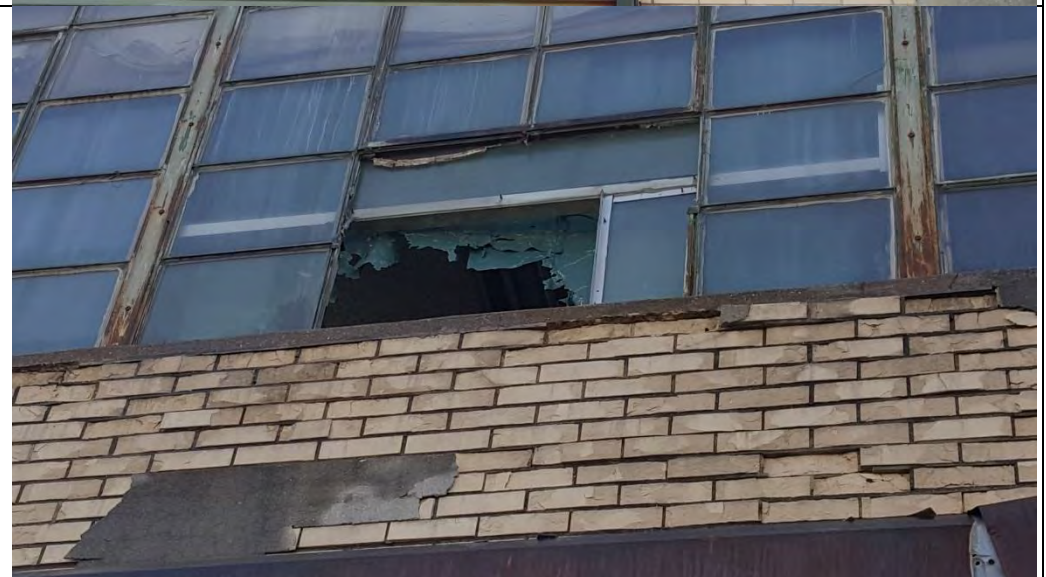
Photo Number: 165

Description  
Tower Building  
– Broken  
window and  
glazed bricks  
on North side of  
building

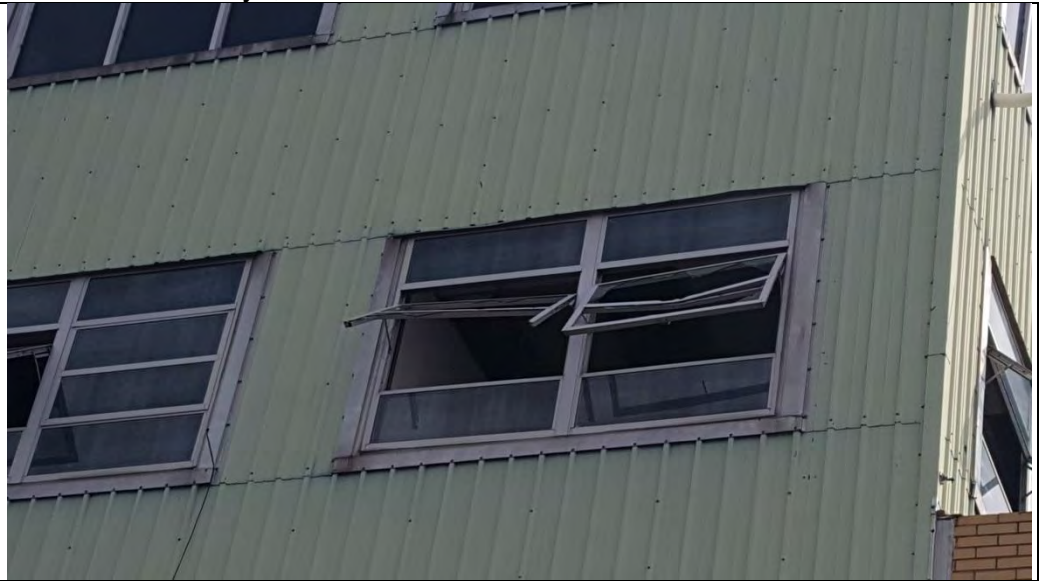
Photo Number: 166

Description  
Tower Building  
– Broken  
windows on  
North side of  
tower

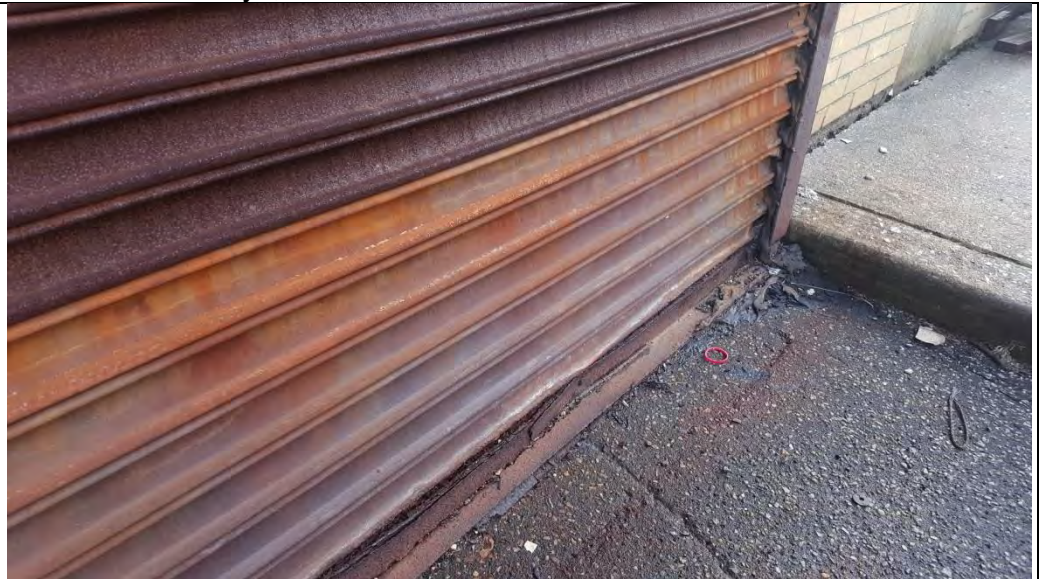
Photo Number: 169  
Date Taken  
February 20, 2018  
Description  
Tower Building  
– Rusted roll  
down gate on  
North side of  
building

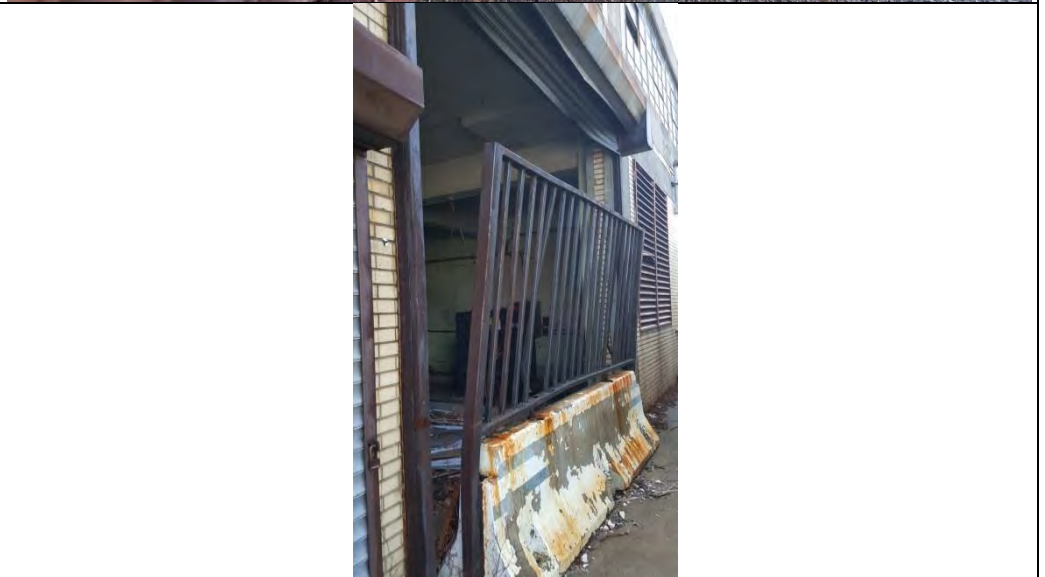
Photo Number: 170  
Date Taken  
February 20, 2018  
Description  
Tower Building  
– Broken roll  
down gate on  
North side of  
building

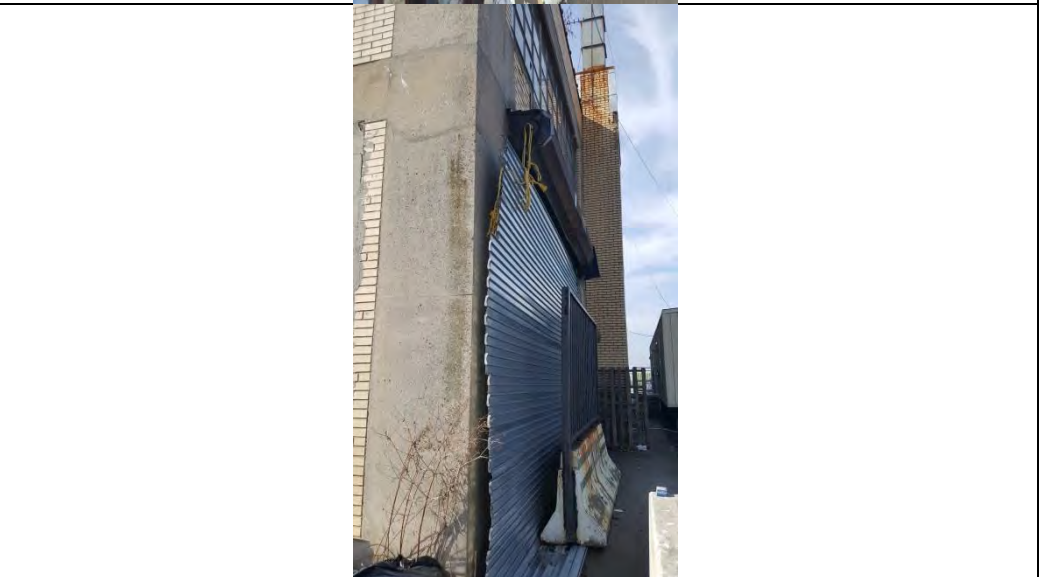
Photo Number: 171  
Date Taken  
February 20, 2018  
Description  
Tower Building  
– Missing/  
broken roll  
down gate on  
North side of  
building

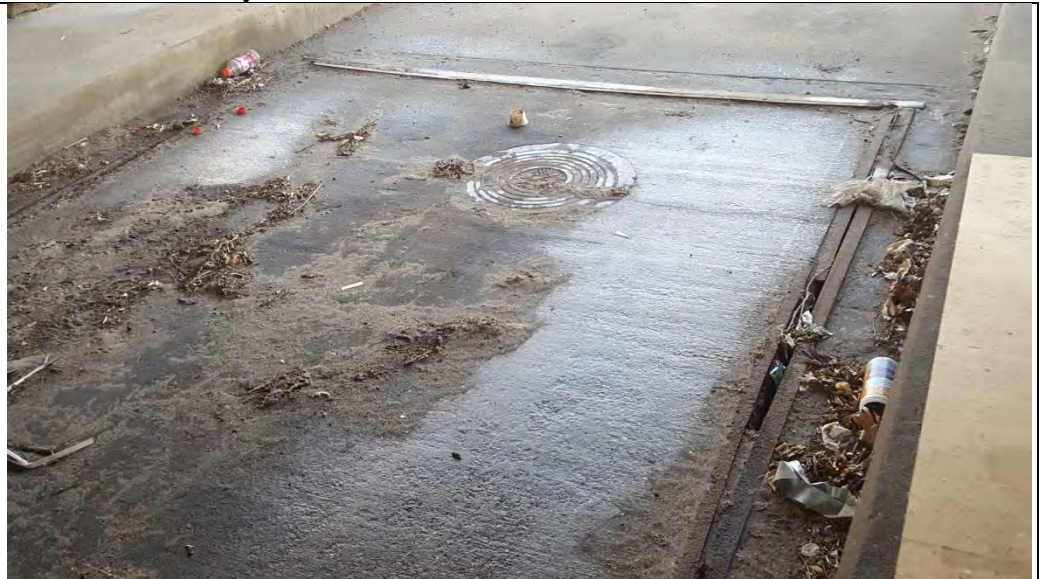
Photo Number: 172

Description  
Tower Building  
– Damaged  
armor on truck  
scales

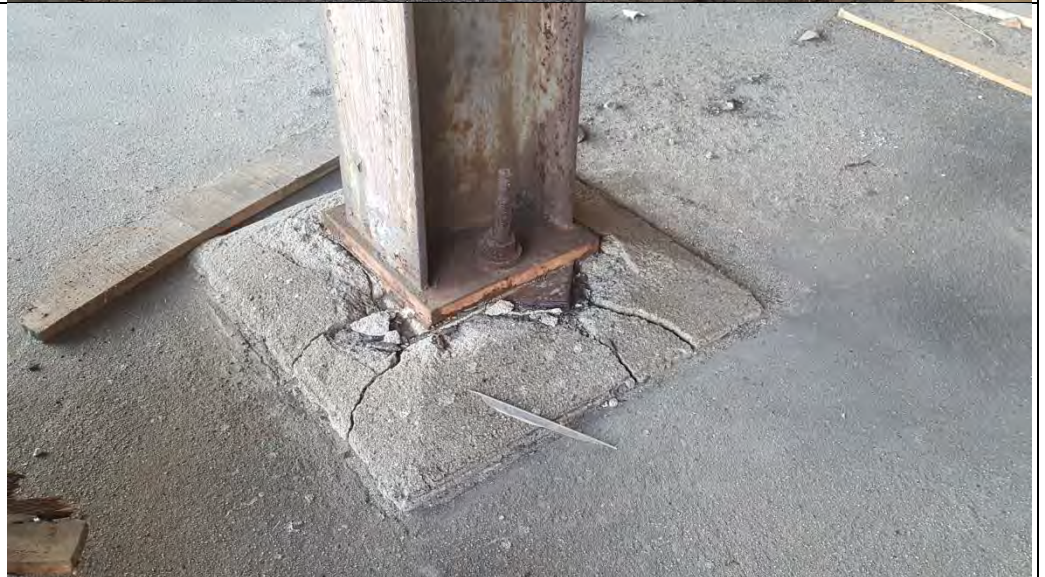
Photo Number: 173

Description  
Tower Building  
– cracked  
concrete in  
truck scale bay

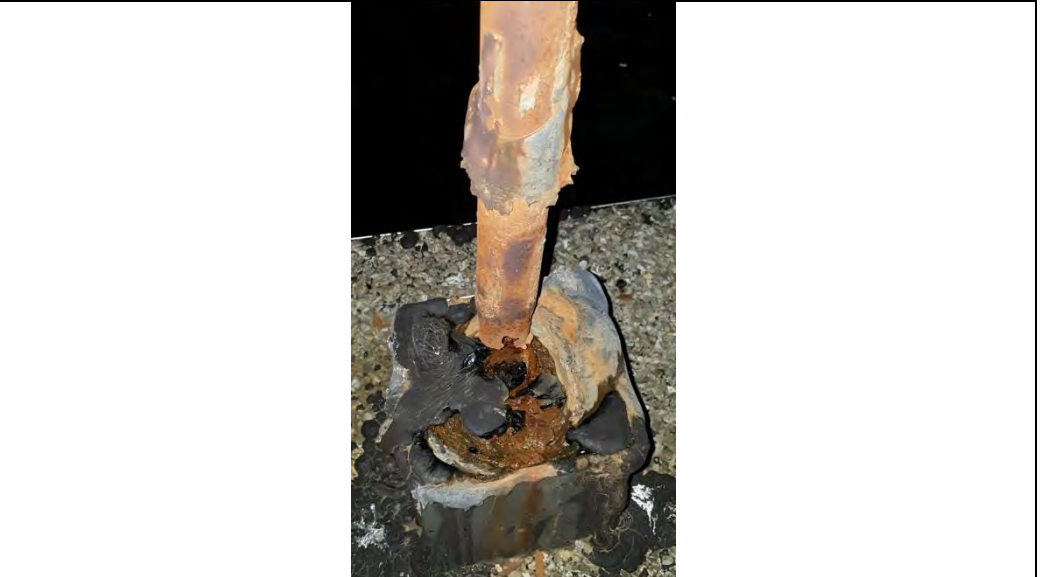
Description  
Tower Building  
– Damaged post on Tower rooftop

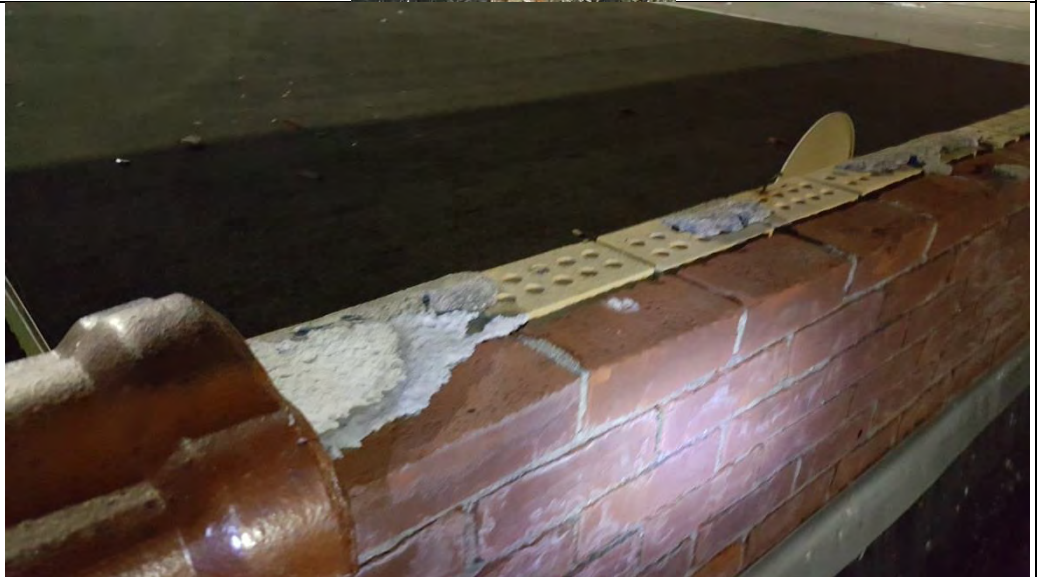
Photo Number: 184

Description  
Tower Building  
– Coping missing/ broken. Coping seal missing
