# Existing Conditions Report

269 37<sup>th</sup> Street  
Brooklyn, New York

Red Hook Container Terminal, LLC  
Brooklyn, New York

June 2018

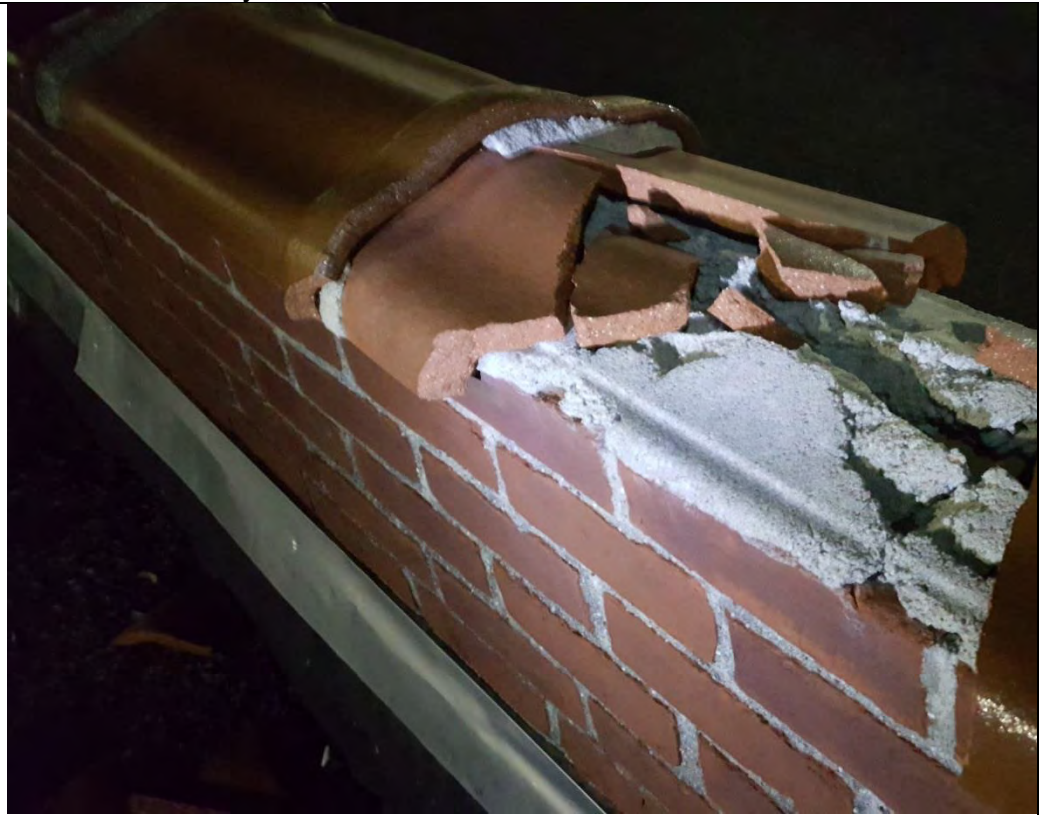
Tower Building  
– Coping  
broken on  
parapet

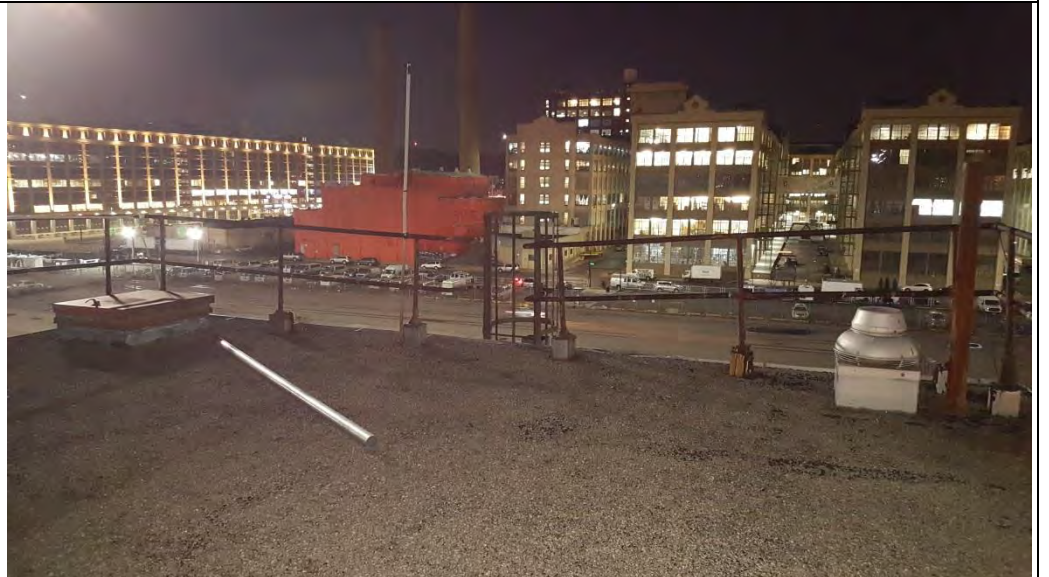
Tower Building  
– Railing  
corroded and  
slanted inboard  
on tower  
rooftop

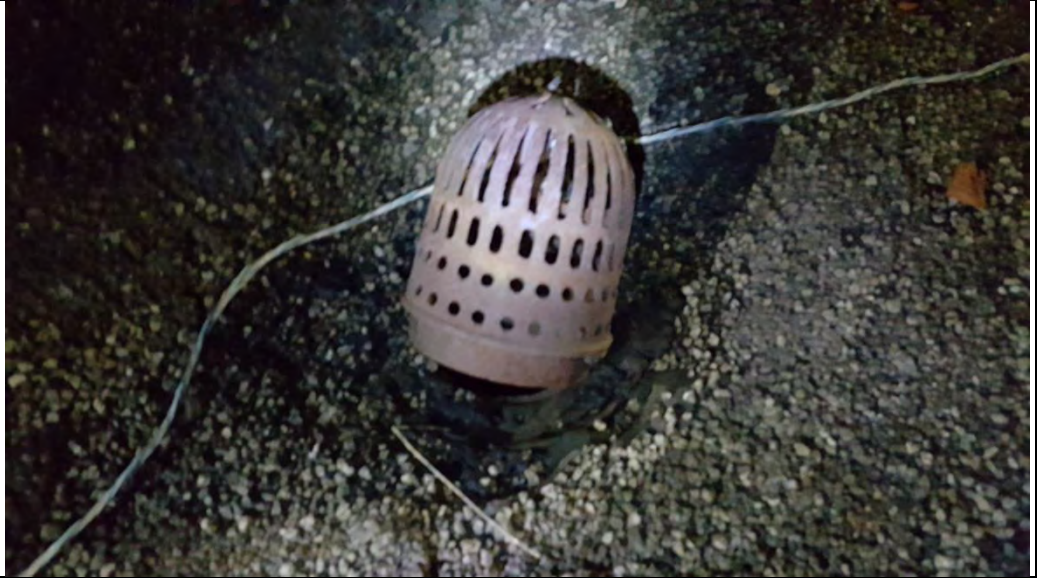
Photo Number: 190  
Date Taken  
February 20, 2018  
Description  
Tower Building  
– Drain cover  
displaced

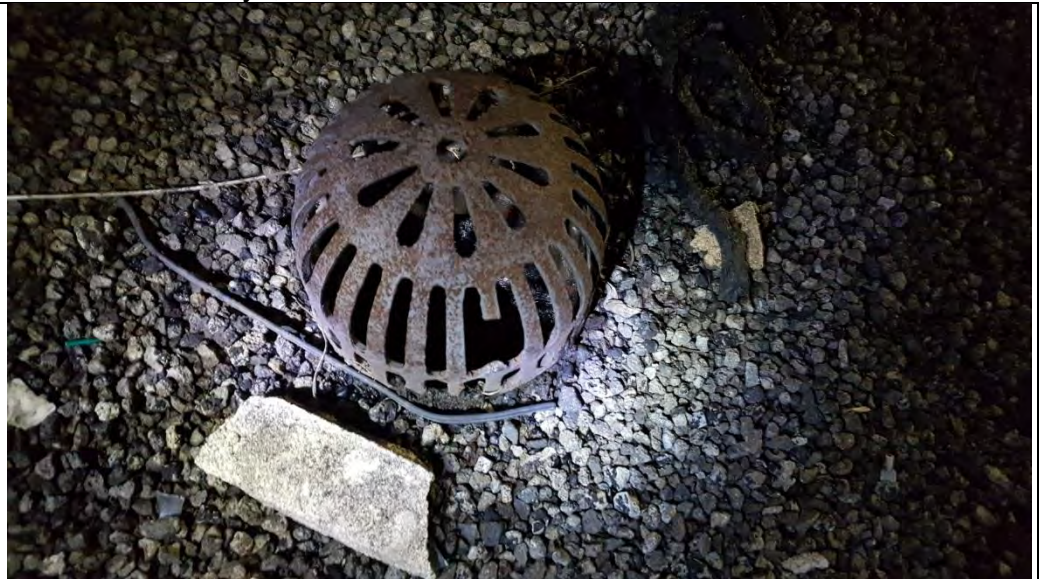
Photo Number: 191  
Date Taken  
February 20, 2018  
Description  
Tower Building  
– Drain cover  
damaged

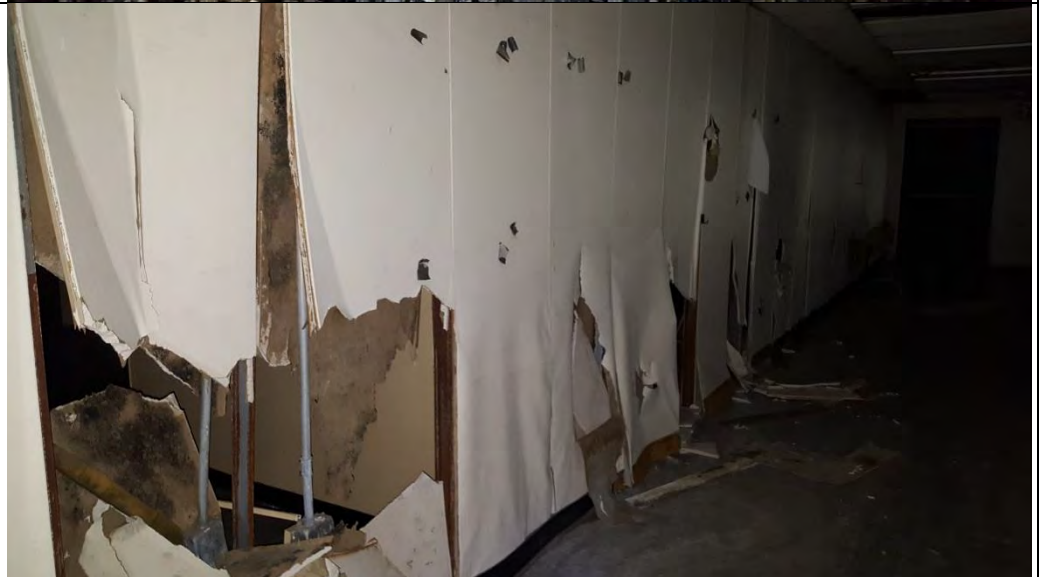
Photo Number: 192  
Date Taken  
February 20, 2018  
Description  
Tower Building  
– Corridor walls  
damaged

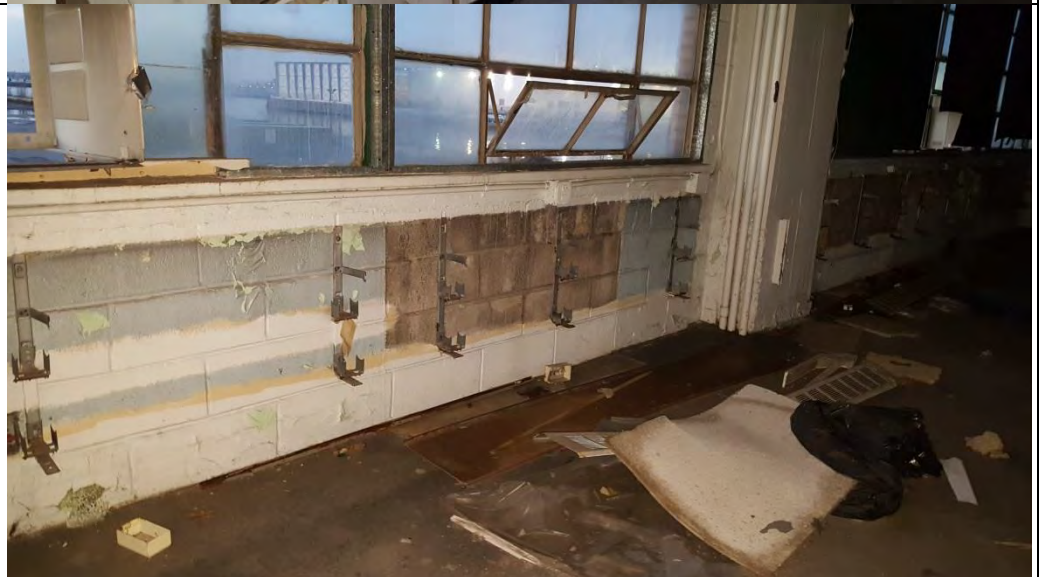
Photo Number: 193  
Date Taken  
February 20, 2018  
Description  
Tower Building  
– Office area  
Heating system  
removed,  
windows  
broken

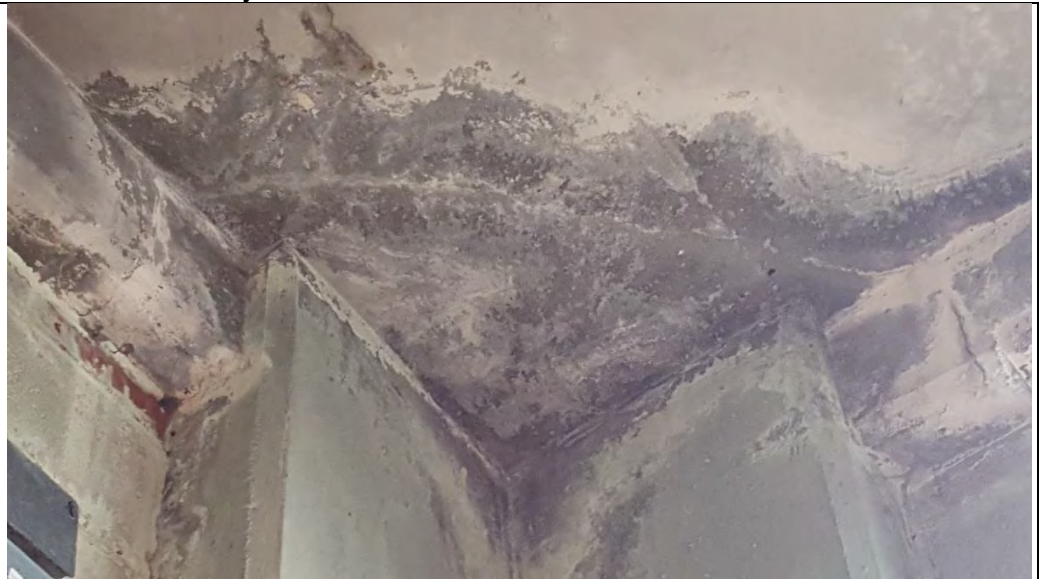
Description  
Tower Building  
– Water  
damage in  
pump room

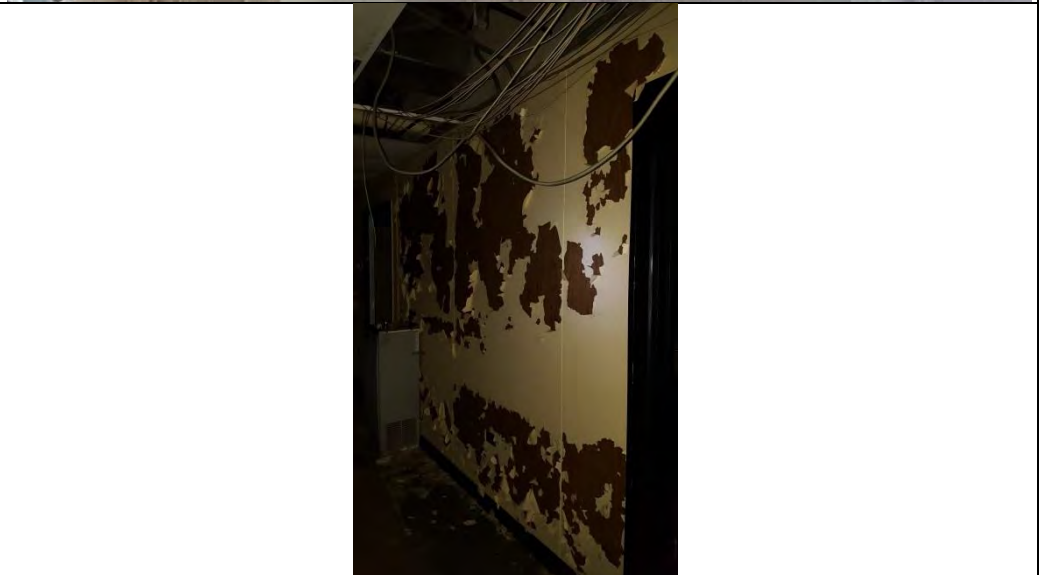
Description  
Tower Building  
– Water  
damage on  
walls on office  
area corridor

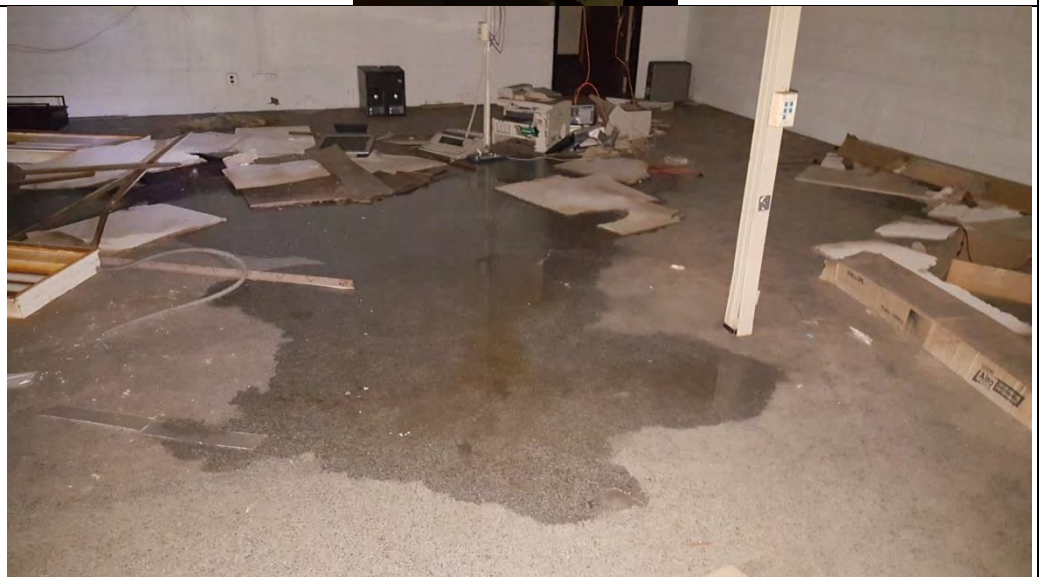
Description  
Tower Building  
– Pooling in  
office area

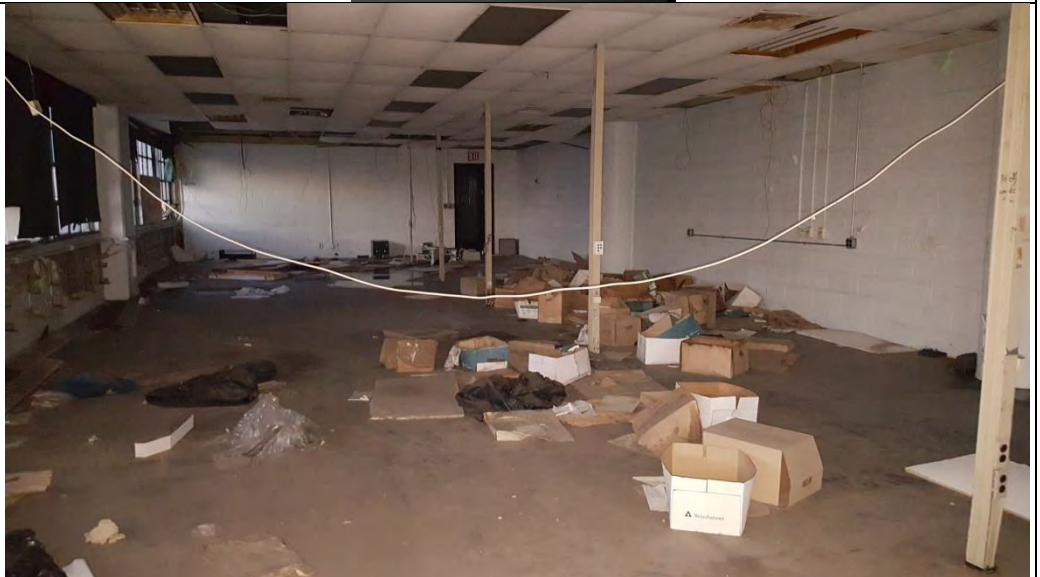
Description  
Tower Building  
– Debris,  
pooling, broken  
windows,  
unserviceable  
lighting system  
in office area

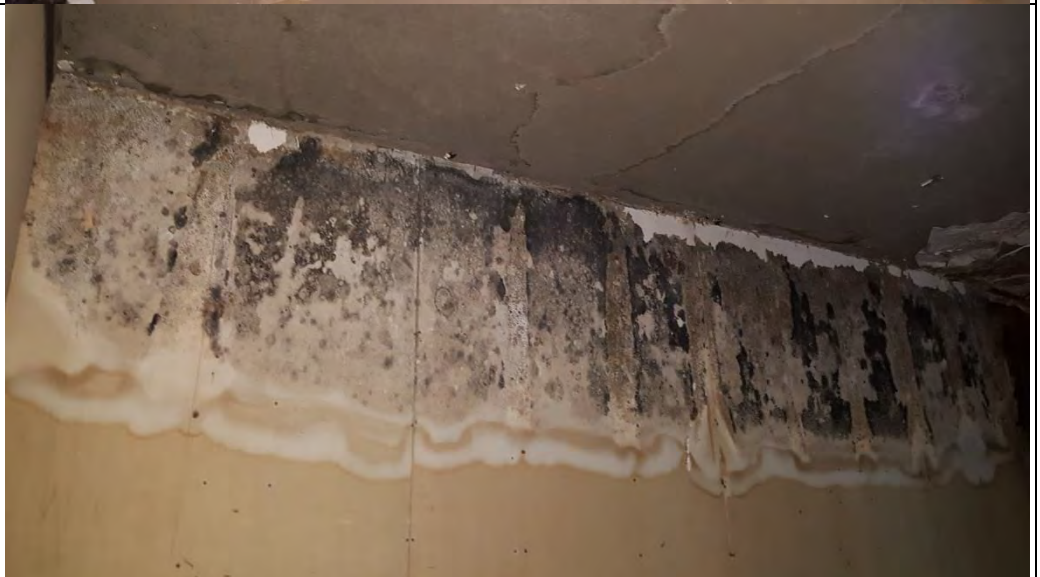
Description  
Tower Building  
– Mold in office  
area corridor

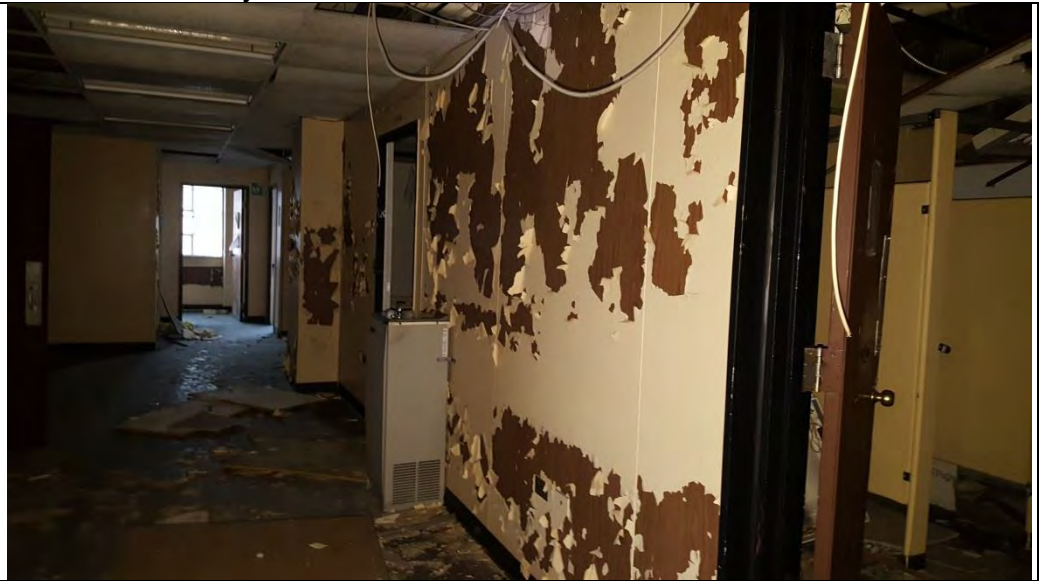
Photo Number: 203  
Date Taken  
February 20, 2018  
Description  
Tower Building – Damaged walls and debris in office area corridor

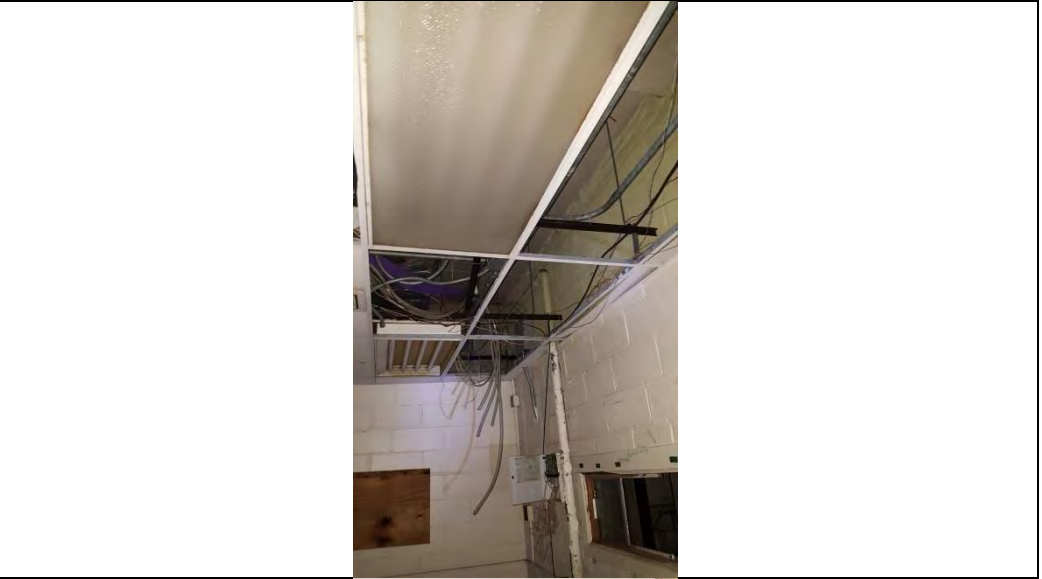
Photo Number: 204  
Date Taken  
February 20, 2018  
Description  
Tower Building – unserviceable lighting in office area

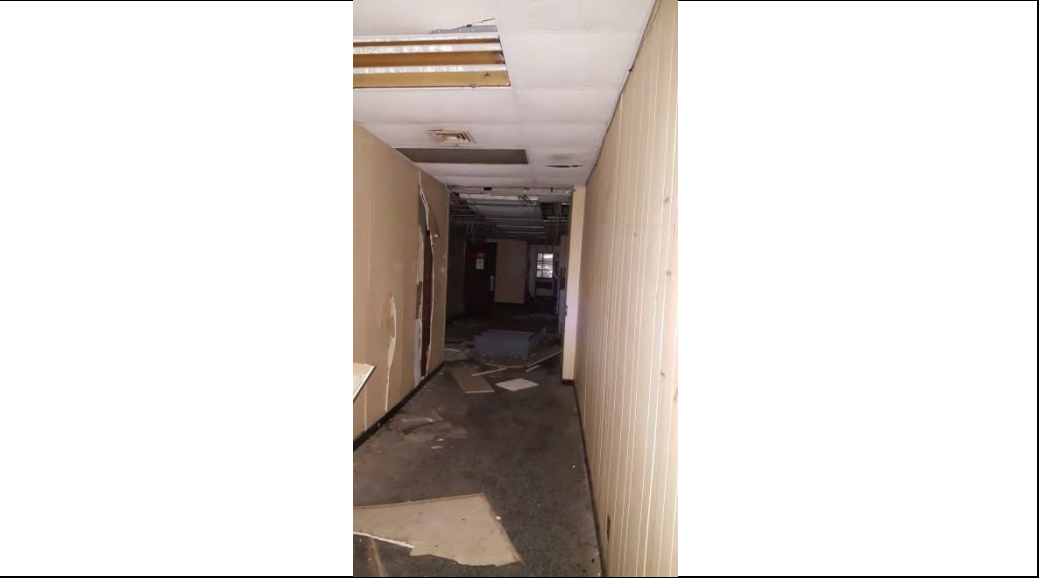
Photo Number: 205  
Date Taken  
February 20, 2018  
Description  
Tower Building – Damaged wall, debris and pooling in corridor in office area

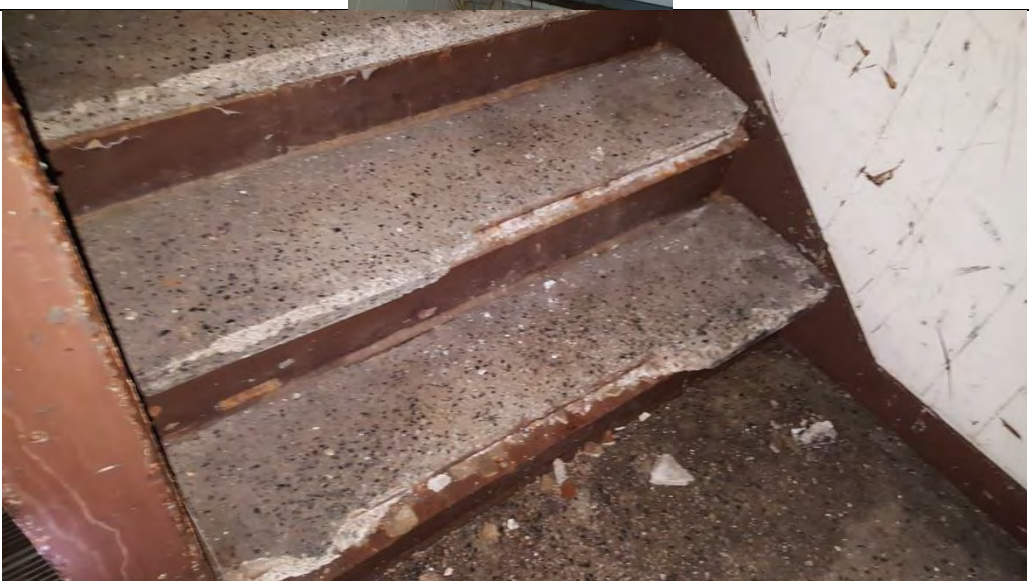
<p>Photo Number: 208</p> <p>Date Taken February 20, 2018</p> <p>Description Tower Building – Broken treads on stairs</p>

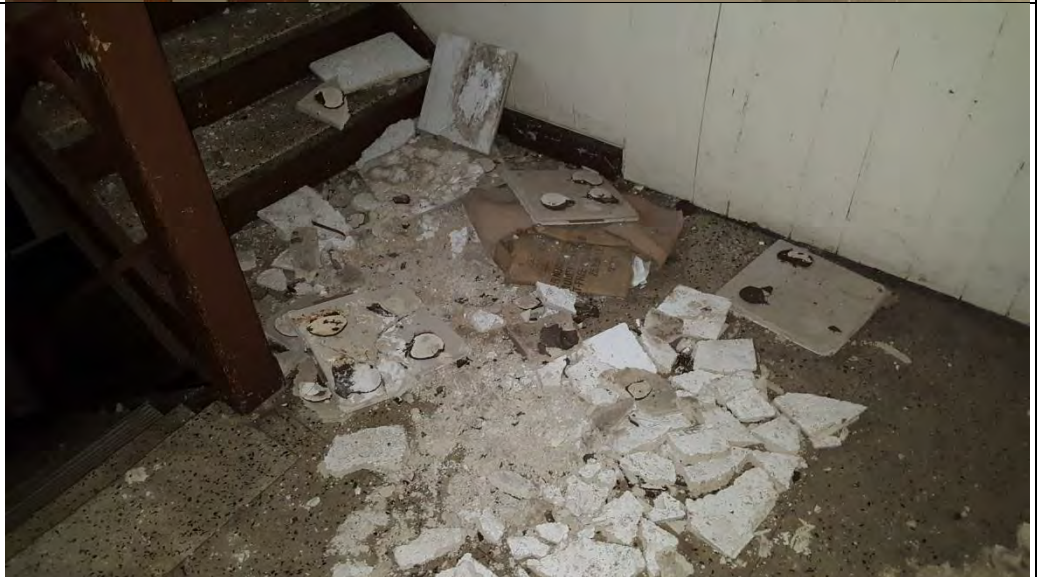
Description  
Tower Building  
– Broken tread  
and debris

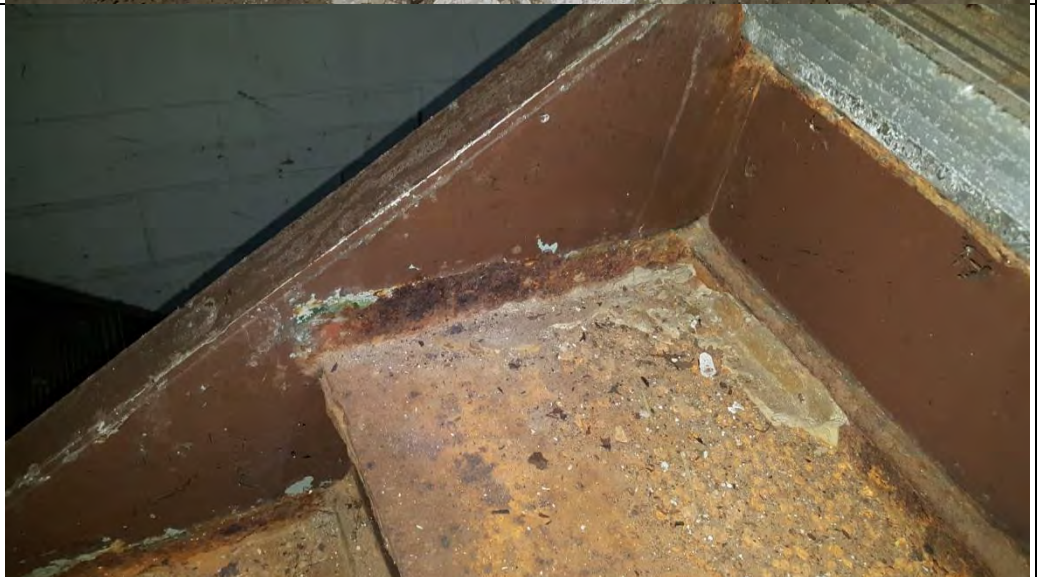
Description  
Tower Building  
– Missing  
concrete pan

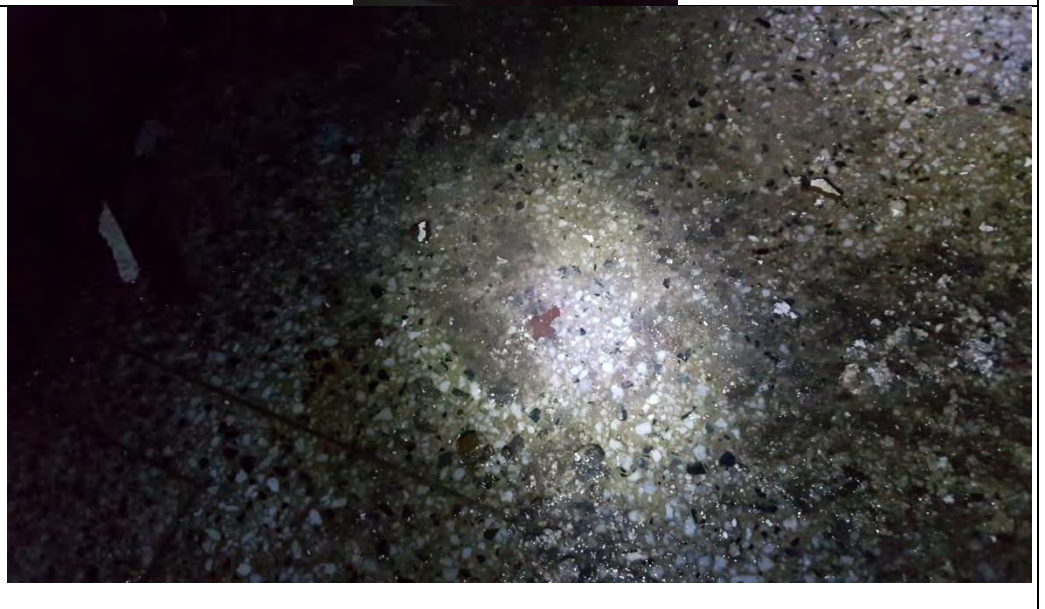
Description  
Tower Building  
– Pooling in on  
landing  
(excessive  
moisture  
observed  
throughout  
entire staircase.  
Walls sweating  
and mold
