**Empire Offshore Wind
Final Environmental
Impact Statement
Volume 6 Part H EAF Appendix K**
September 2023

Appendix K Existing Conditions Report, June 2018

Existing Conditions Report

269 37th Street
Brooklyn, New York

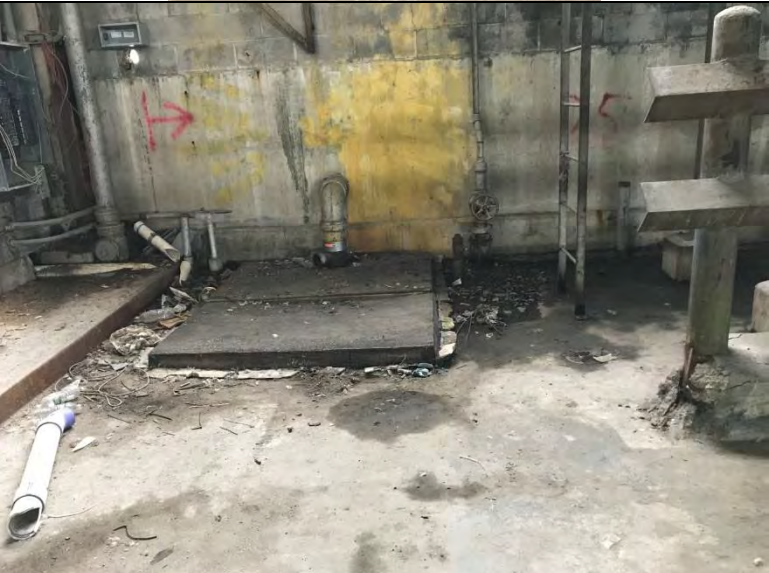
<p>Photo Number: 16</p> <p>Date Taken</p> <p>January 24, 2018</p> <p>Description</p> <p>J1 Shed - Floor crack</p>	 
<p>Photo Number: 17</p> <p>Date Taken</p> <p>January 24, 2018</p> <p>Description</p> <p>J1 Shed - Open cold joint at northwest wall</p>	 
<p>Photo Number: 18</p> <p>Date Taken</p> <p>January 24, 2018</p> <p>Description</p> <p>J1 Shed - Cracked concrete dock</p>

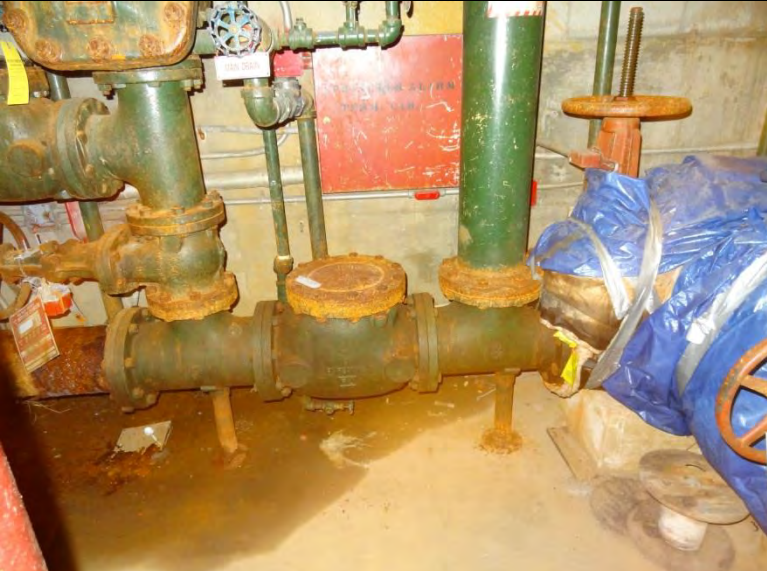
Description
J1 Shed - Fire
Sprinkler
Control Valve
assembly – Fair
to poor
condition.

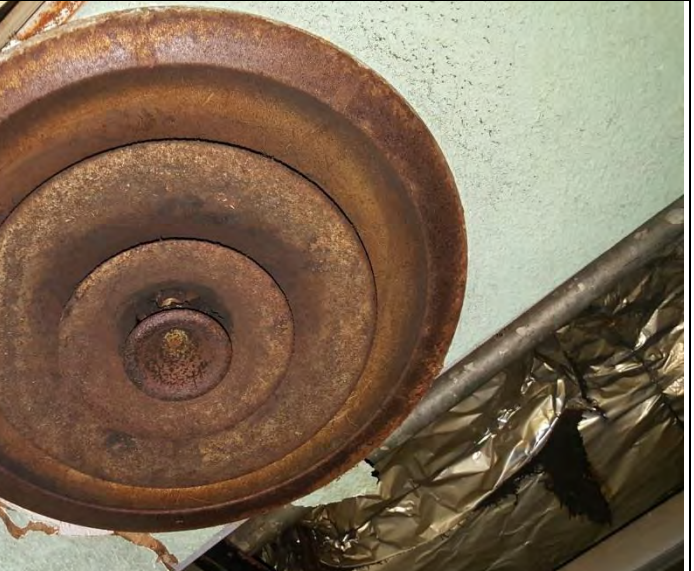
Photo Number: 107
Date Taken
January 24, 2018
Description
J1 Shed Air Management System – Failed

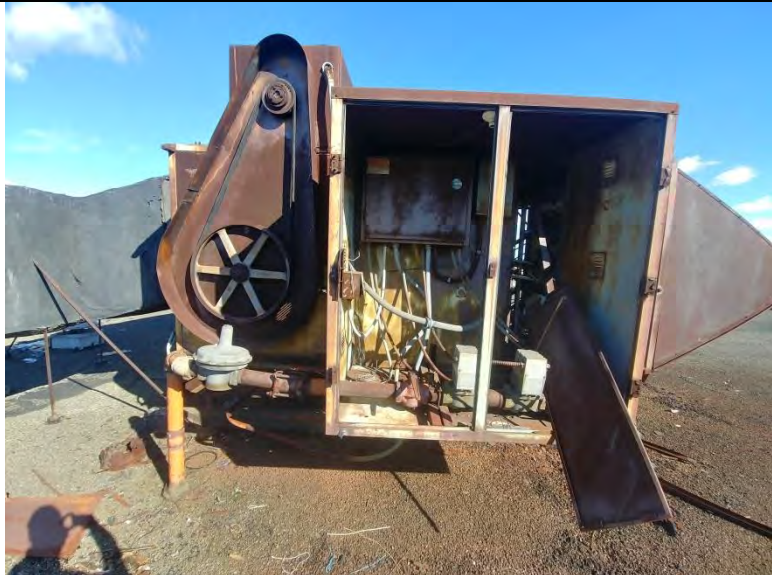
Description
Graffiti Bldg
Roof Mounted
Exhaust Fans -
Fail

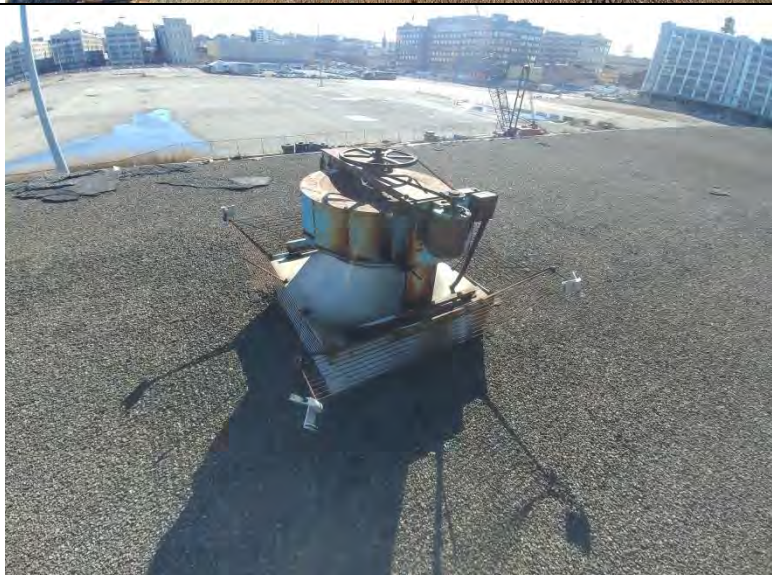
Description
Graffiti Bldg
Mechanical
Exhaust
Assembly - Fail

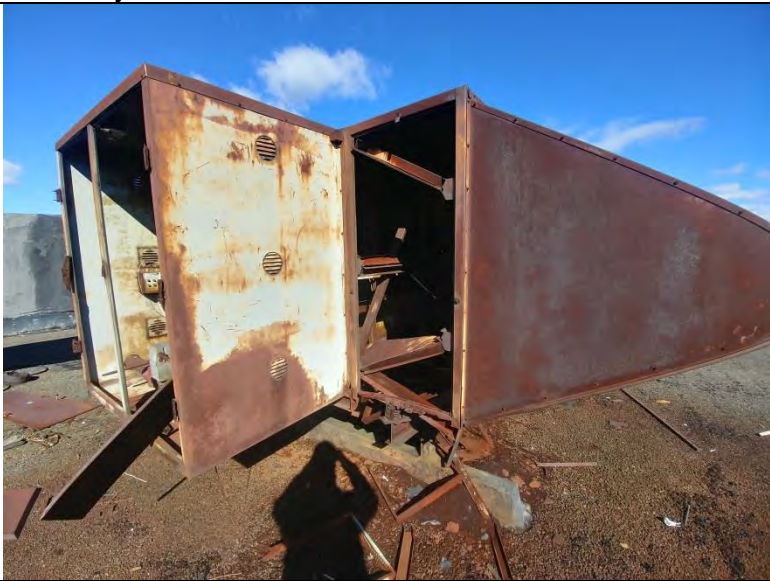
Description
Graffiti Bldg
Mechanical
Exhaust Duct -
Fail

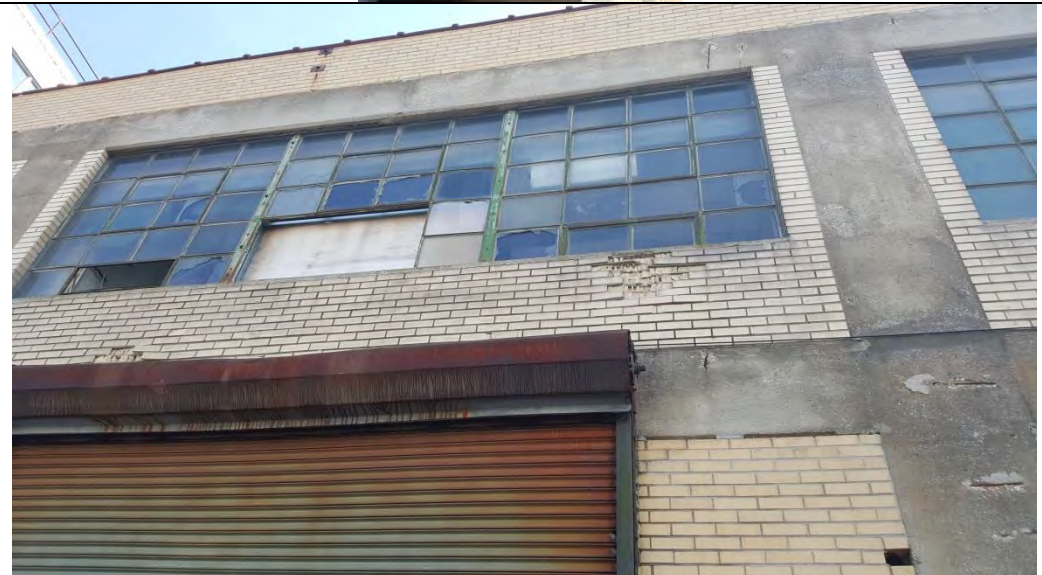
Photo Number: 165
Date Taken
February 20, 2018
Description
Tower Building
– Broken
window and
glazed bricks
on North side of
building

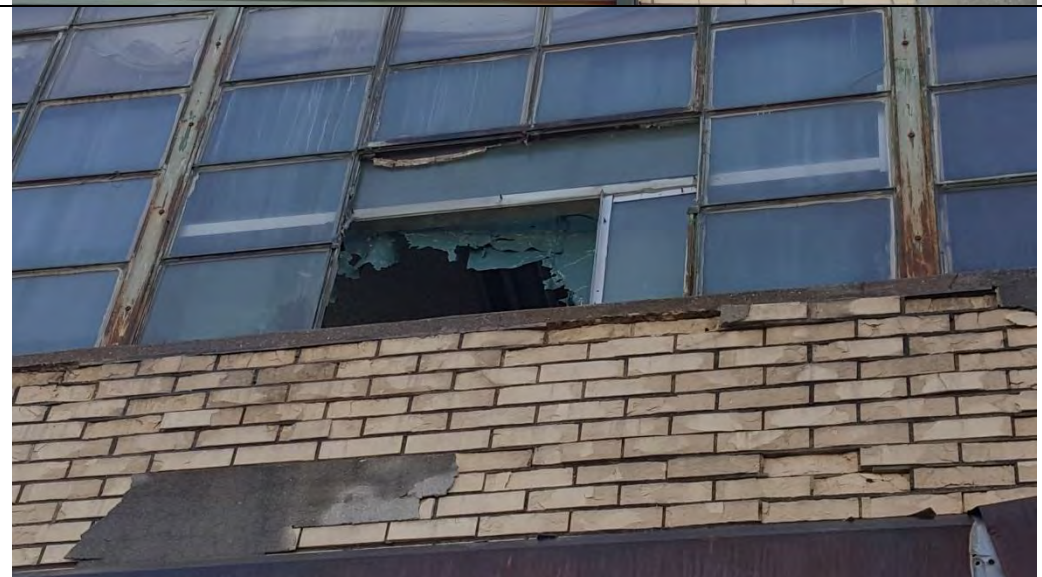
Description
Tower Building
– Broken
windows on
North side of
tower

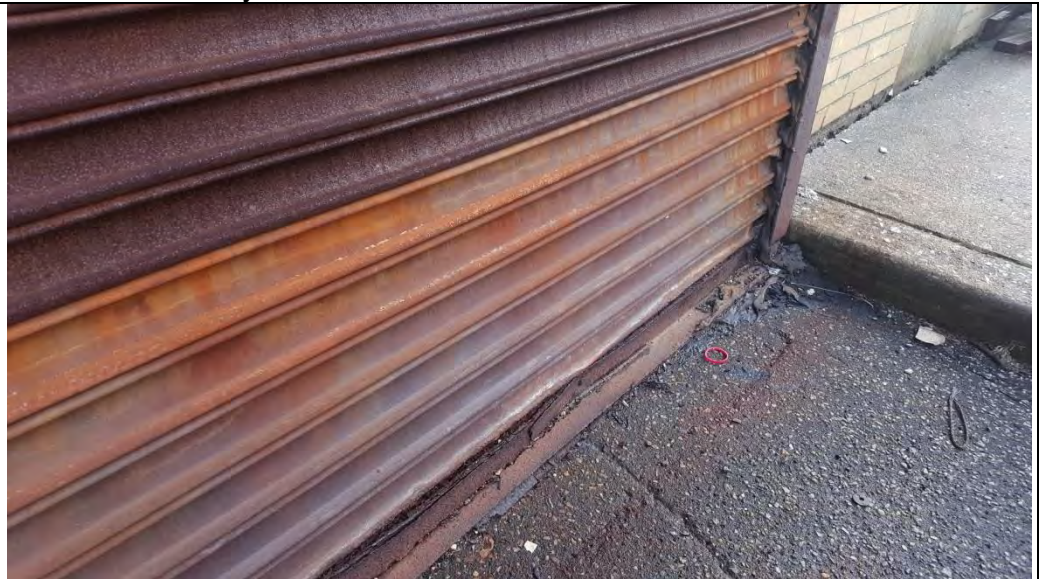
Description
Tower Building
– Broken roll down gate on North side of building

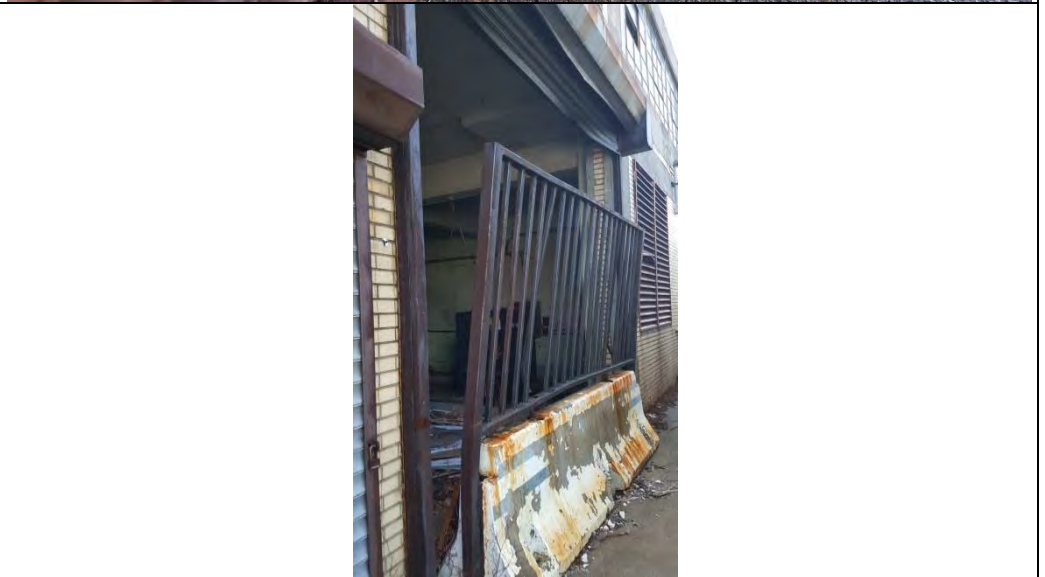
Description
Tower Building
– Missing/broken roll down gate on North side of building

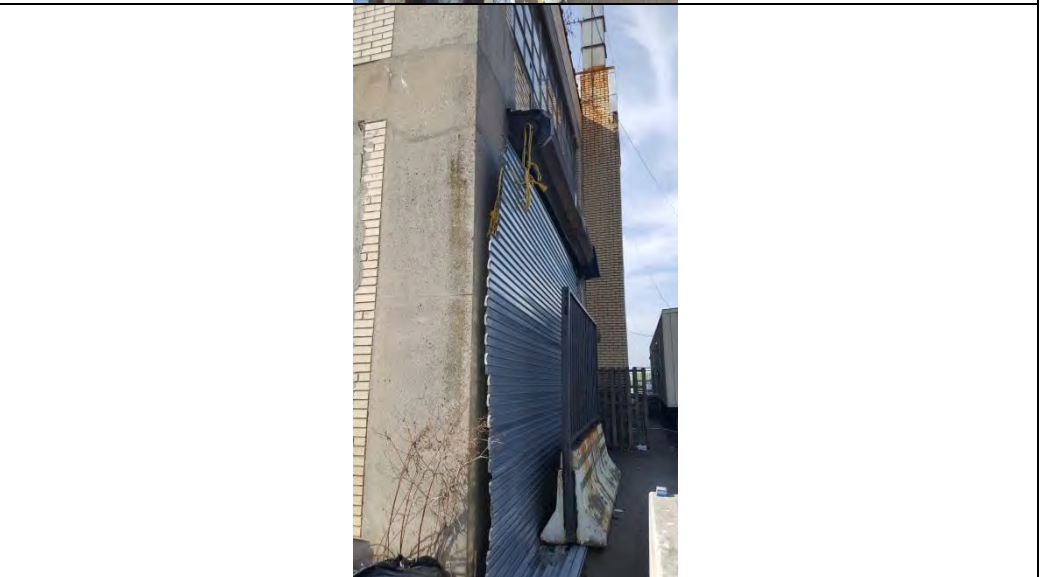
Photo Number: 172
Date Taken
February 20, 2018
Description
Tower Building
– Damaged
armor on truck
scales

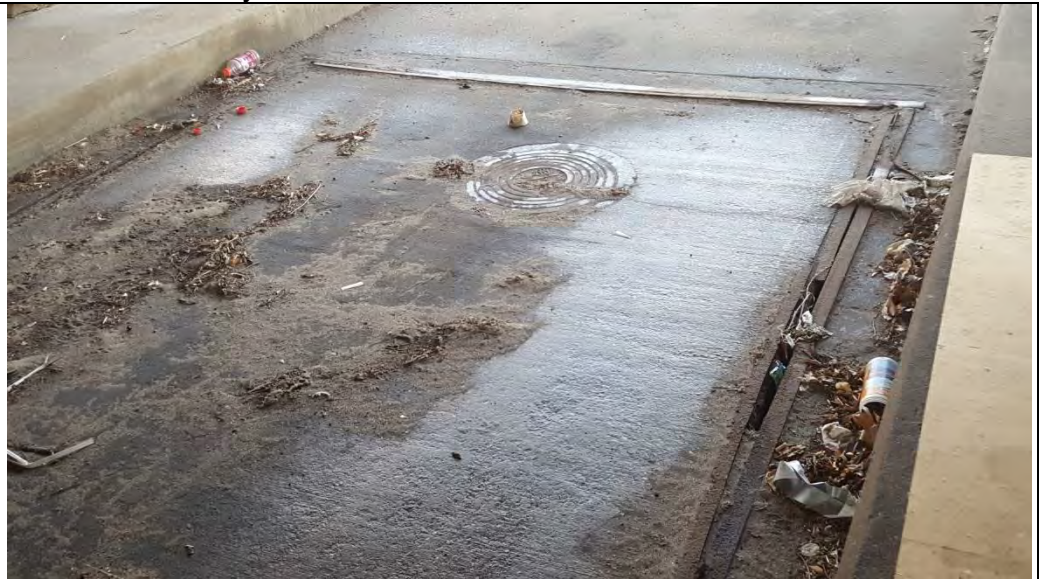
Photo Number: 173
Date Taken
February 20, 2018
Description
Tower Building
– cracked
concrete in
truck scale bay

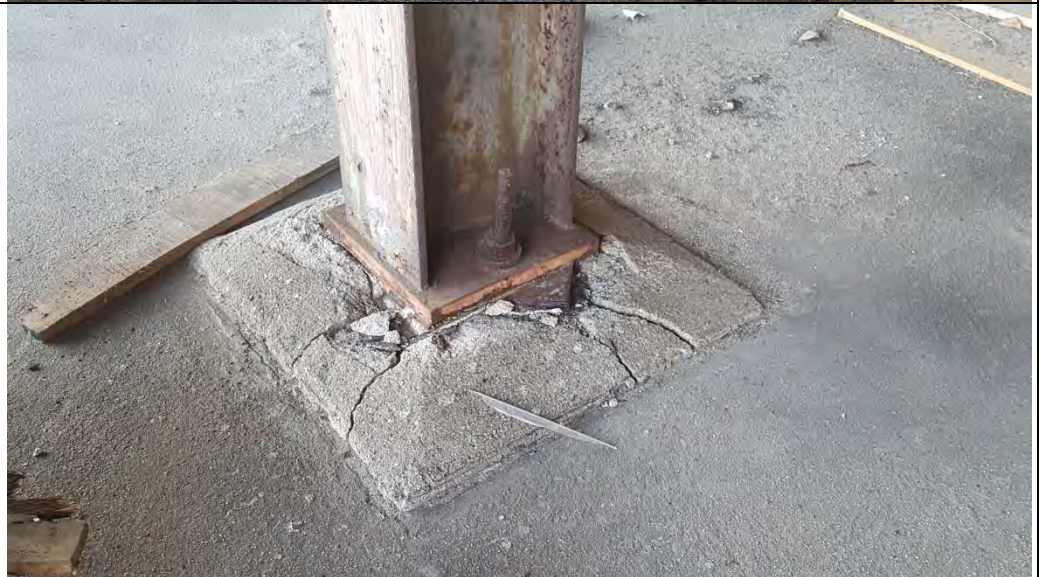
Photo Number: 174
Date Taken
February 20, 2018
Description
Tower Building
– corroded
armor on truck
scale

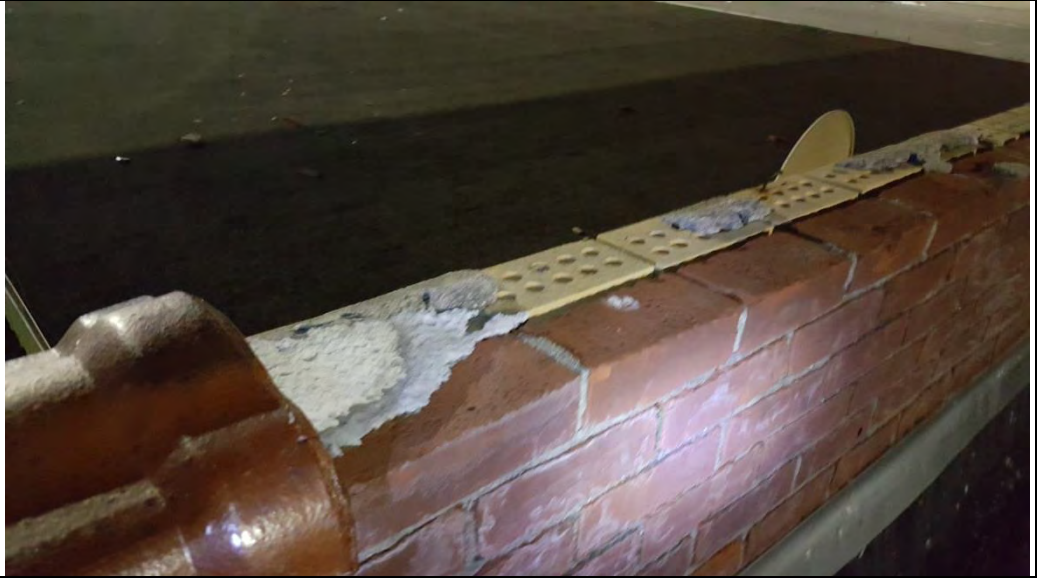
Tower Building
– Coping
broken on
parapet

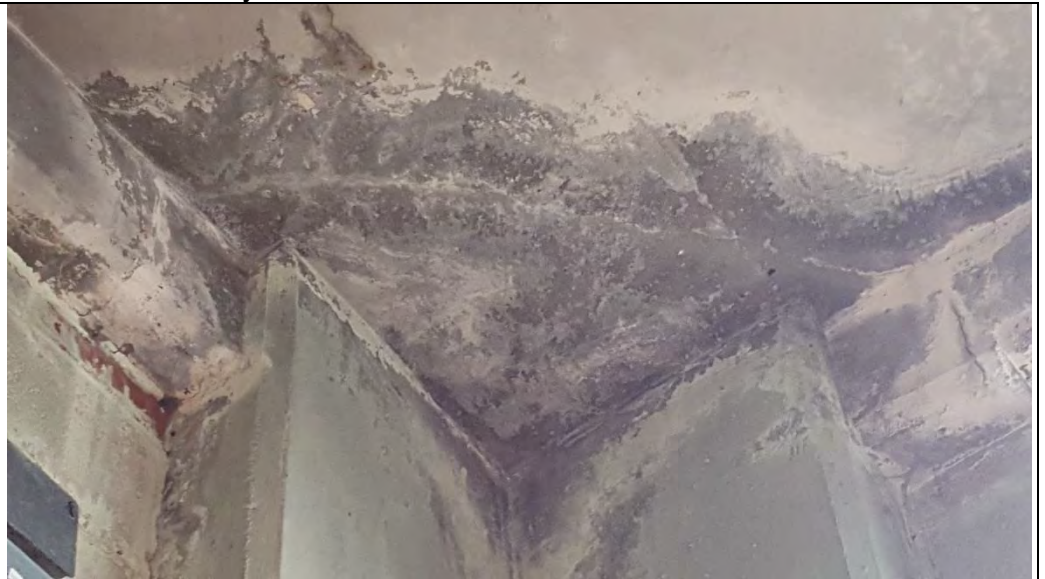
Description
Tower Building
– Water
damage on
walls on office
area corridor
