Observing Cable Laying and Particle Settlement During the Construction of the Block Island Wind Farm

US Department of the Interior
Bureau of Ocean Energy Management
Office of Renewable Energy Programs

March 2017

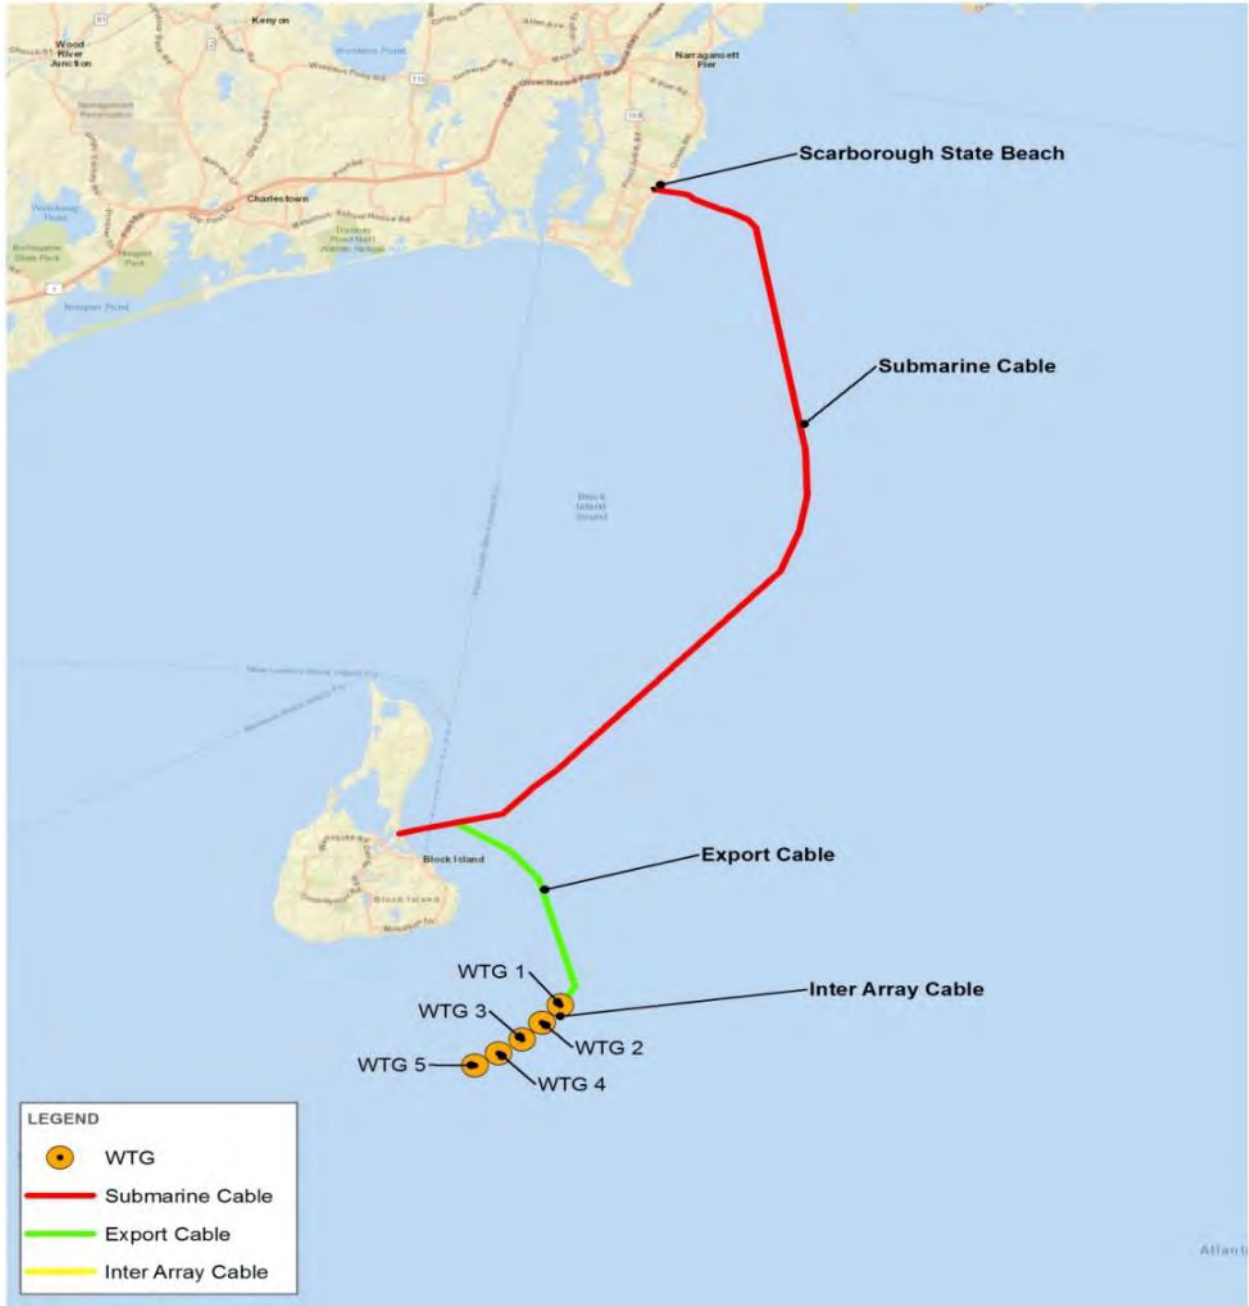
Figure 2. BITS Cable Route

An advance rate of approximately 210 meters/hour (700 feet/hour) was observed during cable laying operations. From the known design of the jet plow rigging and observations on site, it was assumed that the plow was within 50 meters (164 feet) of the stern of Big Max. The marker buoys from the rigging, shown in **Figure 6**, provide guidance on the approximate position of the jet plow. However, the marker buoys would also be affected to an extent by the wind and currents. With this in mind and given the proximity restrictions from the Captain of Big Max, turbidity profiles were taken no closer than 80 m from the stern. This eliminated any risk of entanglement between the jet plow rigging and the survey equipment being deployed from the Jamie Hanna.

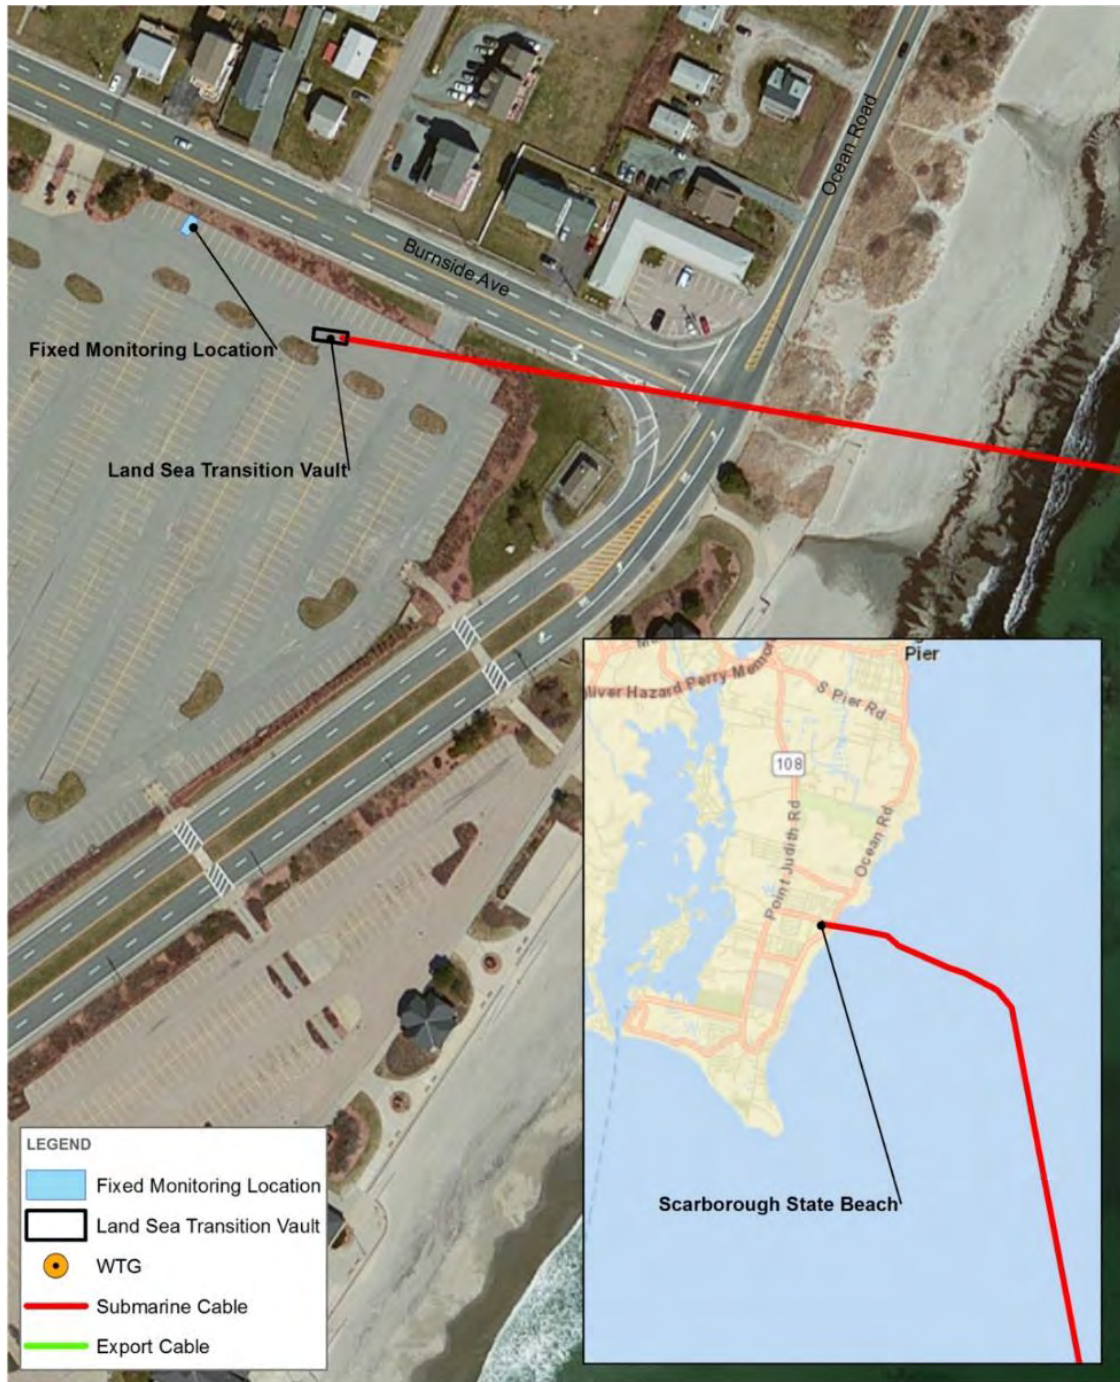
Figure 7. Onshore Monitoring Scarborough State Beach

Figure 7 below shows monitoring position on the mainland at Scarborough State Beach parking lot utilized for monitoring and the cable transition to land. The land sea transition vault was a rectangle shaped hole dug in the parking lot used to connect the BITS cable to the terrestrial cable. An underground conduit for the BITS cable at the beach and the intersection of Ocean Road and Burnside Avenue was already complete upon the team's arrival.

During the initial cable lay which began at Scarborough State Beach, the observer was positioned in the parking lot at the intersection of Burnside Avenue and Ocean Avenue which is adjacent to North Beach. The physical address is 970 Ocean Road, Narragansett, Rhode Island 02882. The exact location for fixed monitoring occurred at the coordinates: N 41°10.390', W 071°33.576. Occasionally a car was parked in the designated location for fixed photos so the team would relocate to the nearest open location which was no more the 6 feet from the designated location. Once a fixed photo was captured, the onshore observer would move about the parking lot construction area to capture better angles of significant construction activities.

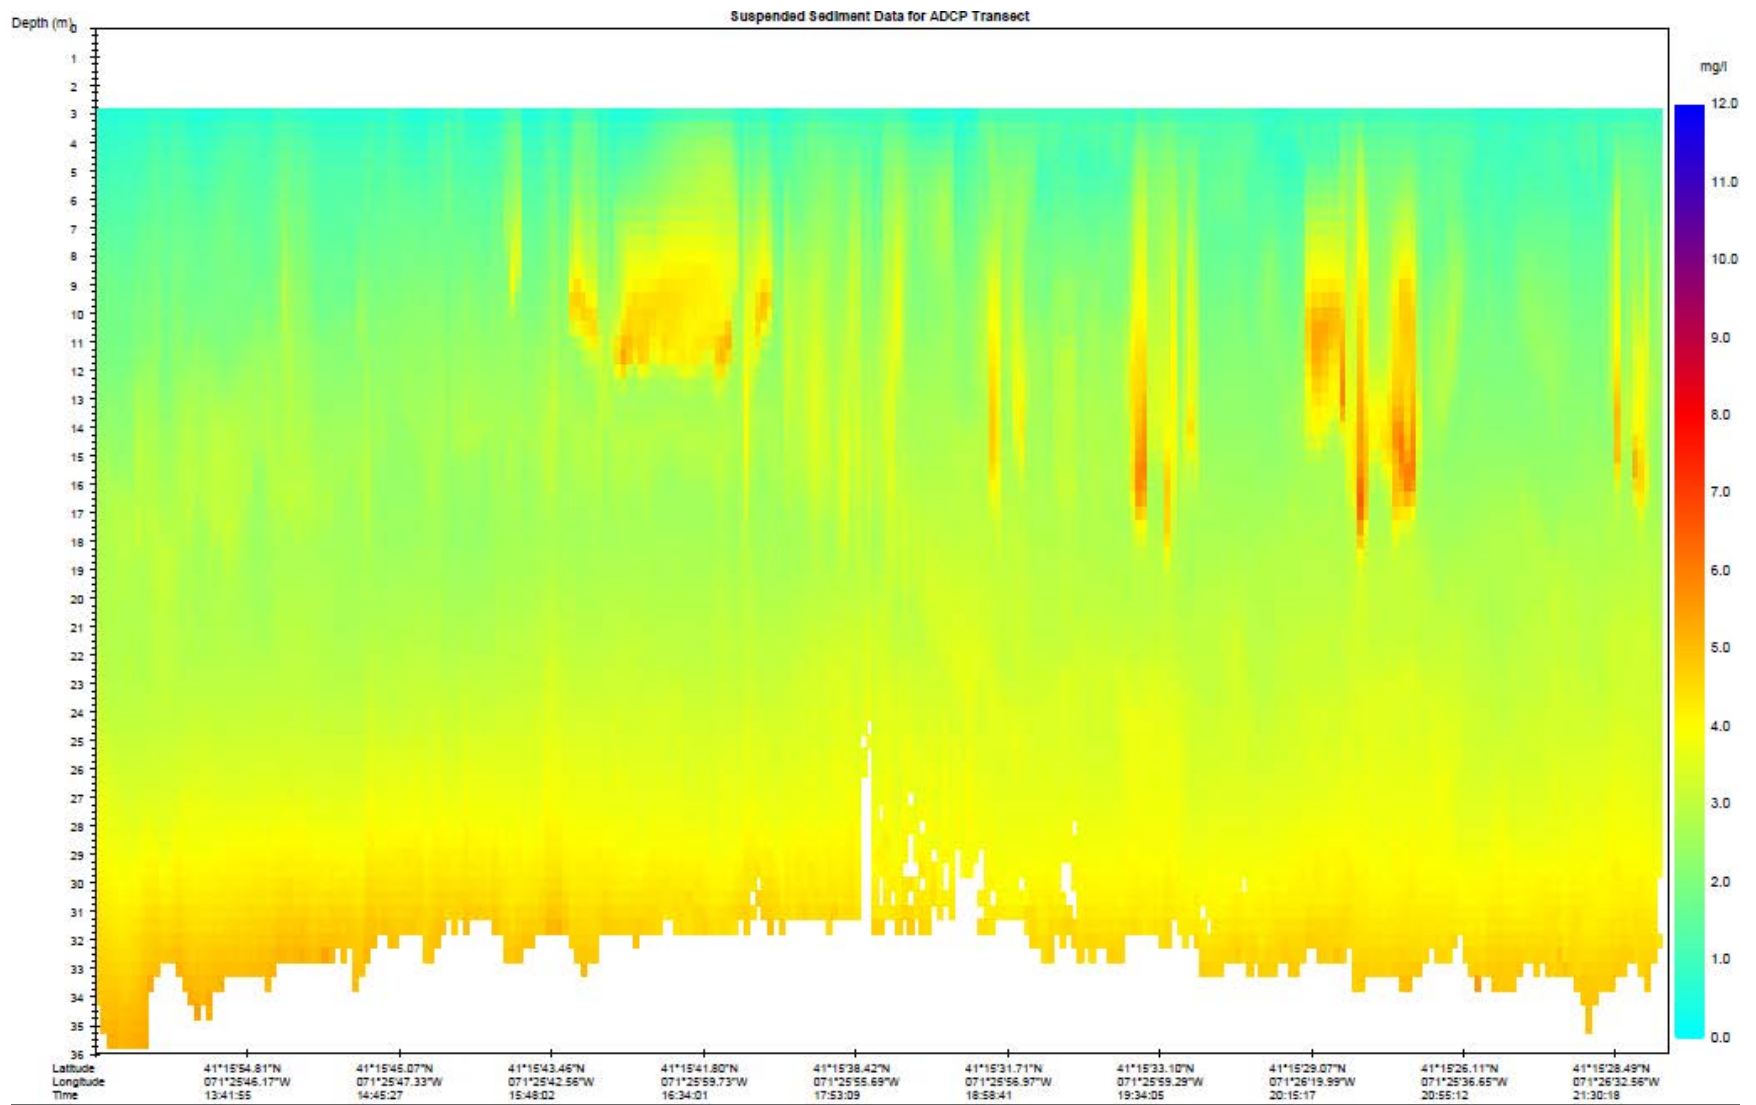
Figure 23. ADCP data showing increased turbidity as a result of instrumentation passing vessel thrusters

Elevated levels of acoustic signal return were observed in both the ADCP and multibeam echosounder (MBES) datasets down to approximately 16 m depth when the instruments passed by the dynamic positioning thrusters from the Big Max. The ADCP data shown in **Figure 23** illustrate this. Increased suspended sediment concentrations were not observed in the Idronaut profiles suggesting that this acoustic return was caused by bubbles rather than sediment. This turbulence on site was photographed and is displayed in **Figure 24**.

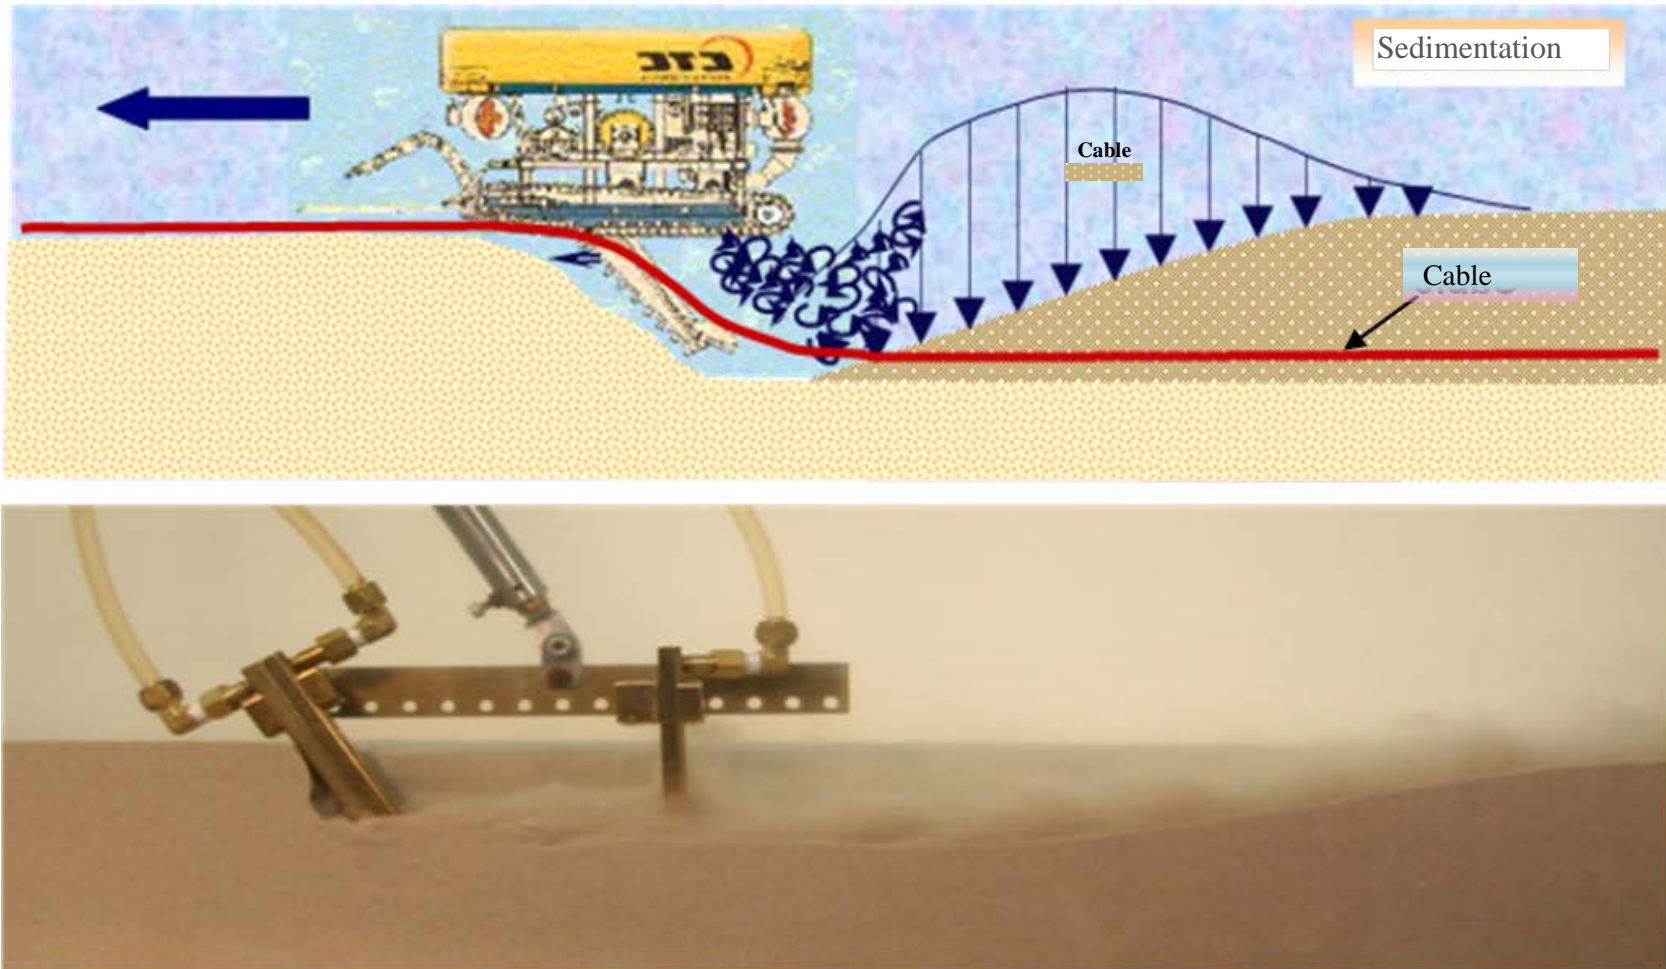
Figure 27. Schematic Illustration of a jet-trencher during operation (Van den Berghe et al., 2008)

2. Lateral Processes. Lateral processes include erosion by the breaching and collapse of the trench side walls. This will occur to a greater extent in looser sediments and those with lower fines contents. Overspill occurs beyond the internal hydraulic jump once the upper boundary of the turbid current exceeds the trench wall. Once the turbid water rises above the trench wall, the plume expands laterally, and some sediment will redeposit outside the trench. The amount of sediment that deposits outside the trench will largely depend on the sediment particle sizes,

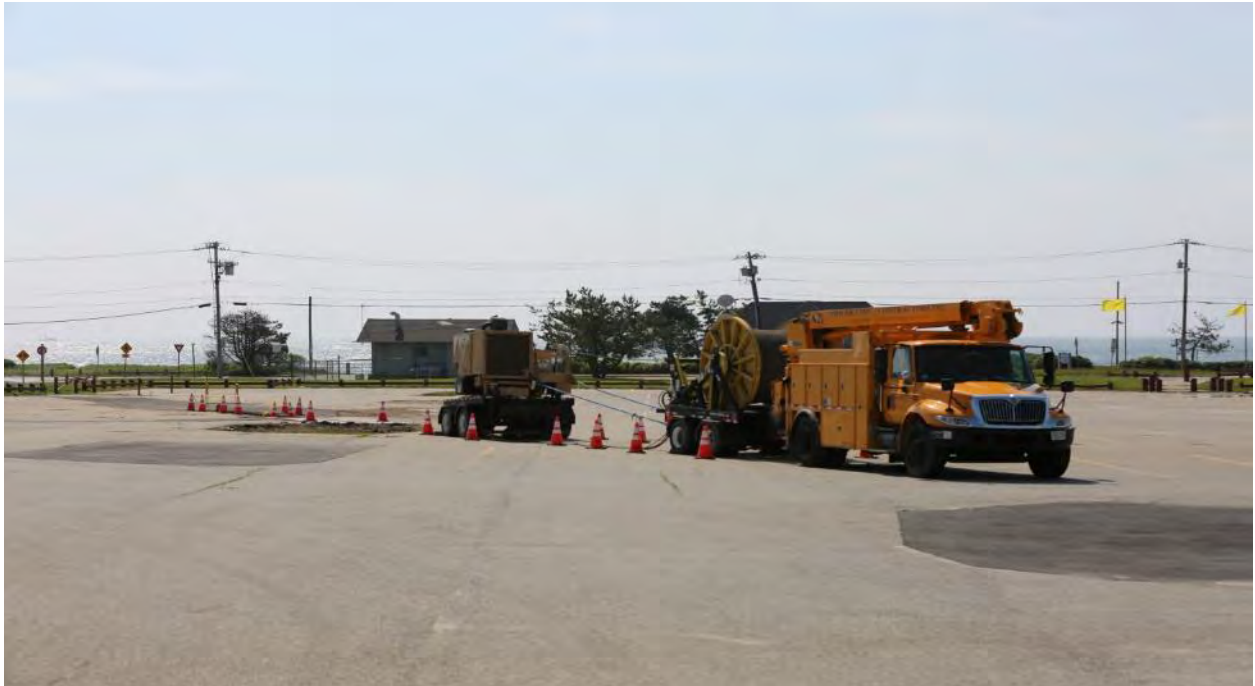
6/6/2016 Scarborough Beach State Park – Photo 0074: Utility truck, winch spool, and winch prepared for BITS cable pull to shore. The land sea transition vault is surrounded by cones.

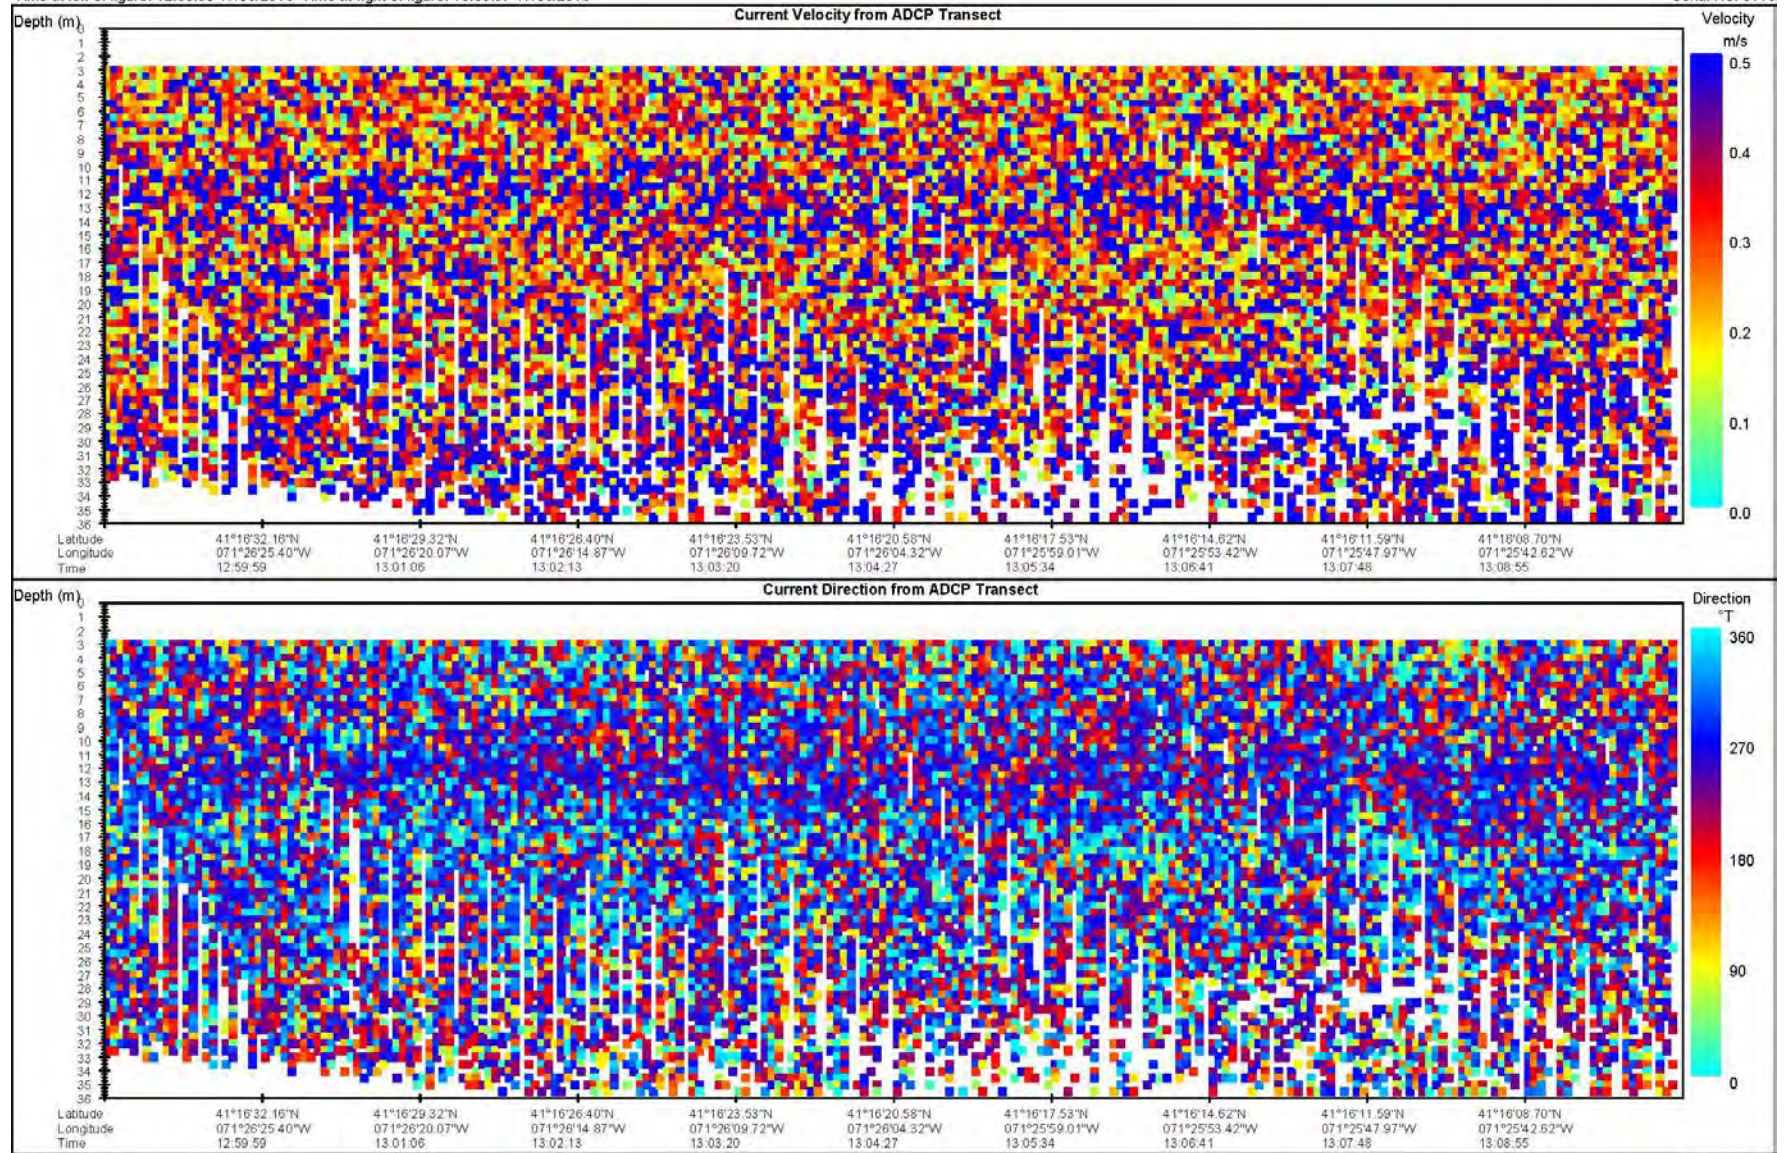
Colour Contour Plots of Current Speed and Direction
Block Island Sediment Plume Monitoring, Jet Plow 1
