Field Observations During Wind Turbine Foundation Installation at the Block Island Wind Farm, Rhode Island

May 2018

HDR. 2018. Field Observations during Wind Turbine Foundation Installation at the Block Island Wind Farm, Rhode Island. Final Report to the U.S. Department of the Interior, Bureau of Ocean Energy Management, Office of Renewable Energy Programs. OCS Study BOEM 2018-029. 175 pp.

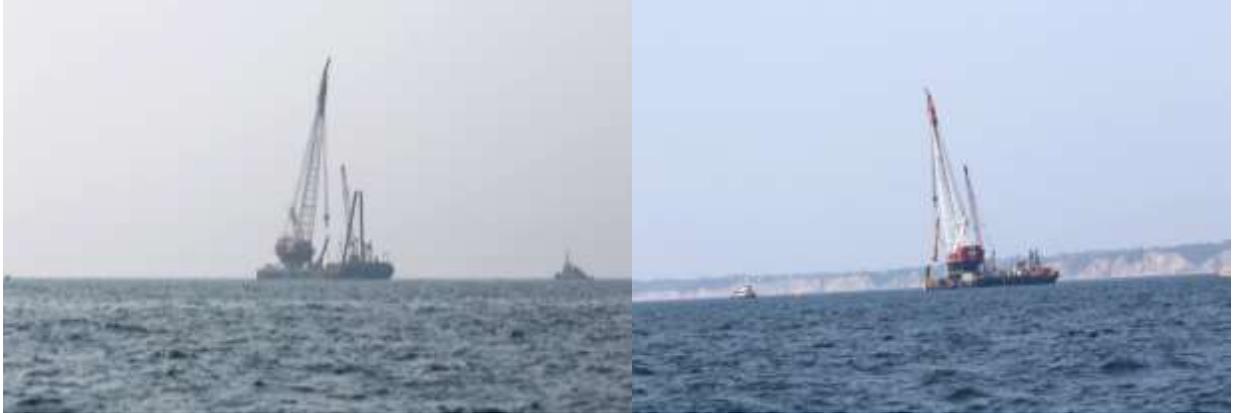
Figure 9. Comparison of offshore areas under foggy versus clear conditions (approximately 457.2 m [500 yards, 1,500 ft]).

Weather and sea state also impacted onshore visual observations. **Figure 9** shows the WTGs under foggy and clear conditions from a distance of 500 m (1,640.4 ft). These images were taken in parallel with the images shown in **Figure 8**.

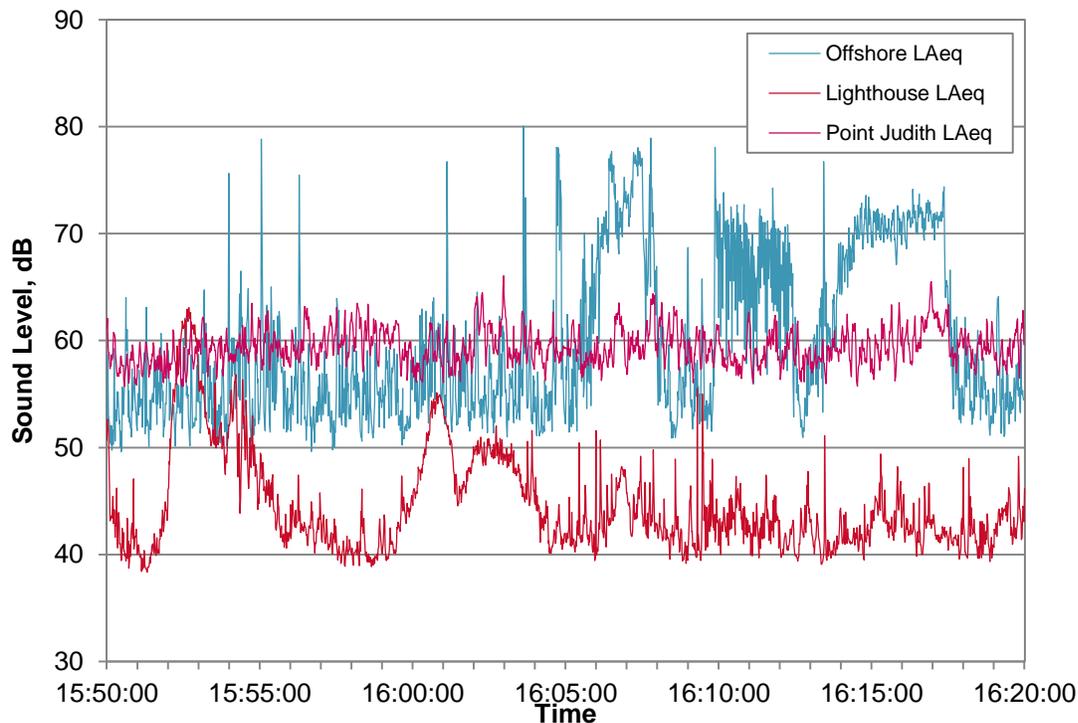
Figure 20. Offshore Southeast Lighthouse and Point Judith $L_{Aeq,1s}$ noise levels versus time recorded during pile driving of WTG 2 on 18 August 2015.

The offshore time history shows a progressive reduction over time, and therefore distance, outside the periods of transit and high engine noise. There is also a clear reduction in the noise level received at the fixed lighthouse location at approximately 11:25, which cannot be explained but may be due to a variation in wind conditions as there was no obvious change in piling in the logs.

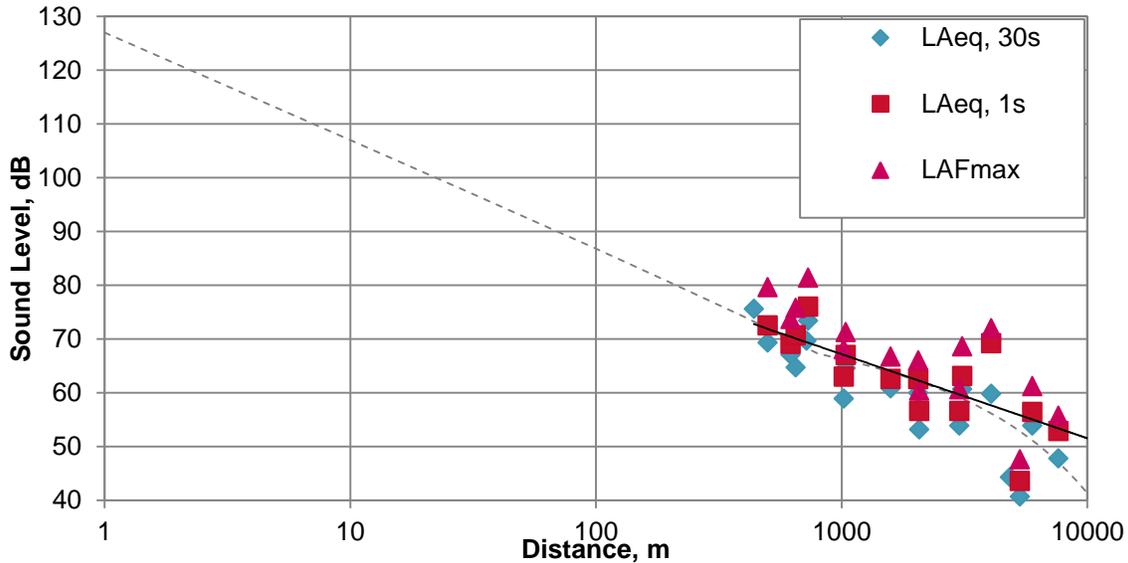
Figure 23. Level vs range plot for winds at 90° to the direction of travel. Far-field coefficients [R>800 m (2,624.7 ft)]: $N = 6$, $\alpha = 0.0021$.

up to $N = 12$ show a progressive steepening of the curve which remains visually within the trend, especially if the sample at 4.1 km (2.6 mi) is considered a spurious outlier.

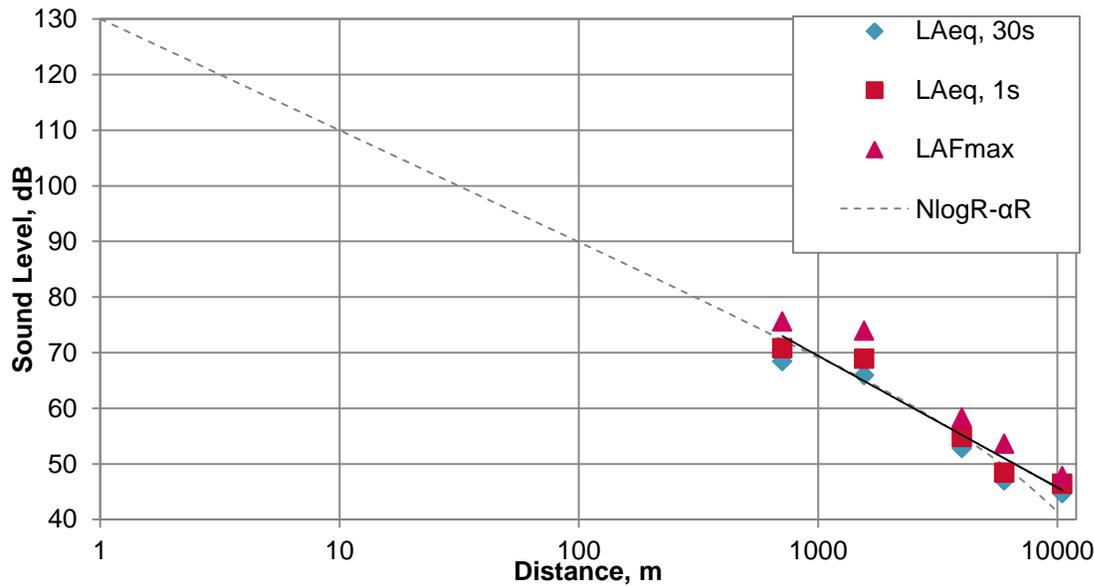
Figure 26. Level vs. range plot for calm winds and seas. Far-field coefficients [$R > 800\text{m}$]: $N = 19$, $\alpha = 0.00063$.

with any wind present) have much slower attenuations with $N = 12$ or less. This may be due to flat seas scattering noise less and reflecting more to the atmosphere, or effects on the layering of the atmosphere.

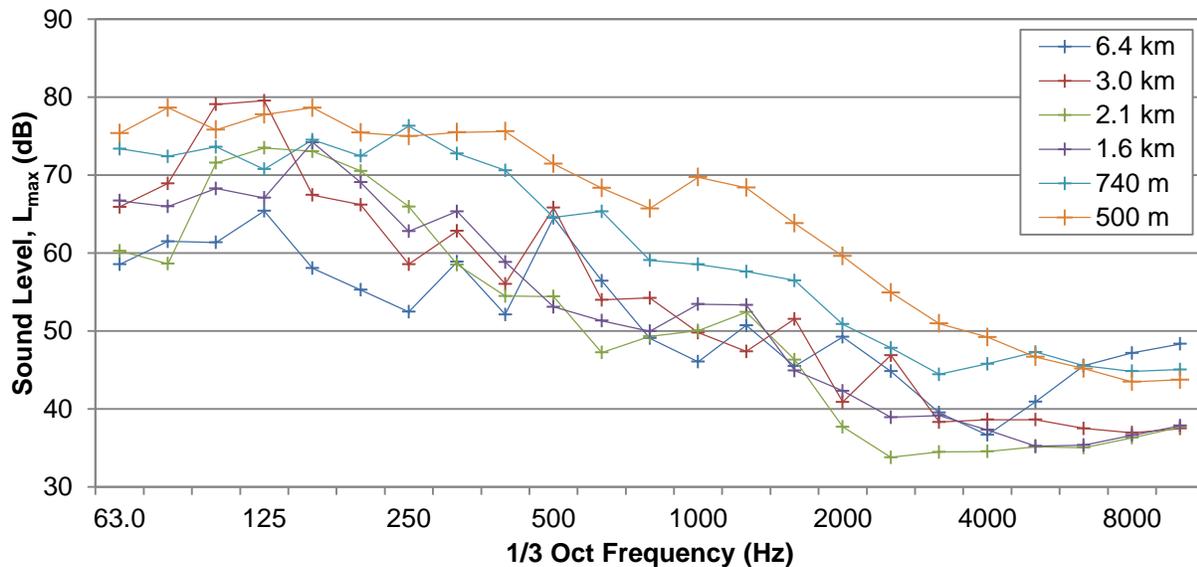
Figure 27. One-third octave band L_{max} spectra taken under downwind conditions on 18 September 2015.

Taken on a southeast transect, with north-westerly winds at 3 m/s (**Figure 27**). Most of the energy received in the strikes is at low frequency and primarily below 400 Hertz (Hz), although the spectra are clearly broadband (non-tonal) in nature.

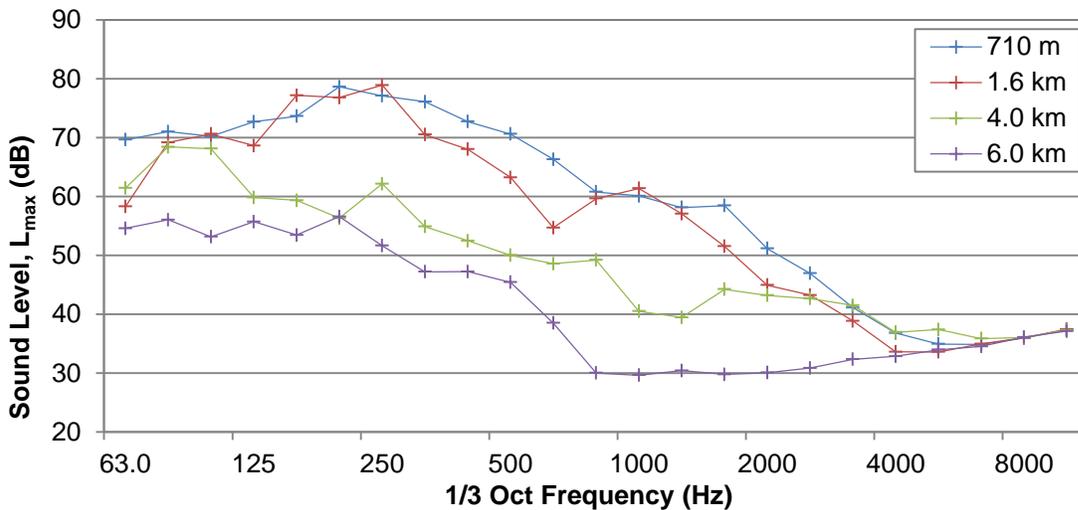
Figure 29. One-third octave band L_{max} spectra taken under upwind conditions on 19 September 2015.

Taken on a northerly transect. Although there are fewer positions on **Figure 29**, this demonstrates clear reductions in all frequencies below 6,300 Hz band, suggesting that little energy is produced by piling above this frequency, or it attenuates so quickly that little arrives at 710 m (2,329.4 ft). However, data presented in **Figure 29** indicate that higher frequencies are present closer to the pile.

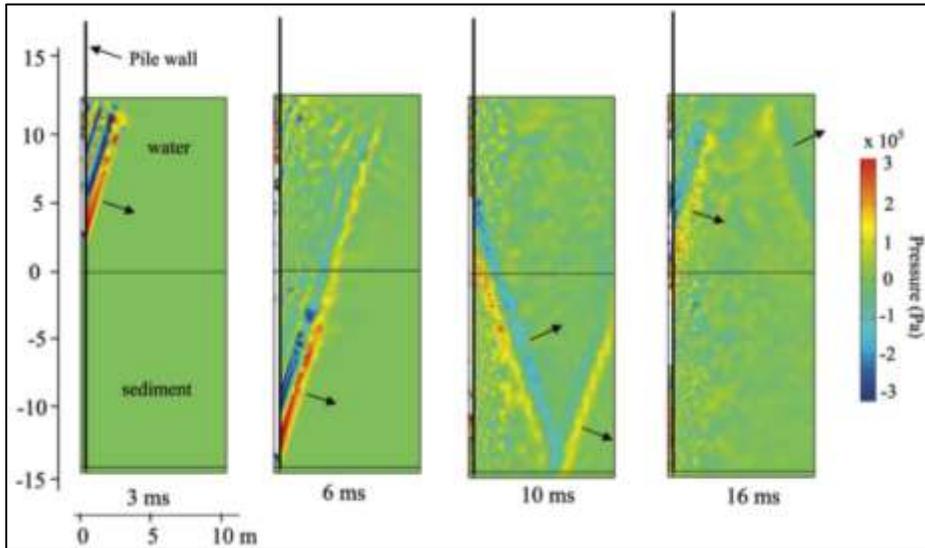
Figure 49. Reinhall and Dahl (2011) modeled the creation of an acoustic wave in the water from a vertical pile. The speed of the wave in the pile is approximately 5,015 m/s and much greater than the water sound speed of approximately 1,500 m/s. This creates a Mach wave which propagates at an angle of approximately 17° from the vertical.
