Louisiana Shelf Dredge Pit Geophysical Studies

Sandy Point Dredge Pit (east, paleo river channel)

Raccoon Island Dredge Pit (middle, paleo river channel)

Peveto Channel Dredge Pit (west, paleo river channel)

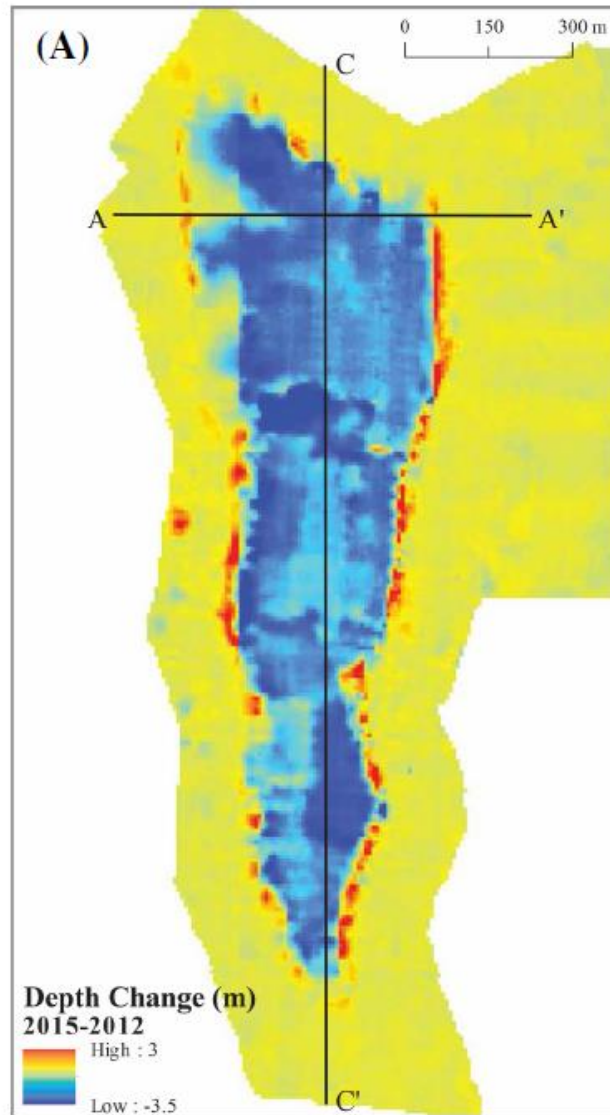
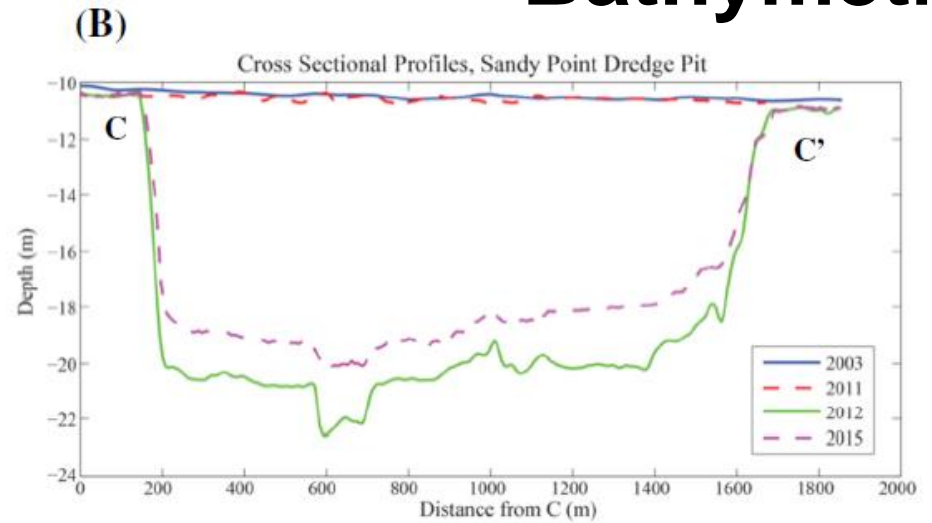
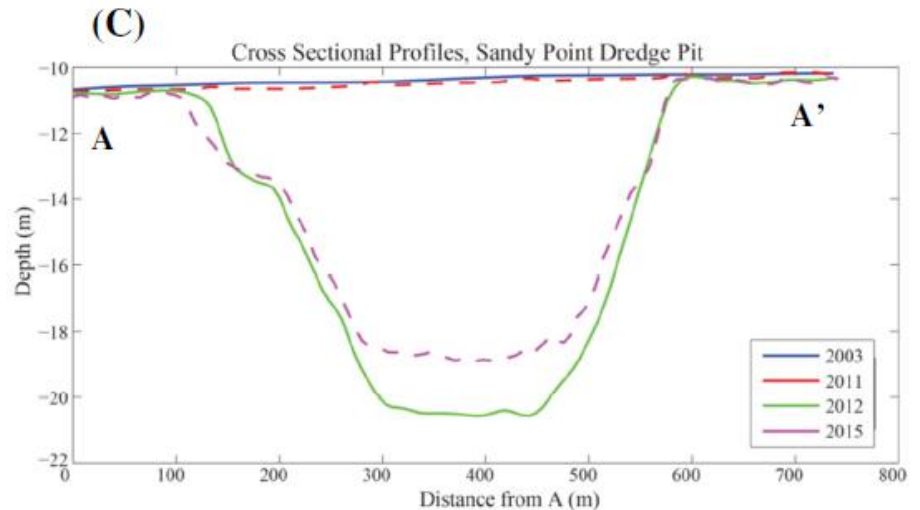
Bathymetry

(A) Differences of depths between 2012 and 2015 bathymetric data sets collected at Sandy Point dredge pit; (B) and (C), topographic profiles along A-A' and C-C' transects collected in 2003, 2011, 2012 and 2015, respectively.

- Pit wall gets more gentle
- Infilling rate around 0.5-1 m/year
- Fast currents at sea surface but slow ones on pit bottom

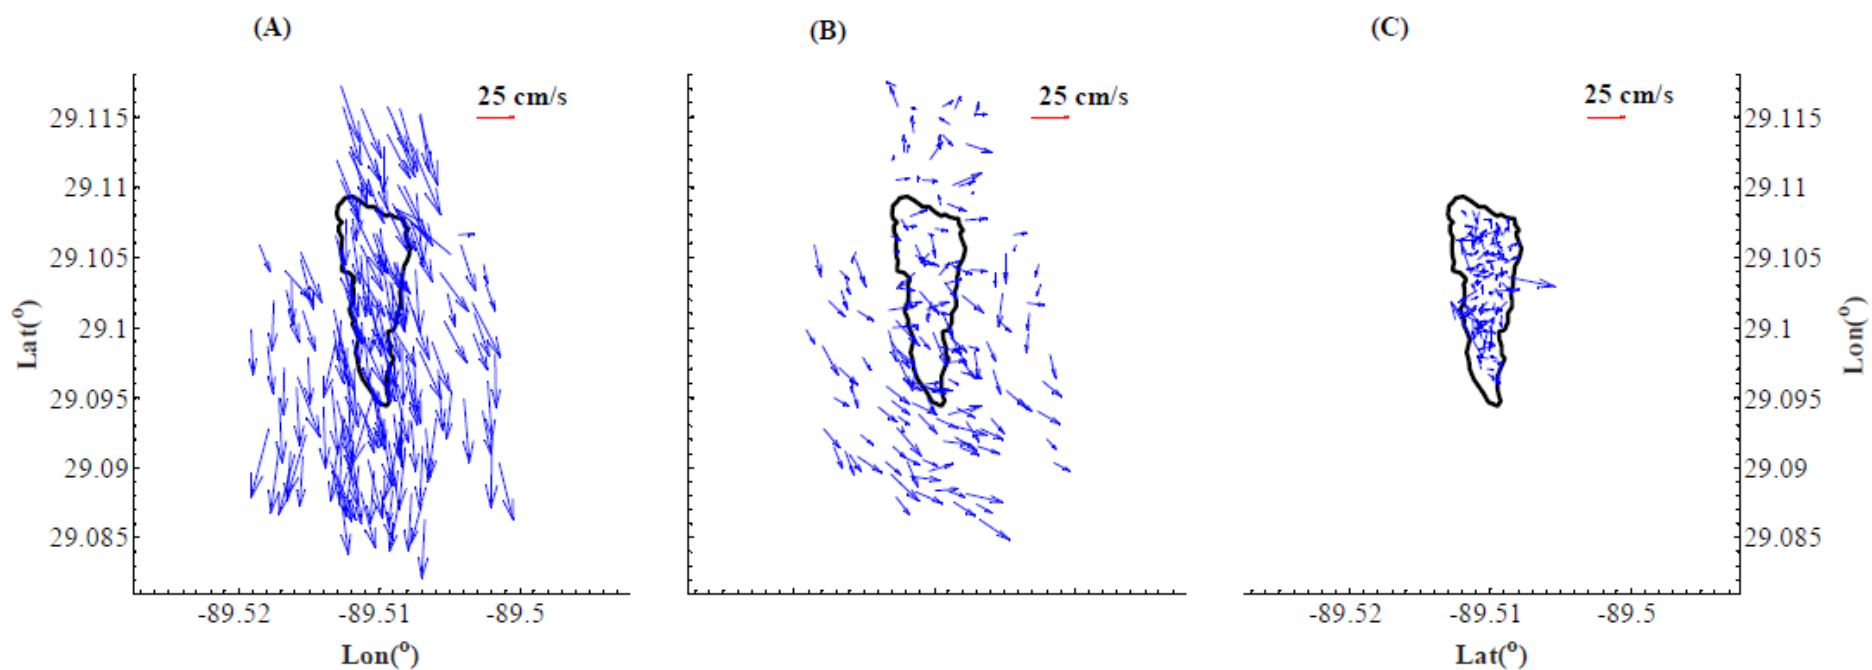
Figure 3. Subsurface current velocity (A) 2.75 m below the surface; (B) 7.75 m subsurface; (C) 16.50 m subsurface at Sandy Point Dredge Pit, and the black line is the edge of the pit in 2015.

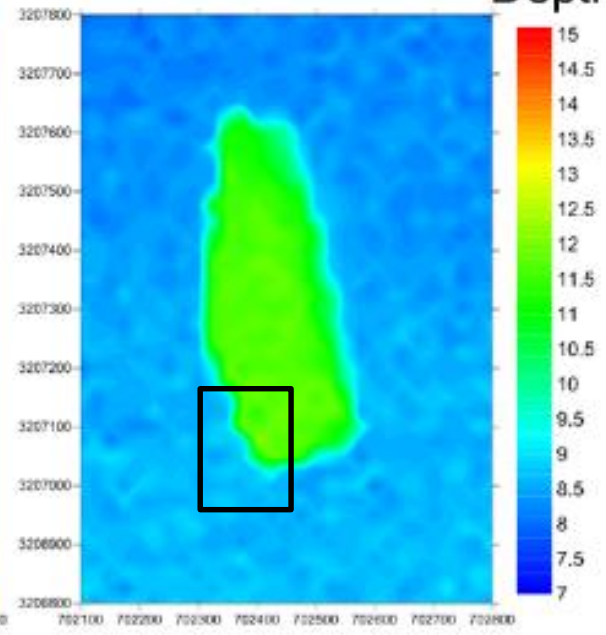
Bathymetry

Mar 2013

Jun 2015

Mar 2013 – Jun 2015

Deposition

Difference (m)

Erosion

- Rough and sharp pit walls
- Surprising fast infilling from 2015-2018
- Flat surface with biogenic gas escaping

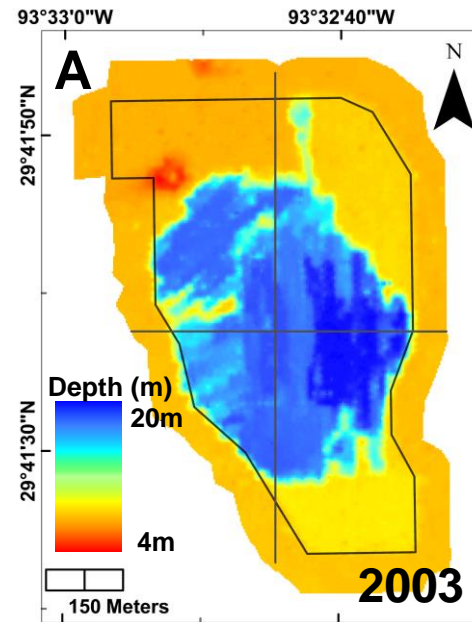
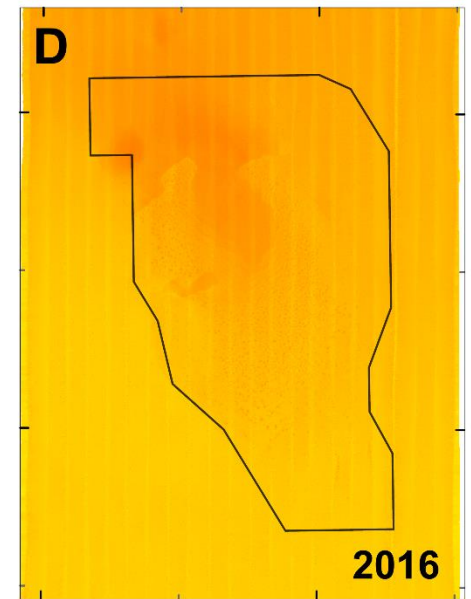
Bathymetry

- Complete infilling in 13 years
- Pit floor evens out over time
- Positive relief in 2016
- Rough pockmarked surface

Warm colors=Shallow
Cool colors=Deep
