IMPACTS OF RECENT HURRICANE ACTIVITY ON HISTORICAL SHIPWRECKS IN THE GULF OF MEXICO OUTER CONTINENTAL SHELF

Contract No. M07PC13010

Impacts of Recent Hurricane Activity on Shipwrecks in the Gulf of Mexico

DAMAGE ASSESSMENT & RECOMMENDATIONS

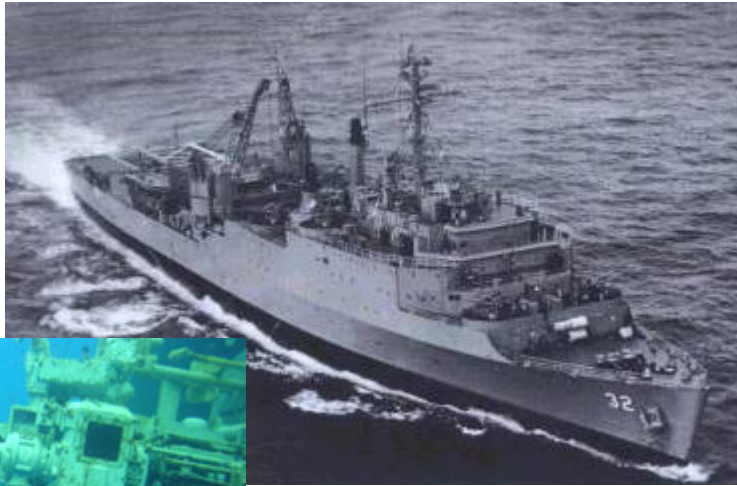
Before Dennis

On 9 July 2005 Hurricane Dennis turned the 510-foot *Spiegel Grove* upright from its position on its starboard side in 130 feet of water.

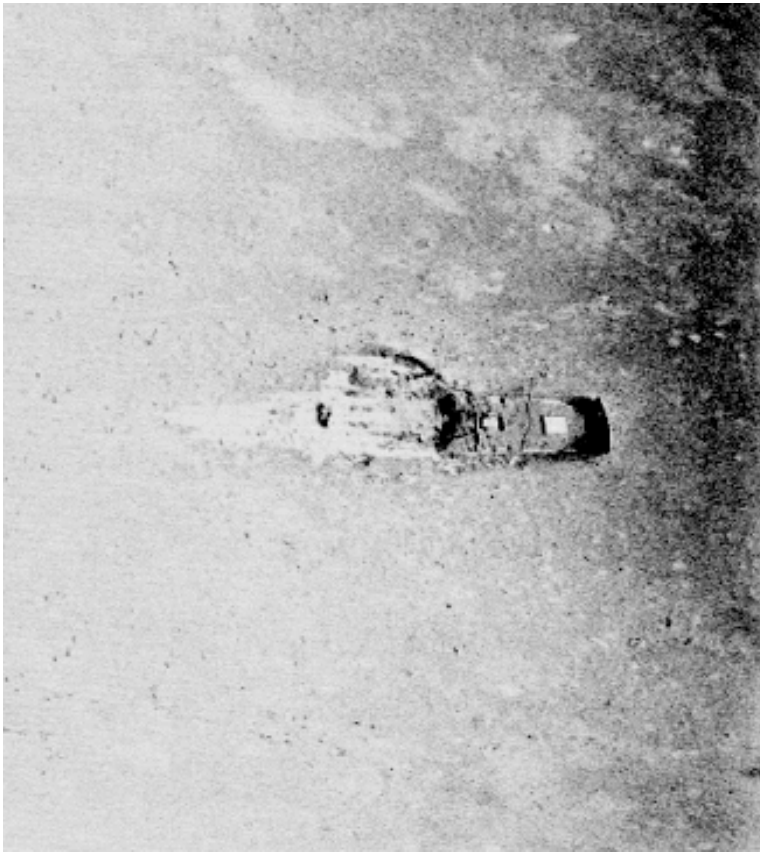
Site 343

NAME	HURRICANE PROXIMITY	DAMAGE	RECOMMENDATIONS
<i>New York</i>	29.9 nm west of Rita	Increased exposure; reports of salvage activity	Diving to document extent of salvage and storm damage
<i>Gulf Tide</i>	7.3 nm west of Rita	Possibly increased exposure but earlier sonar imagery of poor quality	Diving to document extent of storm damage
<i>Site 323</i>	24.8 nm east of Rita	Broken near stern	Diving to document extent of storm damage
<i>Castine</i>	26.4 nm west of Katrina	No apparent change	Diving is recommended because this is the closest wreck to Katrina
<i>*R.M. Parker Jr.</i>	60.5 nm west of Katrina	No apparent change	No further investigation
<i>*Sheherazade</i>	71.8 nm east of Rita	No apparent change	No further investigation
<i>*Site 15306</i>	32.6 nm east of Rita	No apparent change	No further investigation
<i>**Site 389</i>	55.0 nm west of Katrina	No apparent change	No further investigation
<i>**Site 343</i>	20.3 nm west of Rita	Change undeterminable	No further investigation

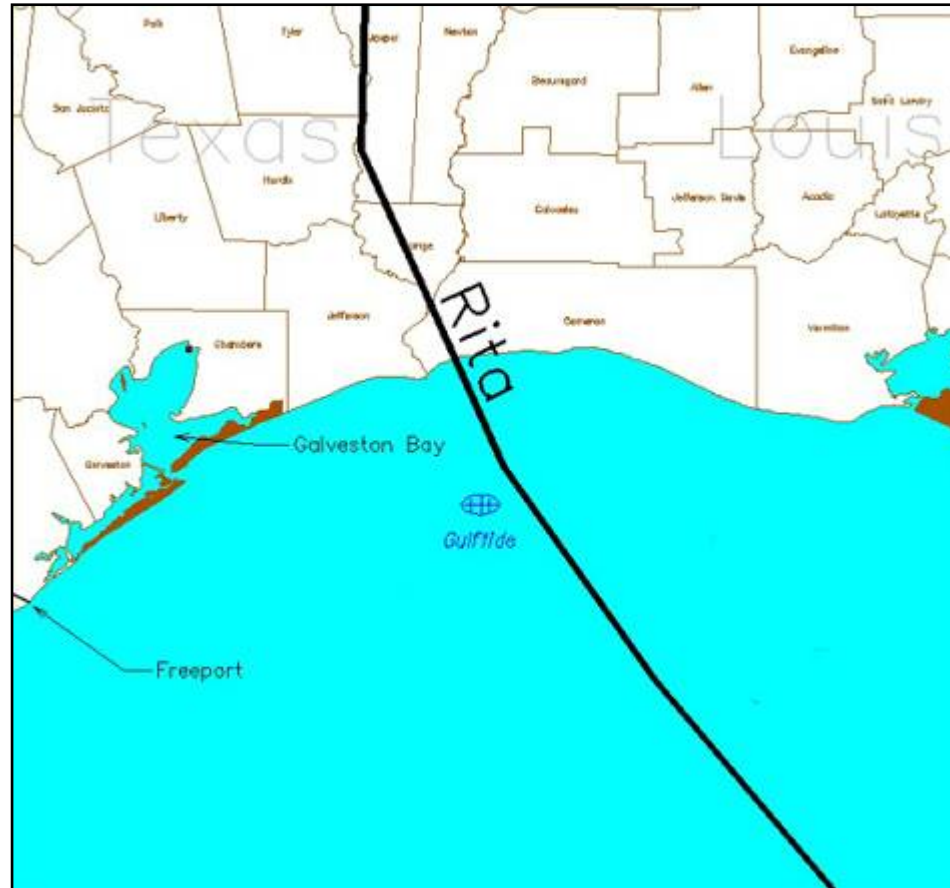
Gulf Tide

Hindcast Data

7.3 nautical miles west of eye
79 mph – peak sustained wind
23 ft – maximum significant wave height

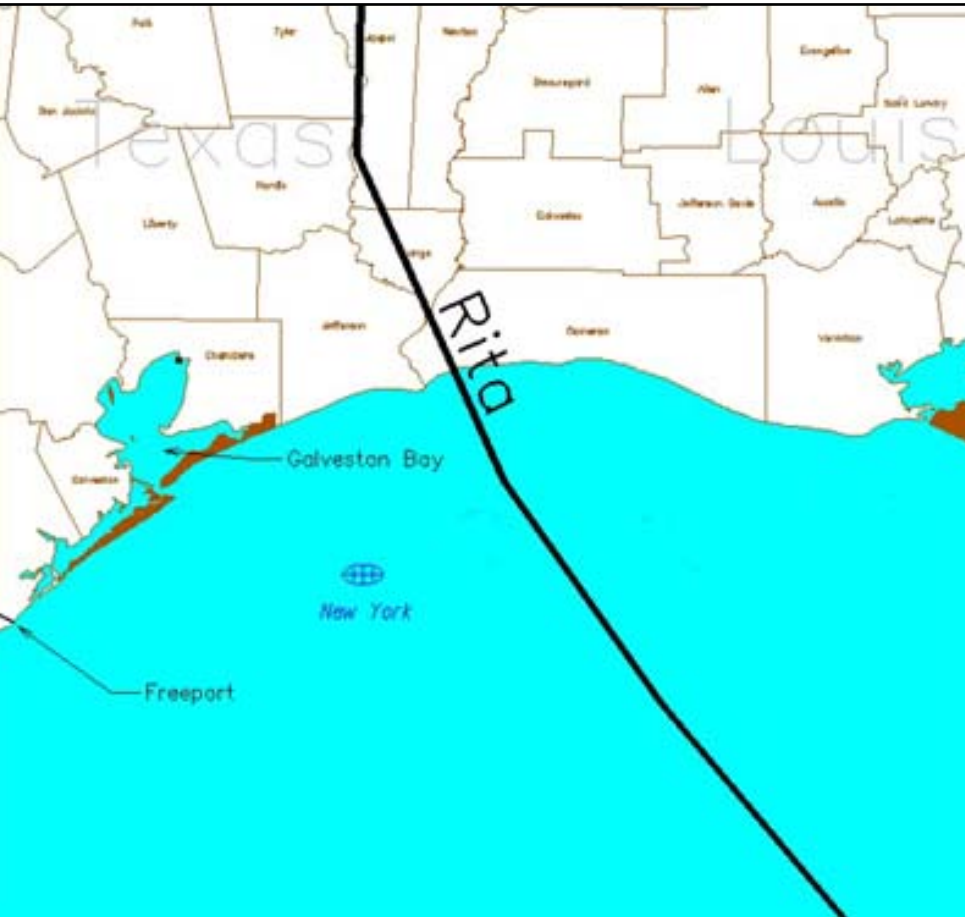
SS New York

Hindcast Data

26 nautical miles west of path

74 mph – peak sustained wind

32 ft – maximum sustained wave height
