Sunrise Wind Farm Project

Appendix L Onshore Ecological Assessment and Field Survey Report

**Sunrise Wind: Onshore Ecological
Assessment and Field Survey Report**

Stantec Consulting Services Inc.

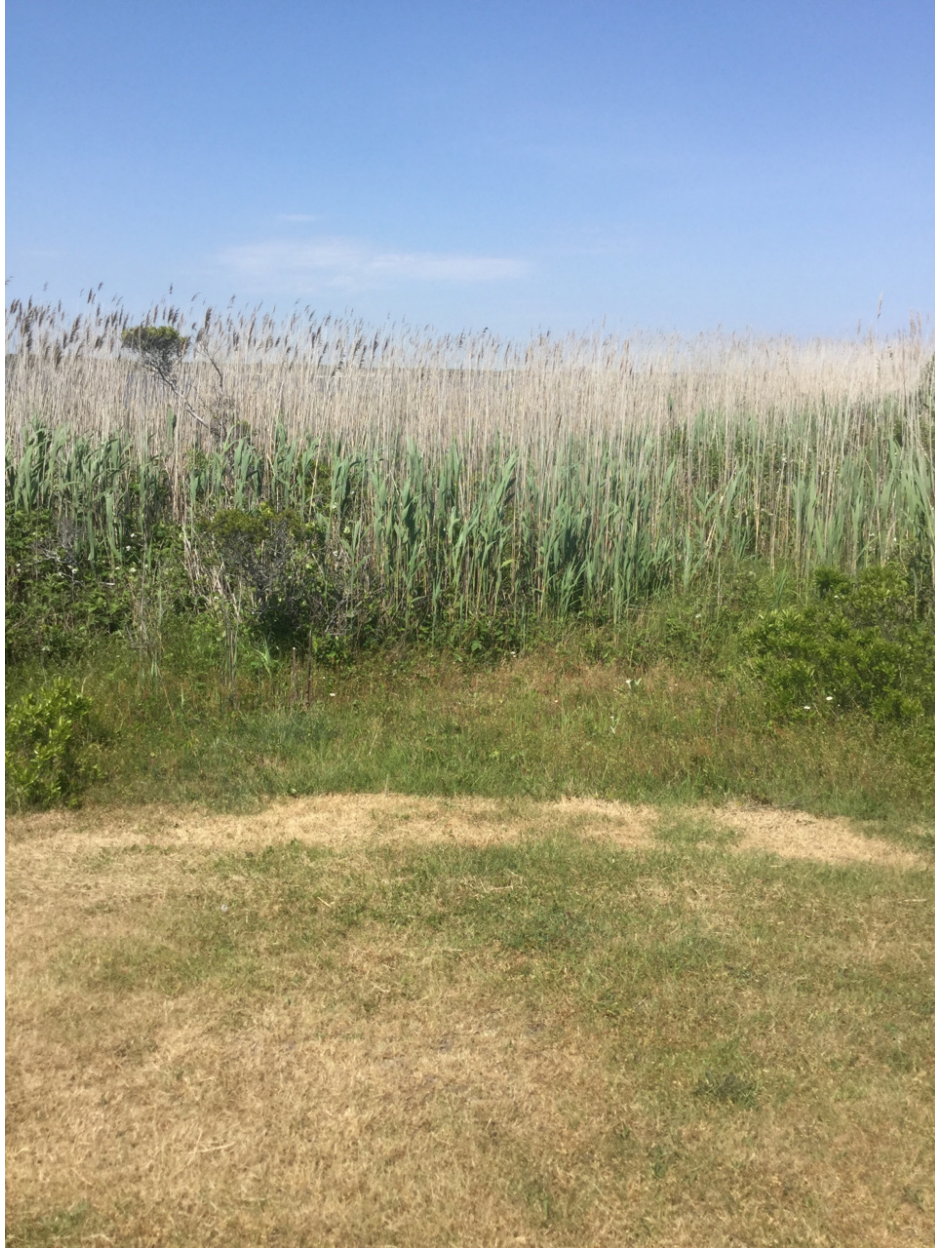
Photograph 1. Wetland 01ASA – Wetland View looking east. Stantec. June 2020.

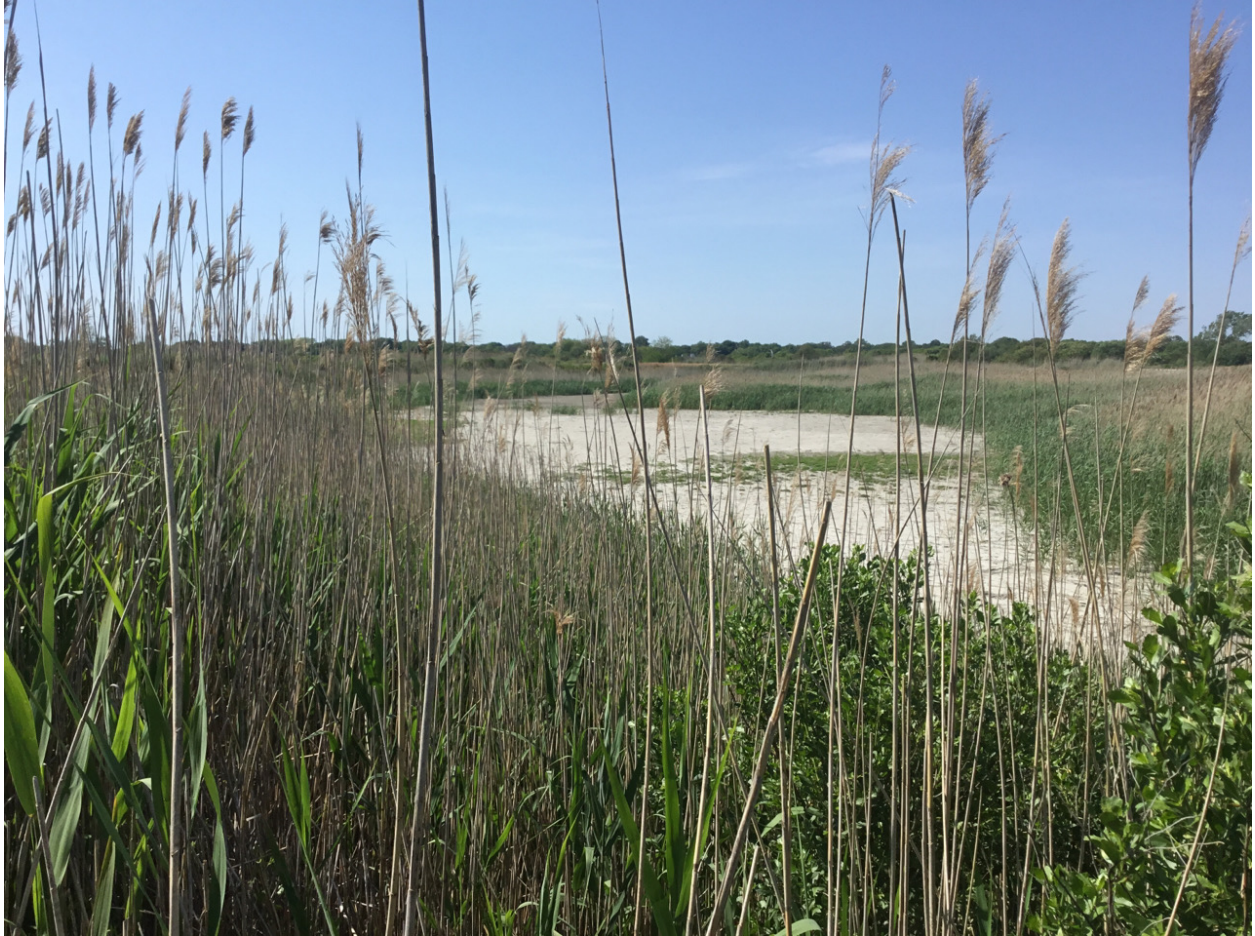
Photograph 9. Wetland 01CFB – Upland and Wetland View looking west. Stantec. June 2020.

- **Wetland W-01CFB** is a palustrine (freshwater), man-made basin dominated by common reed (PEM). The wetland is located on the southeastern shore of Great South Bay at the Smith Point Marina on the mainland, along the edge of the survey area. This feature occurs within the Town of Brookhaven Coastal Zone Area South CEA unit. The wetland contains sandy soils with redoximorphic features. At the time of the delineation, evidence of wetland hydrology included soil saturation within 12 in of the surface, geomorphic position, and soil cracks. A portion of the wetland located outside the survey limits contained standing water and waterfowl were observed.

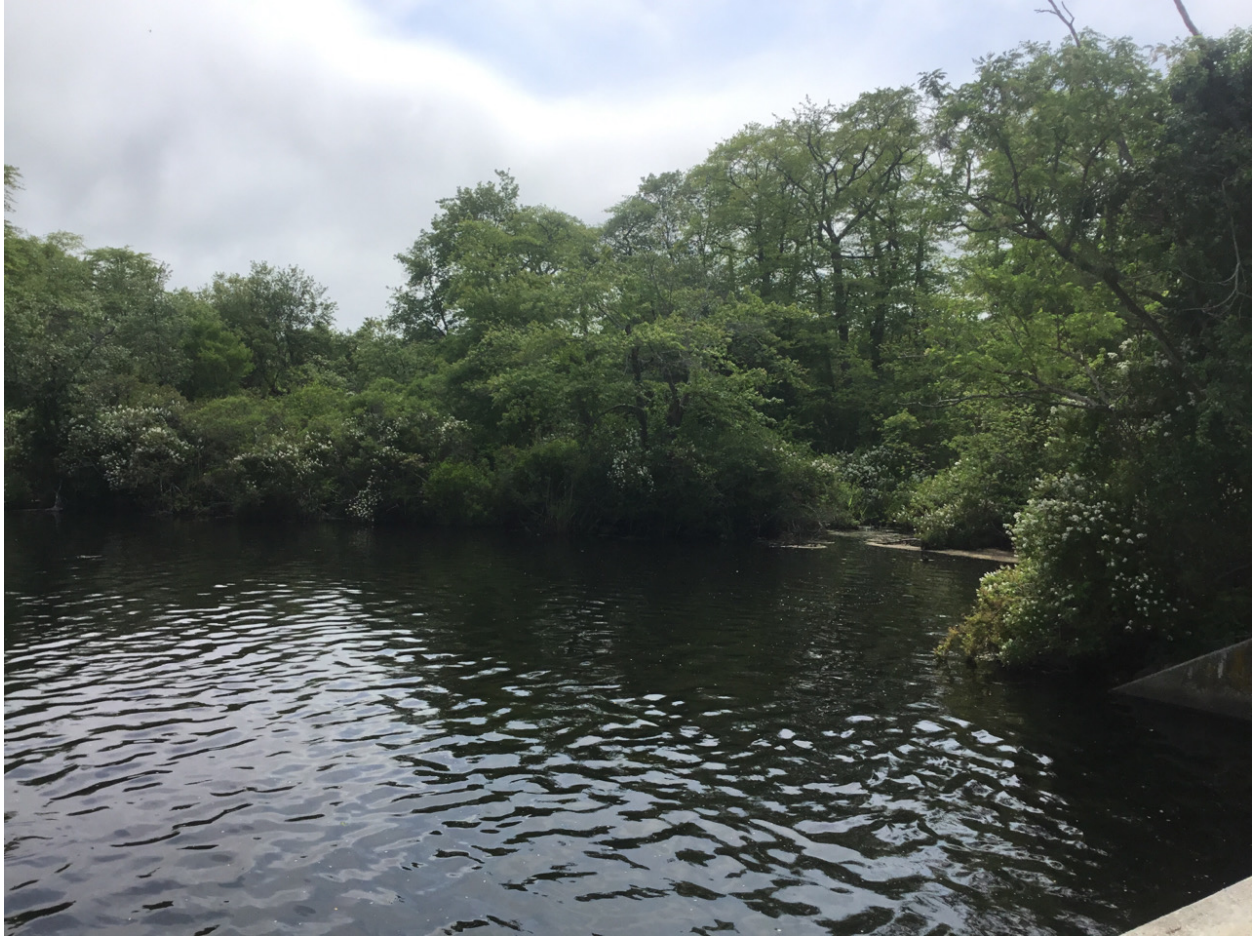
Photograph 10. Wetland 01CFC/01JRB – Wetland View looking west across Carmans River from public right-of-way. Stantec. June 2020.
