Appendix E – Biological Survey Results

Aerial Seal Haul-out Surveys Ocean Wind Offshore Windfarm

Ocean Wind Offshore Windfarm

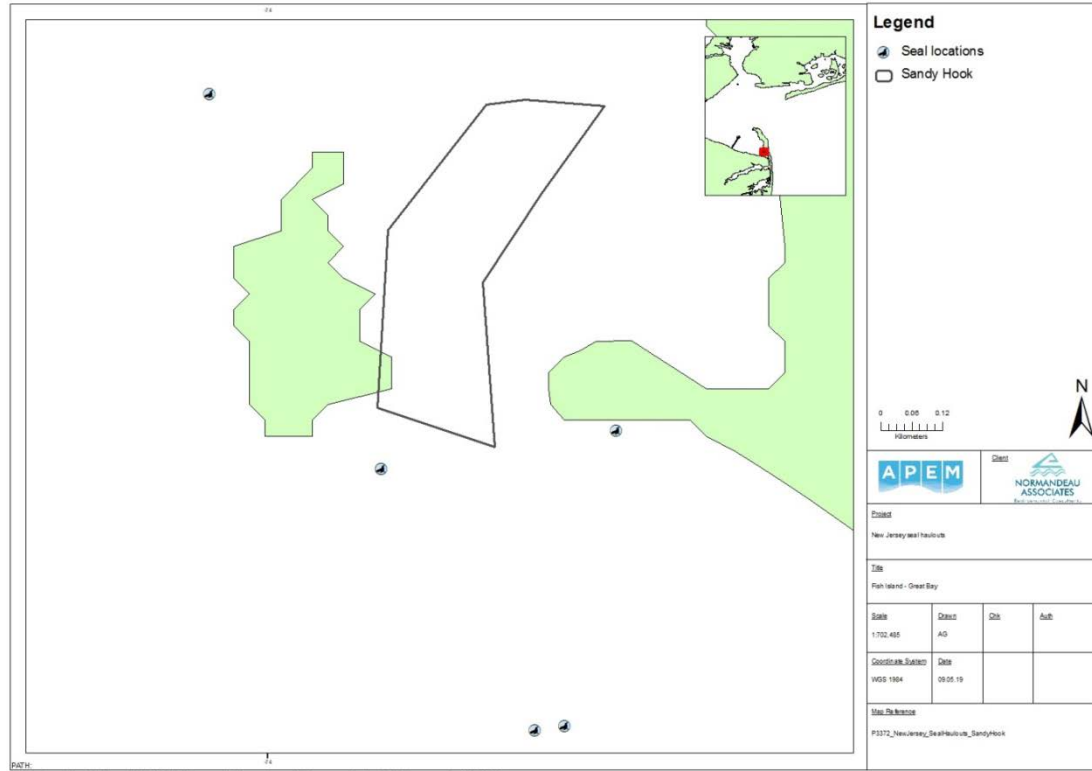
Figure 8. Sandy Hook seal locations.

The distributions of detected seals are shown in Figure 7 to Figure 9. Each point shows an individual seal location in each of the survey areas. Of the three main seal colony locations, Barnegat Light also included the area around the potential cable landfall route (Figure 7, Figure 8, Figure 9). In total 45 seals were detected within the images: six in the Sandy Hook area, five in the Barnegat Light area, and 34 in the Fish Island–Great Bay area (Table 7). The majority of the seals detected were in the water, with very few hauled out, making some identifications difficult. Only 7 of the 45 seals were identified to species, of which all were identified as probable harbor seals (Table 8).

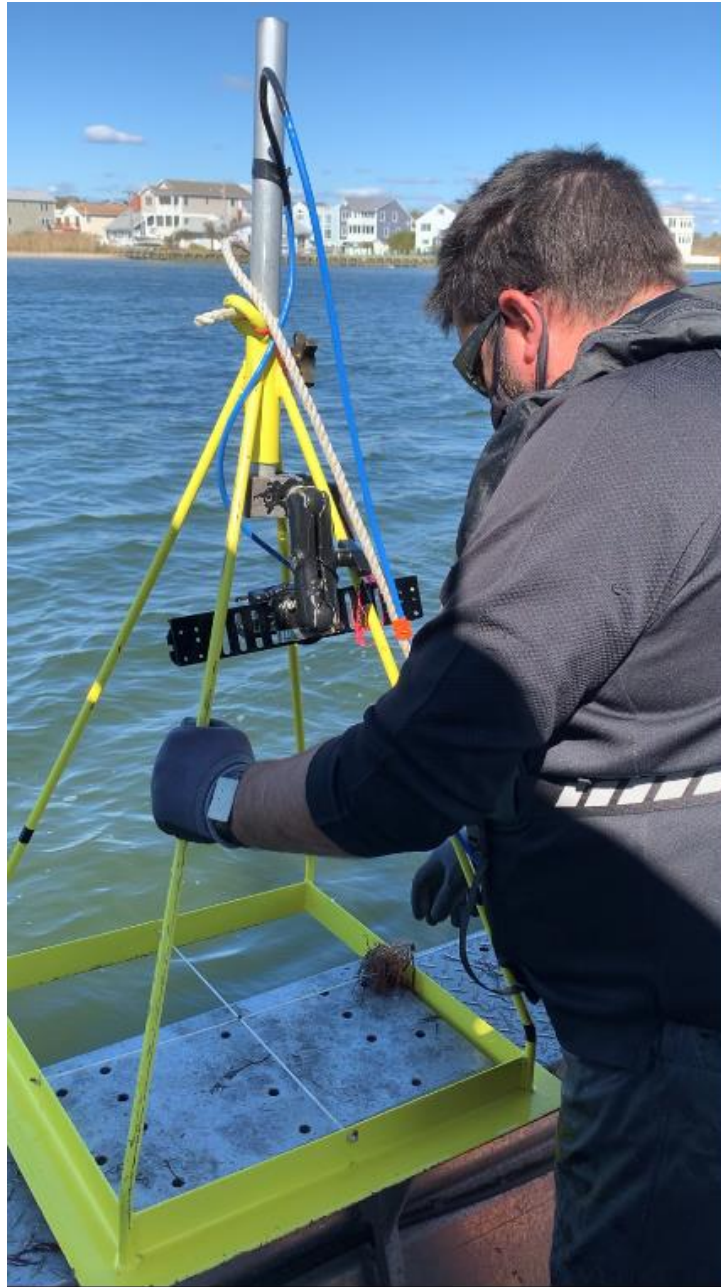
Figure 3. Quadrat Frame with Mounted GoProHero3 for SAV Sampling.

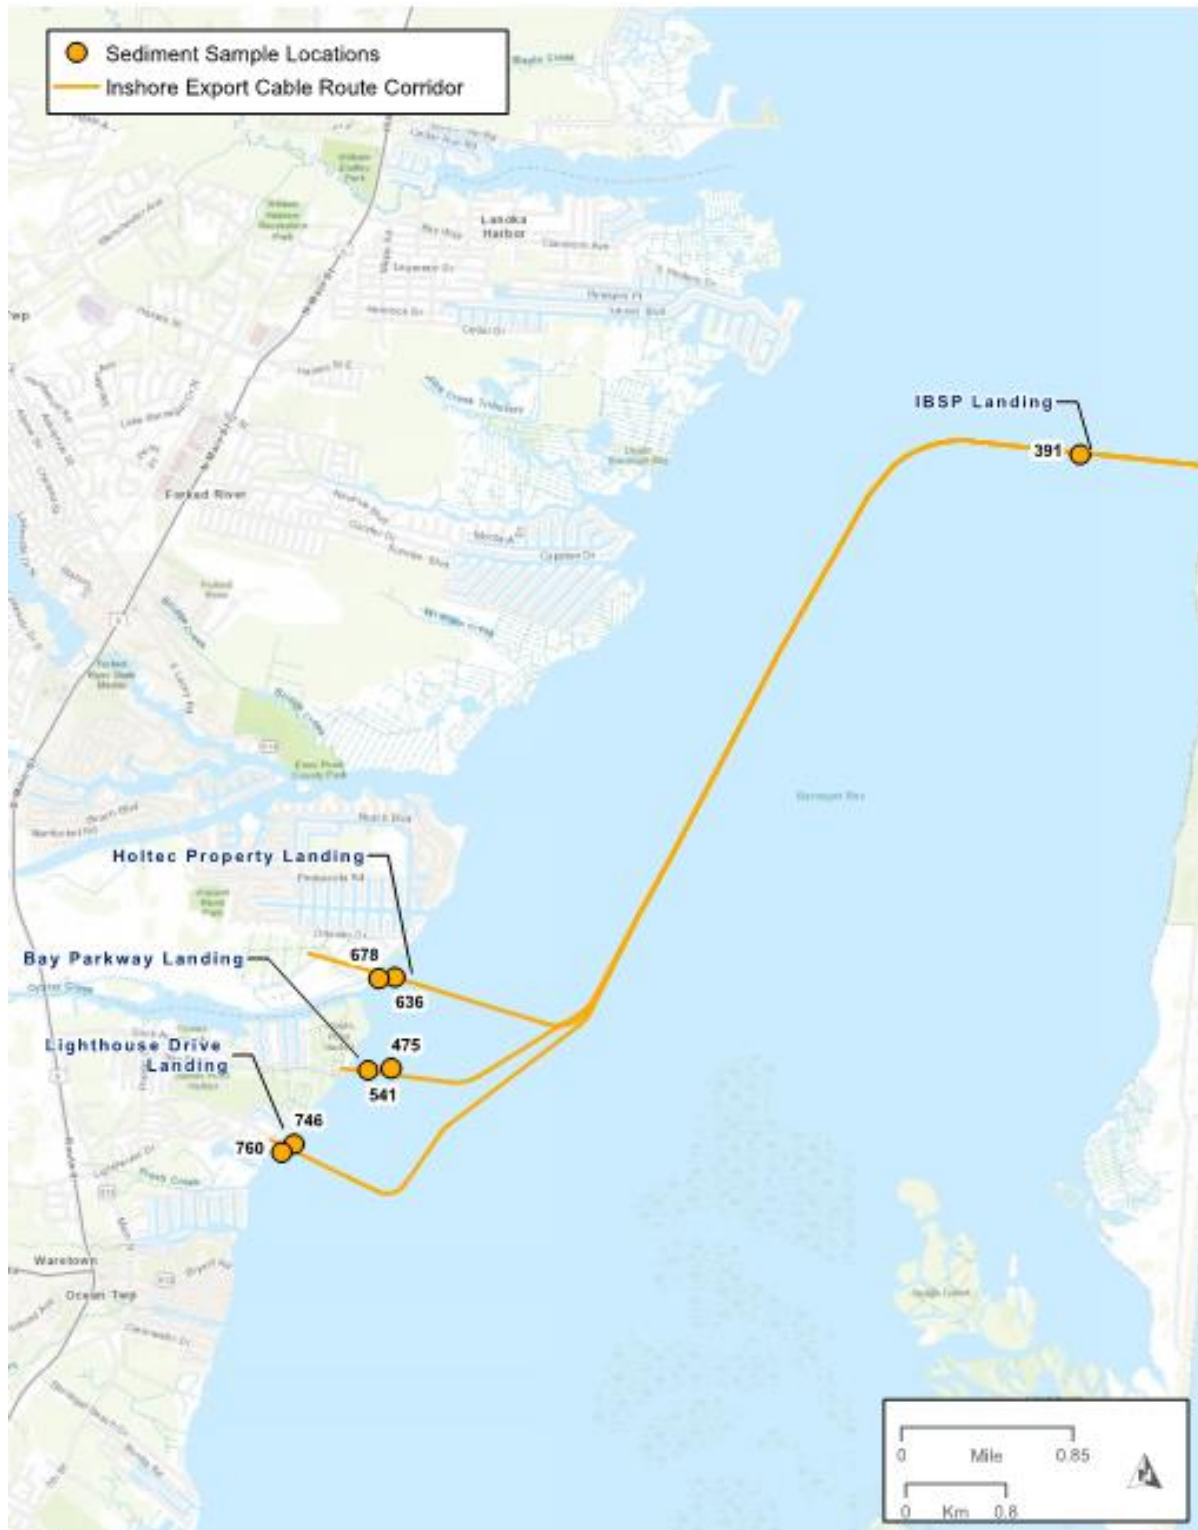
Figure 4. Sediment Sampling Locations.

Per the NJDEP (2015) SAV Survey Guidance document and the Project survey protocol, sediment samples were collected for grain size analysis. The sediment samples were collected on October 8, 2020, using a petite ponar grab from locations representative of the observed sediment types within each of the four potential landfall areas during the SAV survey (**Figure 4**). The sediment samples were photographed, then homogenized, placed in glass jars, and sent to an analytical laboratory for grain size analysis consistent with the American Society for Testing and Materials (ASTM) methods D6913 and D7928. The results were reported according to the Wentworth (1922) grain size scale.

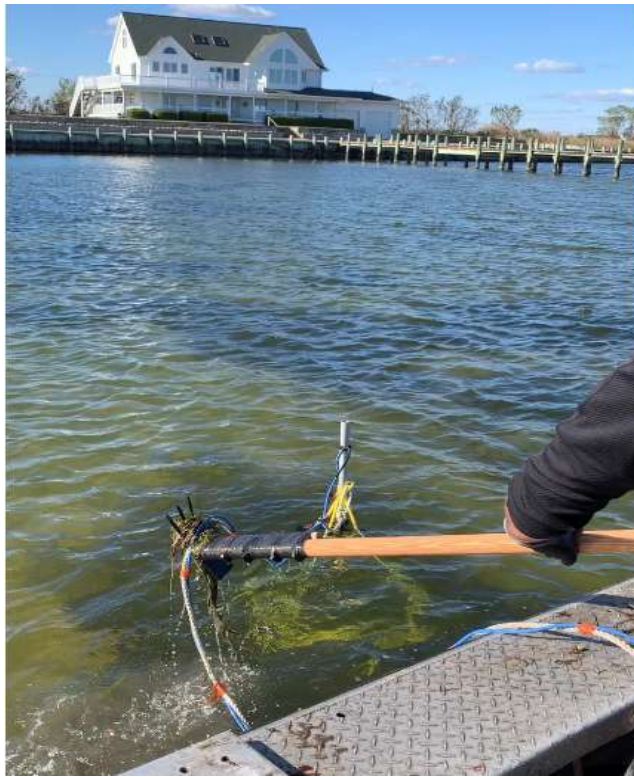
Photo 15: Photo showing Bay Parkway Landing shoreline, SAV rake, and camera frame in the water.
