**Investigation of Blowout, Injuries, & Fatality,
Brazos Block 417
OCS-G 22190, Well 1
July 13, 2001**

Gulf of Mexico
Off the Texas Coast

U.S. Department of the Interior
Minerals Management Service
Gulf of Mexico OCS Regional Office

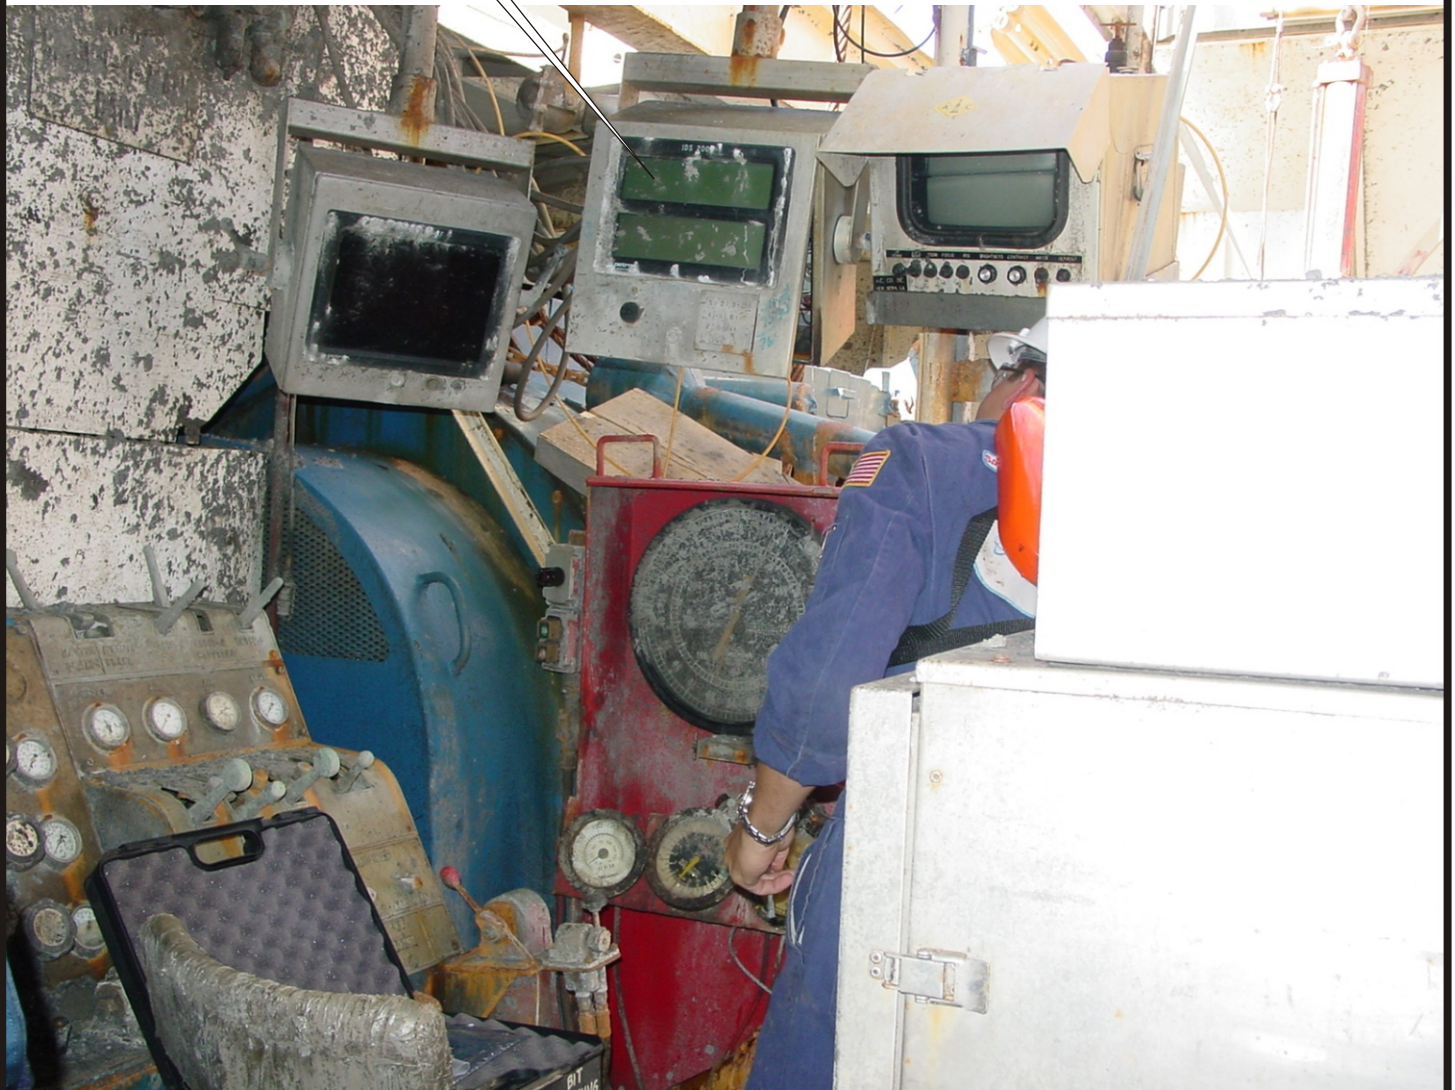
Photo of Drillers Console

Failure to illuminate the trough prevented the driller from noticing the well was still flowing.
