Oil Spill During Hurricane Lili, Ship Shoal Block 119: Responses, Fate, and Effects

**U.S. Department of the Interior
Minerals Management Service
Gulf of Mexico OCS Region**

**New Orleans
July 2003**

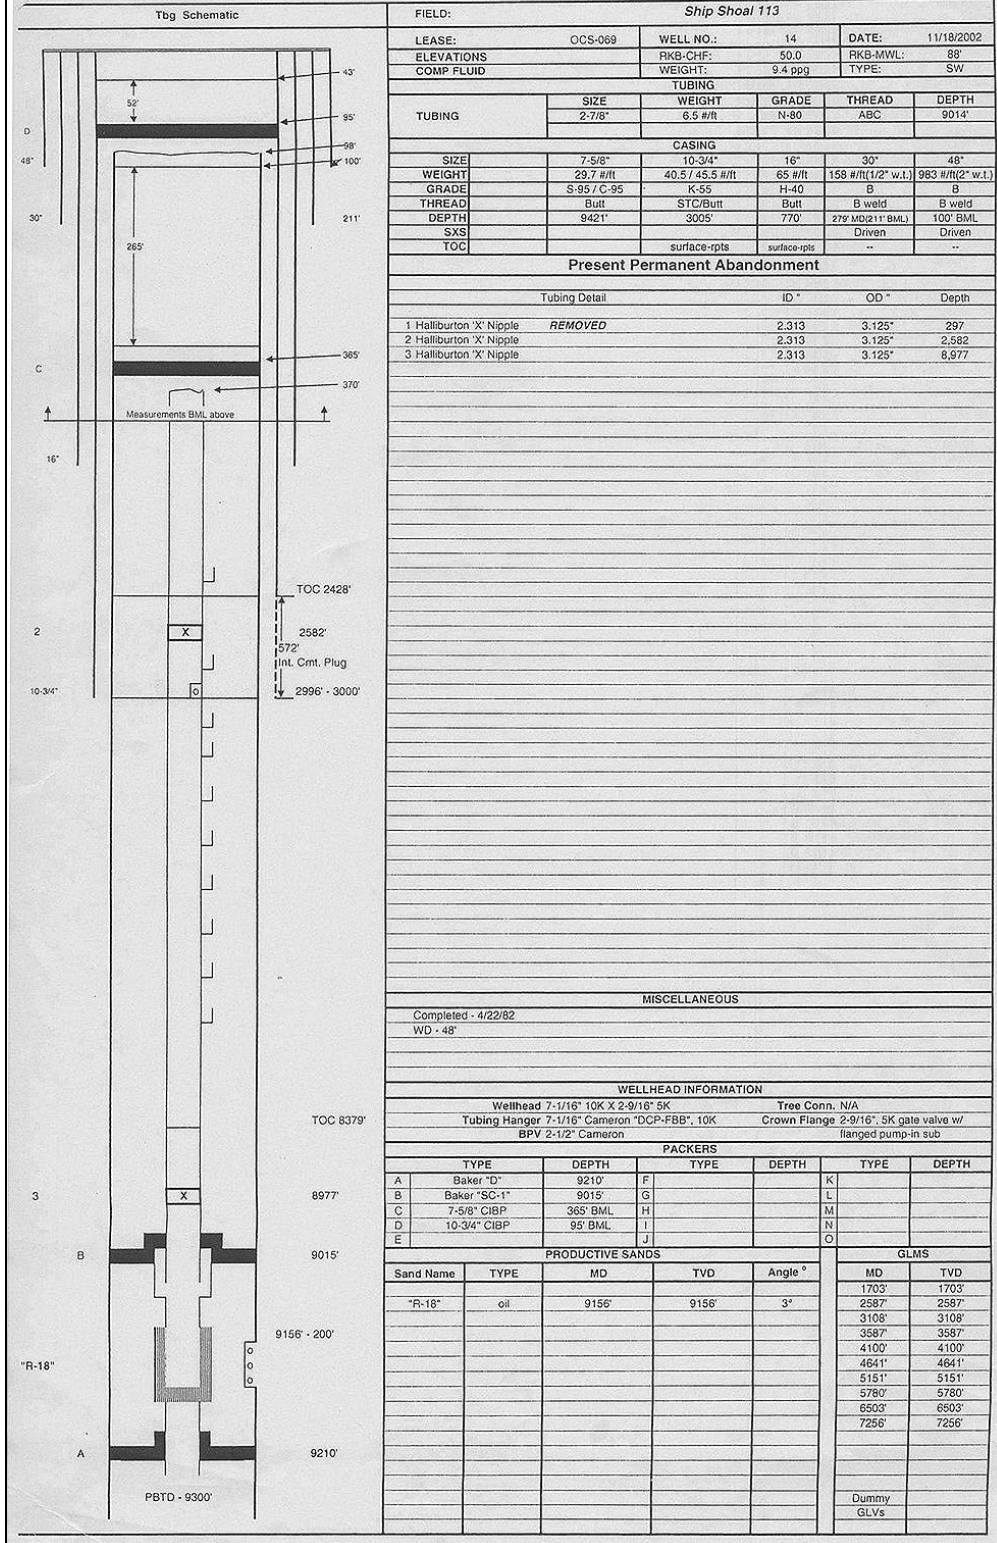
Figure 3. Engineering Diagram of the Well.

Murphy Exploration and Production Company (Murphy) was the lease owner at Ship Shoal Block 119 (Figure 2) located 18 mi from shore. During Hurricane Lili, the wellhead at Caisson No. 14 was damaged (Attachment 1) (U.S. Dept. of Commerce, NOAA, 2002a). The well was not in production. It had been shut in and was awaiting MMS approval for plugging and abandonment operations. The engineering diagram for the well is provided in Figure 3. An investigation of the engineering aspects of the release by MMS is ongoing. A mixture of oil, gas, and water spewed into the air. Murphy estimated that 350 bbl of oil spilled (Figures 4 and 5) and later reported that 145 bbl of oil was recovered through skimming. About 205 bbl was not recovered and is assumed to have dissipated. On October 6, 2002, at 1730 CDT, the well was shut in (Table 1).
