**Investigation of Loss of Well Control  
Eugene Island Block 277, Well A-3 BP  
OCS-G 10744  
9 February 2004**

Gulf of Mexico  
Off the Louisiana Coast

U.S. Department of the Interior  
Minerals Management Service  
Gulf of Mexico OCS Regional Office

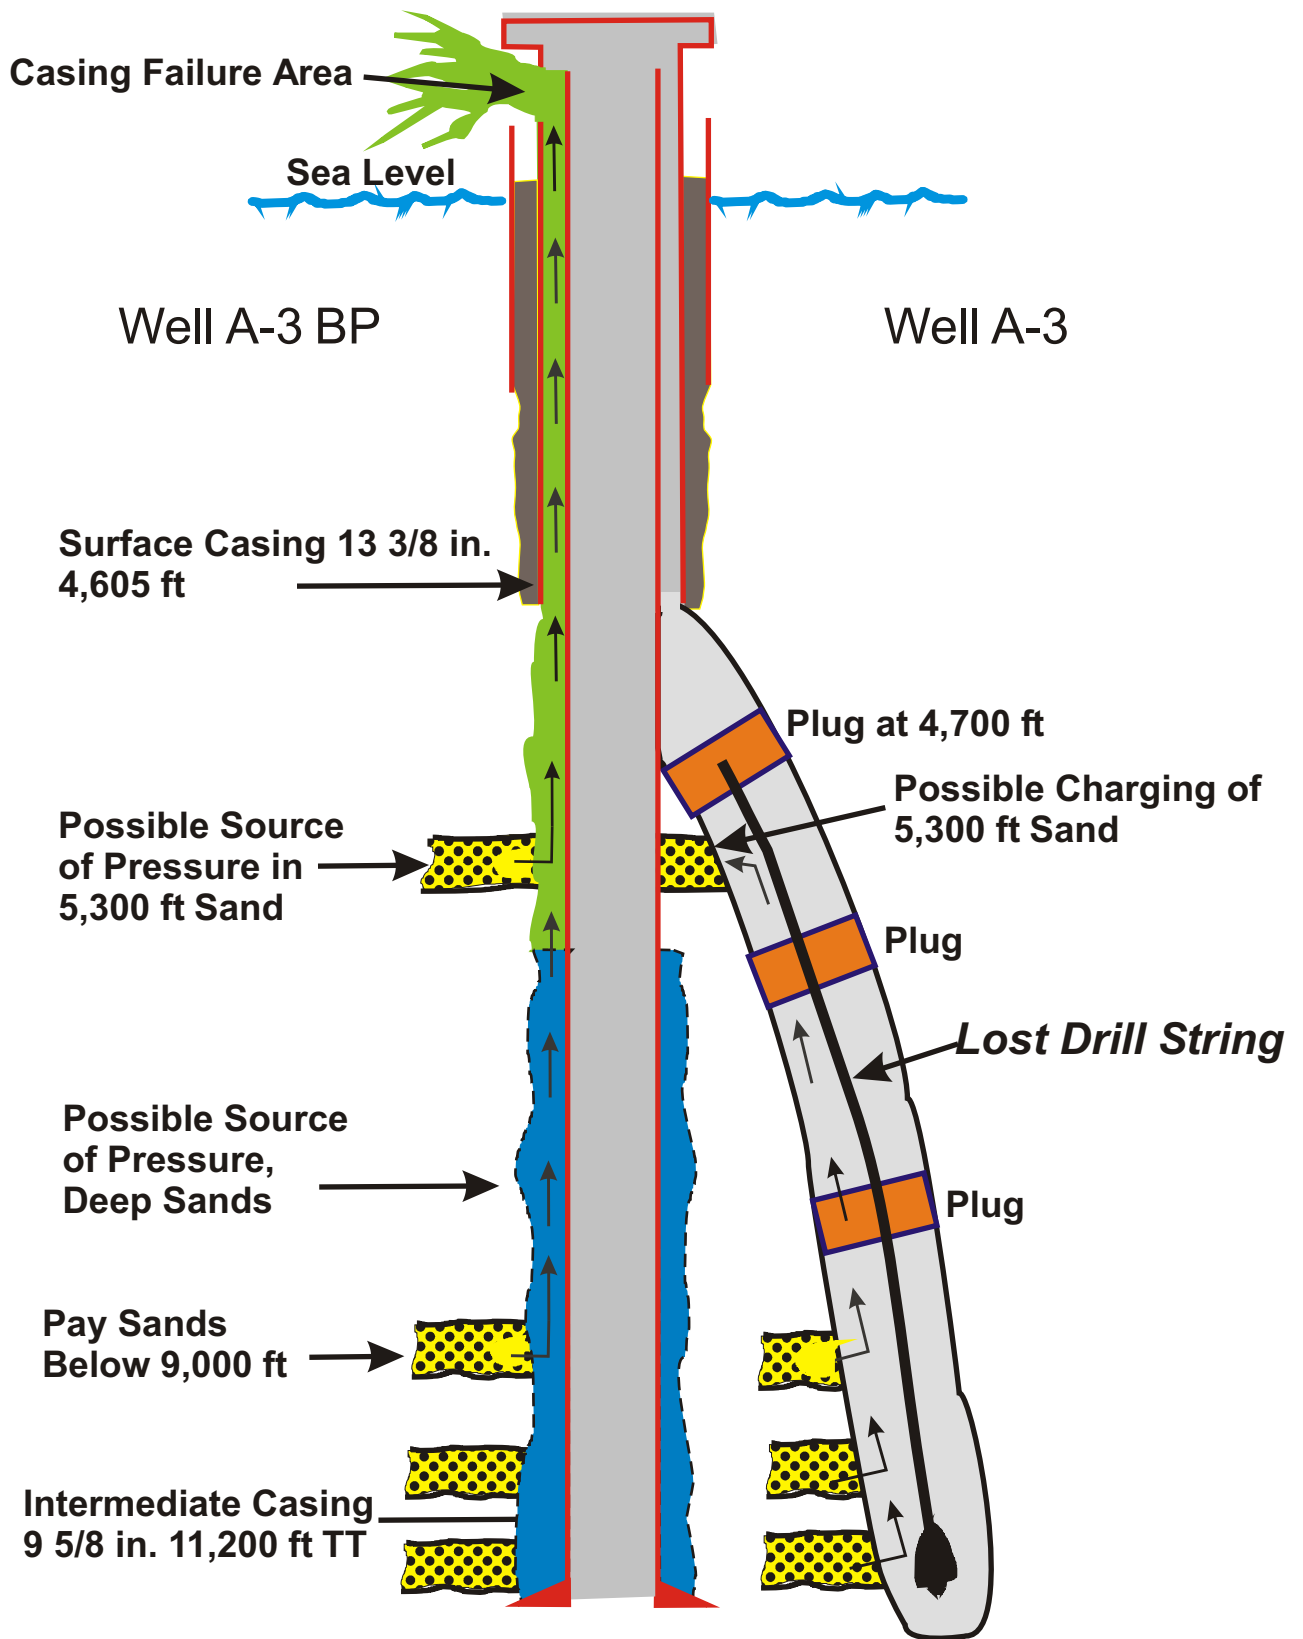
Schematic: Eugene Island Block 277 Well A-3, Well A-3 BP.

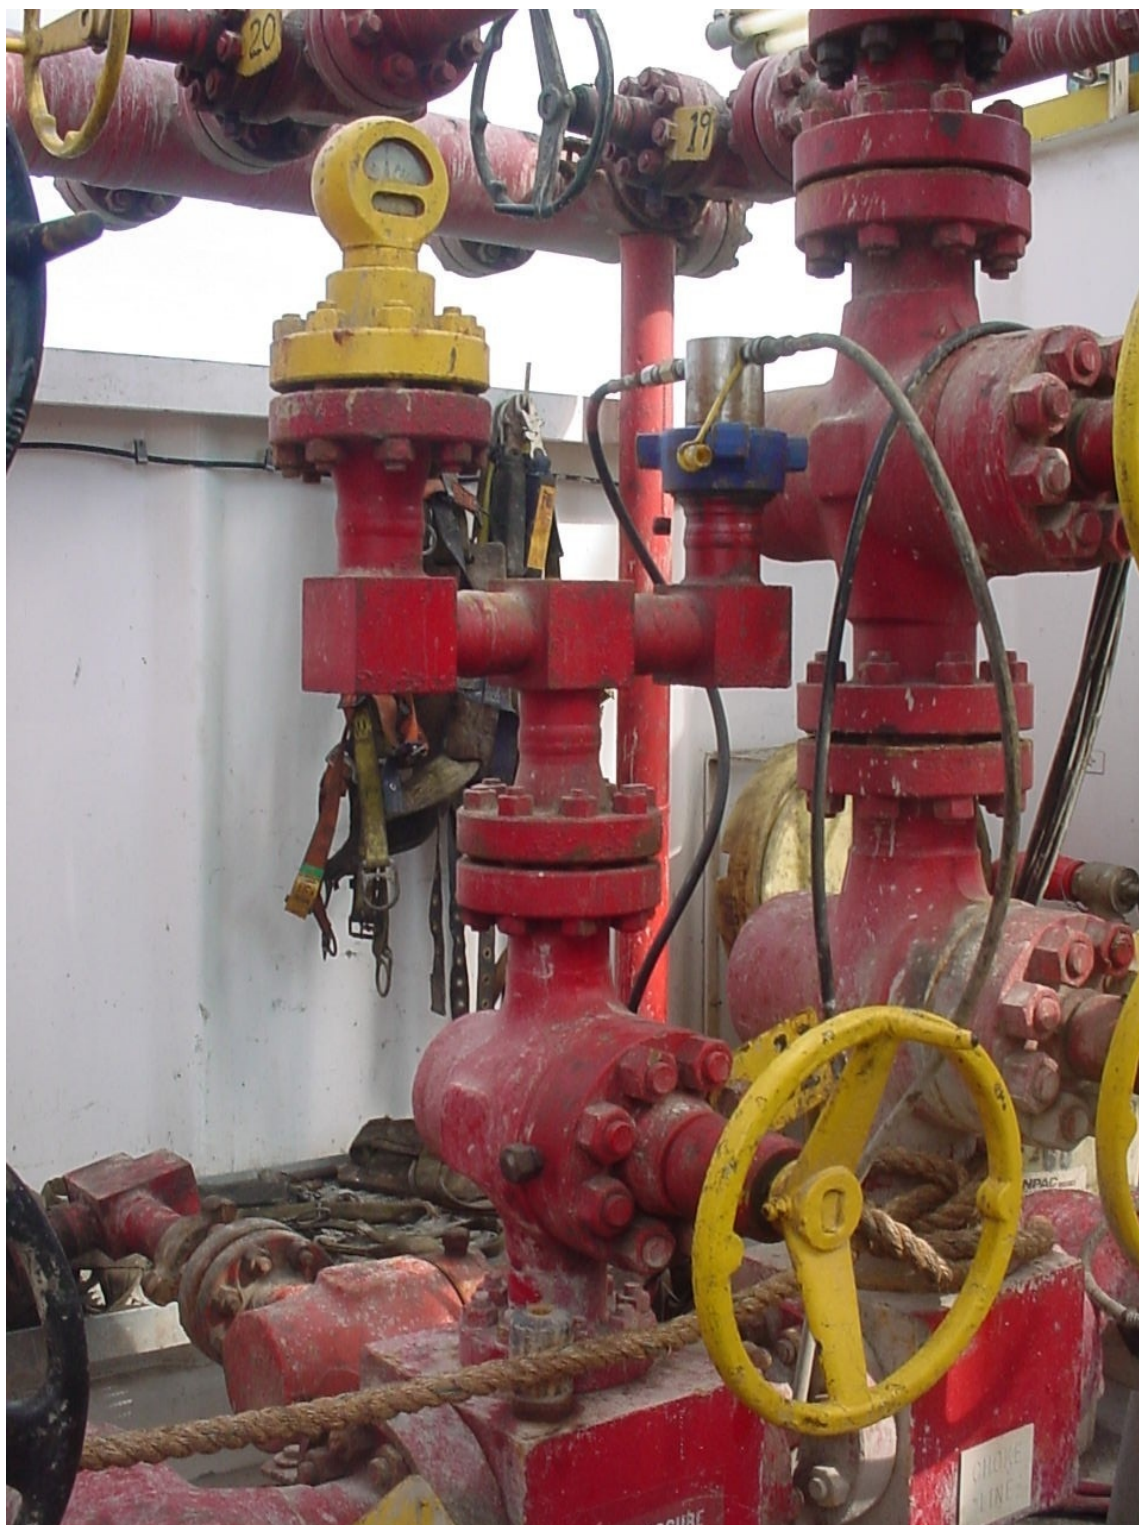
***Gauge Failure and Pressure Monitoring of Casing, Hydraulic Leak*** – The gauges in the driller's console failed to record the proper pressure, giving a false reading. This failure was probably the result of a hydraulic leak in the control lines from the sensor to the gauges. This leak was not identified or recognized by personnel on the operation site.

Connections for gauges on choke manifold.

- 1) Careful attention to rig alignment and periodic checks of same;
- 2) Monitoring of ditch magnets and other evidence for wear in casing;
- 3) Redundant capacities, systems and/or sensors for gauges;
- 4) Frequent routine checks of hydraulic systems for gauges;
- 5) Detailed analysis of logs to identify unexpected pressure and productive zones, especially shallow gas; and
- 6) Pressure tests of casing at or near the required dates.

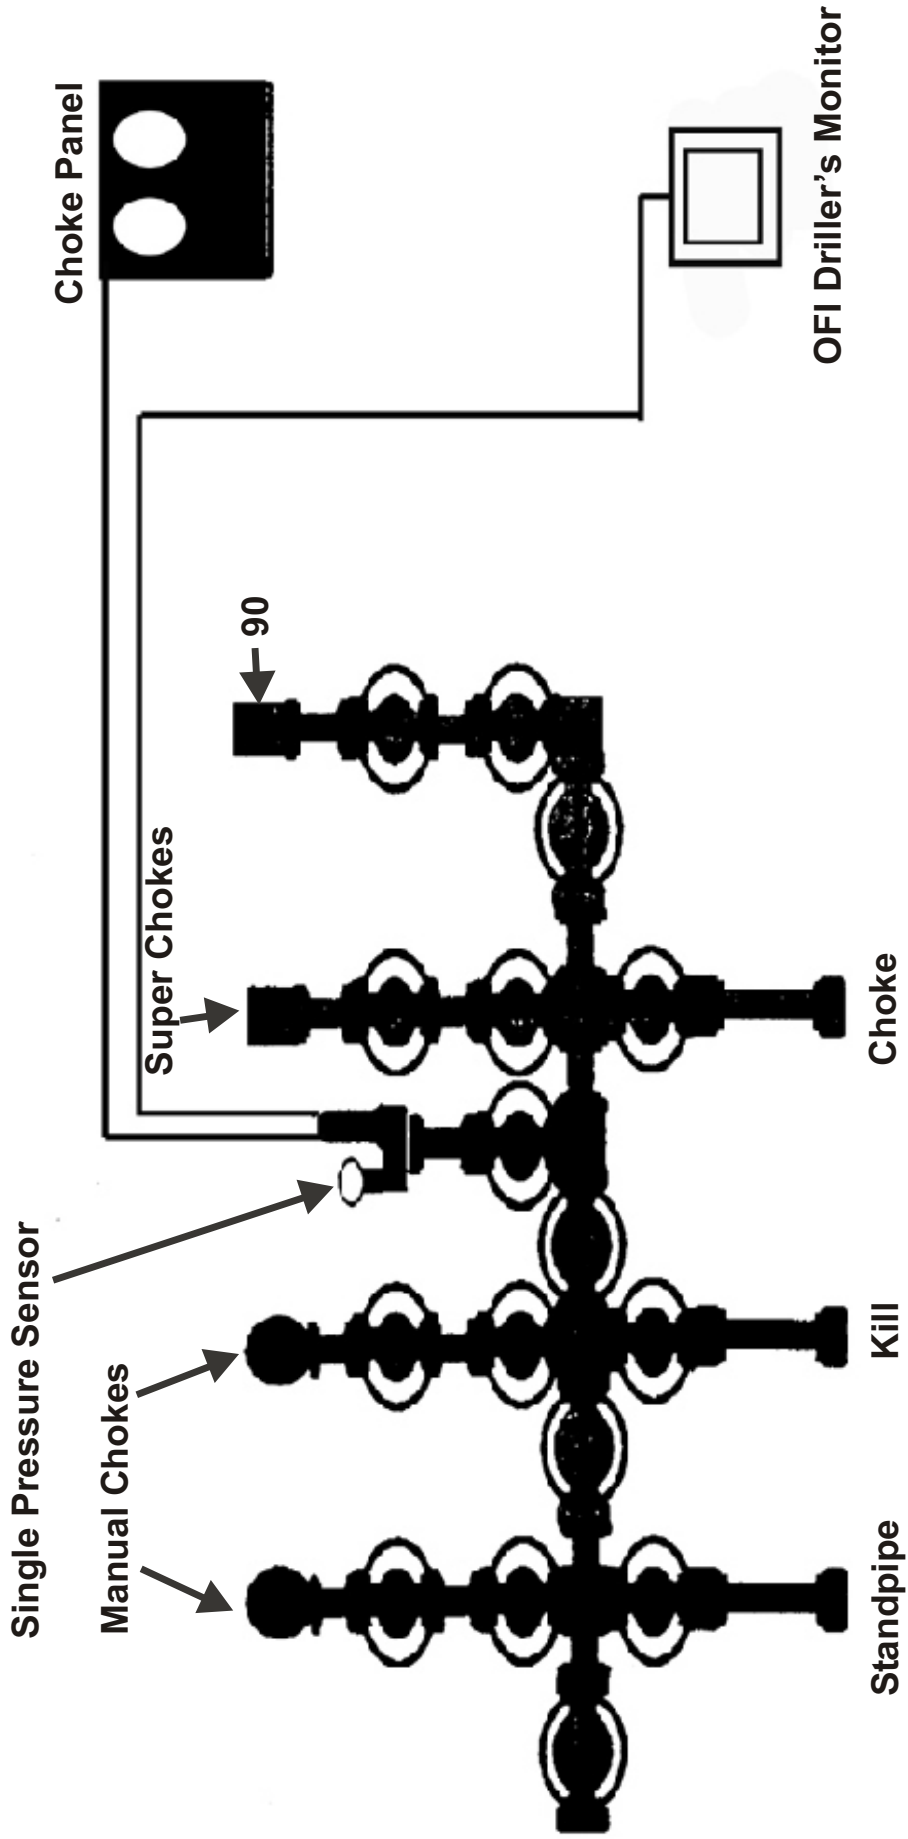
***Gauge Failure and Pressure Monitoring of Casing, Lack of Redundancy*** – Both of the gauges in the driller's console were tied into the same sensor and hydraulic system. No redundancy was available on the driller's console to check the pressures. However, a third gauge was available on the choke from a redundant sensor. This gauge was not monitored or checked by supervisory personnel until immediately prior to the failure of the casing.

Schematic: Setup of gauges and hydraulic system.
