MIDÉ TECHNOLOGY CORPORATION
200 Boston Avenue, Suite 1000, Medford, MA 02155

Deep Water Drilling Risk Reduction Assessment

PRODUCED FOR: Bureau of Ocean Energy Management, Regulation and Enforcement
under subcontract to Industrial Economics, Inc

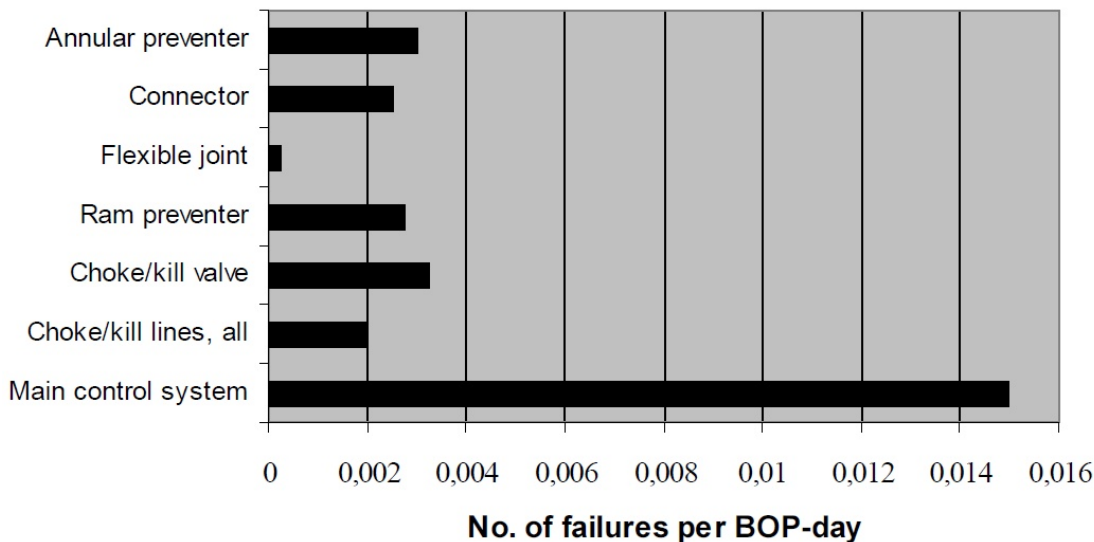
No. of failures per BOP-day (Phase II DW data)

Figure 2: Failure Rates of Different Components in the BOP System⁷. Note the number of failures attributed to the Control System. Note that the X-axis values are in SI format where a comma is used for the decimal separator. In U.S. format the values are 0, 0.002, 0.004, etc.

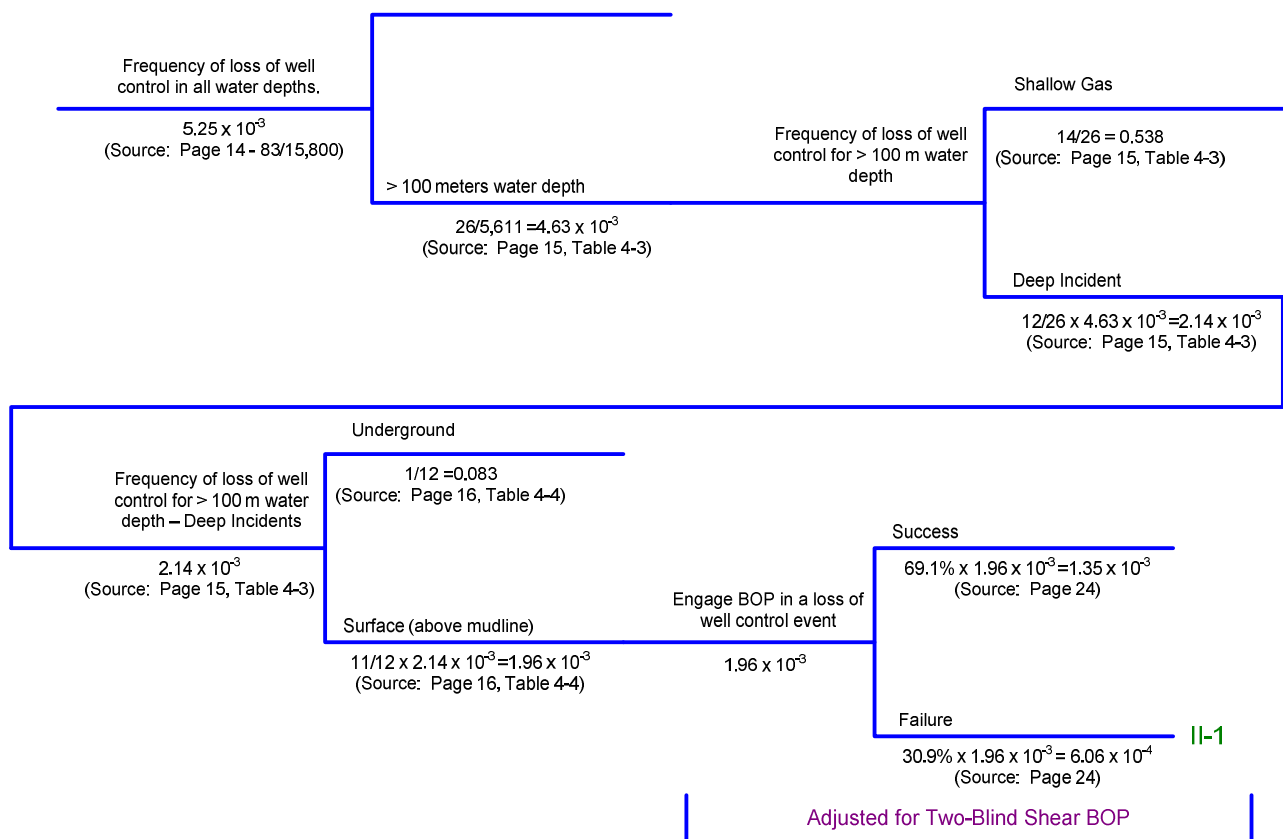
Figure 5: Event Tree for a Two Blind Shear Ram BOP System. Duplication of the Event Tree(s) in the DNV Beaufort Sea Study.

The BOP process event tree is presented in Figure 5 through Figure 7. The first is essentially the event tree presented in the DNV Beaufort Sea Study. The only modification is that an additional branch was added to include a secondary control system. However to verify the DNV study the probability of success for this event is set to 0%. This confirms the accuracy of the DNV event tree analyses. Small differences with what is reported in the DNV report are due to rounding.

In conclusion, using the modified reliability numbers associated with the two blind shear ram BOP system (Figure 5 to Figure 7) to predict the numbers of wells that can be drilled before an uncontrolled blowout occurs results in an answer of 6,213 (Table 12). This is almost a quarter of the number of wells predicted by the DNV study (Table 10).

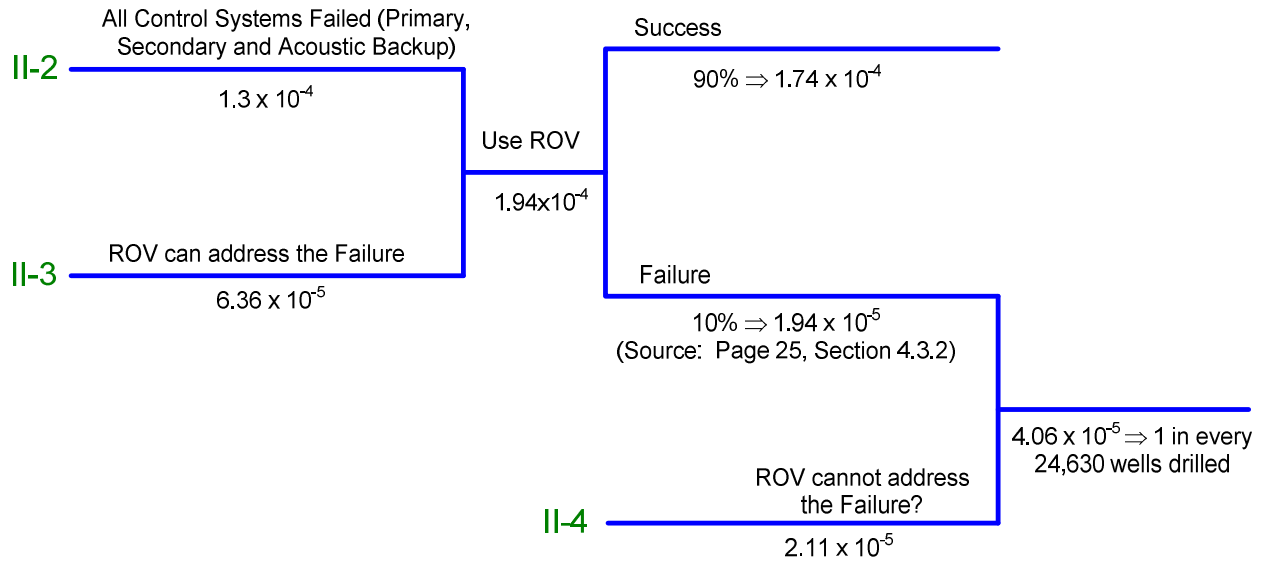
Figure 7: Continuation of the Event Tree for a Two Blind Shear Ram BOP System. Duplication of the Event Tree(s) in the DNV Beaufort Sea Study.

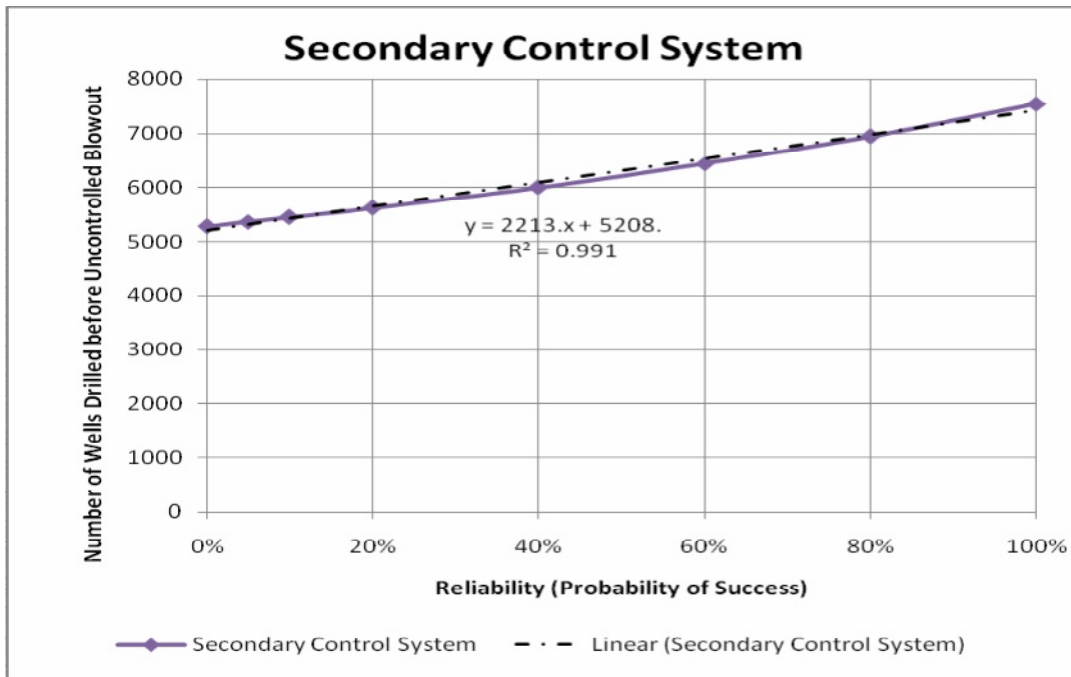
Figure 9: Sensitivity of the Number of Wells that can be drilled before an Uncontrolled Blowout from a Deep Zone Occurs on the Reliability of the Secondary Control System. Study conclusions are moderately dependent on this parameter and the number of wells that can be drilled before an uncontrolled blowout is linearly dependent on this sub-system’s reliability. Note 50% reliability was assumed in the study.

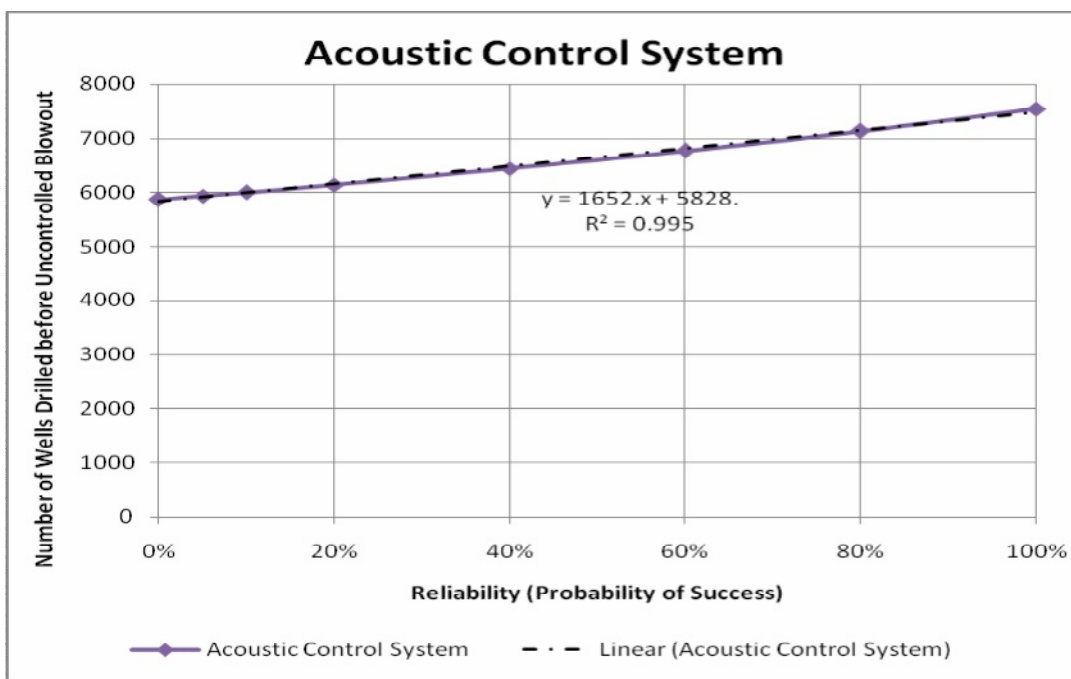
Figure 10: Sensitivity of the Number of Wells that can be drilled before an Uncontrolled Blowout from a Deep Zone Occurs on the Reliability of an Acoustic Backup Control System. Study conclusions are weakly dependent on this parameter and the number of wells that can be drilled before an uncontrolled blowout is linearly dependent on this sub-system’s reliability. Note 25% reliability was assumed in the study.

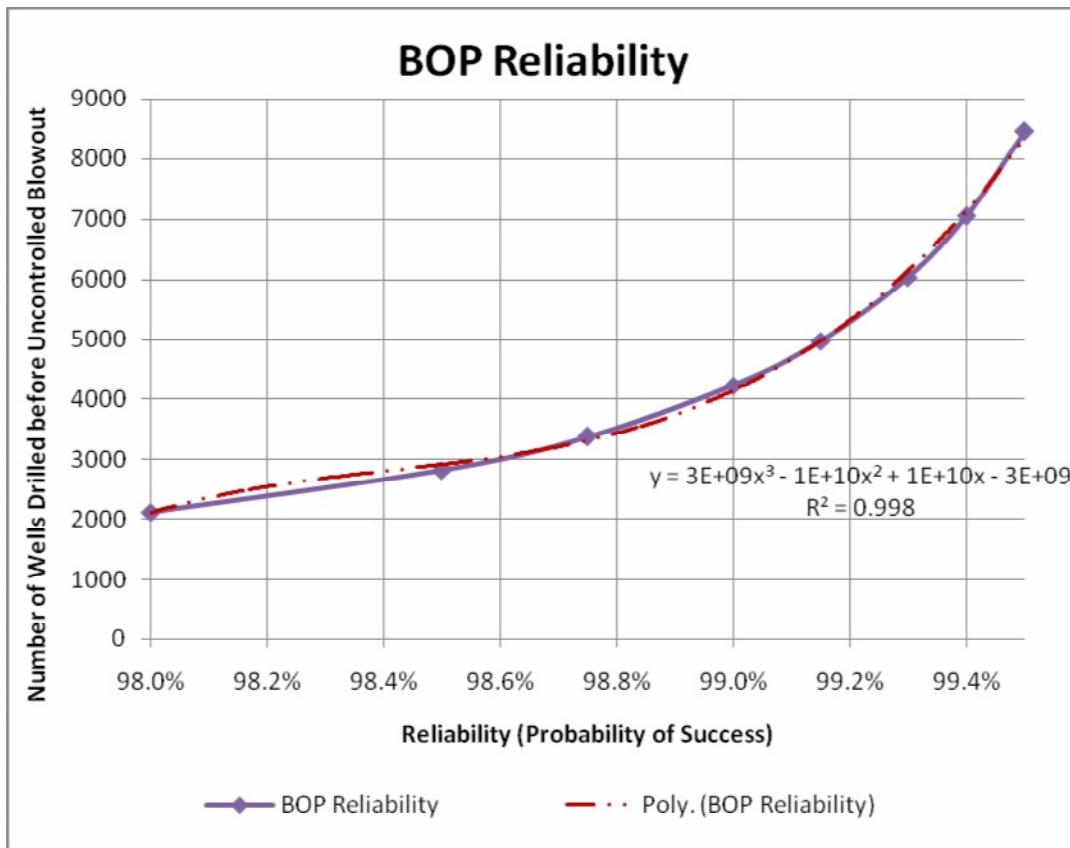
Figure 13: Sensitivity of the Number of Wells before a BOP system cannot close and secure a blowout to the reliability of two blind shear rams.

The impact of the reliability of a two blind shear ram BOP system was also considered (Figure 13). At approximately 99% reliability, the number of wells that can be drilled increases by 620 wells per 0.1% increase in reliability of the BOP systems. For example, the predicted reliability of the two blind shear ram BOP is 0.32% more than that of a single blind shear ram system. The number of wells that can be drilled before an uncontrolled blowout increases from 4,225 wells, for the single blind shear ram, to 6,213 (4,225 + 3.2*620 ≈ 6,213) wells for the two blind shear ram system.

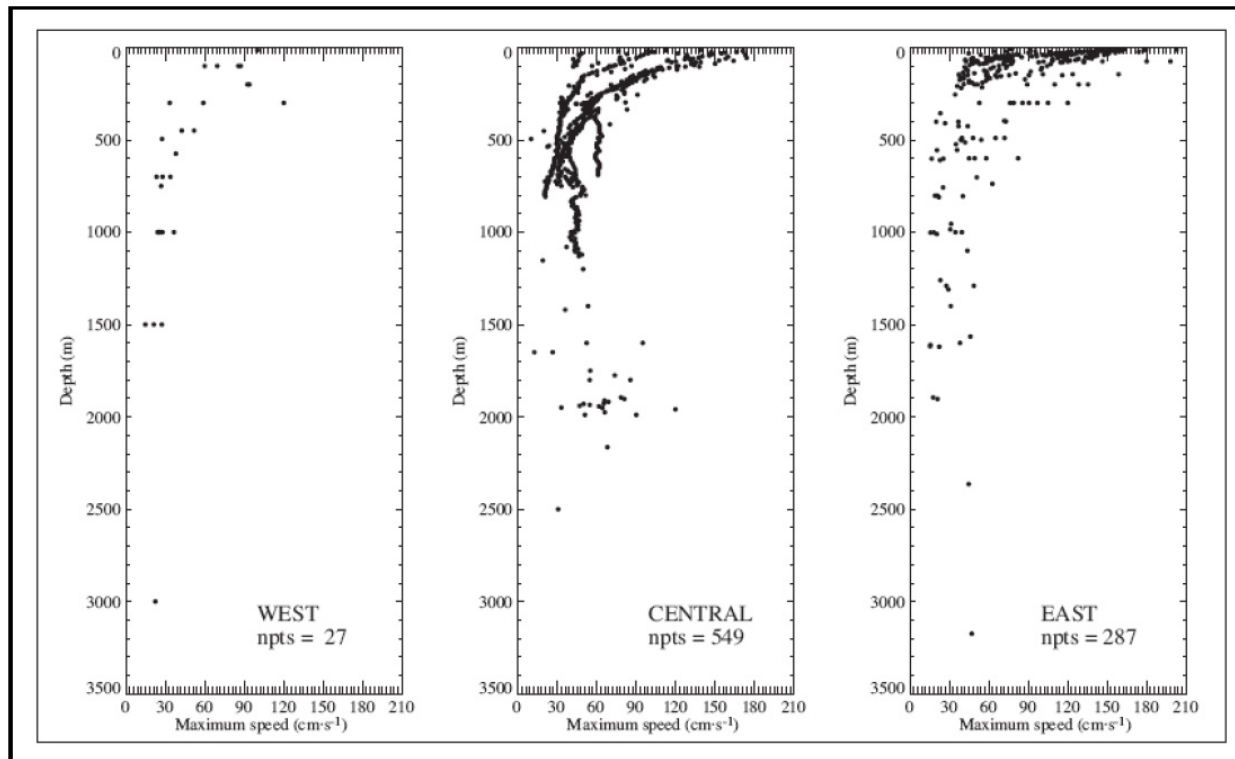
Fig. 1.5 – GOM maximum currents profile vs. depth.²²

Figure 20: Gulf of Mexico maximum currents profile versus depth¹².

Drilling in deep water Figure 20 offers the benefit that the well head is experiencing significantly lower current speeds. This may explain why well blowouts decrease with water depth.

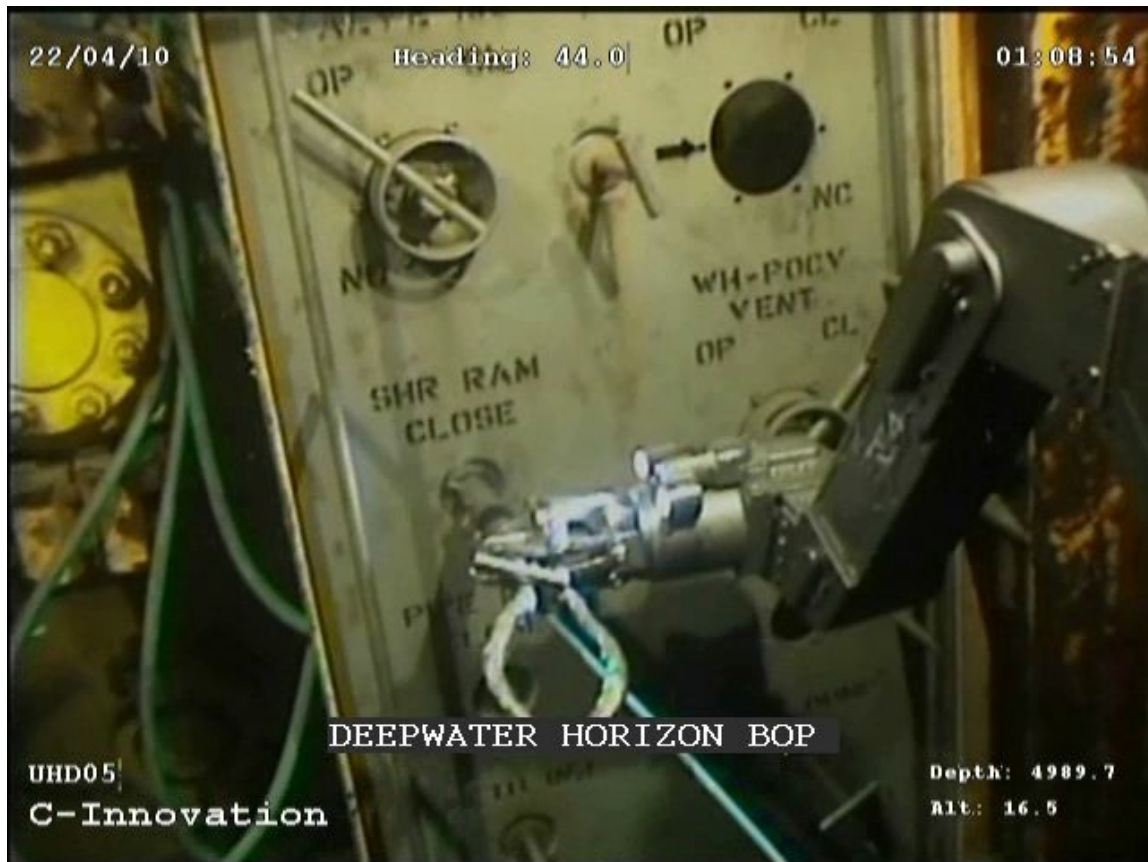
ROV Activation

Figure 27: A robotic arm of a Remotely Operated Vehicle (ROV) attempts to activate the "Deepwater Horizon" Blowout Preventer (BOP), Thursday, April 22, 2010.

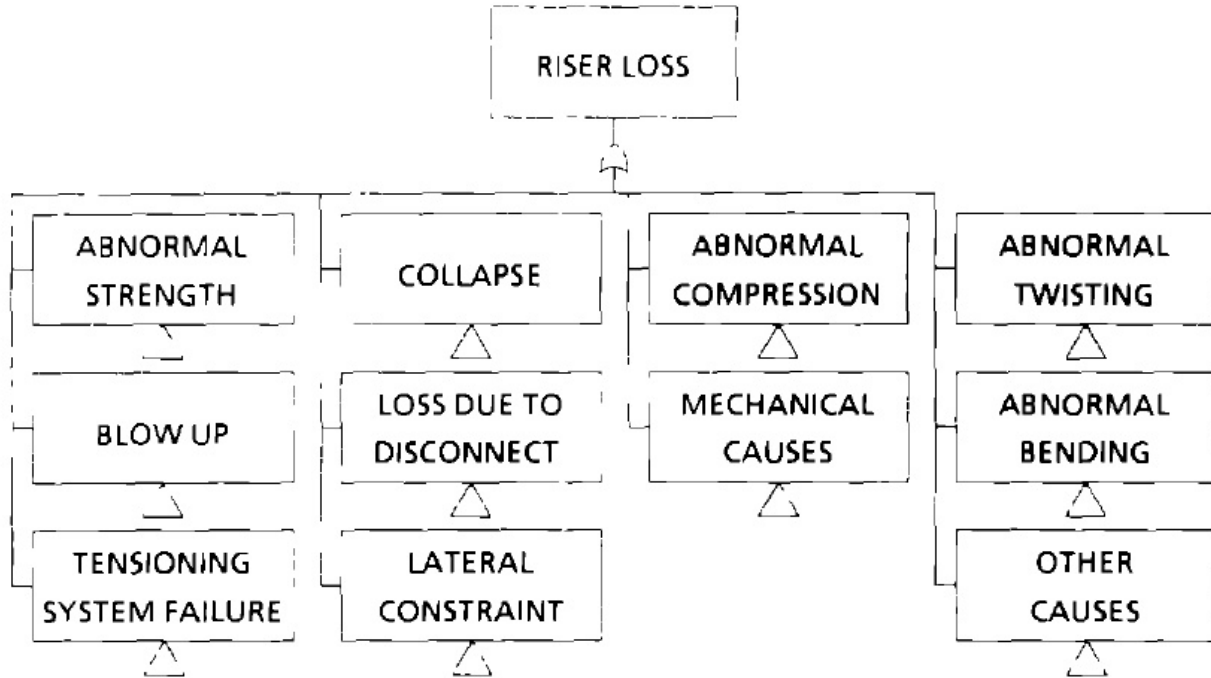
Fig. 1. Riser-loss causes

Figure 28: Riser Loss Causes¹⁵

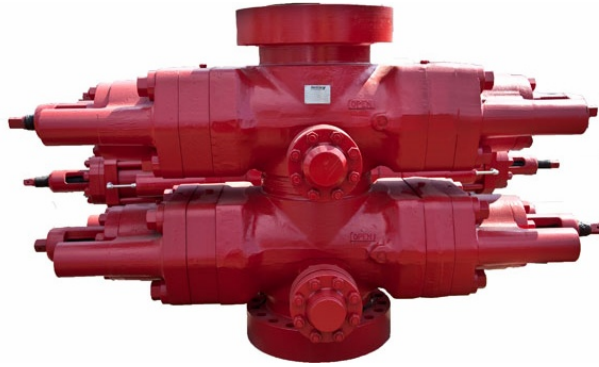
Figure 34: A double Ram Blowout Preventer.

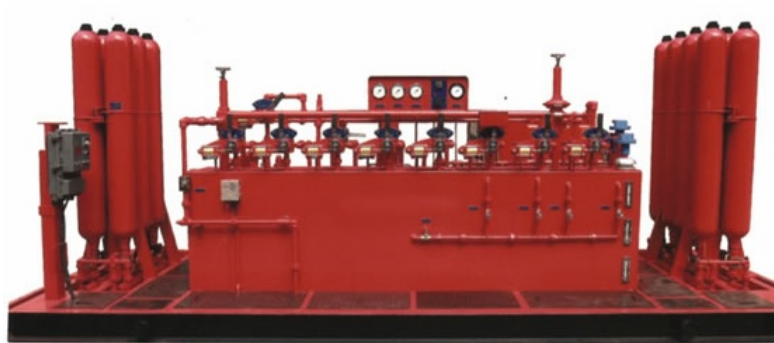
Figure 35: A BOP Control System.
