Evaluation of Sub-Sea Physical Environmental Data for the Beaufort Sea OCS and Incorporation into a Geographic Information System (GIS) Database

By Warren L. Horowitz, Oceanographer, MMS Alaska OCS Region

Locations of past Shallow Hazard Site Surveys and Pipeline Route Surveys for the Beaufort Sea Federal Outer Continental Shelf, Alaska

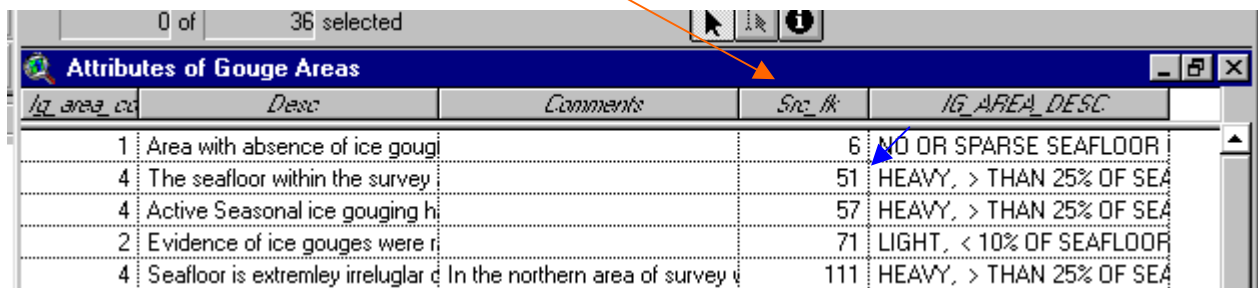
All the relationships are based on the values of a common field found in both tables. Regarding the relationship with Environmental Sources Meta Data, most themes in the Geohazards Dataset have a Src_FK Field (*Source Foreign Key field*).

The common field in the Geohazards.mdb Microsoft Access Database is the sn_envm_src_pk field of the envm_sources table. This data link shows the source map used to generate data.
