# Existing Conditions Report

269 37<sup>th</sup> Street  
Brooklyn, New York

Red Hook Container Terminal, LLC  
Brooklyn, New York

June 2018

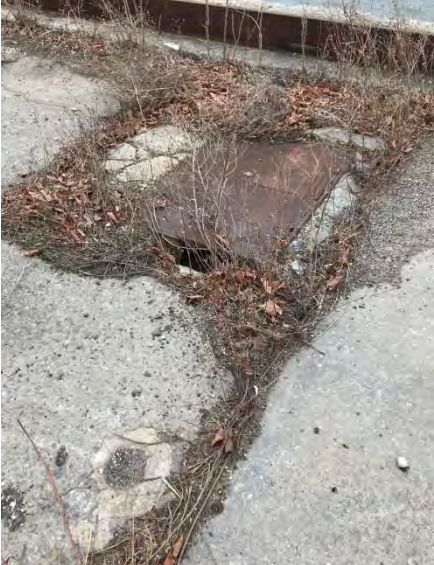
<p>Photo Number: 7</p> <p>Date Taken January 24, 2018</p> <p>Description J1 Shed Exterior/Site - Cracked exterior wall and rusted curb</p>

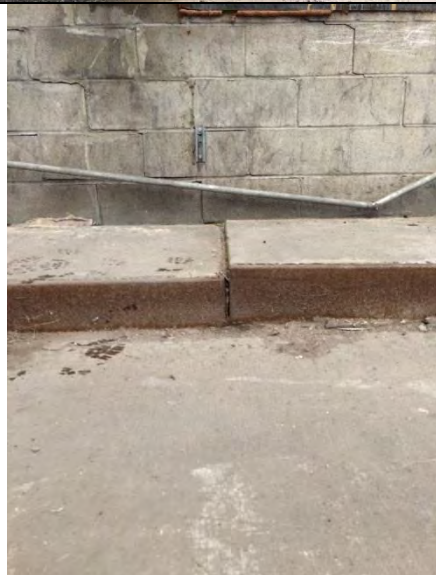
Description  
J1 Shed  
- Floor  
settlement

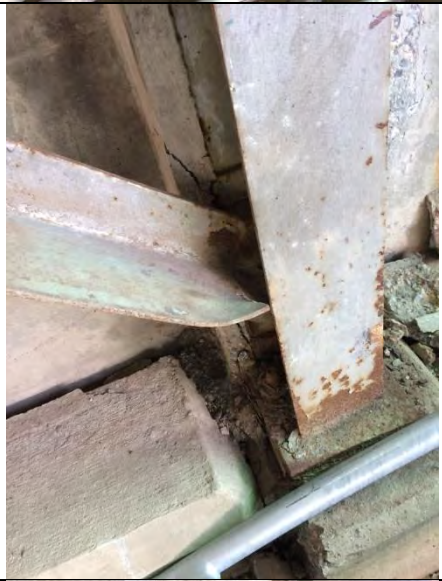
<p>Photo Number: 34</p> <p>Date Taken January 24, 2018</p> <p>Description J2 Shed - Tilted grade beam</p>

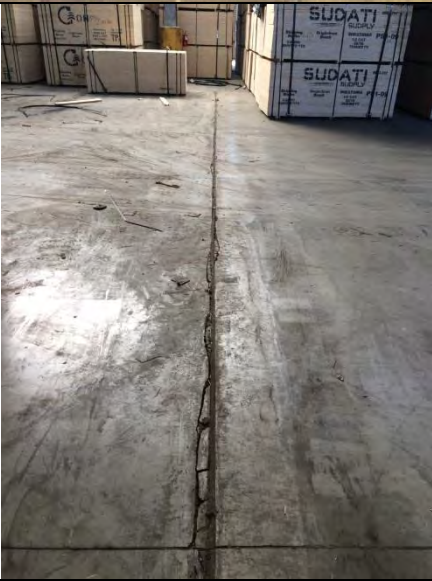
<p>Photo Number: 37</p> <p>Date Taken January 24, 2018</p> <p>Description J2 Shed - Open cold joint at northwest side wall</p>

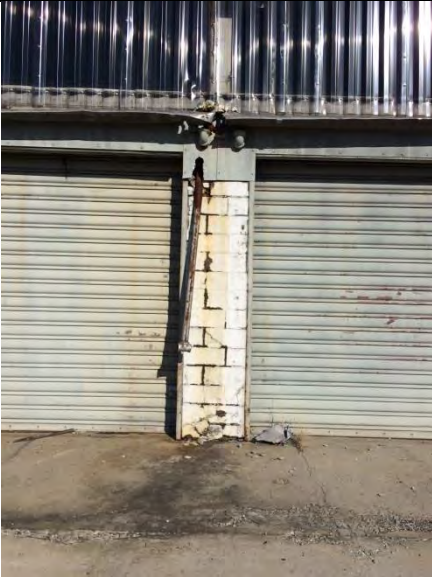
<p>Photo Number: 41</p> <p>Date Taken January 24, 2018</p> <p>Description J2 Shed - Damaged drain pipe</p>

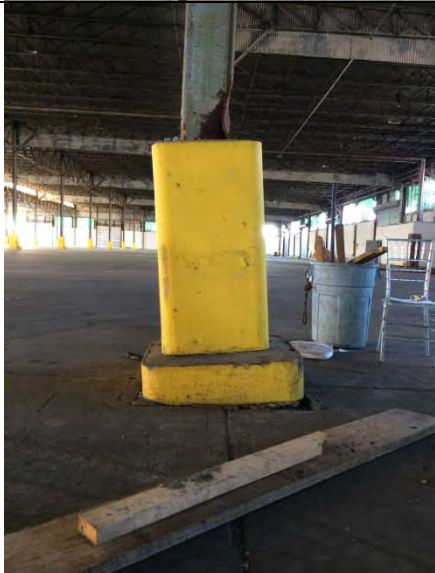
A close-up photograph of a concrete floor joint. The joint is a vertical crack in the concrete, showing some debris and a dark, possibly oily, substance at the bottom.	
<p>Photo Number: 52</p> <p>Date Taken January 24, 2018</p> <p>Description N Shed - Damaged column</p>

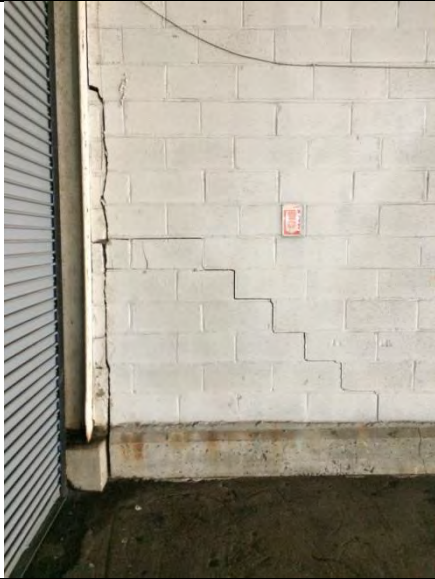
<p>Photo Number: 53</p> <p>Date Taken January 24, 2018</p> <p>Description N Shed - Settlement at column/wall</p>

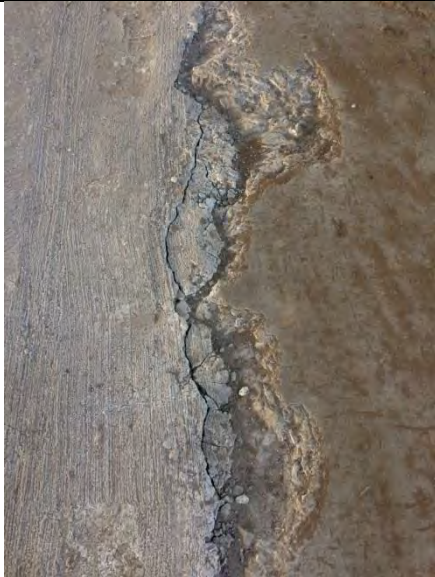
<p>Photo Number: 54</p> <p>Date Taken January 24, 2018</p> <p>Description N Shed - Cracks on concrete floor</p>

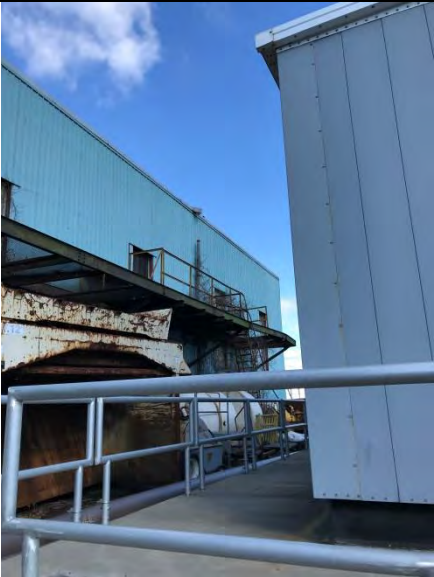
<p>Photo Number: 58</p> <p>Date Taken</p> <p>January 24, 2018</p> <p>Description</p> <p>Graffiti Building Exterior</p> <ul style="list-style-type: none"><li>- Damaged drainage</li></ul>

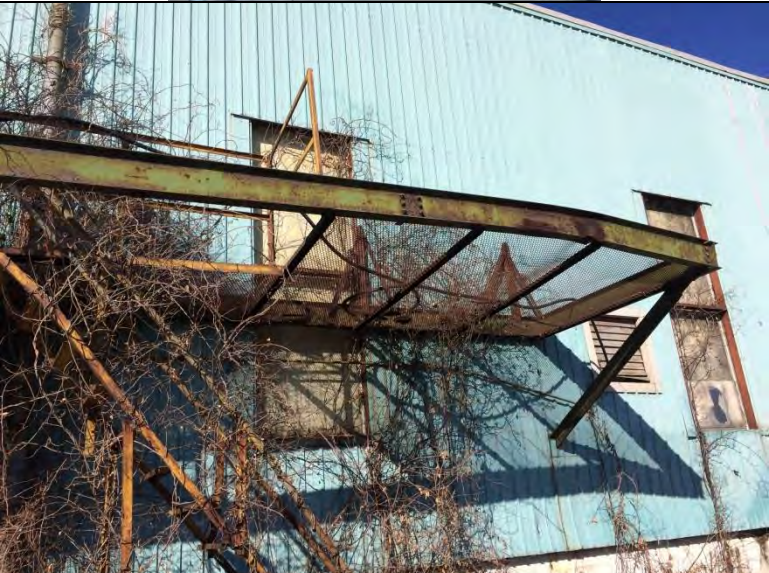
<p>Photo Number: 59</p> <p>Date Taken</p> <p>January 24, 2018</p> <p>Description</p> <p>Graffiti Building Exterior</p> <ul style="list-style-type: none"><li>- Falling walkway</li></ul>

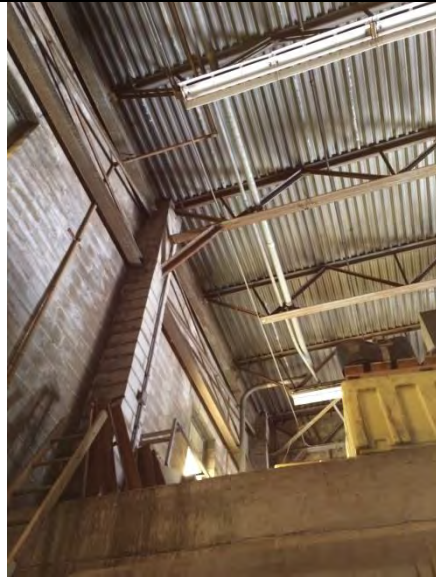
Photo Number: 61

Description  
Graffiti Building  
- Roof metal  
deck

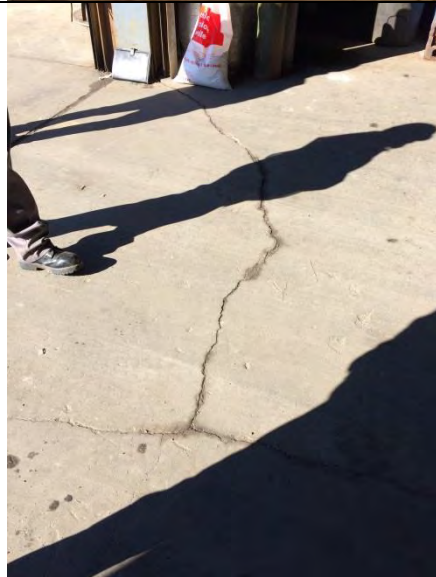
Photo Number: 62

Description  
Graffiti Building  
- Crack on  
concrete  
floor

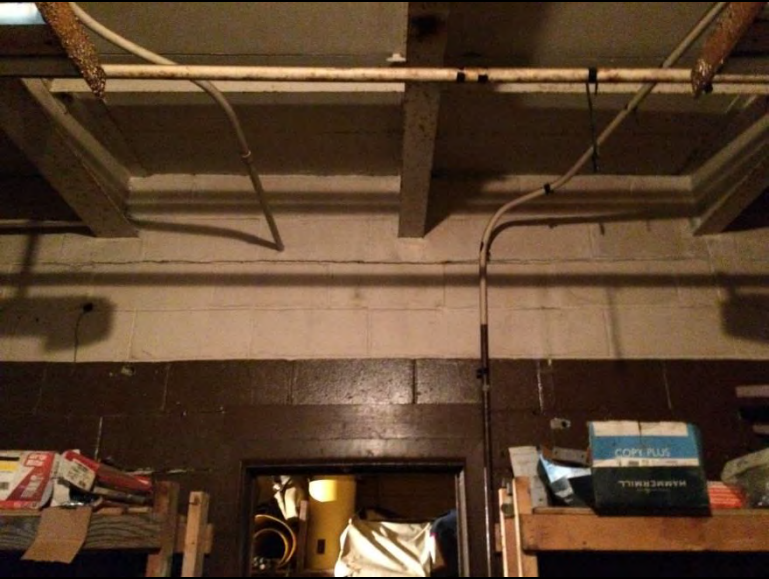
<p>Photo Number: 64</p> <p>Date Taken</p> <p>January 24, 2018</p> <p>Description</p> <p>Graffiti Building - Wall settlement</p>

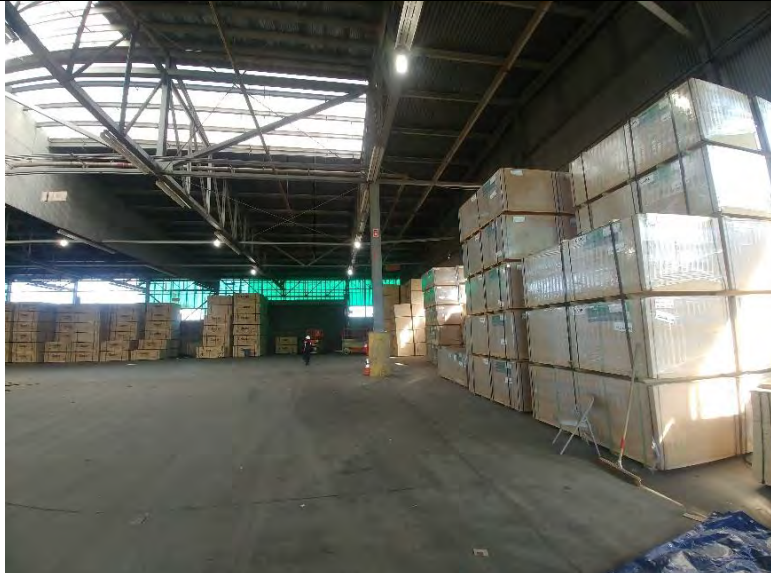
Photo Number: 71

Description  
J2 Shed Interior  
Lighting –  
Temporary  
Construction  
LEDs, partially  
building  
coverage only.

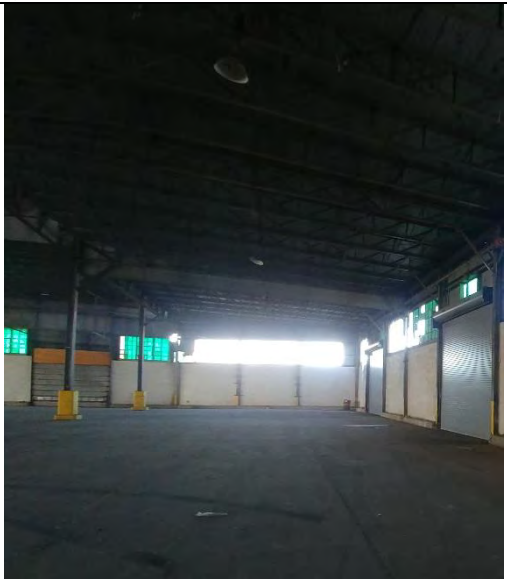
Photo Number: 72

N Shed Interior  
Lighting – non-  
operational  
high bay lights.

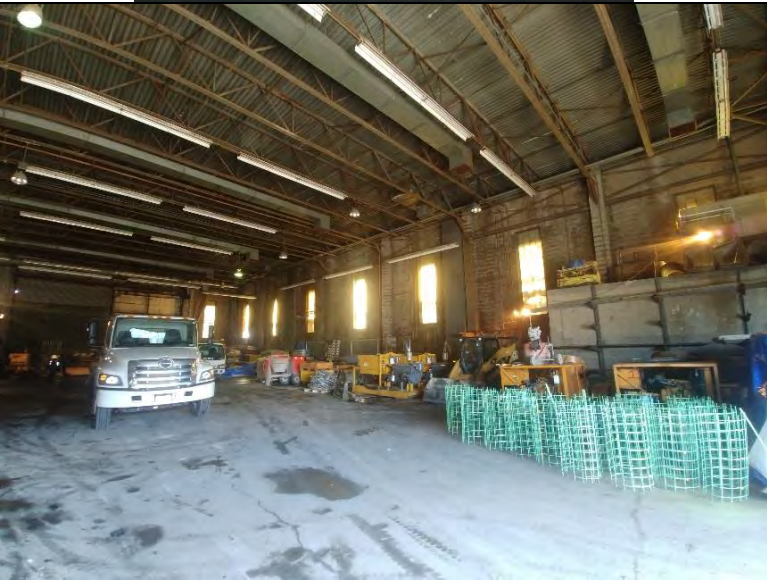
Photo Number: 73

Graffiti Building  
Interior Lighting  
– Non-  
operational  
fluorescent high  
bay lights.  
Partial  
operation of  
high pressure  
sodium lights in  
high bay  
lighting fixtures.

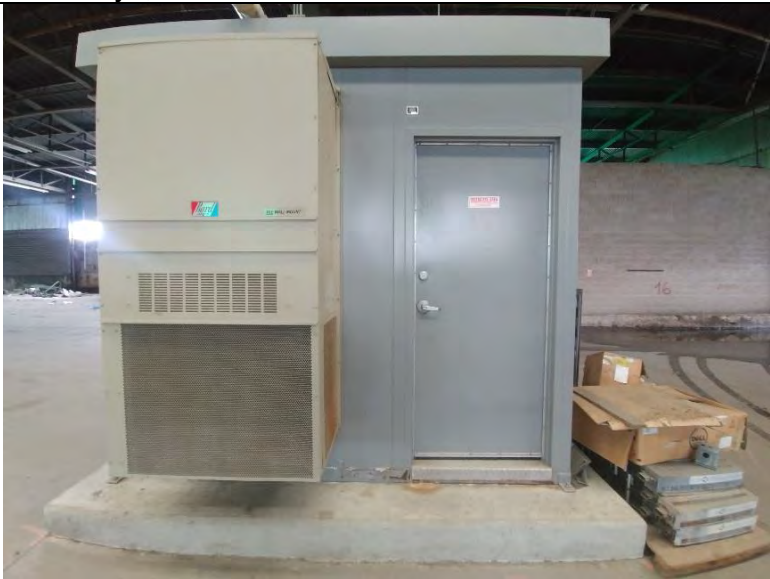
Photo Number: 74

Description  
J1 Shed  
Electrical  
Enclosure –  
Non-  
Accessible.

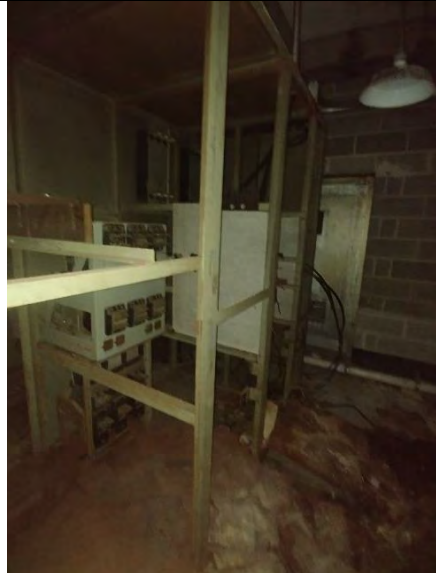
Photo Number: 76

Description  
J1 Shed  
Electrical  
Switchboard –  
Abandoned  
near Boiler  
Room.

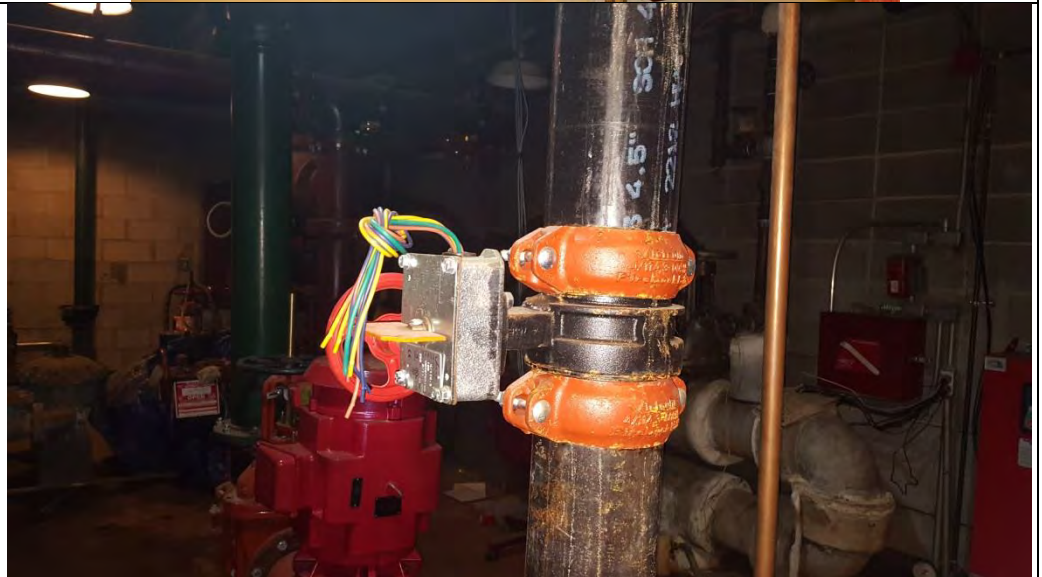
Description  
J1 Shed Pump  
Room – Fair to  
Poor

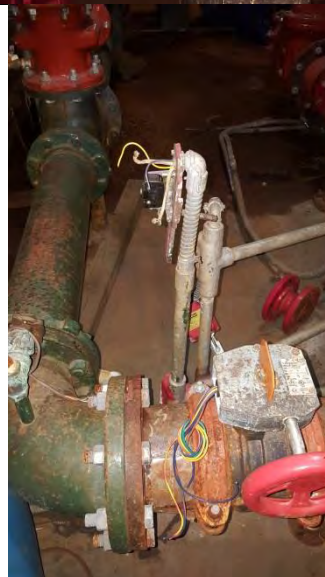
Photo Number: 103

Description  
J1 Shed Water  
sensor - Failed

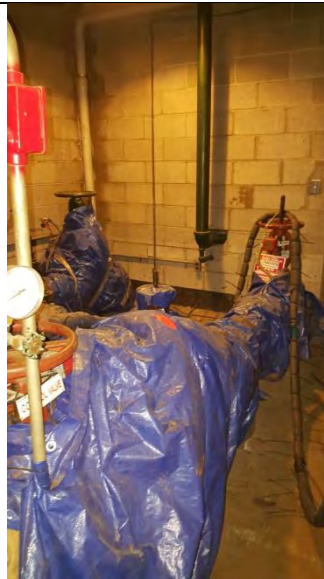
Photo Number: 104

J1 Shed Fire  
Sprinkler  
Control Valve –  
Fair to poor.

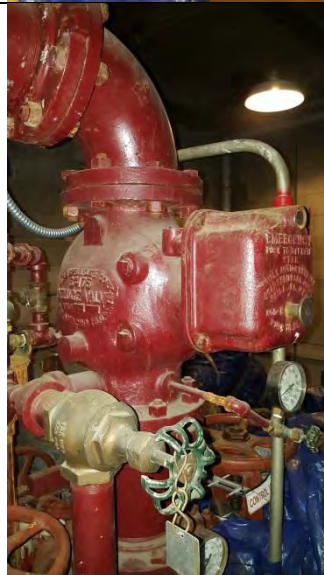
Photo Number: 105

J1 Shed Fire  
Sprinkler  
Control and  
Deluge Valve  
assembly – Fair  
to poor.

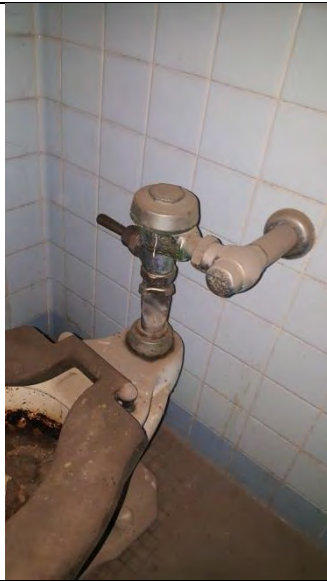
<p>Photo Number: 113</p> <p>Date Taken January 24, 2018</p> <p>Description J1 Shed Water Closet - Failed</p>

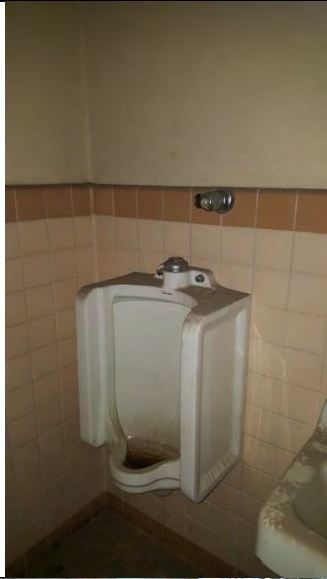
<p>Photo Number: 114</p> <p>Date Taken January 24, 2018</p> <p>Description J1 Shed Urinal - Failed</p>

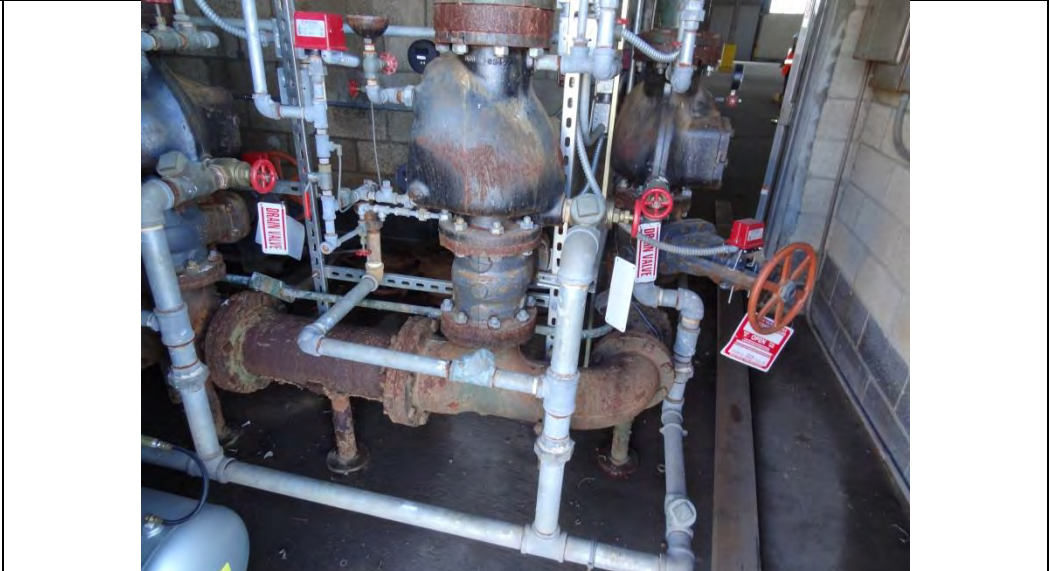
<p>Photo Number: 115</p> <p>Date Taken January 24, 2018</p> <p>Description N Bldg Sprinkler pipes - Fair to Poor</p>

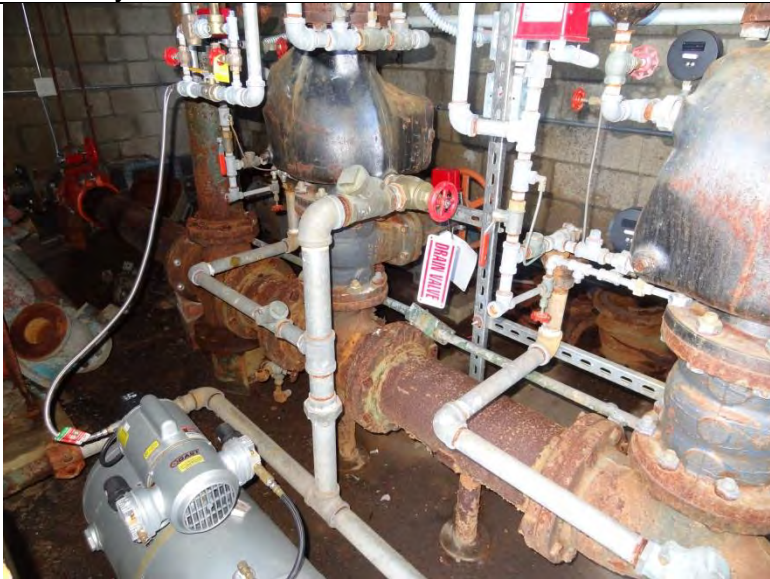
Photo Number: 116  
Date Taken  
January 24, 2018  
Description  
N Bldg  
Sprinkler pipes  
– Fair to Poor

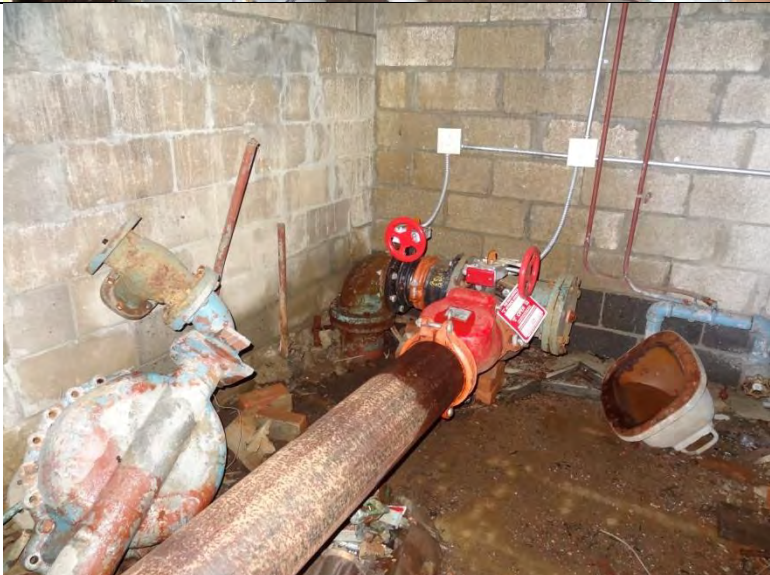
Photo Number: 117  
Date Taken  
January 24, 2018  
Description  
N Bldg  
Sprinkler pipes  
– Fair to Poor

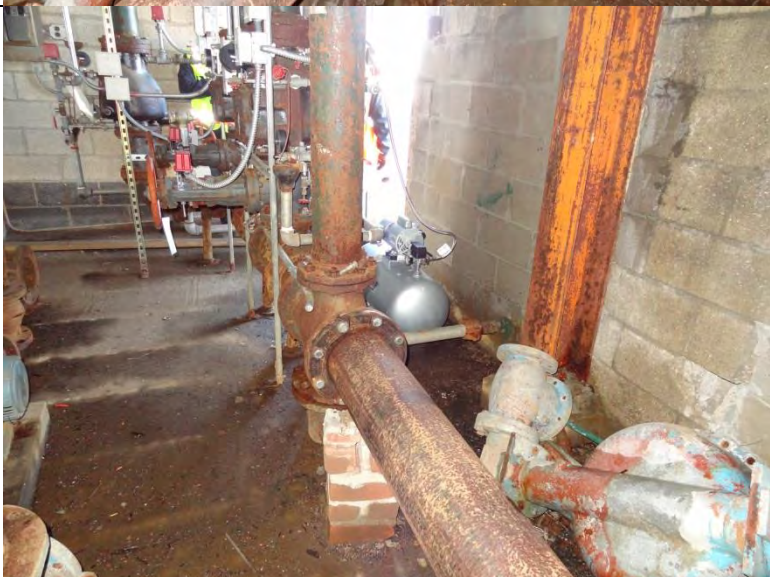
Photo Number: 118  
Date Taken  
January 24, 2018  
Description  
N Bldg  
Sprinkler Pipes  
– Fair to Poor

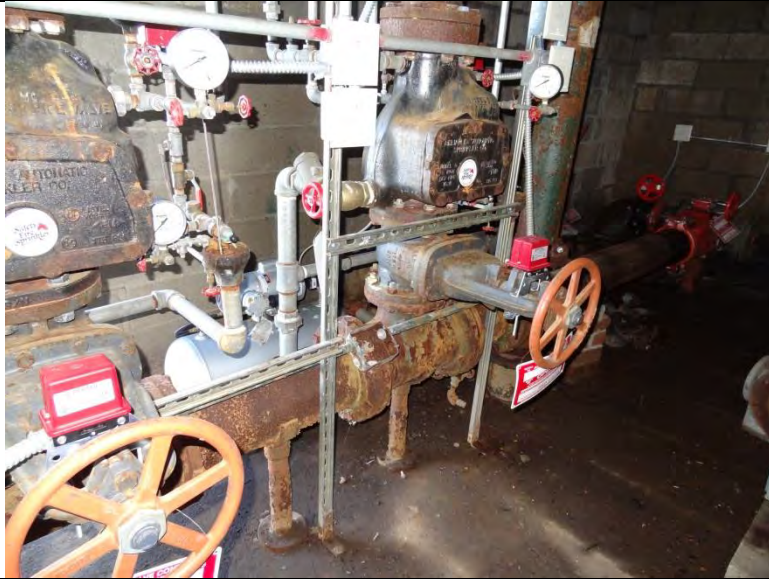
Photo Number: 119

Description  
N Bldg  
Sprinkler  
Valves – Fair to  
Poor

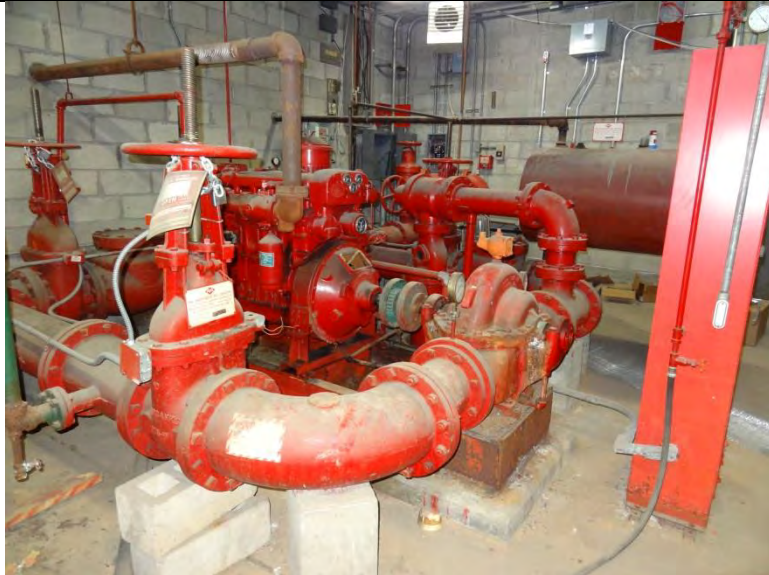
Photo Number: 120

Description  
N Bldg Fire  
Sprinkler Pump  
Assembly –  
Fair to poor

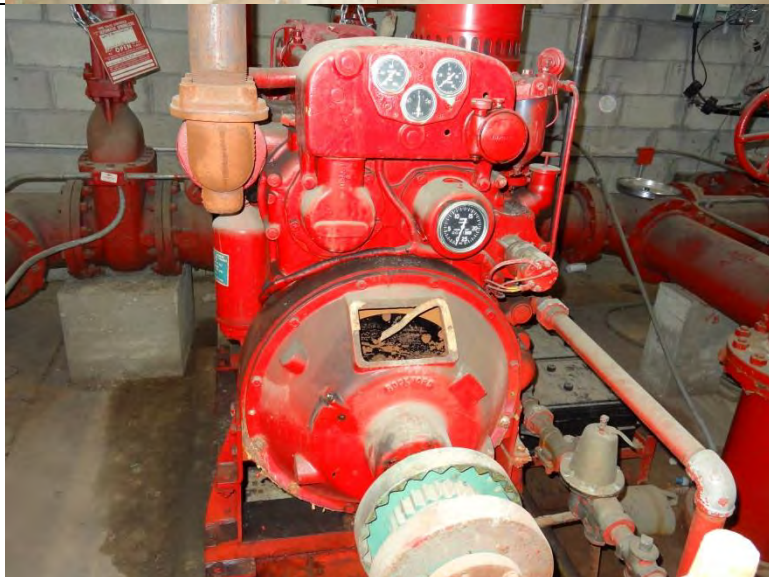
Photo Number: 121

Description  
N Bldg Fire  
Sprinkler  
Suction Pump  
assembly – Fair  
to poor

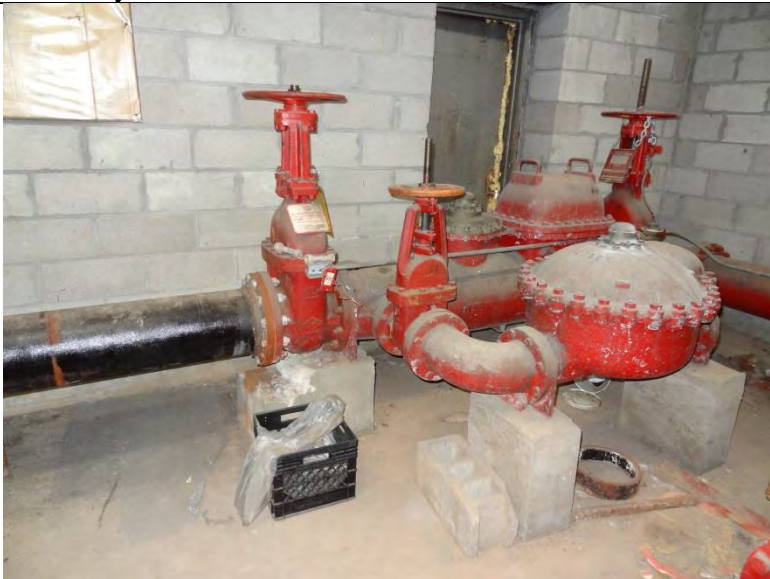
Photo Number: 122

Description  
N Bldg Fire  
Sprinkler  
Valves – Fair to  
Poor

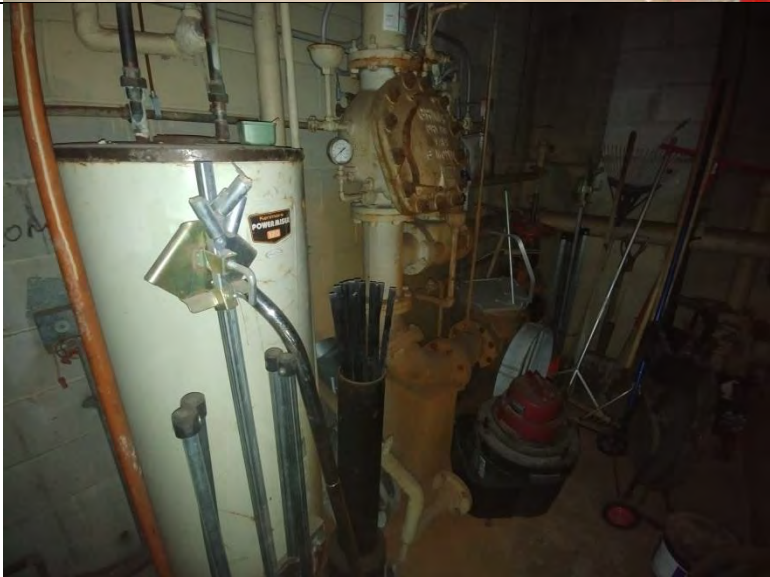
Photo Number: 123

Description  
Graffiti Bldg  
Domestic hot  
water – Fair to  
Poor

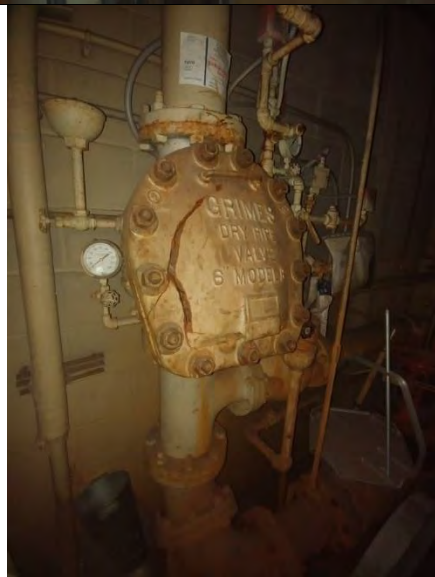
Photo Number: 124

Description  
Graffiti Bldg Dry  
Pipe Valve -  
Fail

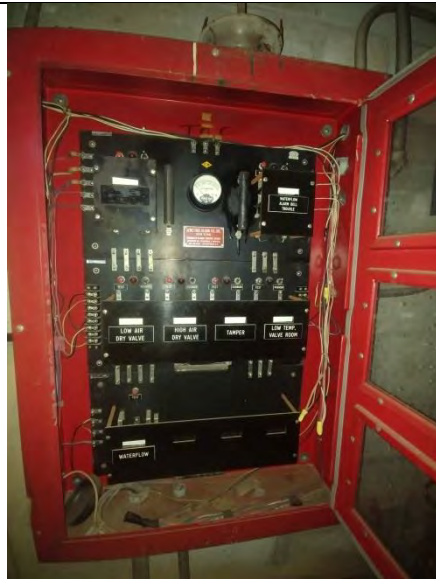
Photo Number: 125  
Date Taken  
January 24, 2018  
Description  
Graffiti Bldg  
Sprinkler  
Control Board -  
Fair

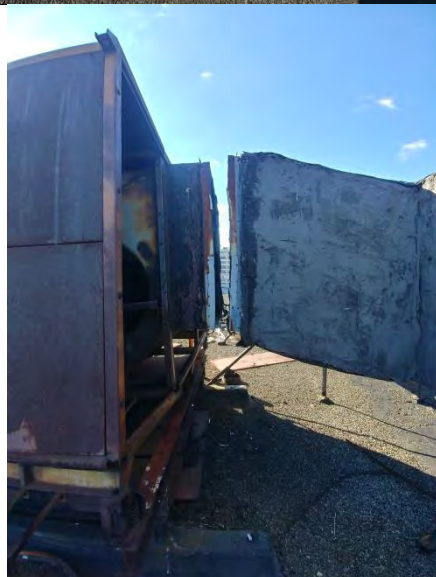
Description  
Graffiti Bldg  
Mechanical  
Exhaust Duct -  
Fai

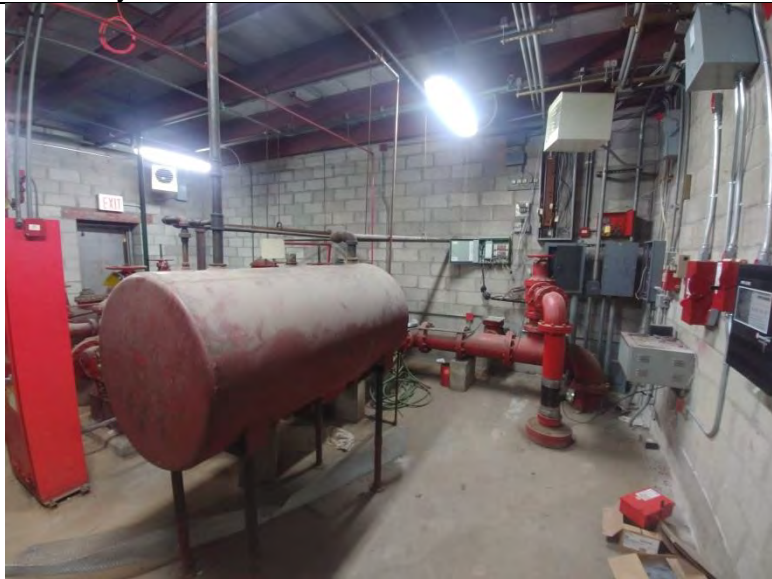
Photo Number: 131

Description  
N Bldg Fire  
Sprinkler  
Control Room –  
Fair to Poor

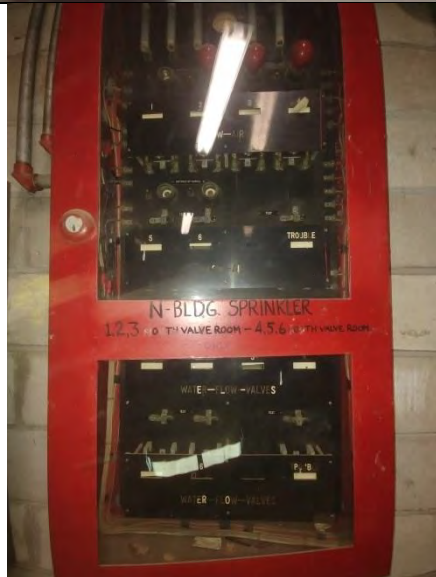
Photo Number: 132

Description  
N Bldg Fire  
Sprinkler  
Control Panel -  
Fair

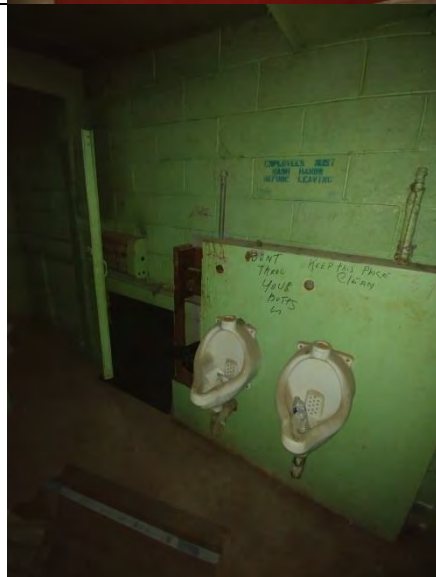
Photo Number: 133

Description  
N Bldg Mens  
Restroom –  
Fair to Poor

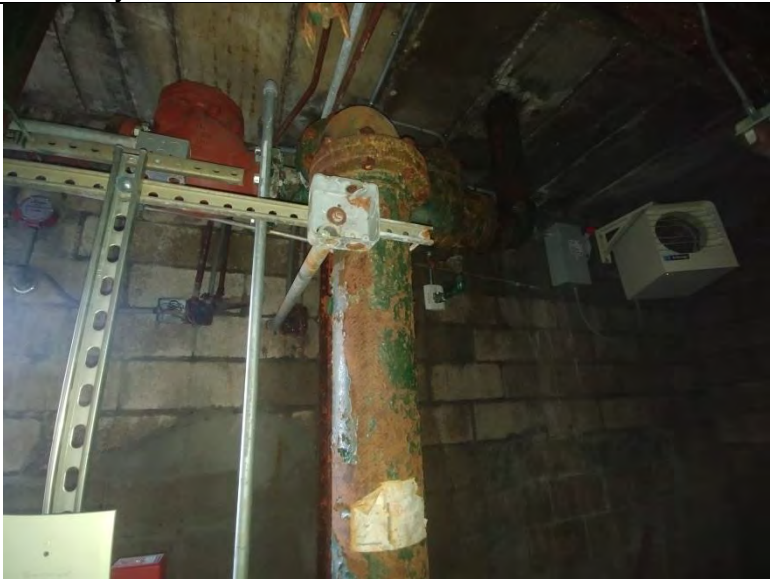
Photo Number: 134

Description  
N Bldg  
Sprinkler Pipes  
– Fair to Poor

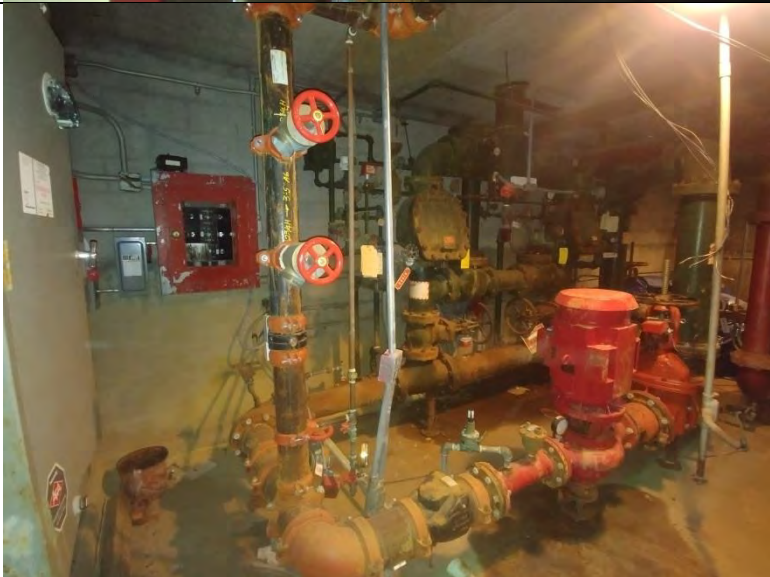
Photo Number: 135

Description  
J2 Shed Fire  
Sprinkler  
Control Valves  
& Pipes Room  
– Poor

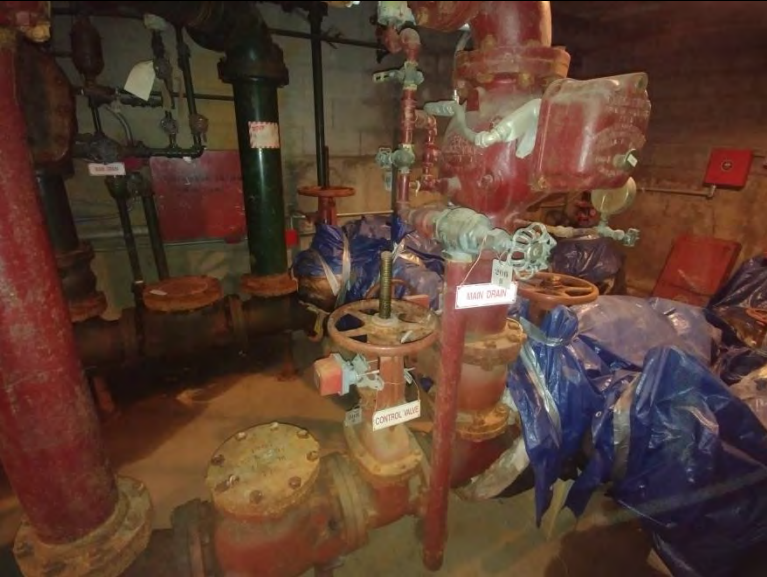
<p>Photo Number: 138</p> <p>Date Taken January 24, 2018</p> <p>Description J2 Shed Fire Sprinkler Main Valve – Poor</p>

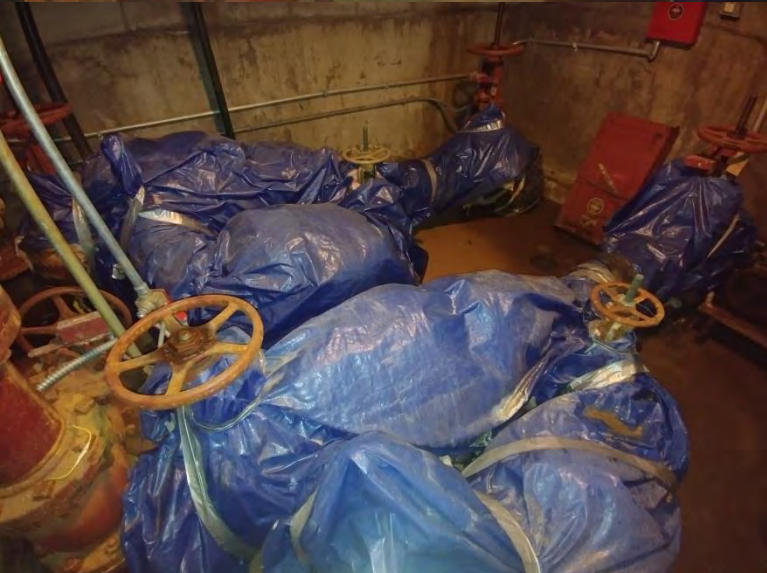
<p>Photo Number: 139</p> <p>Date Taken January 24, 2018</p> <p>Description J2 Shed Fire Sprinkler Valves &amp; Pipe – Poor</p>

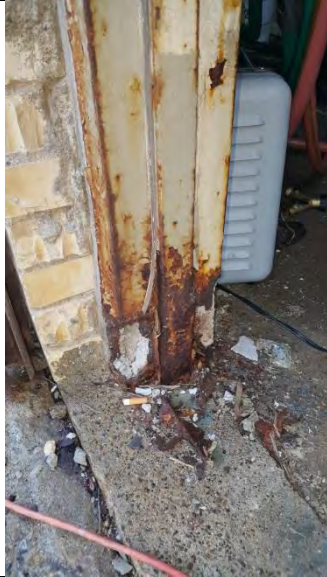
Photo Number: 168

Description  
Tower Building  
– Corroded  
door frame on  
West side of  
building

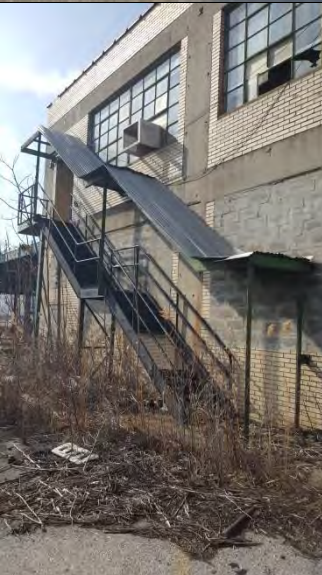
<p>Photo Number: 177</p> <p>Date Taken February 20, 2018</p> <p>Description Tower Building - Broken exterior stairs on East side of building</p>

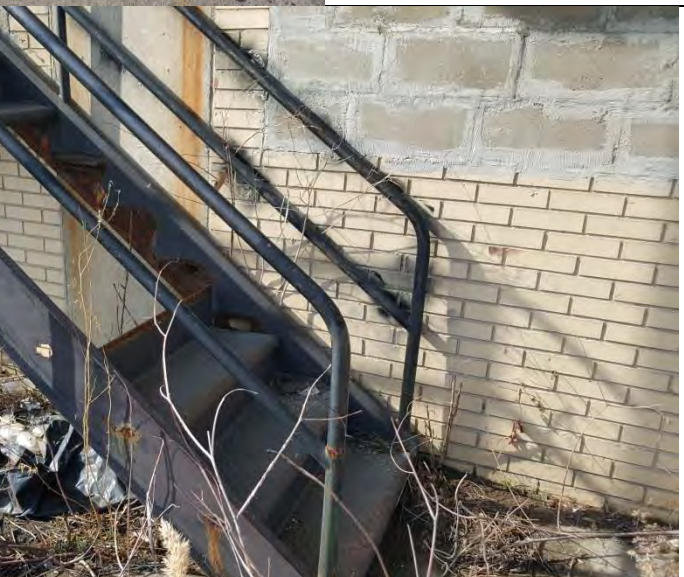
Photo Number: 178

Description  
Tower Building  
- Broken  
exterior stairs  
on East side of  
building

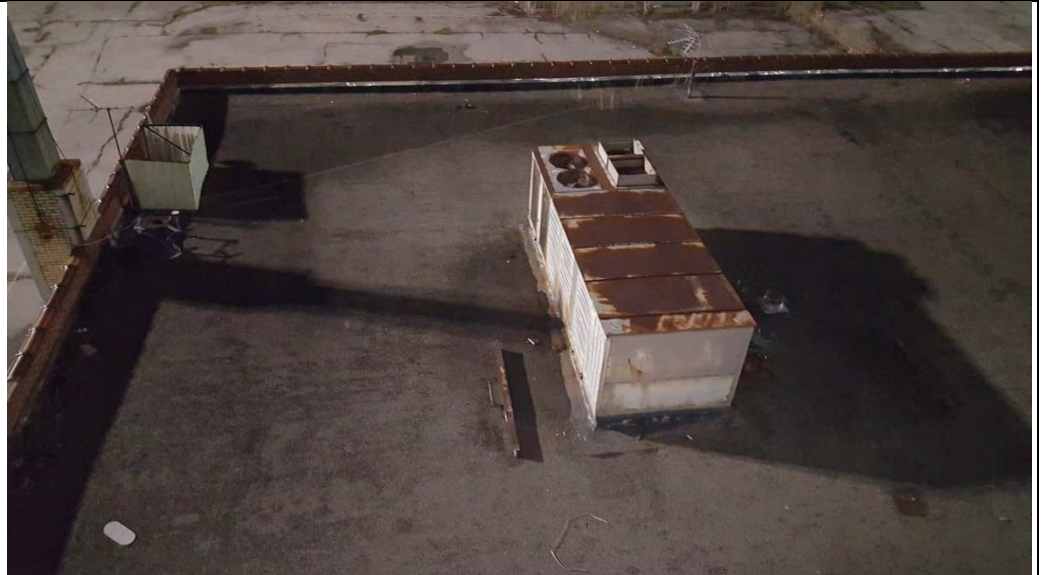
Photo Number: 181

Description  
Tower Building  
- Pooling on  
rooftop

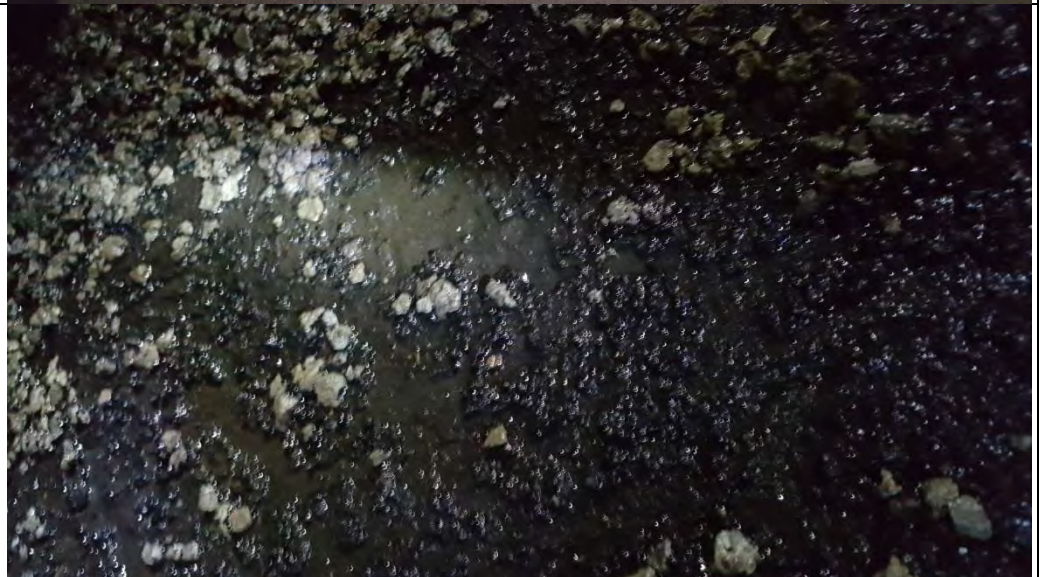
Photo Number: 182

Description  
Tower Building  
– Ponding water and blistered/ bubbling roof membrane

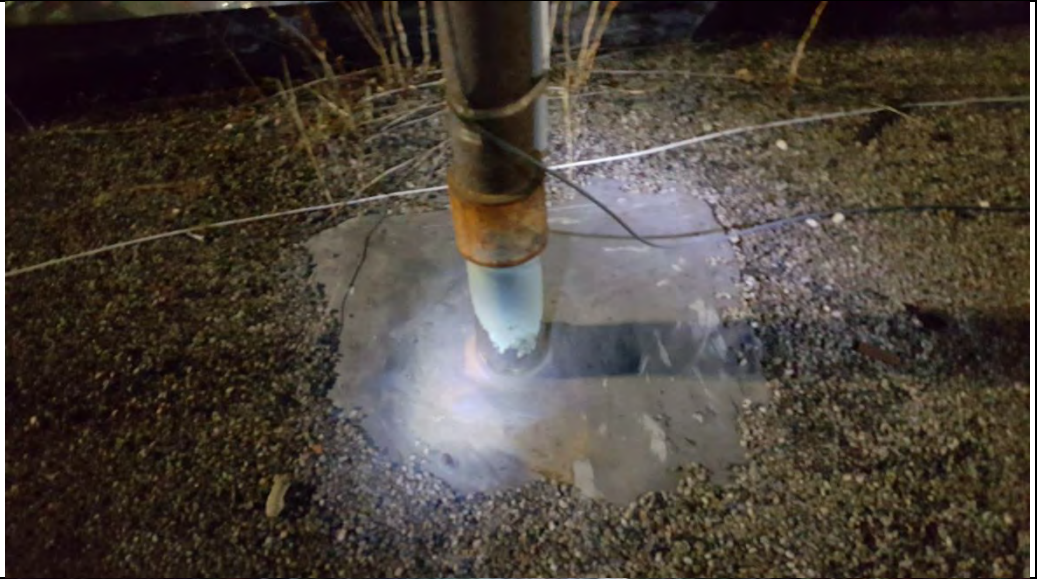
Photo Number: 190  
Date Taken  
February 20, 2018  
Description  
Tower Building  
– Drain cover  
displaced

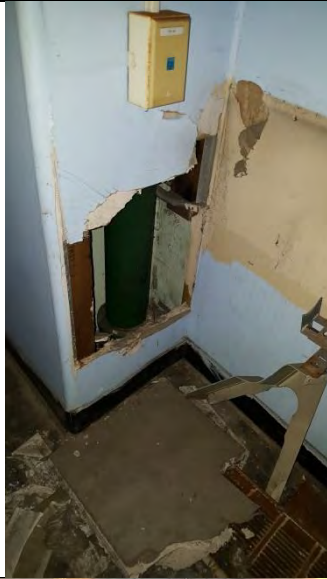
<p>Photo Number: 199</p> <p>Date Taken February 20, 2018</p> <p>Description Tower Building – Heating system removed and pipes cut in office area</p>

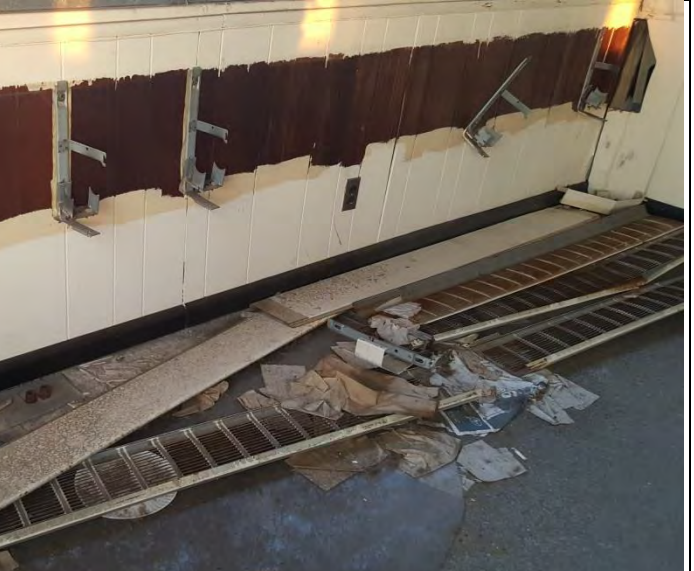
Photo Number: 200

Description  
Tower Building  
– Wall  
damaged in  
office area

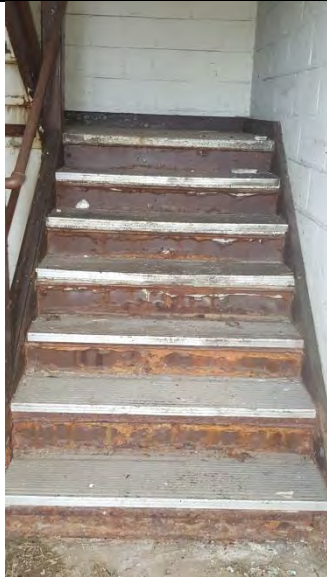
<p>Photo Number: 207</p> <p>Date Taken February 20, 2018</p> <p>Description Tower Building – reinforced steel channels on stairs. Rusted stairs</p>

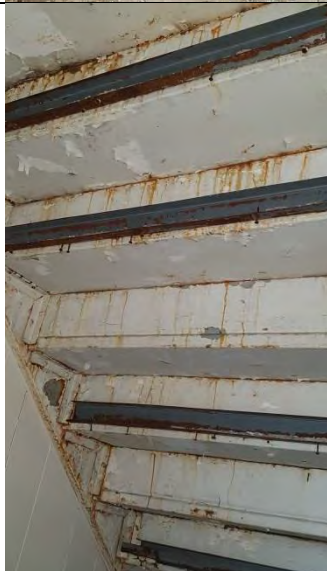
<p>Photo Number: 208</p> <p>Date Taken February 20, 2018</p> <p>Description Tower Building – Broken treads on stairs</p>

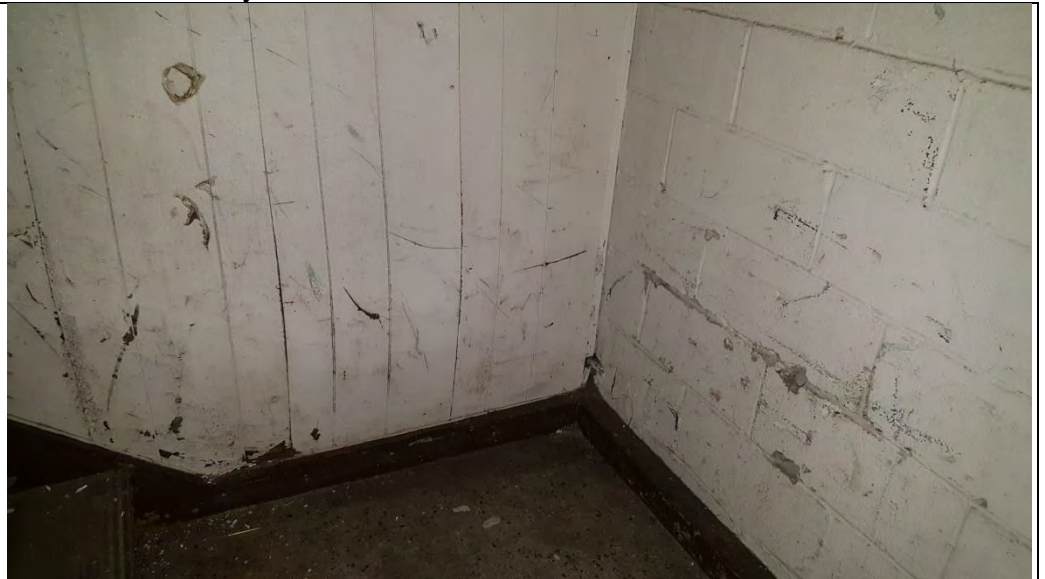
Photo Number: 213

Description  
Tower Building  
– No railing on  
stairs  
(throughout)

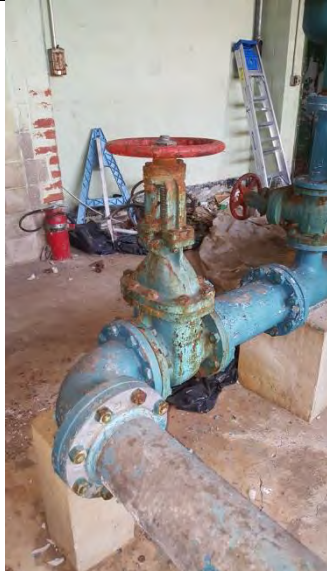
Photo Number: 239

Description  
Tower Building  
– Water main  
pipe  
unattached

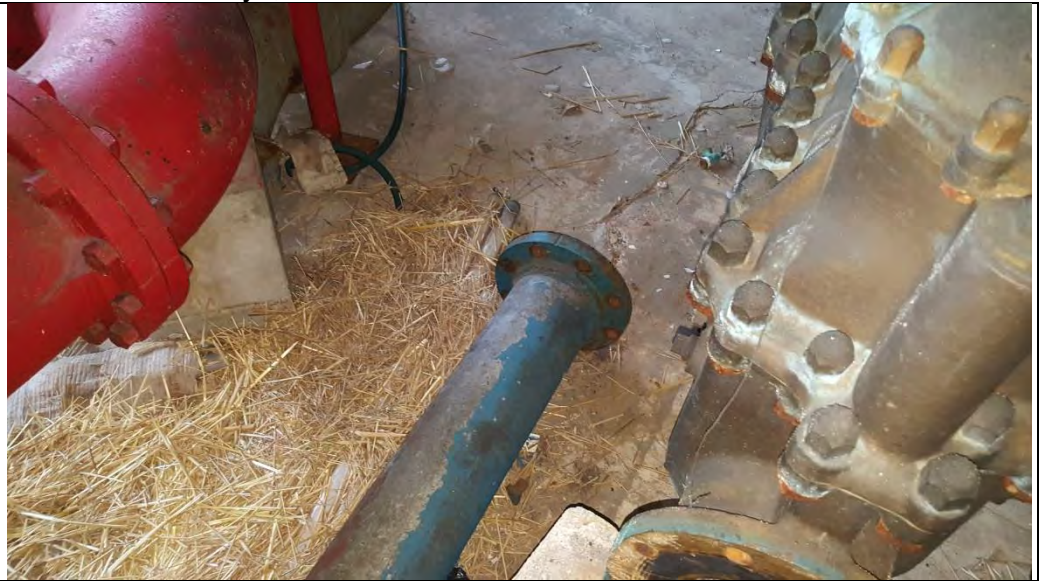
Photo Number: 240

Description  
Tower Building  
– Hydronic  
Heating system  
outlet pipe cut

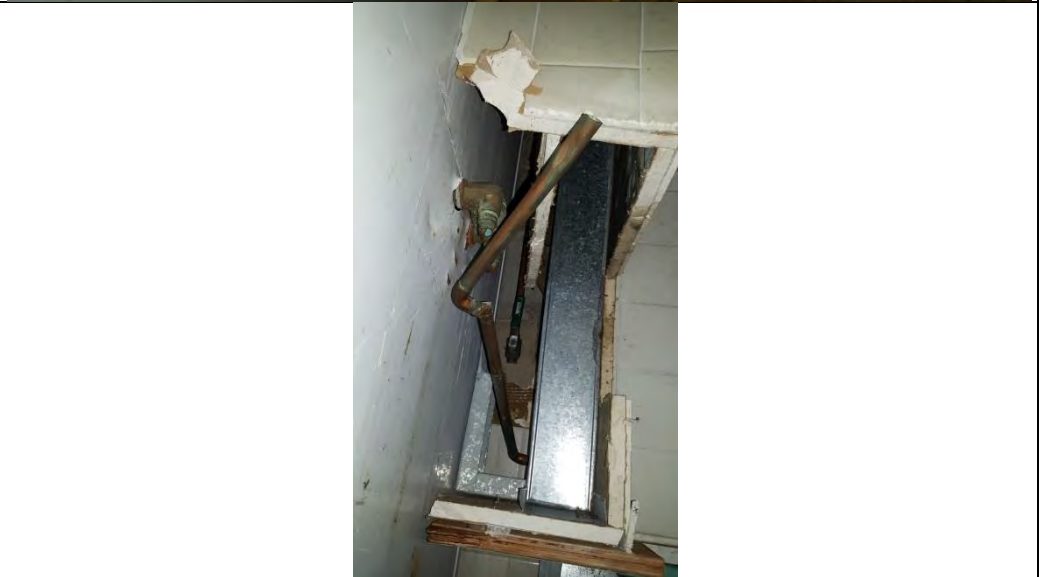
Photo Number: 242

Description  
Tower Building  
– Domestic Hot  
Water heater  
Inlet and outer  
pipes cut.

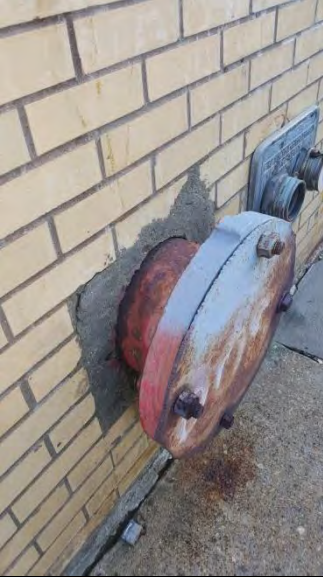
A photograph showing a blue metal standpipe connection mounted on a light-colored brick wall. The connection has a large, open end and a smaller, capped end.	
<p>Photo Number: 246</p> <p>Date Taken February 20, 2018</p> <p>Description Tower Building – Fire Water Main</p>
