**Empire Offshore Wind
Final Environmental
Impact Statement
Volume 6 Part H EAF Appendix K**
September 2023

Appendix K Existing Conditions Report, June 2018

Existing Conditions Report

269 37th Street
Brooklyn, New York

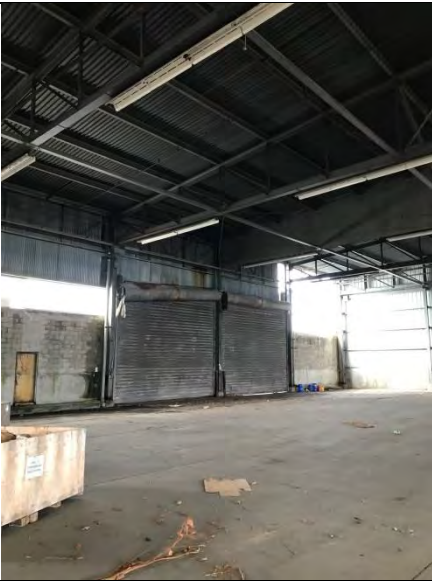
<p>Photo Number: 11</p> <p>Date Taken January 24, 2018</p> <p>Description J1 Shed - Corroded vertical steel door</p>

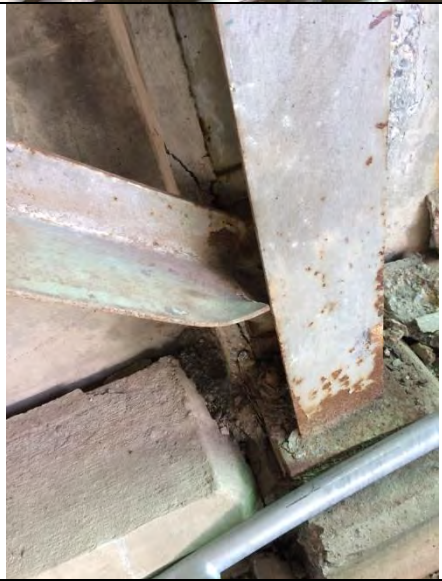
<p>Photo Number: 34</p> <p>Date Taken January 24, 2018</p> <p>Description J2 Shed - Tilted grade beam</p>

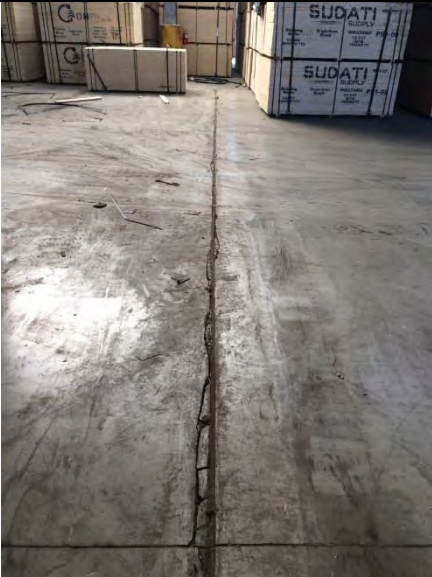
<p>Photo Number: 37</p> <p>Date Taken January 24, 2018</p> <p>Description J2 Shed - Open cold joint at northwest side wall</p>

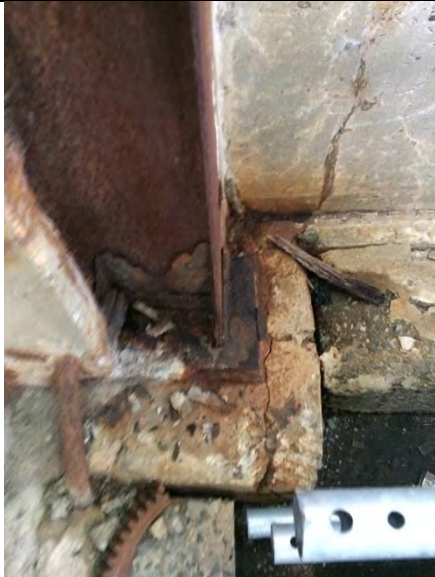
A close-up photograph showing a vertical drain pipe at the base of a shed. The pipe is heavily damaged, with a large section missing or broken, and the surrounding concrete and metal are rusted and crumbling.	
<p>Photo Number: 42</p> <p>Date Taken</p> <p>January 24, 2018</p> <p>Description</p> <p>J2 Shed - Rusted column and cracked concrete base</p>

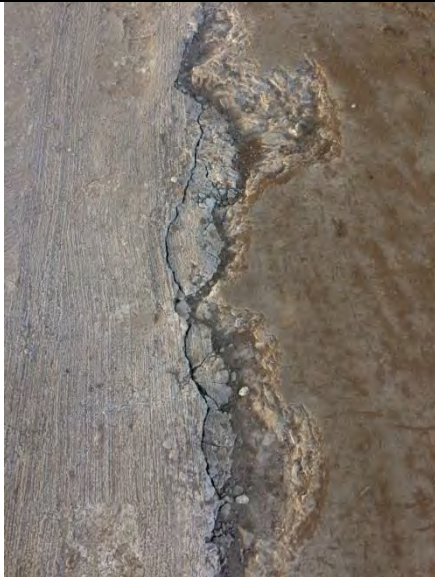
<p>Photo Number: 53</p> <p>Date Taken</p> <p>January 24, 2018</p> <p>Description</p> <p>N Shed - Settlement at column/wall</p>		 	
<p>Photo Number: 54</p> <p>Date Taken</p> <p>January 24, 2018</p> <p>Description</p> <p>N Shed - Cracks on concrete floor</p>

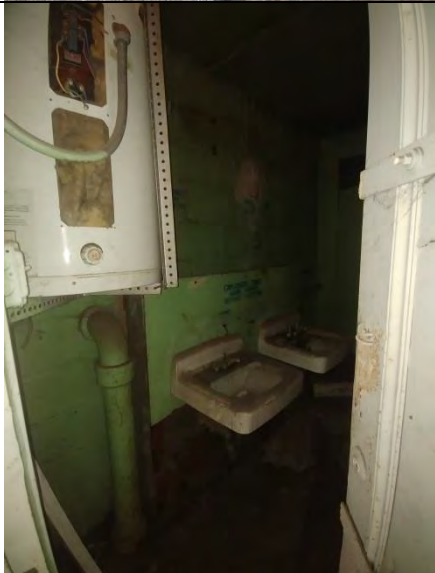
<p>Photo Number: 55</p> <p>Date Taken</p> <p>January 24, 2018</p> <p>Description</p> <p>N Shed - Restroom</p>

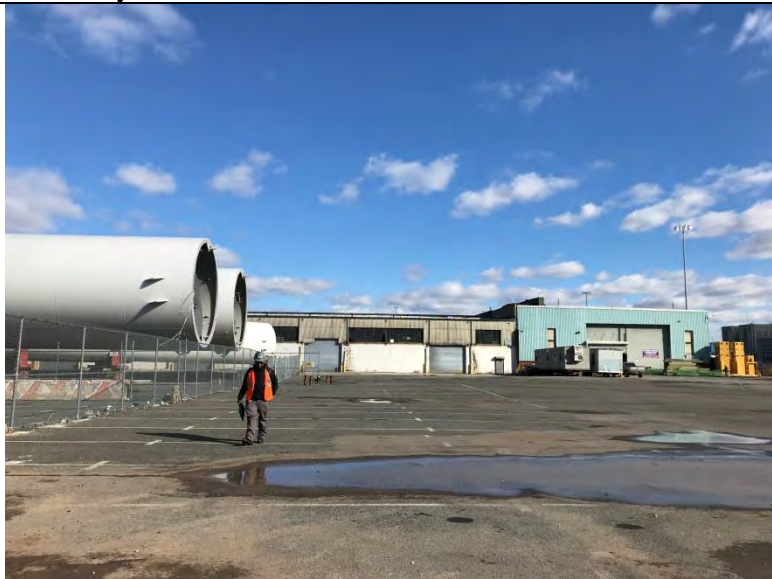
Photo Number: 56

Graffiti Building
and N Shed
Exterior
- Southwest
side

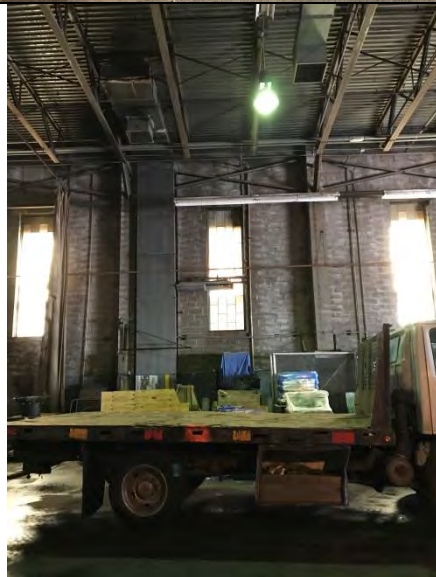
Photo Number: 56a

Graffiti Building
Exterior
- Window

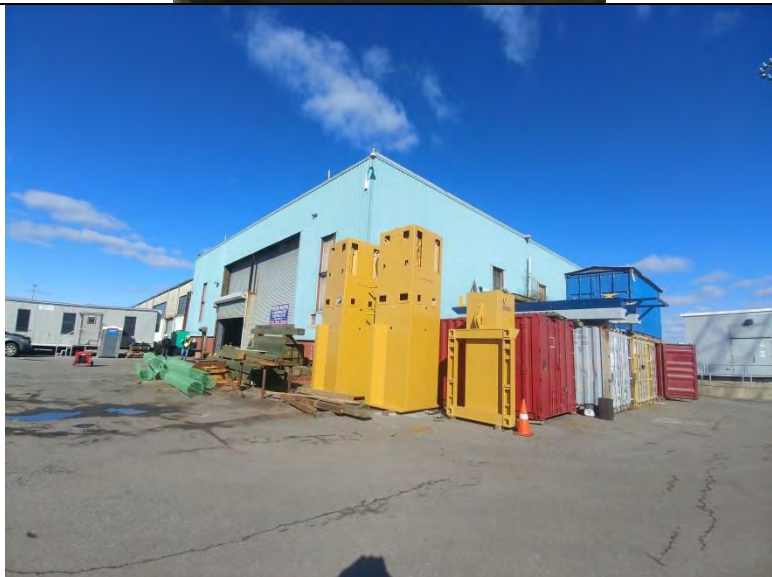
Photo Number: 56b

Graffiti Building
Exterior
- Exterior
door

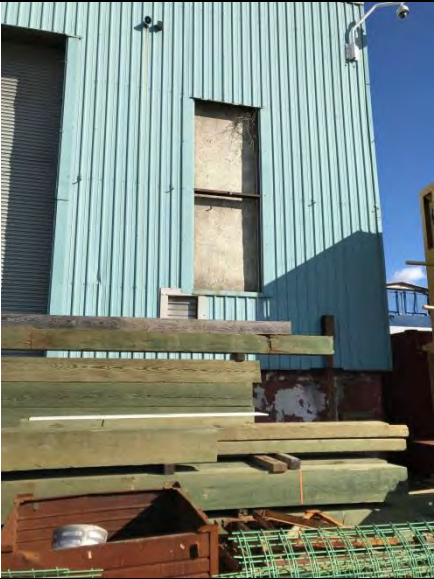
<p>Photo Number: 57</p> <p>Date Taken</p> <p>January 24, 2018</p> <p>Description</p> <p>Graffiti Building Exterior</p> <ul style="list-style-type: none">- Wall Assembly

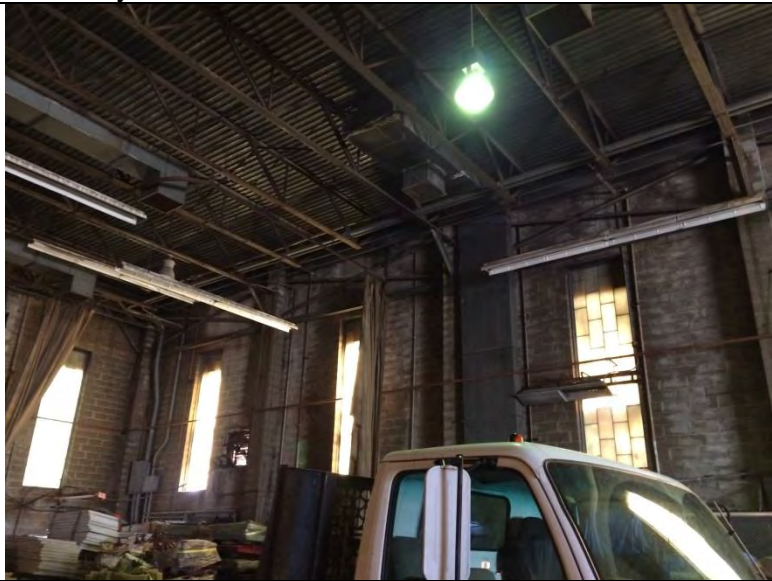
Photo Number: 60

Description
Graffiti Building
Interior
- Northeast
side

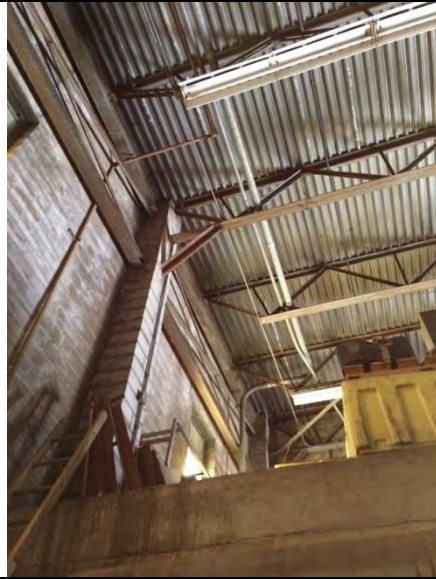
Photo Number: 61

Description
Graffiti Building
- Roof metal
deck

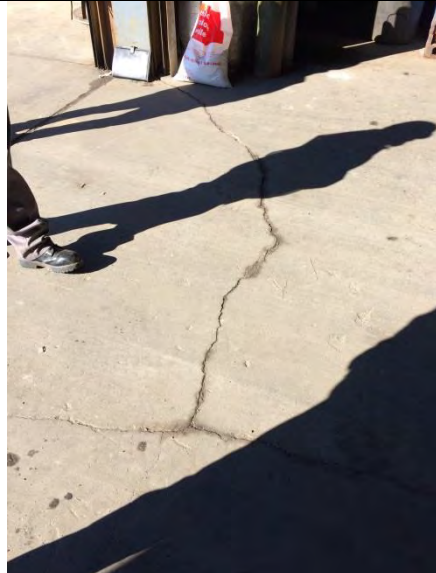
Photo Number: 62

Description
Graffiti Building
- Crack on
concrete
floor

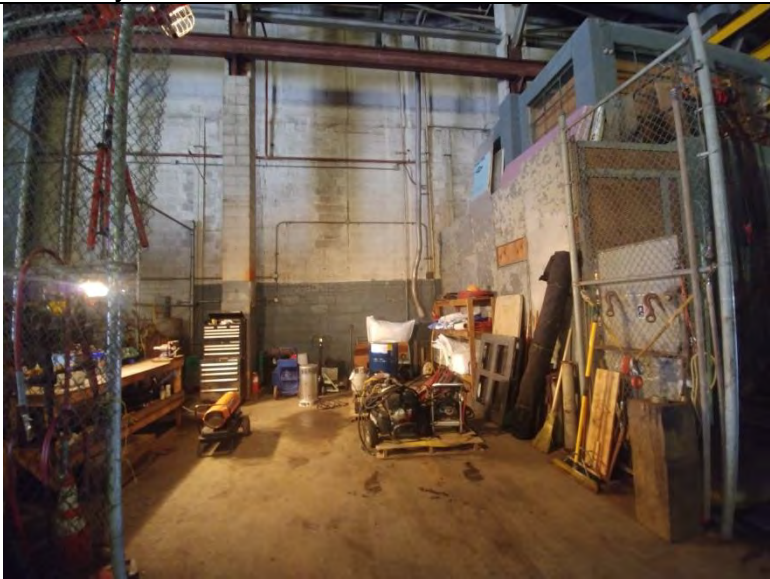
Photo Number: 66

Description
Graffiti Building
- Office

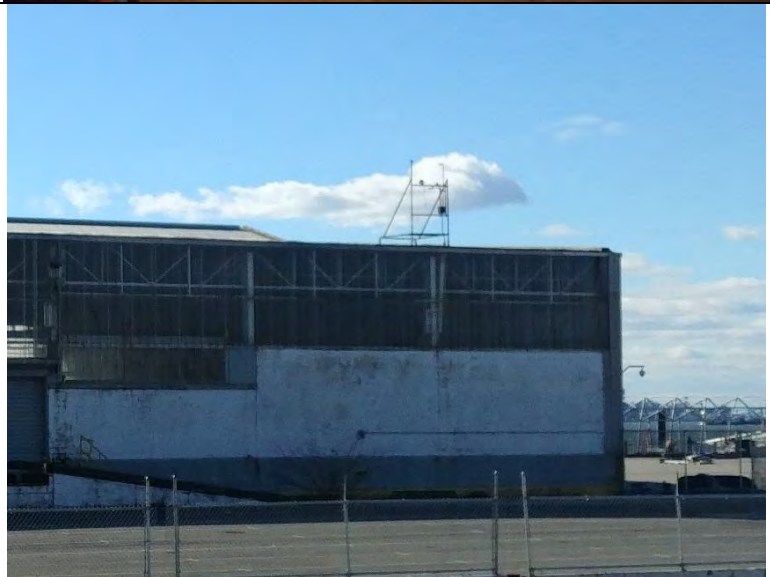
Photo Number: 67

Description
J1 Site Exterior
Lighting – West
End.

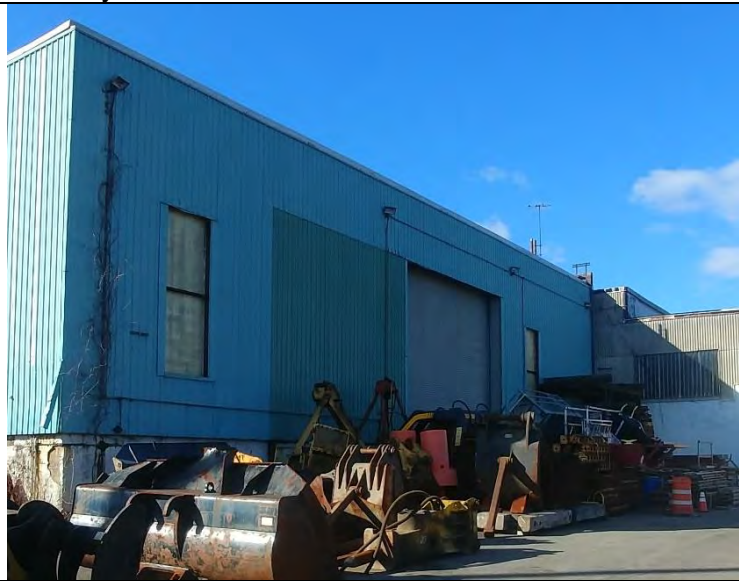
Photo Number: 69

Description
Graffiti Building
Site Lighting –
North End.

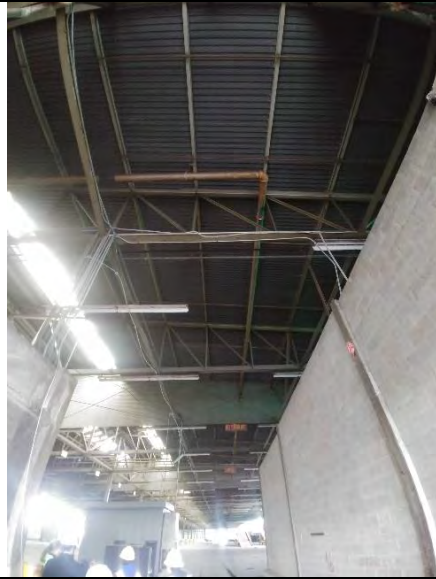
Photo Number: 70

Description
J1 Shed Interior
Lighting.

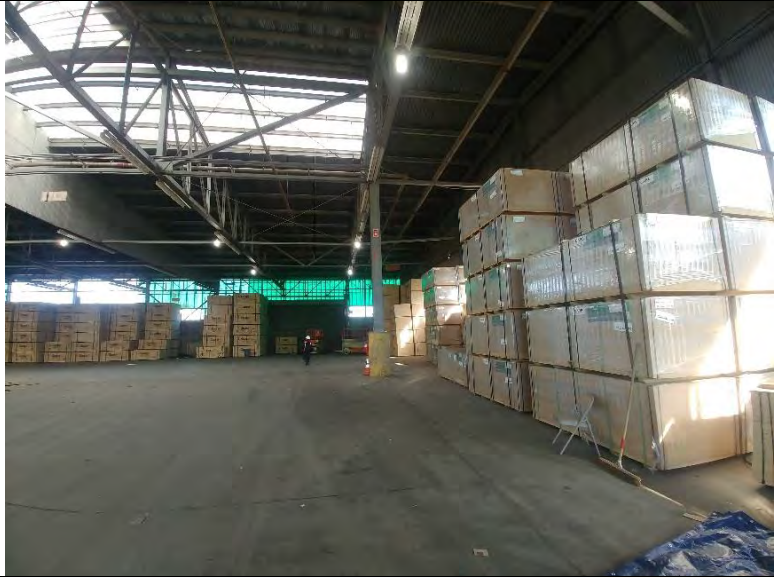
Photo Number: 71

Description
J2 Shed Interior
Lighting –
Temporary
Construction
LEDs, partially
building
coverage only.

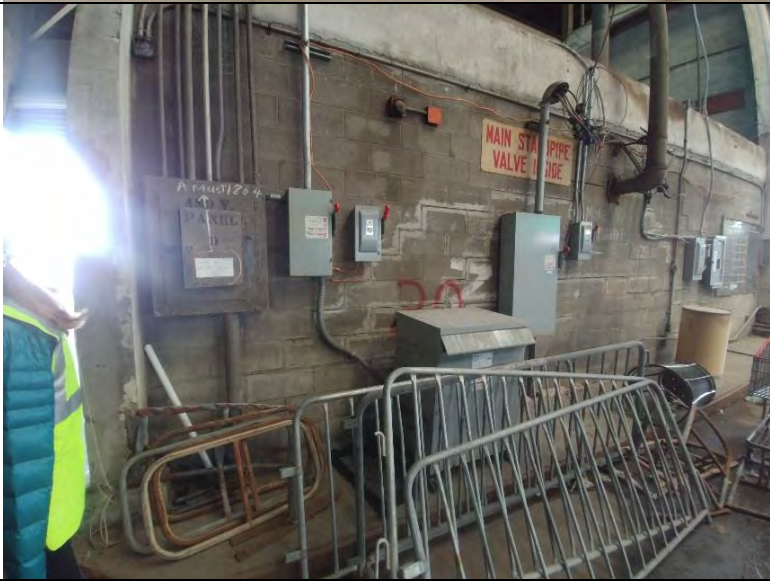
Photo Number: 75

Description
J1 Shed
Electrical
Switches and
Circuit
Breakers
recently
replaced.

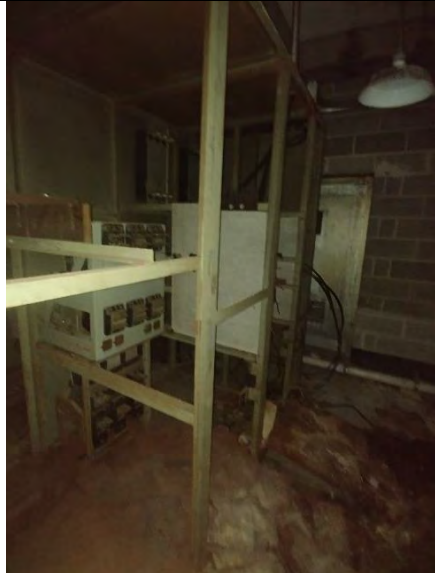
Photo Number: 76

Description
J1 Shed
Electrical
Switchboard –
Abandoned
near Boiler
Room.

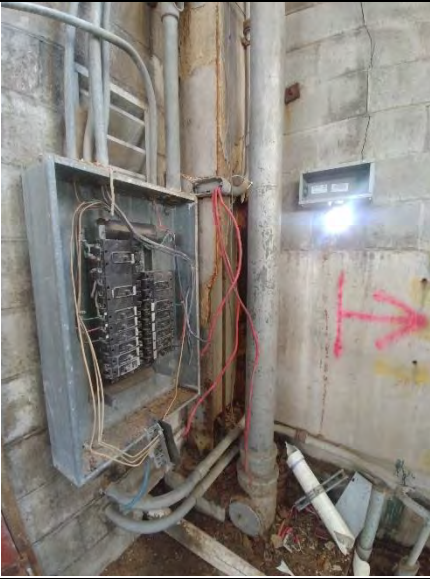
<p>Photo Number: 77</p> <p>Date Taken January 24, 2018</p> <p>Description J1 Shed Electrical Circuit Breaker near Boiler Room.</p>

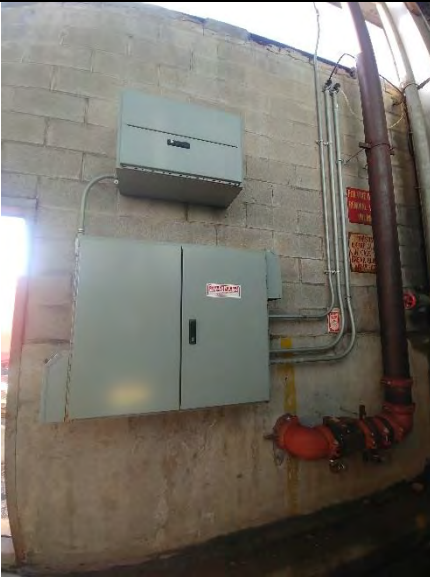
<p>Photo Number: 78</p> <p>Date Taken January 24, 2018</p> <p>Description J2 Shed Newly replaced Locked Electrical Enclosure near the South West.</p>

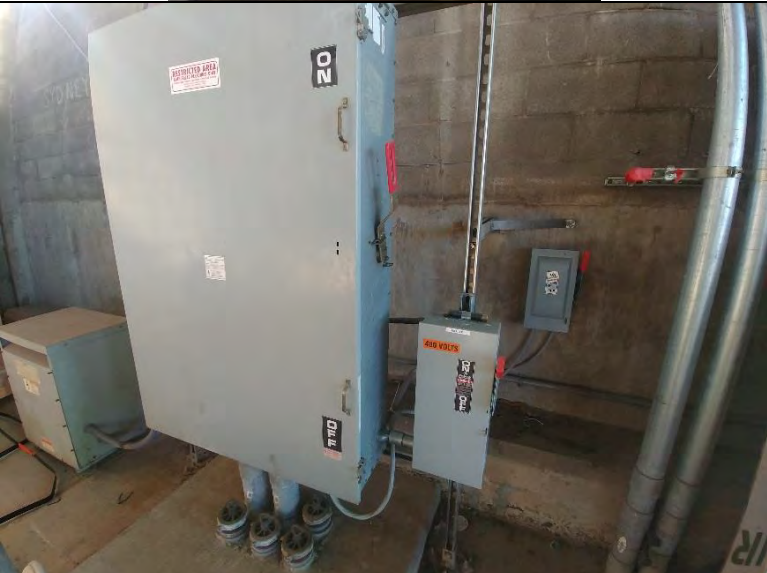
<p>Photo Number: 79</p> <p>Date Taken January 24, 2018</p> <p>Description J2 Shed newly replaced locked electrical enclosures containing Transformer and Switches.</p>

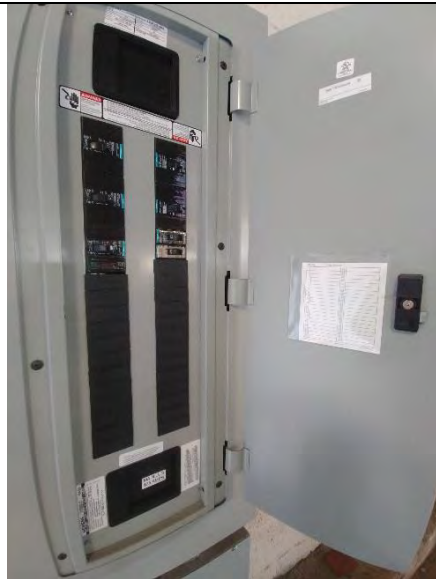
Photo Number: 80

Description
N Shed South
East Entrance
– new electrical
enclosure
containing
circuit breakers.

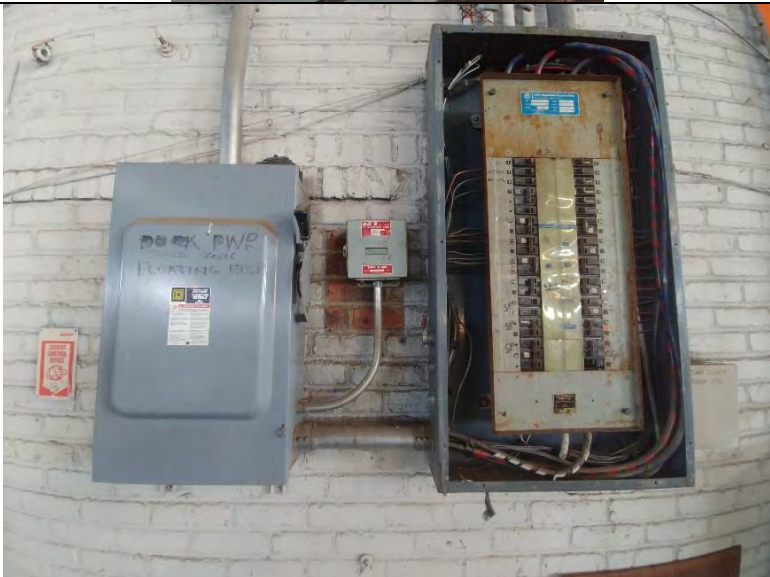
Photo Number: 81

Description
N Shed South
East wall – old
electrical switch
and circuit
breakers.

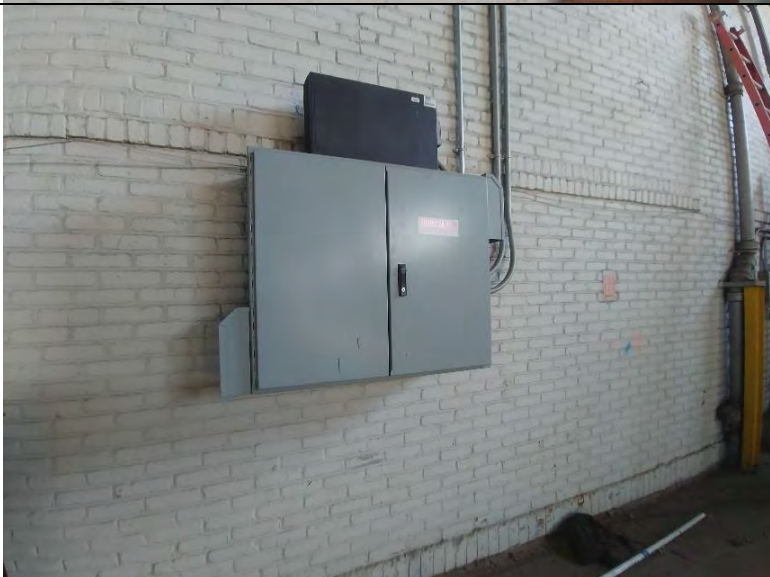
Photo Number: 82

Description
N Shed South
East wall – new
locked
electrical
enclosure.

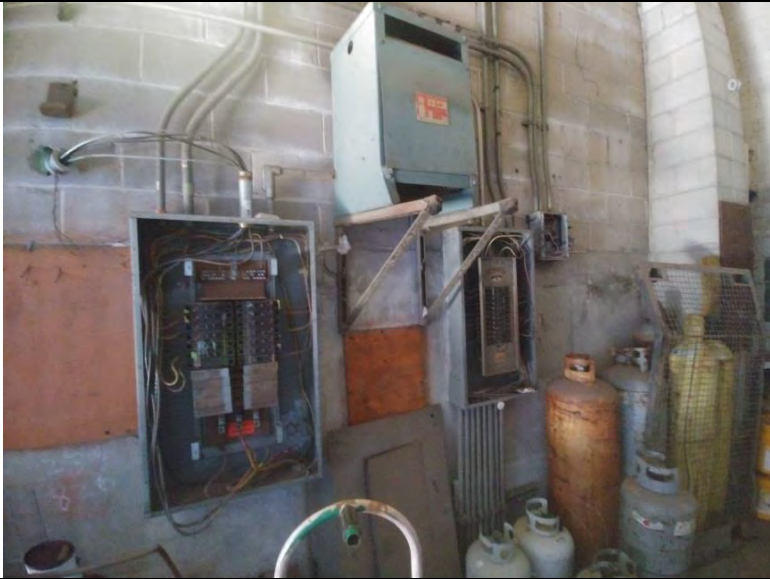
Photo Number: 83

Description
Graffiti Building
South West
wall – old
electrical circuit
breakers and
components.

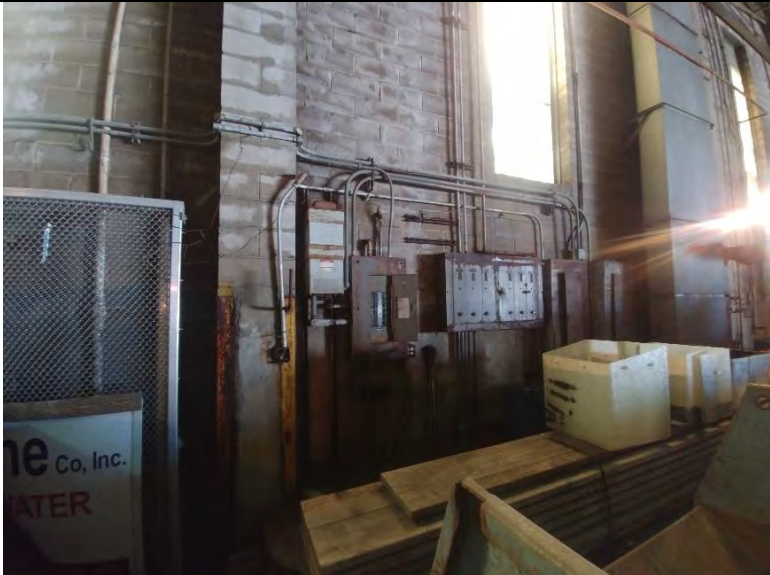
Photo Number: 84

Description
Graffiti Building
South East wall – Electrical
components
excessive
wear. Some
enclosure
rusted shut.

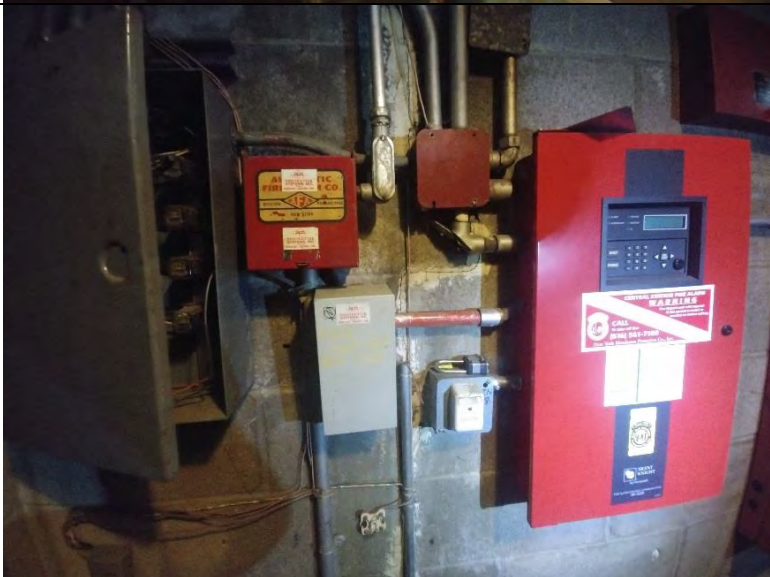
Photo Number: 85

Description
J1 Shed pump
room – new fire
alarm control
panel near old
alarm
components.

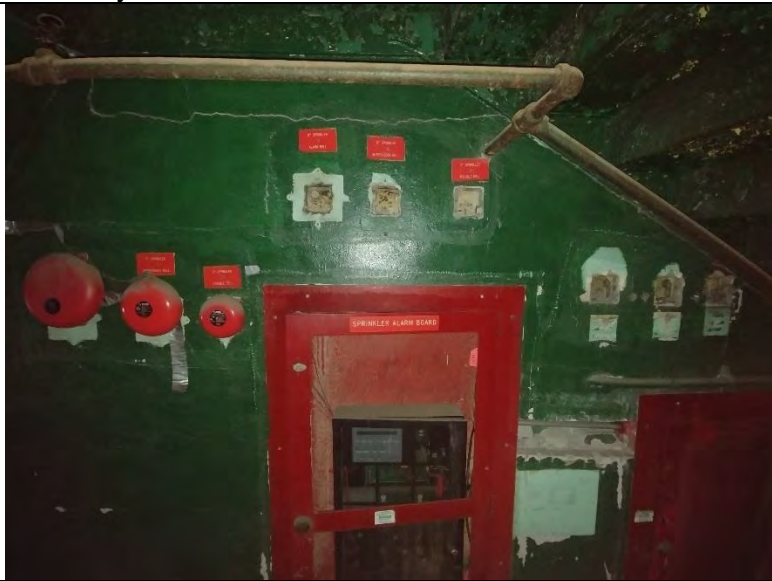
Photo Number: 86

J1 Shed near
pump room –
sprinkler alarm
board and
bells.

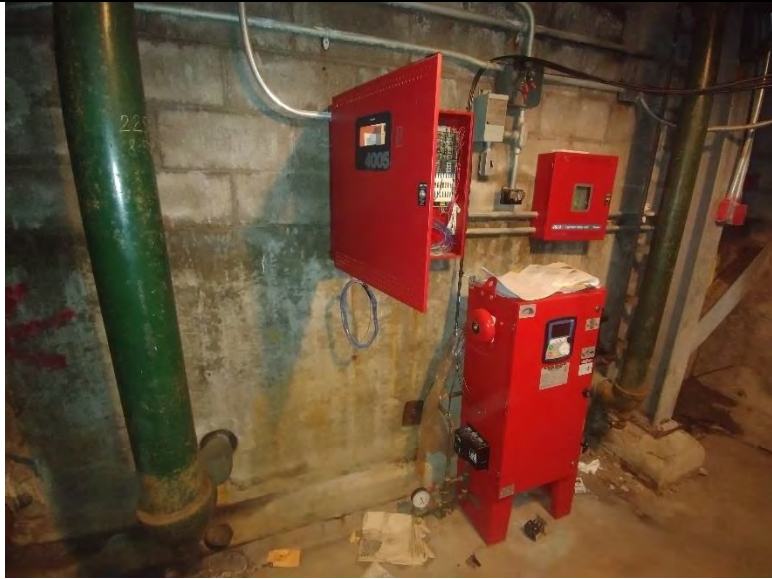
Photo Number: 87

J2 Shed meter
and pump room
– fire alarm
control panel,
electric fire
pump controller
and
suppression
release panel.

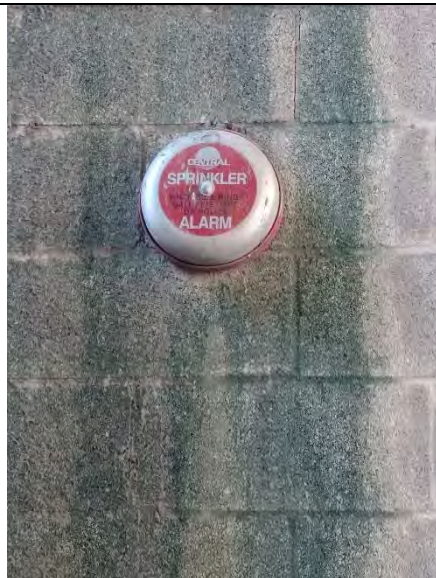
Photo Number: 88

J2 Shed on
meter and
pump room wall
– alarm.

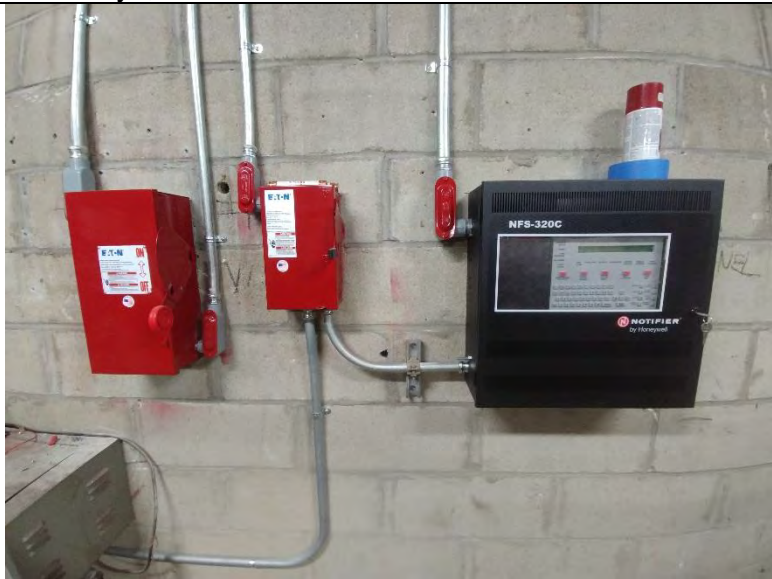
Photo Number: 89

Description
N Shed pump
room – new fire
alarm control
panel and
switches.

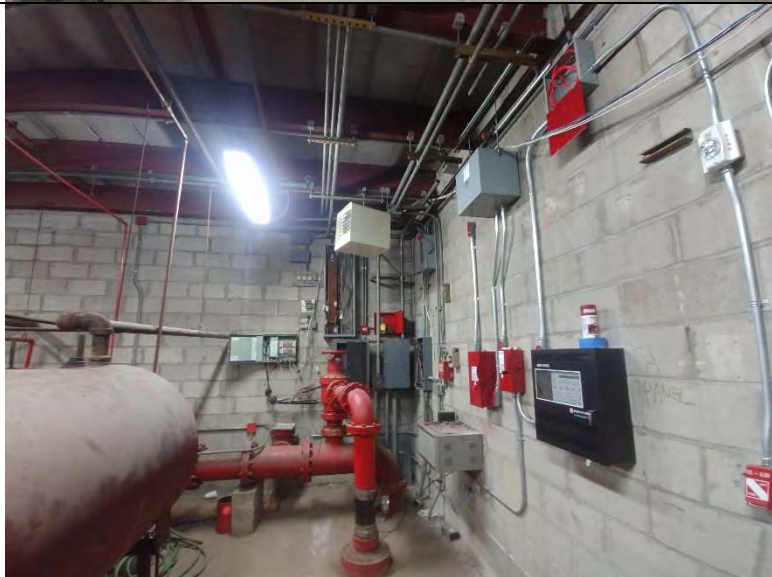
Photo Number: 90

Description
N Shed pump
room

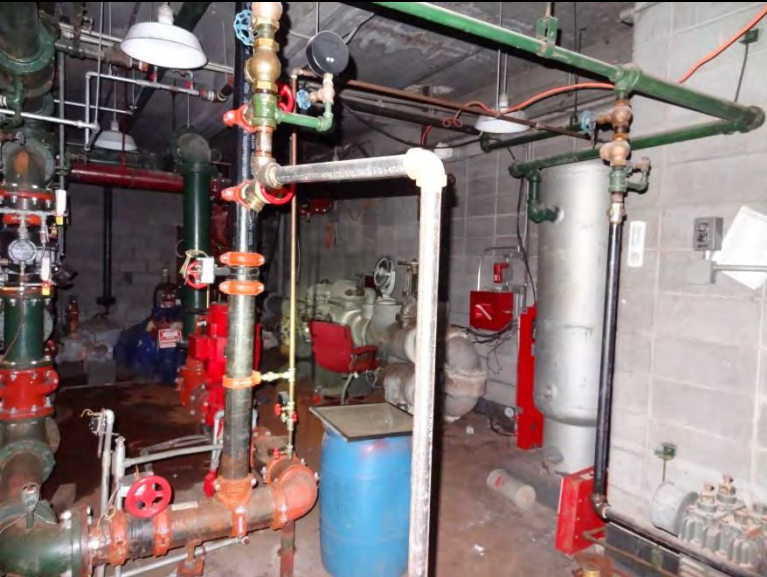
<p>Photo Number: 98</p> <p>Date Taken</p> <p>January 24, 2018</p> <p>Description</p> <p>J1 Shed Pump Room – Main water service and sprinkler valve - Piping in fair to poor condition.</p>

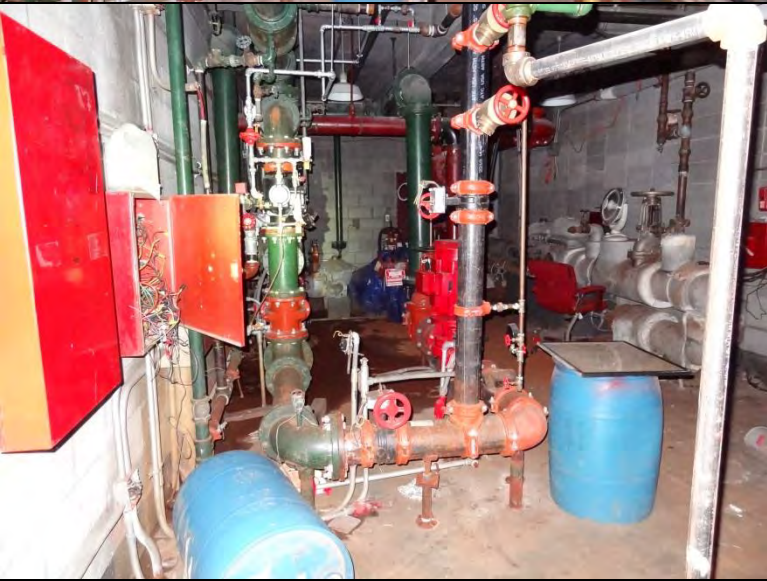
A wide-angle photograph of a pump room. The room is filled with a dense network of pipes, valves, and electrical conduits. A large blue barrel is visible in the foreground. The walls are white, and the floor is concrete. The lighting is somewhat dim, with overhead fixtures.
<p>Photo Number: 99</p> <p>Date Taken</p> <p>January 24, 2018</p> <p>Description</p> <p>J1 Shed Pump Room – Piping in fair to poor condition.</p>

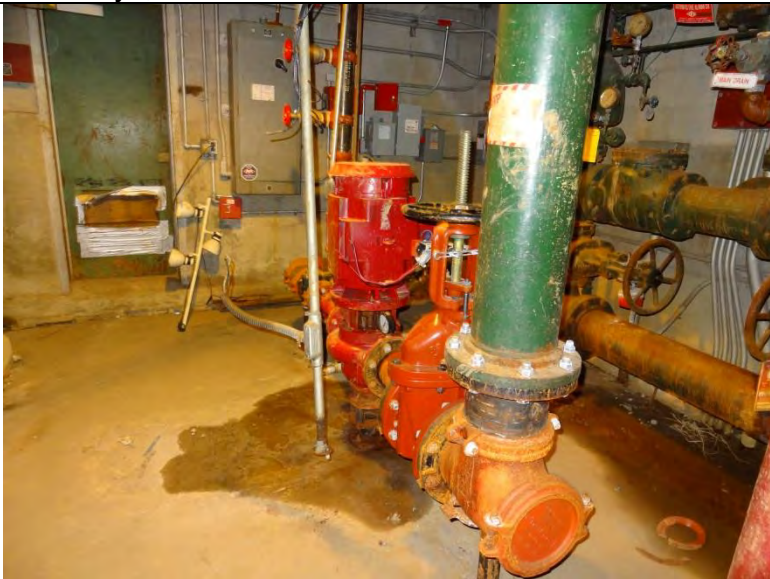
Description
J1 Shed - Fire
Sprinkler
Control Valve
assembly – Fair
to poor
condition.

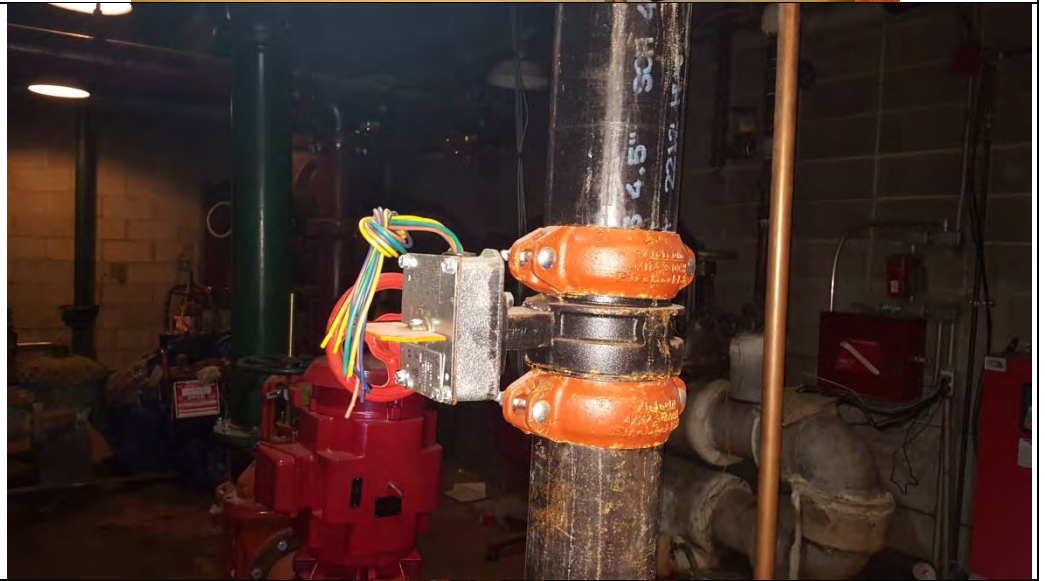
Photo Number: 102

Description
J1 Shed Pump
Room – Fair to
Poor

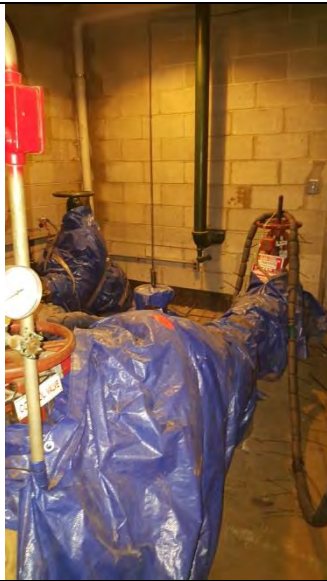
<p>Photo Number: 104</p> <p>Date Taken January 24, 2018</p> <p>Description J1 Shed Fire Sprinkler Control Valve – Fair to poor.</p>

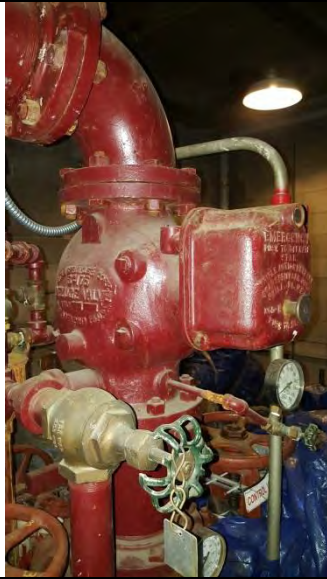
<p>Photo Number: 105</p> <p>Date Taken January 24, 2018</p> <p>Description J1 Shed Fire Sprinkler Control and Deluge Valve assembly – Fair to poor.</p>

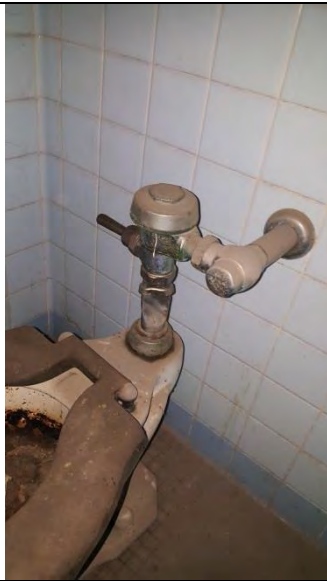
<p>Photo Number: 113</p> <p>Date Taken</p> <p>January 24, 2018</p> <p>Description</p> <p>J1 Shed Water Closet - Failed</p>

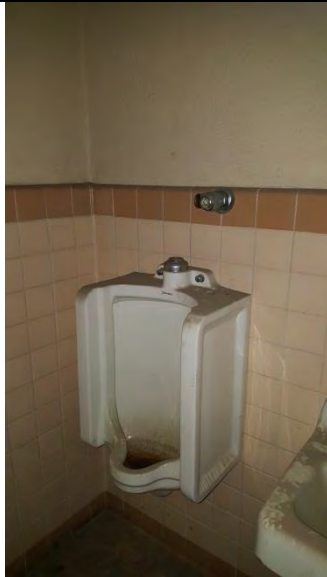
<p>Photo Number: 114</p> <p>Date Taken</p> <p>January 24, 2018</p> <p>Description</p> <p>J1 Shed Urinal - Failed</p>

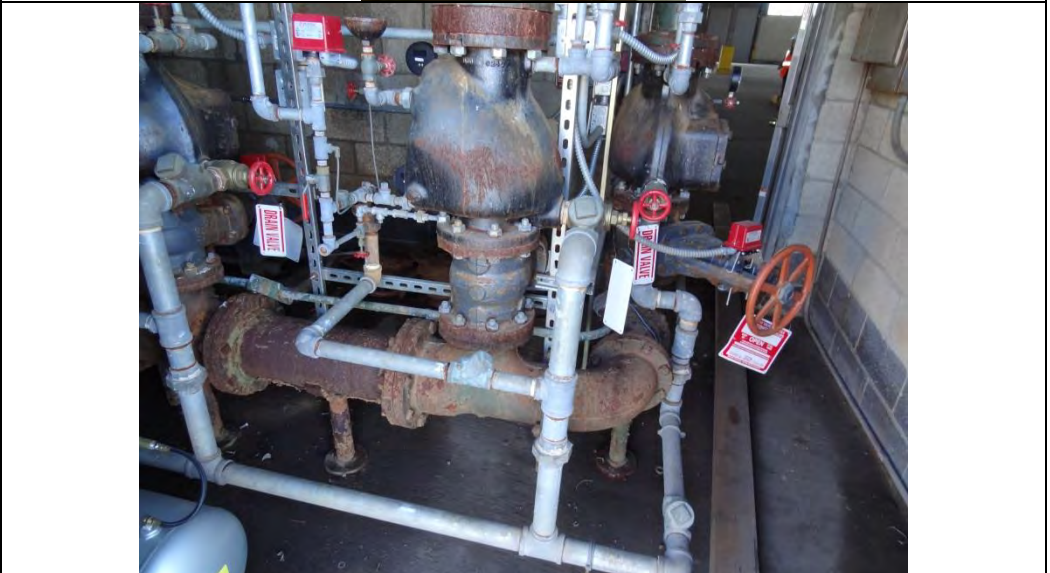
<p>Photo Number: 115</p> <p>Date Taken</p> <p>January 24, 2018</p> <p>Description</p> <p>N Bldg Sprinkler pipes - Fair to Poor</p>

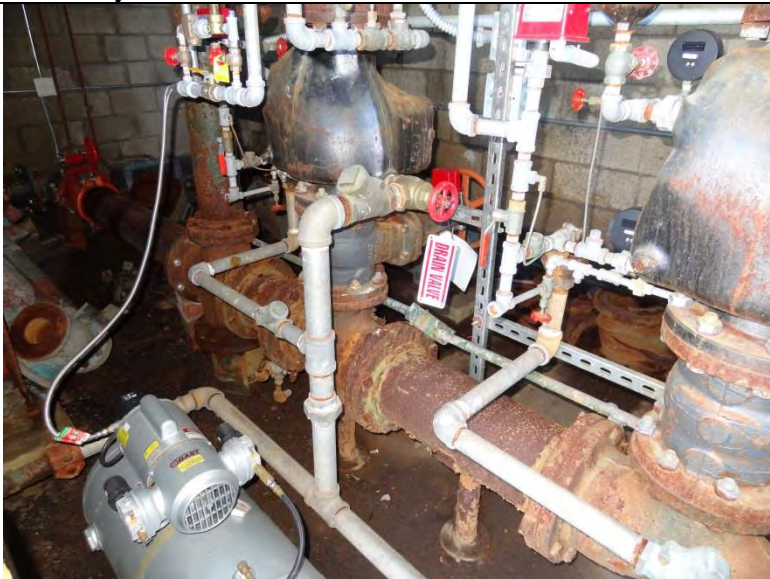
Photo Number: 116
Date Taken
January 24, 2018
Description
N Bldg
Sprinkler pipes
– Fair to Poor

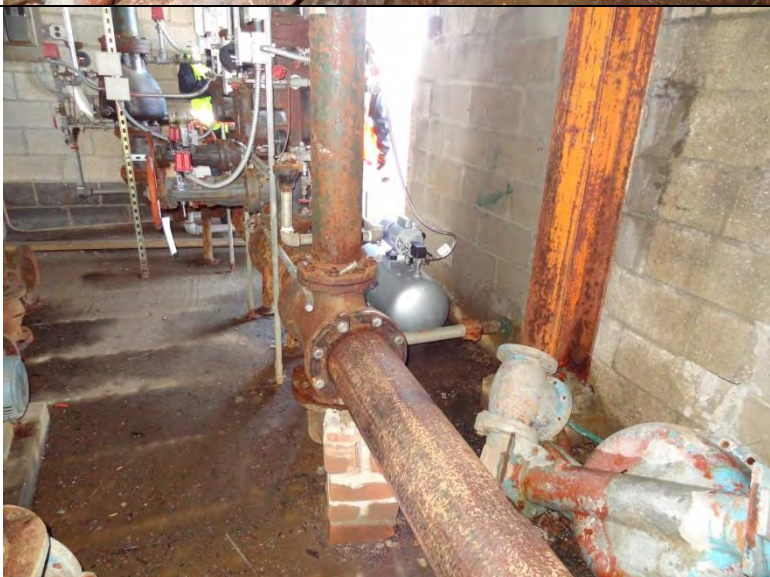
Photo Number: 118
Date Taken
January 24, 2018
Description
N Bldg
Sprinkler Pipes
– Fair to Poor

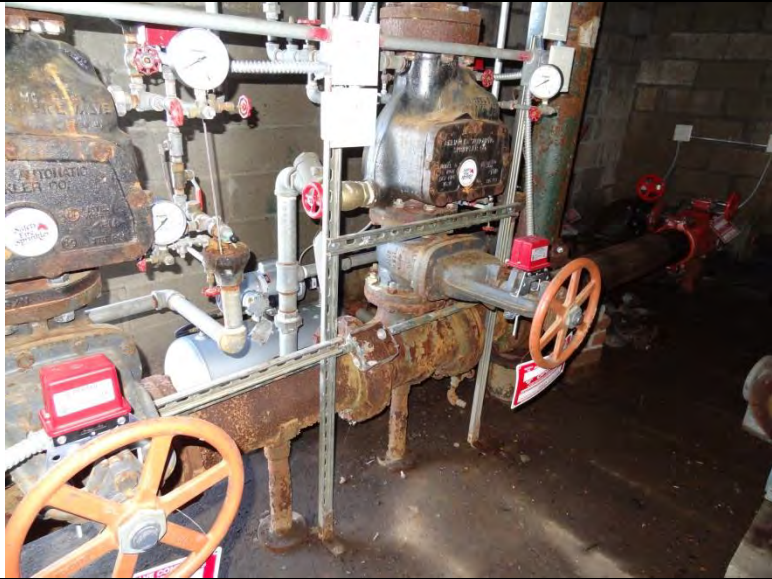
Photo Number: 119

Description
N Bldg
Sprinkler
Valves – Fair to
Poor

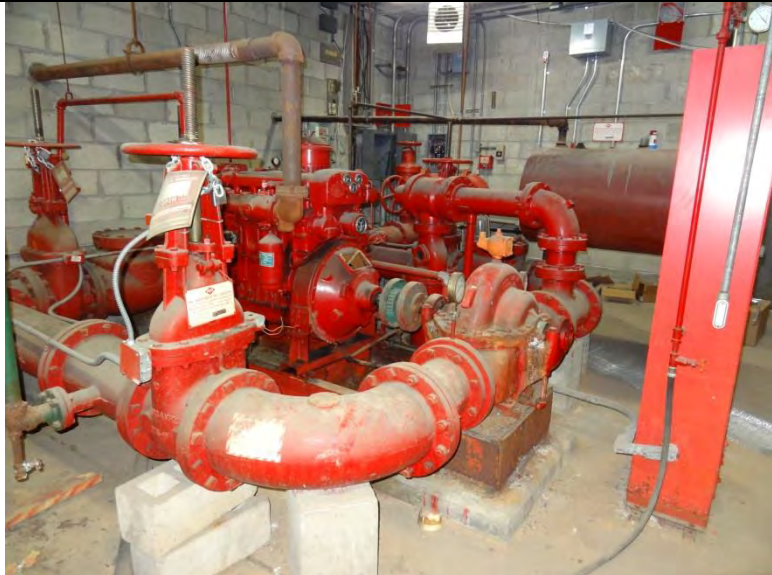
Photo Number: 120

Description
N Bldg Fire
Sprinkler Pump
Assembly –
Fair to poor

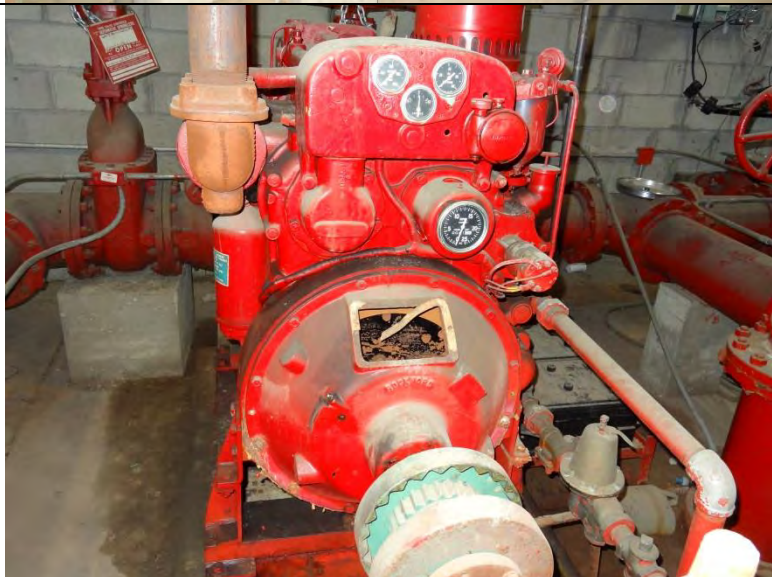
Photo Number: 121

Description
N Bldg Fire
Sprinkler
Suction Pump
assembly – Fair
to poor

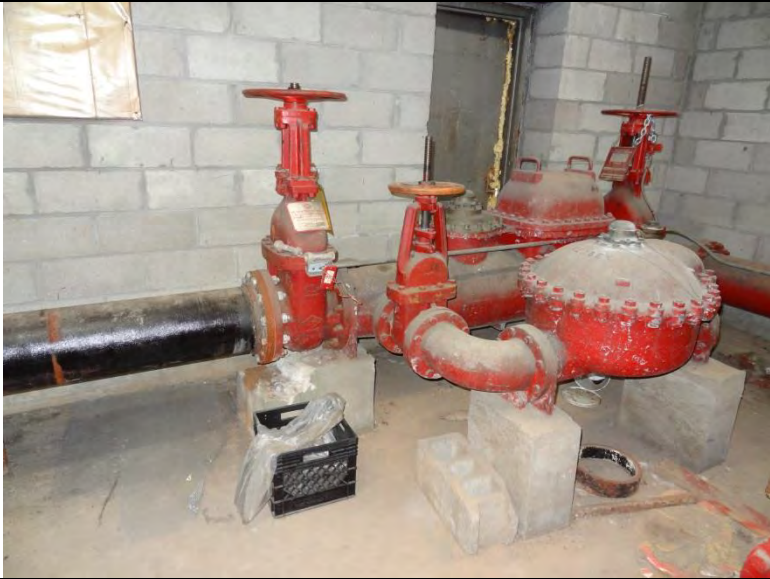
Photo Number: 122
Date Taken
January 24, 2018
Description
N Bldg Fire
Sprinkler
Valves – Fair to
Poor

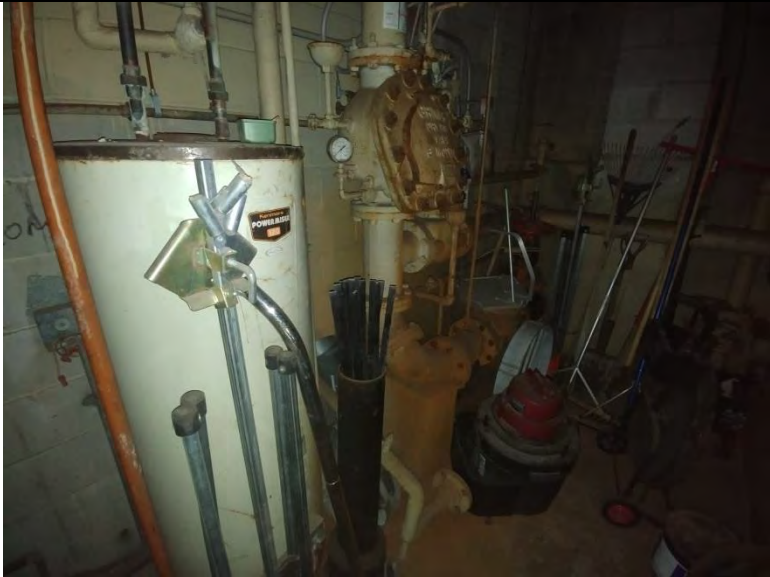
Photo Number: 123
Date Taken
January 24, 2018
Description
Graffiti Bldg
Domestic hot
water – Fair to
Poor

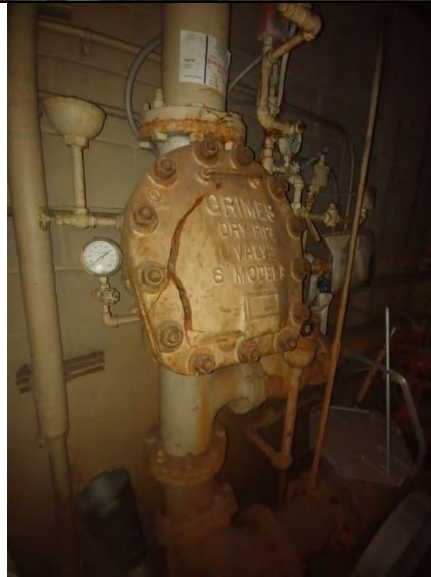
Photo Number: 124
Date Taken
January 24, 2018
Description
Graffiti Bldg Dry
Pipe Valve -
Fail

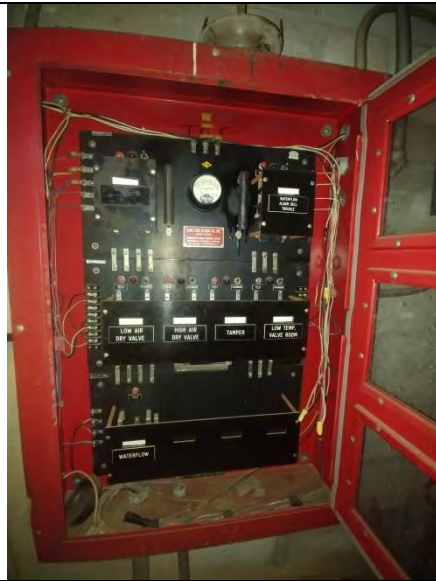
Photo Number: 125

Description
Graffiti Bldg
Sprinkler
Control Board -
Fair

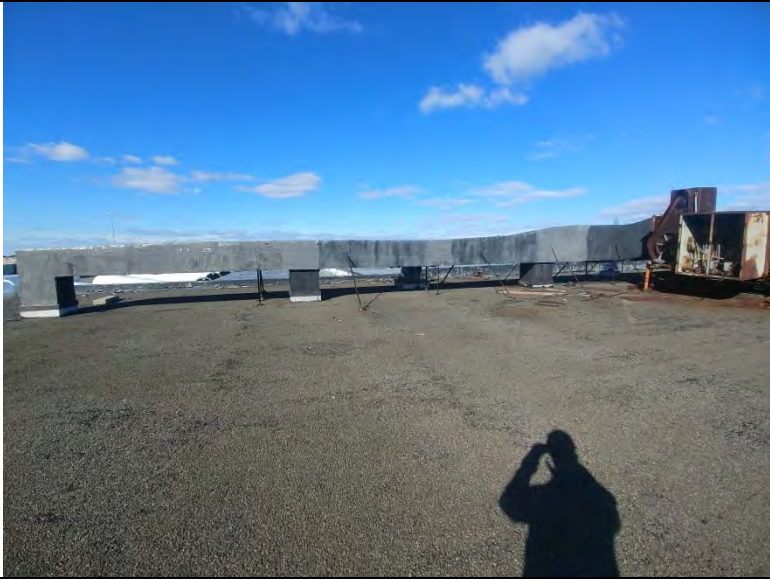
Description
Graffiti Bldg
Mechanical
Exhaust Duct -
Fail

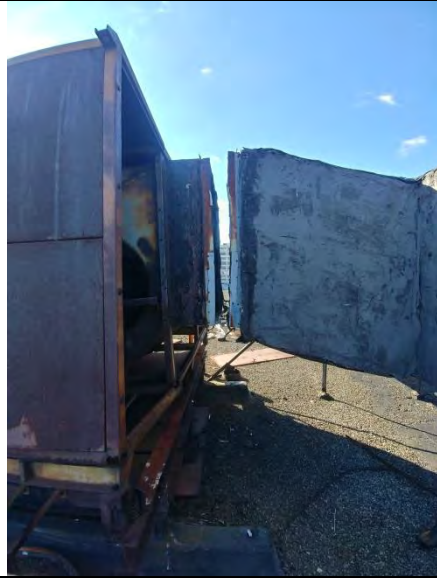
Photo Number: 130

Description
Graffiti Bldg
Mechanical
Exhaust Duct -
Fai

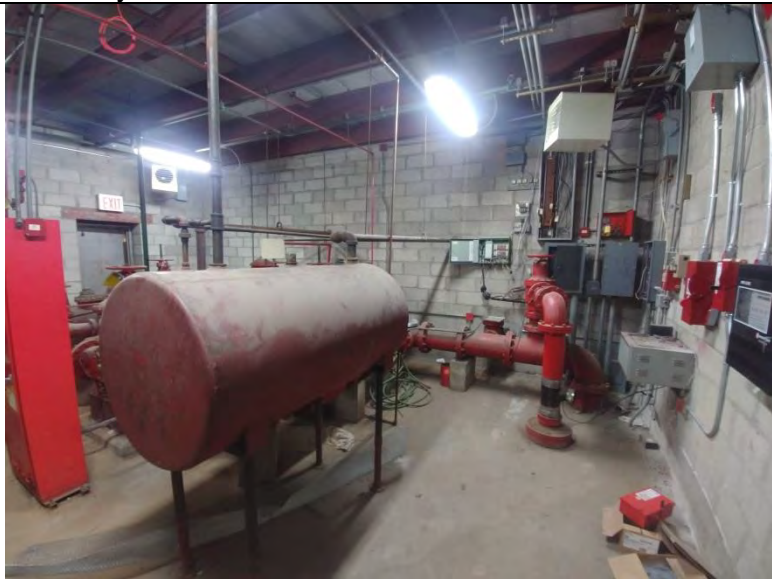
Photo Number: 131

Description
N Bldg Fire
Sprinkler
Control Room –
Fair to Poor

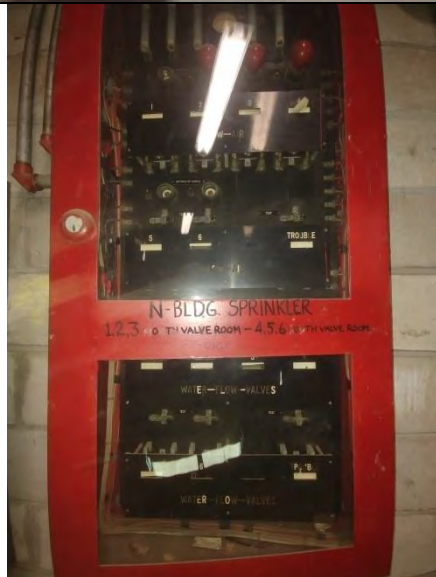
Photo Number: 132

Description
N Bldg Fire
Sprinkler
Control Panel -
Fair

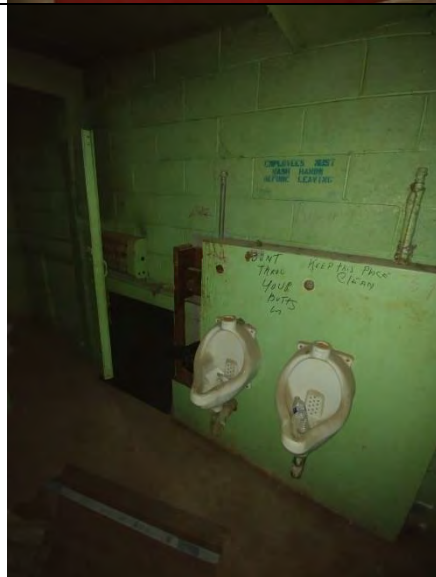
Photo Number: 133

Description
N Bldg Mens
Restroom –
Fair to Poor

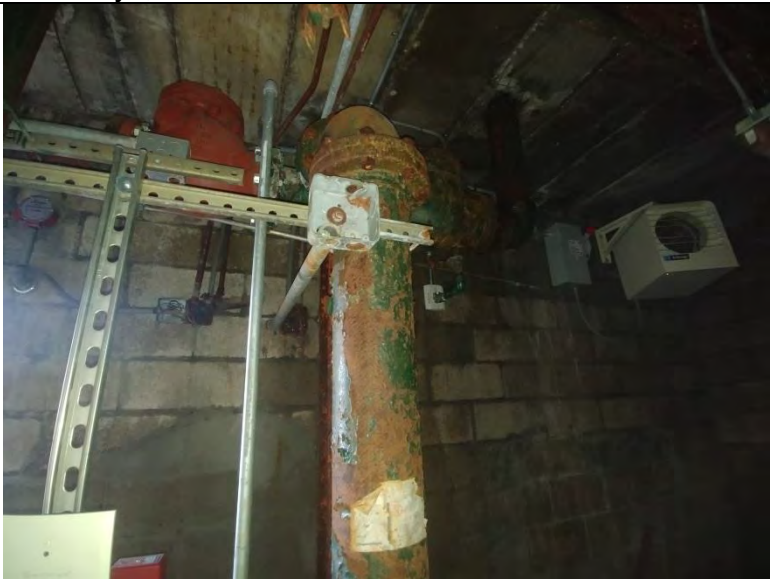
Photo Number: 134

Description
N Bldg
Sprinkler Pipes
– Fair to Poor
