**Empire Offshore Wind
Final Environmental
Impact Statement
Volume 6 Part H EAF Appendix K**
September 2023

Appendix K Existing Conditions Report, June 2018

Existing Conditions Report

269 37th Street
Brooklyn, New York

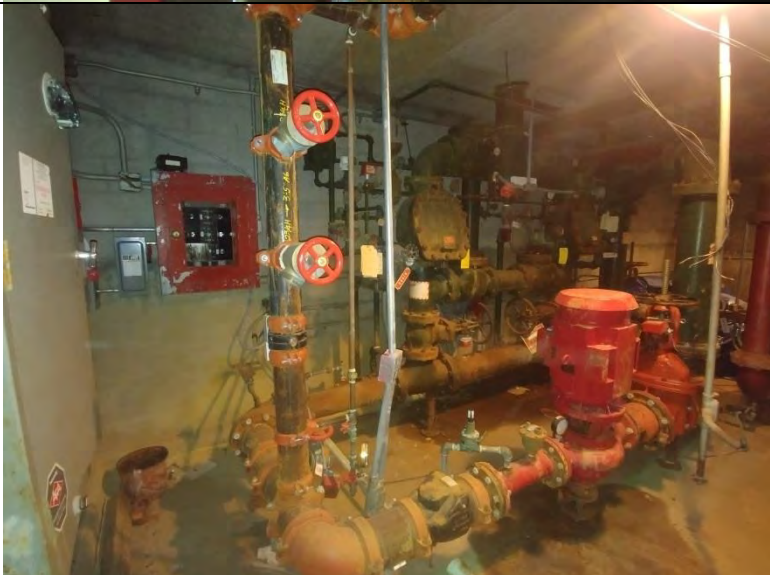
Photo Number: 135

Description
J2 Shed Fire
Sprinkler
Control Valves
& Pipes Room
– Poor

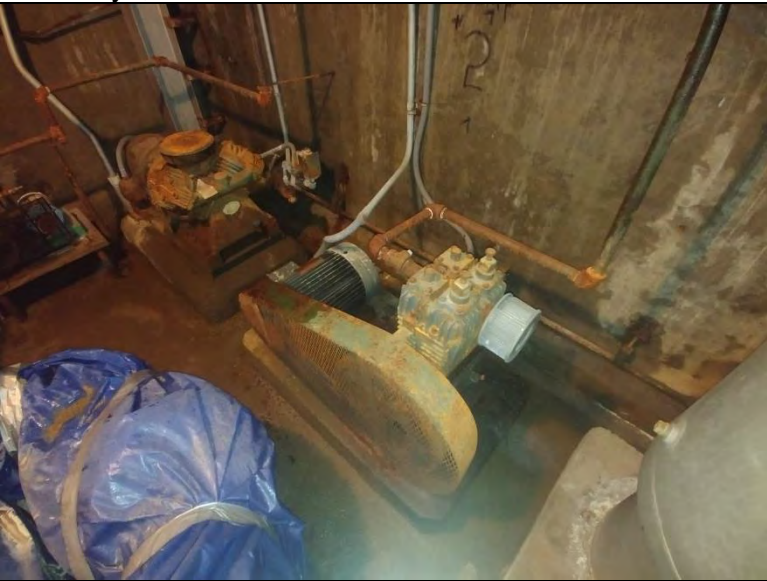
<p>Photo Number: 137</p> <p>Date Taken January 24, 2018</p> <p>Description J2 Shed Mechanical Motor - Fail</p>

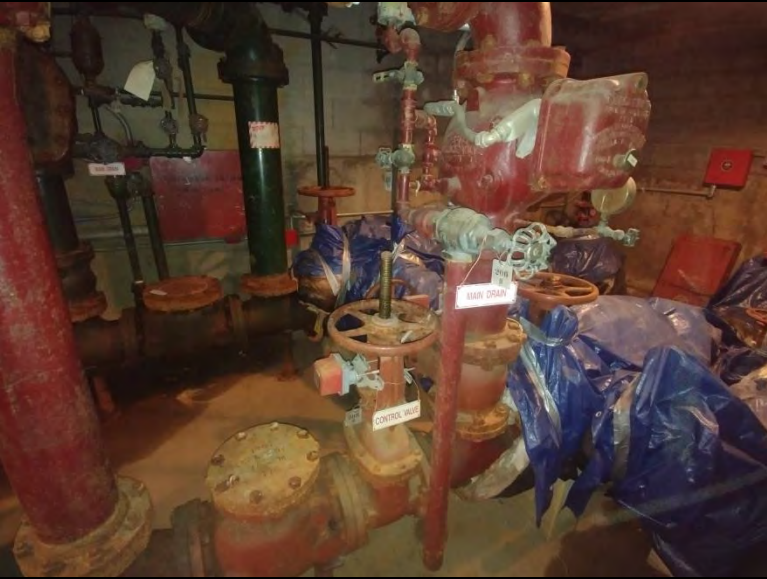
<p>Photo Number: 138</p> <p>Date Taken January 24, 2018</p> <p>Description J2 Shed Fire Sprinkler Main Valve – Poor</p>

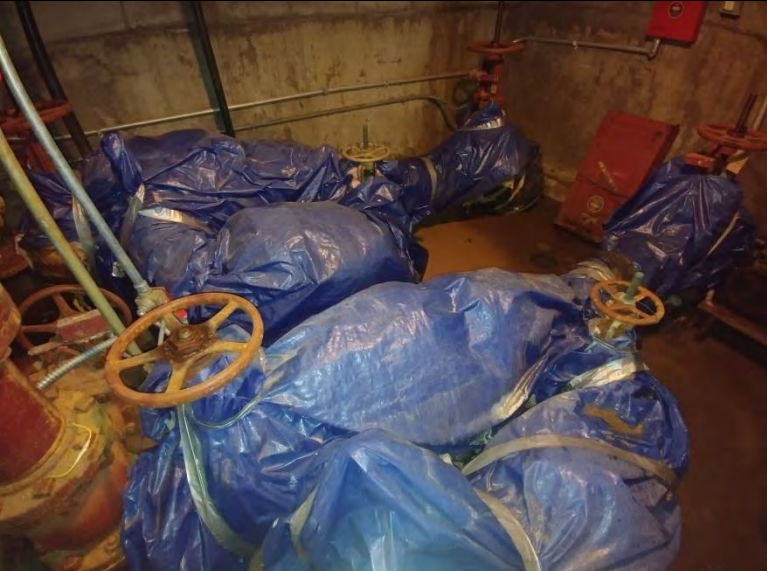
<p>Photo Number: 139</p> <p>Date Taken January 24, 2018</p> <p>Description J2 Shed Fire Sprinkler Valves & Pipe – Poor</p>

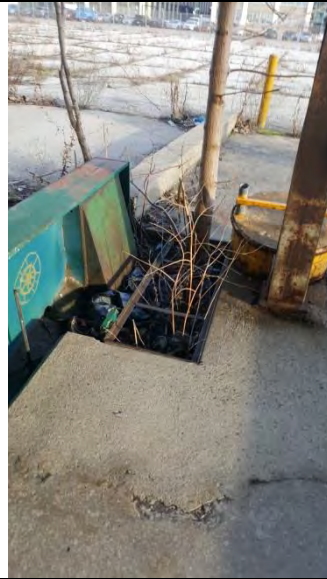
Photo Number: 176

Description
Tower Building
– Broken
exterior stairs
on East side of
building

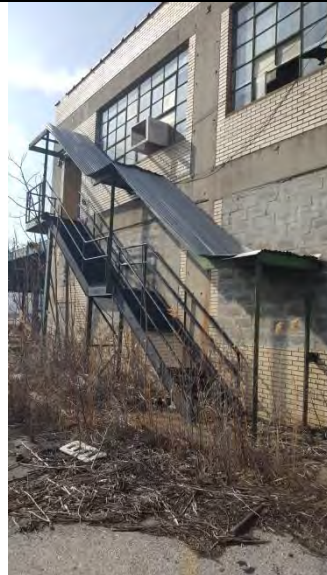
Photo Number: 177

Description
Tower Building
- Broken
exterior stairs
on East side of
building

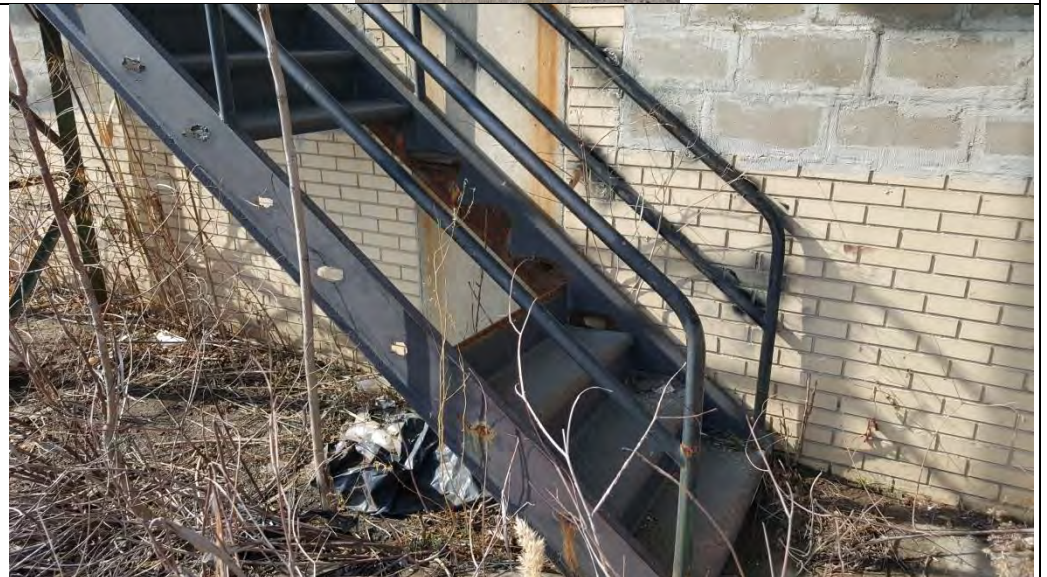
Photo Number: 178

Description
Tower Building
- Broken
exterior stairs
on East side of
building

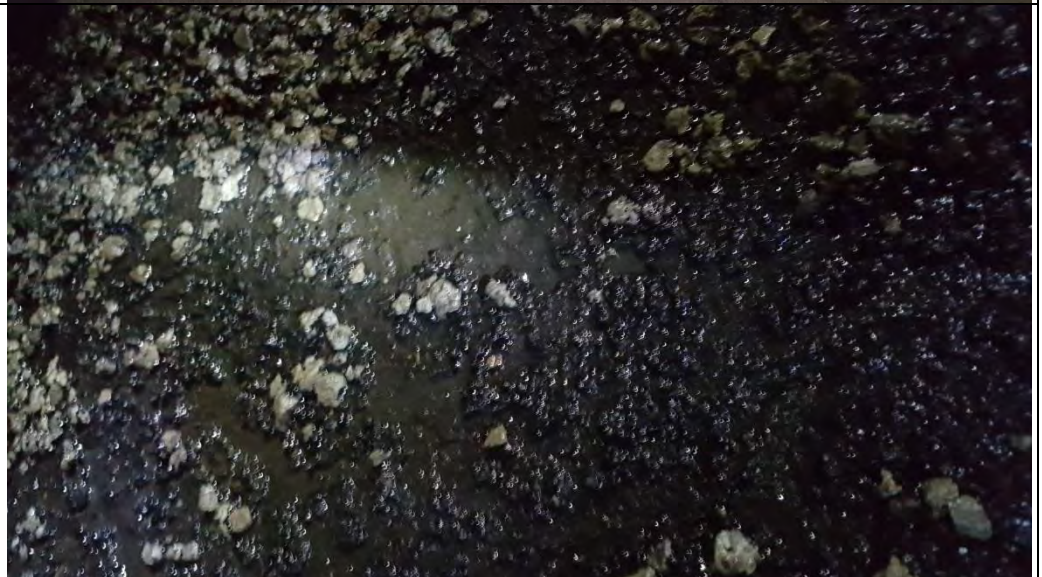
Photo Number: 182

Description
Tower Building
– Ponding water and blistered/ bubbling roof membrane

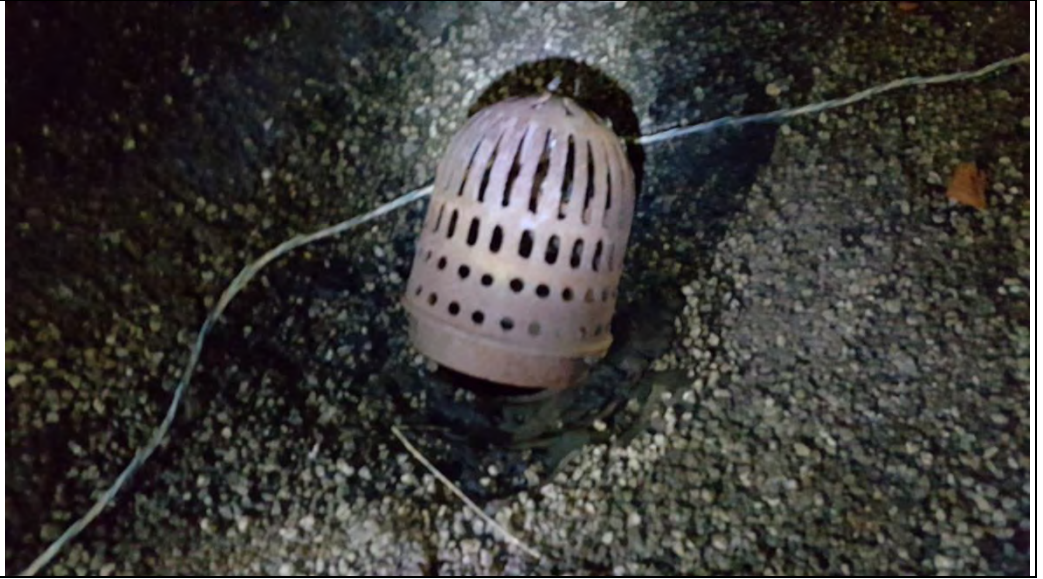
Photo Number: 191

Description
Tower Building
– Drain cover
damaged

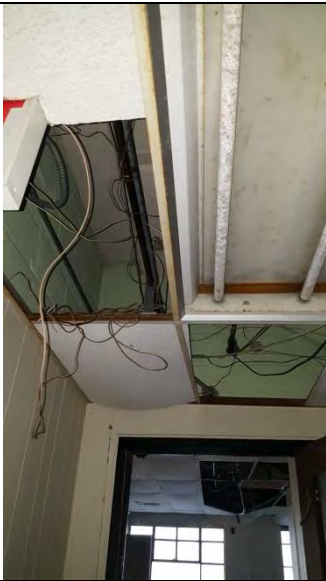
<p>Photo Number: 198</p> <p>Date Taken February 20, 2018</p> <p>Description Tower Building - Damaged wall in office area. Pipe observed cut from heating system</p>

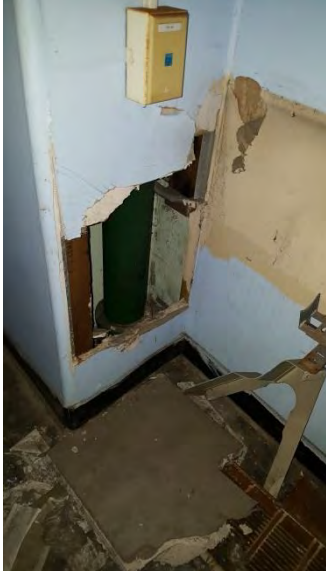
<p>Photo Number: 199</p> <p>Date Taken February 20, 2018</p> <p>Description Tower Building - Heating system removed and pipes cut in office area</p>

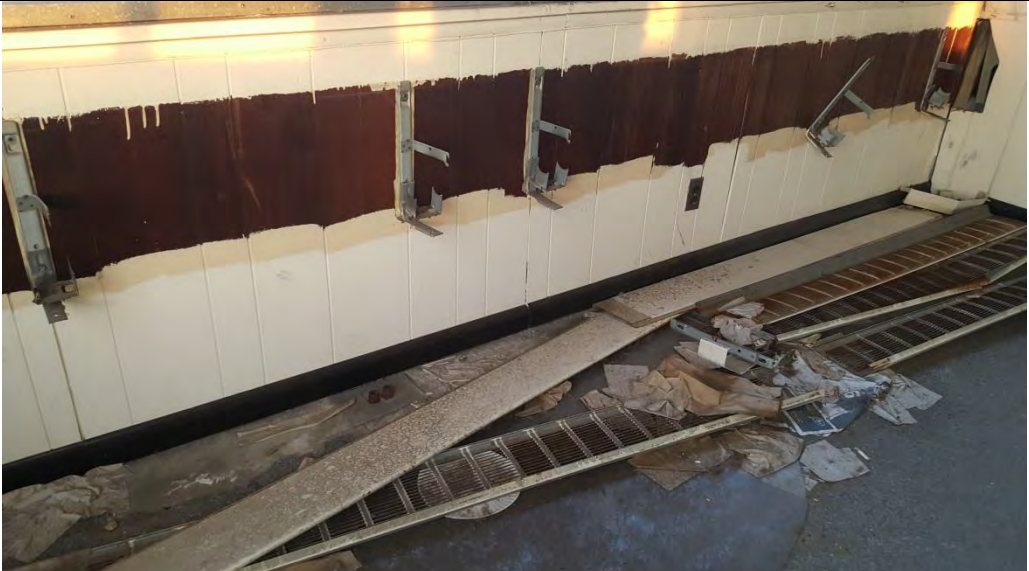
Photo Number: 200

Description
Tower Building
– Wall
damaged in
office area

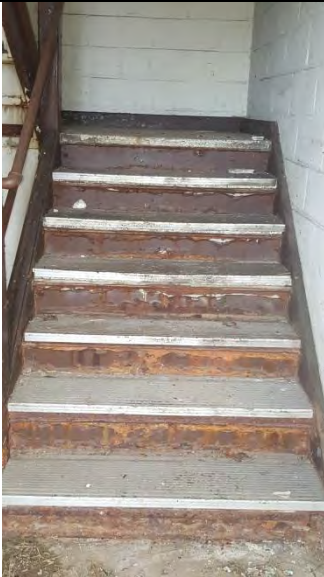
<p>Photo Number: 207</p> <p>Date Taken February 20, 2018</p> <p>Description Tower Building – reinforced steel channels on stairs. Rusted stairs</p>

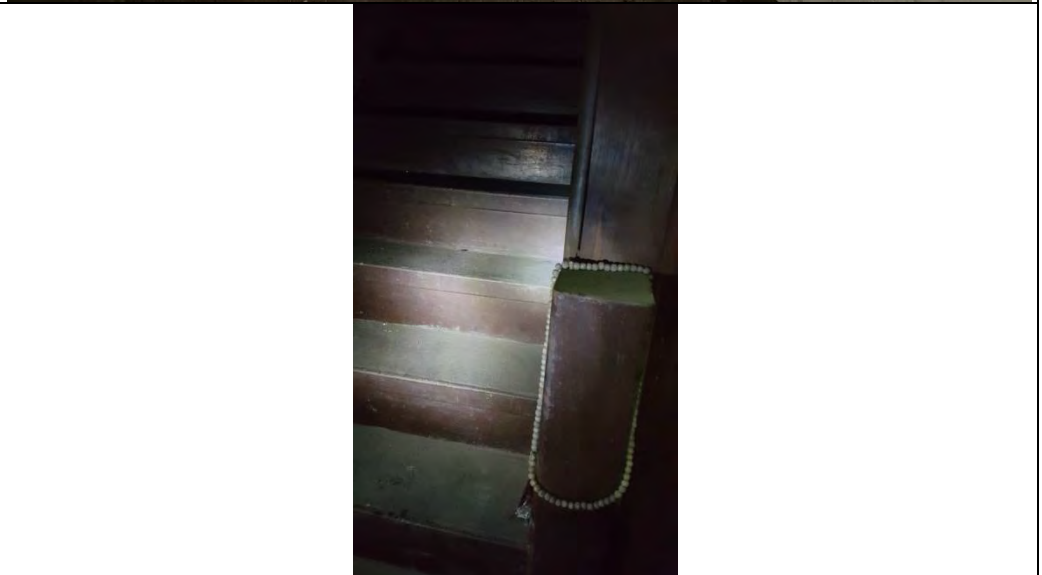
Photo Number: 214

Description
Tower Building
– Pooling in on
landing
(excessive
moisture
observed
throughout
entire staircase.
Walls sweating
and mold

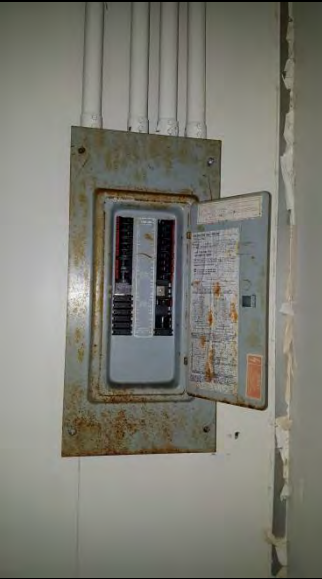
<p>Photo Number: 227</p> <p>Date Taken February 20, 2018</p> <p>Description Tower Building - Office Space Electrical Panel</p>

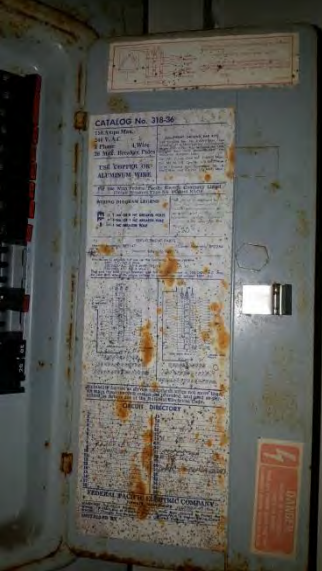
<p>Photo Number: 228</p> <p>Date Taken February 20, 2018</p> <p>Description Tower Building - Office Space Electrical Panel</p>

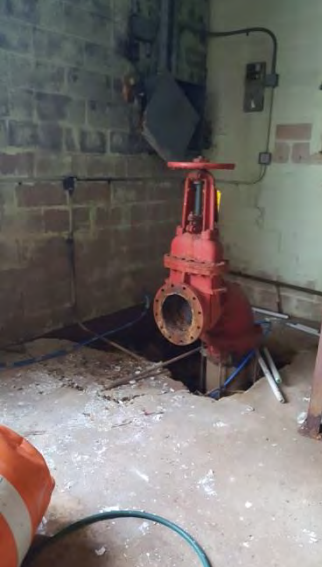
<p>Photo Number: 229</p> <p>Date Taken February 20, 2018</p> <p>Description Tower Building - Fire Sprinkler Valve</p>

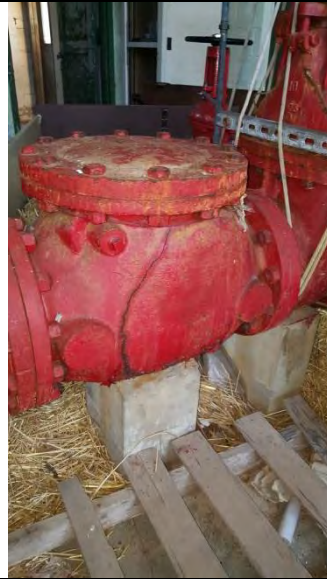
Photo Number: 233

Description
Tower Building
– Firepump
valve

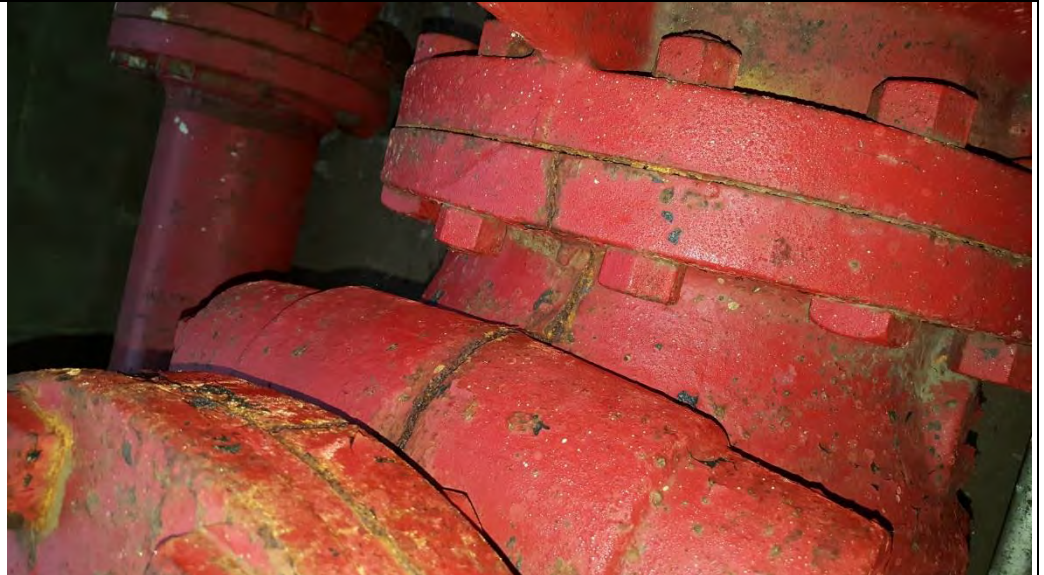
Photo Number: 234

Description
Tower Building
– Fire Pump
Discharge
Flange

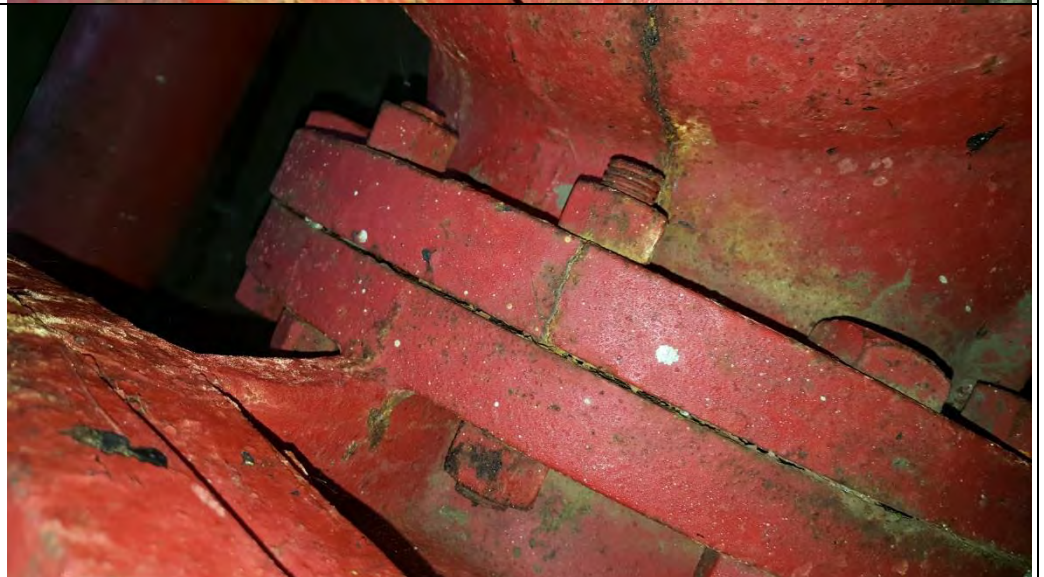
Photo Number: 235

Description
Tower Building
- Fire Pump
Discharge
Flange

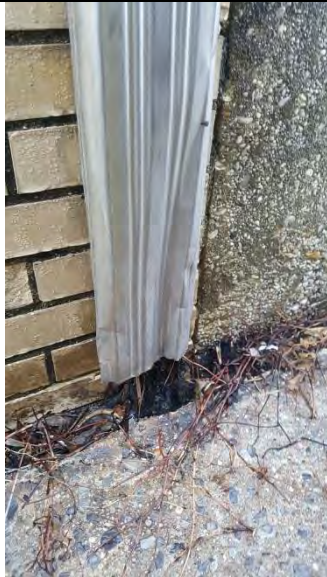
<p>Photo Number: 237</p> <p>Date Taken February 20, 2018</p> <p>Description Tower Building – Roof Drainage</p>

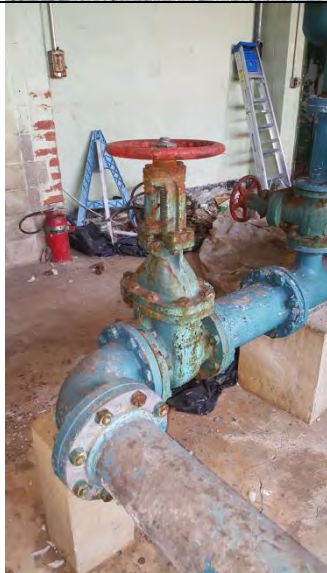
<p>Photo Number: 238</p> <p>Date Taken February 20, 2018</p> <p>Description Tower Building – Water main Valve</p>

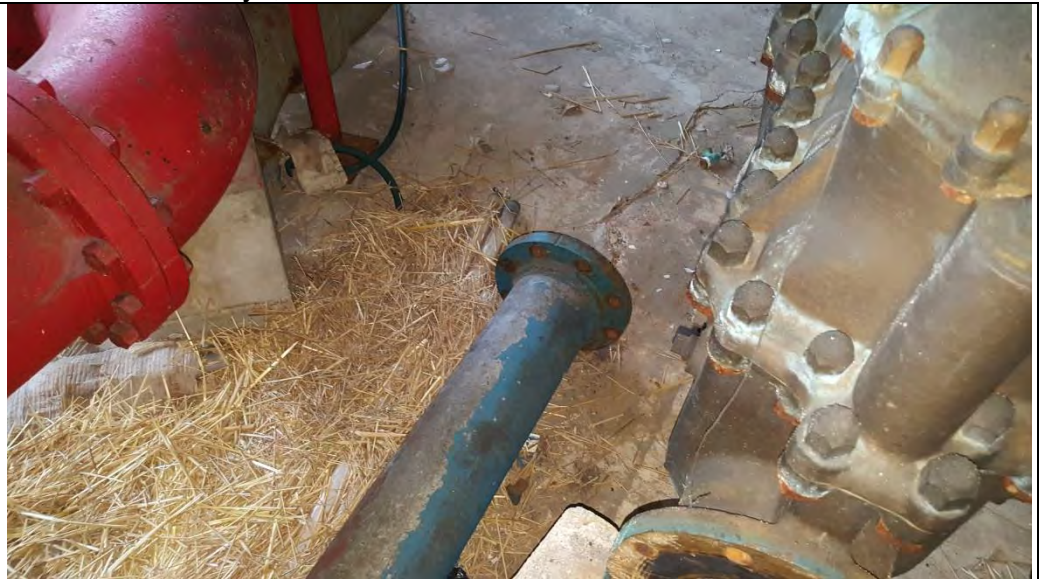
Photo Number: 239
Date Taken
February 20, 2018
Description
Tower Building
– Water main
pipe
unattached

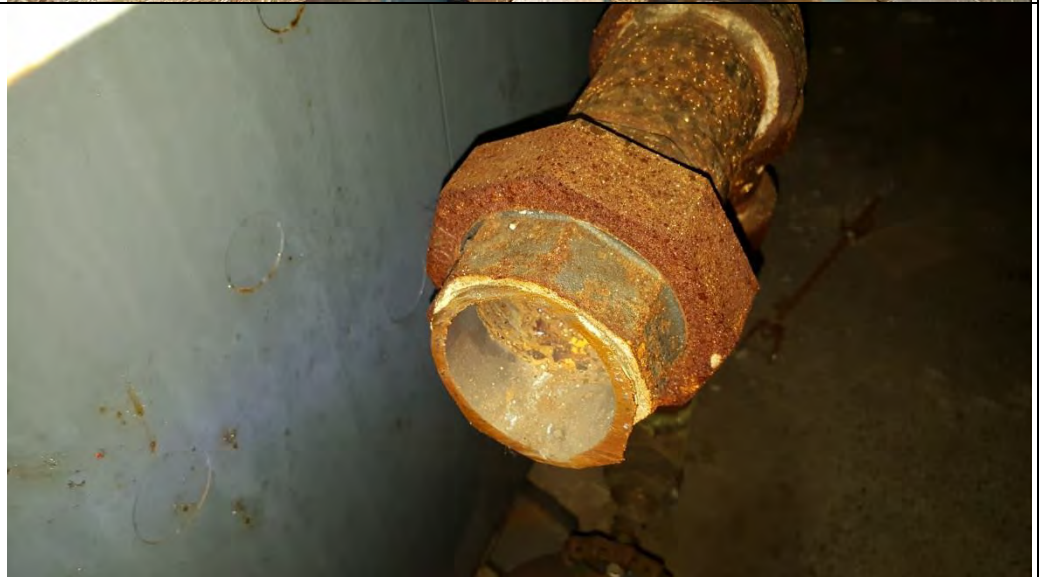
Photo Number: 240
Date Taken
February 20, 2018
Description
Tower Building
– Hydronic
Heating system
outlet pipe cut

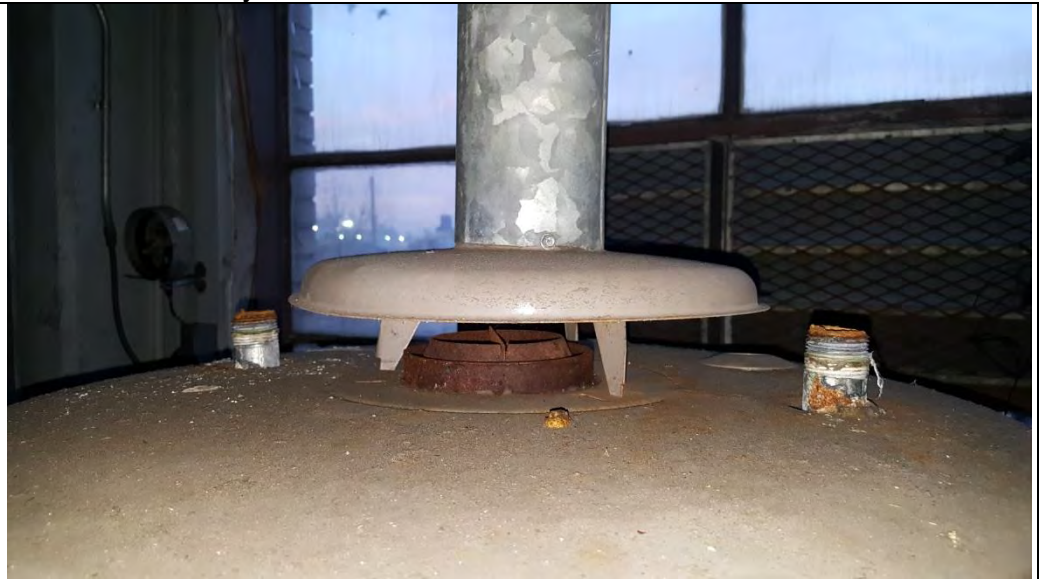
Photo Number: 242

Description
Tower Building
– Domestic Hot
Water heater
Inlet and outer
pipes cut.

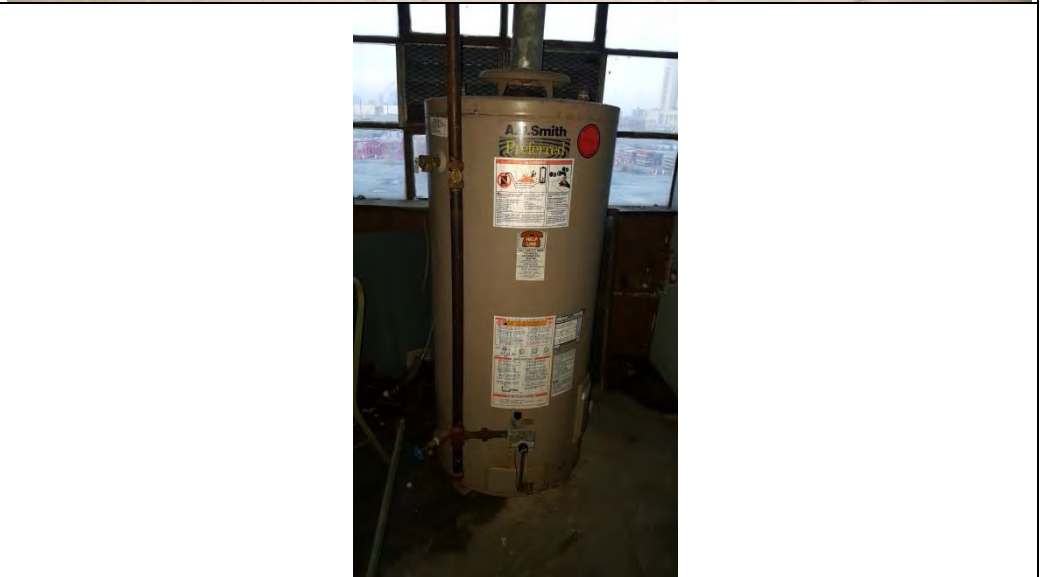
Photo Number: 243

Description
Tower Building
– Domestic Hot
Water Heater

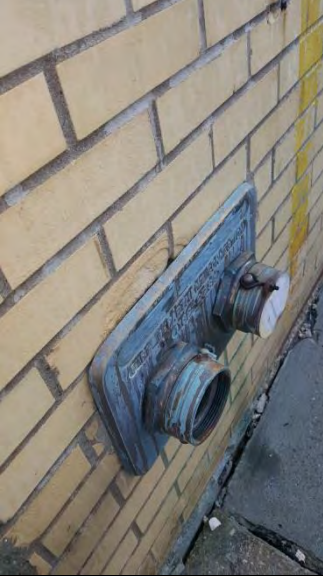
<p>Photo Number: 245</p> <p>Date Taken February 20, 2018</p> <p>Description Tower Building – Exterior standpipe connection</p>
